**ANALYTICAL RESULTS REPORT
SITE INSPECTION**

**GOLD HILL TAILINGS SITE
EPA ID# COD983801275**

**U.S. ENVIRONMENTAL PROTECTION AGENCY
REGION VIII**

October 14, 1994

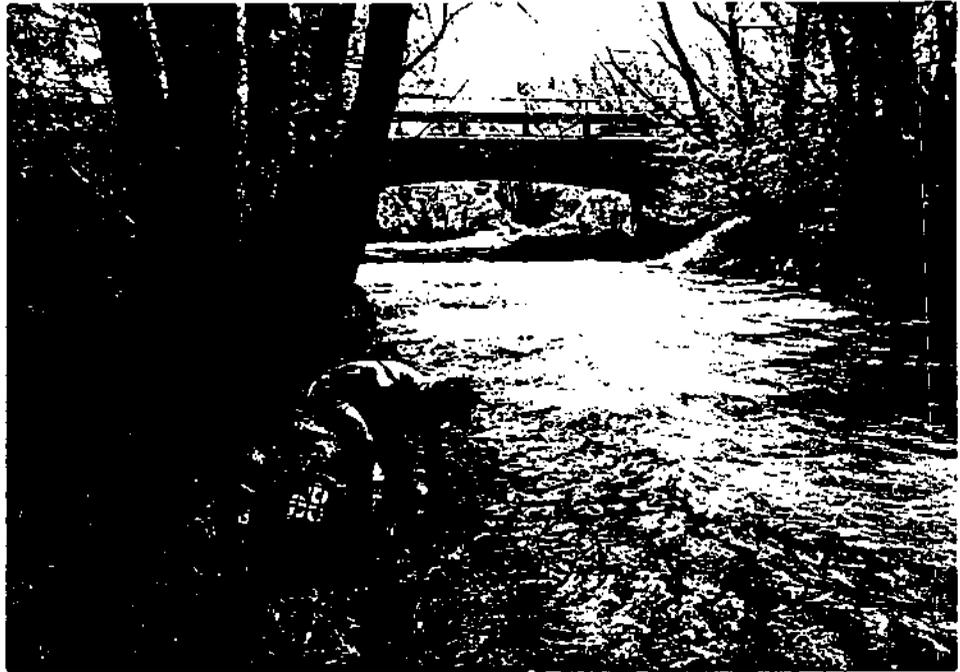
Photo No.
1

Photographer/Witness Mark Lunsford
Date 5/17/94 Time 1100 Direction Southeast
Description MK collecting upstream surface water sample GH-SW-1 from Fountain Creek. The 21st street bridge is downstream. Sediment sample GH-SE-1 was collected in center of stream at this location.

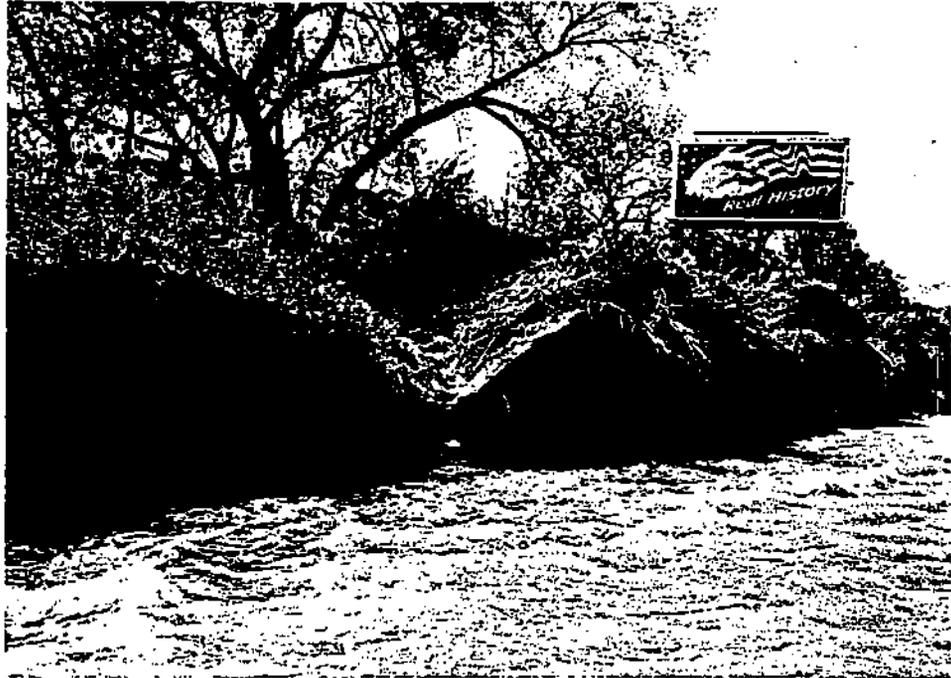
Photo No.
5

Photographer/Witness Mark Lunsford
Date 5/17/94 Time 1535 Direction West
Description "Mouth" of drainage channel from north central part of tailings pile. Sample GH-SE-3 was collected at edge of channel above Fountain Creek. Sample GH-SW-3 was collected in the creek beneath the 2-foot drop from the channel.

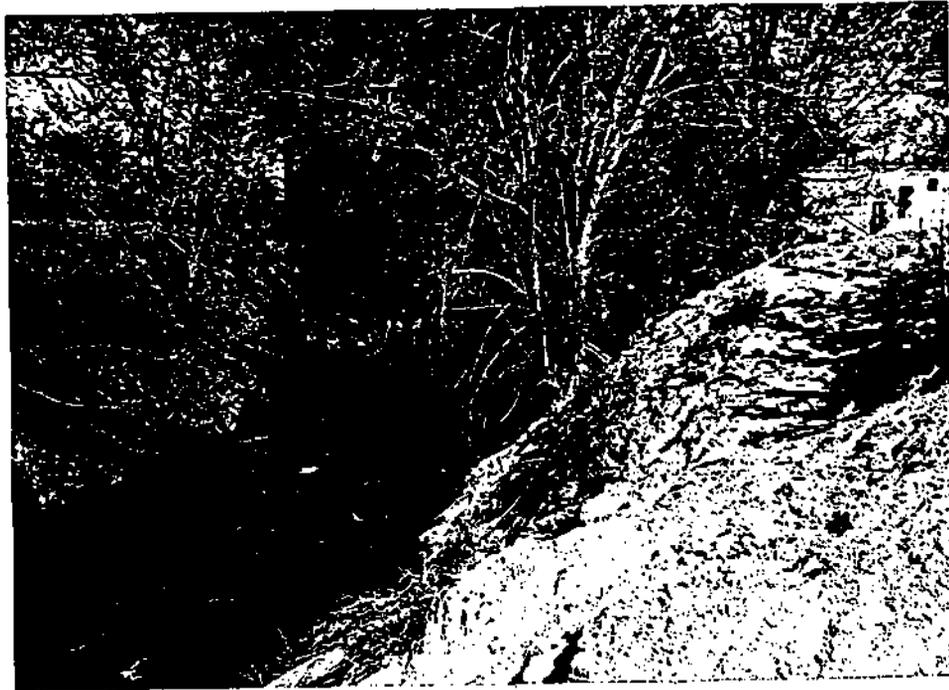
Photo No.
9

Photographer/Witness Mark Lunsford
Date 5/17/94 Time _____ Direction East
Description Tailings material in drainage channel from northeast face of pile enters
Fountain Creek at this location.

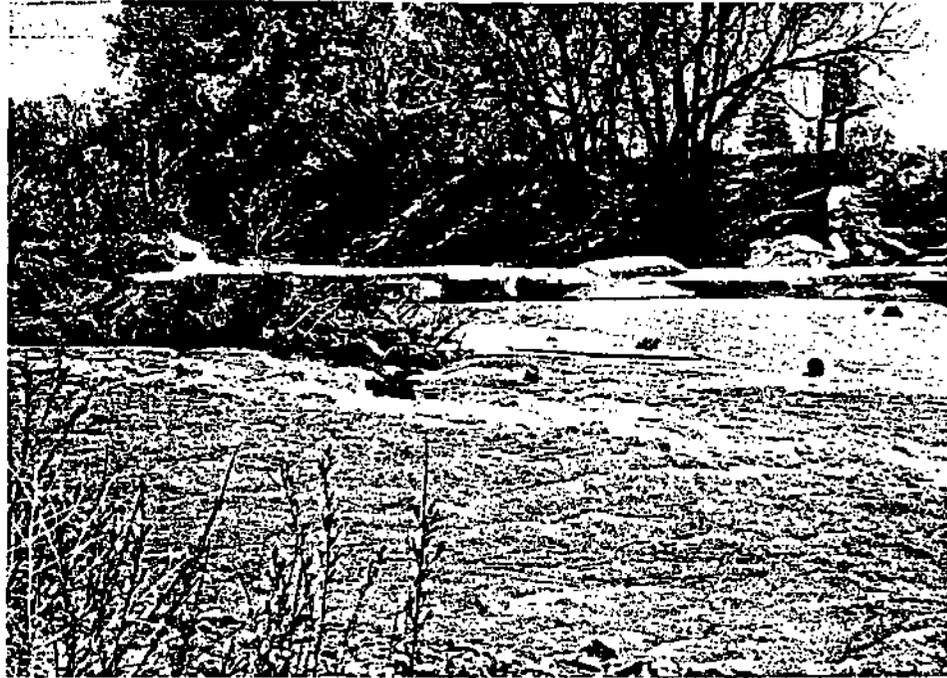
Photo No.
11

Photographer/Witness Mark Lunsford
Date 5/11/94 Time 1755 Direction Northeast
Description Confluence of Fountain Creek (on left) and Monument Creek (on right)
from beneath Cimarron Street bridge. Sample GH-SE-5 was collected from small pool of
water in Fountain Creek adjacent to sand spit separating the creeks. Sample GH-SW-5 was
collected near the west bank of Fountain Creek in lower portion of photo.

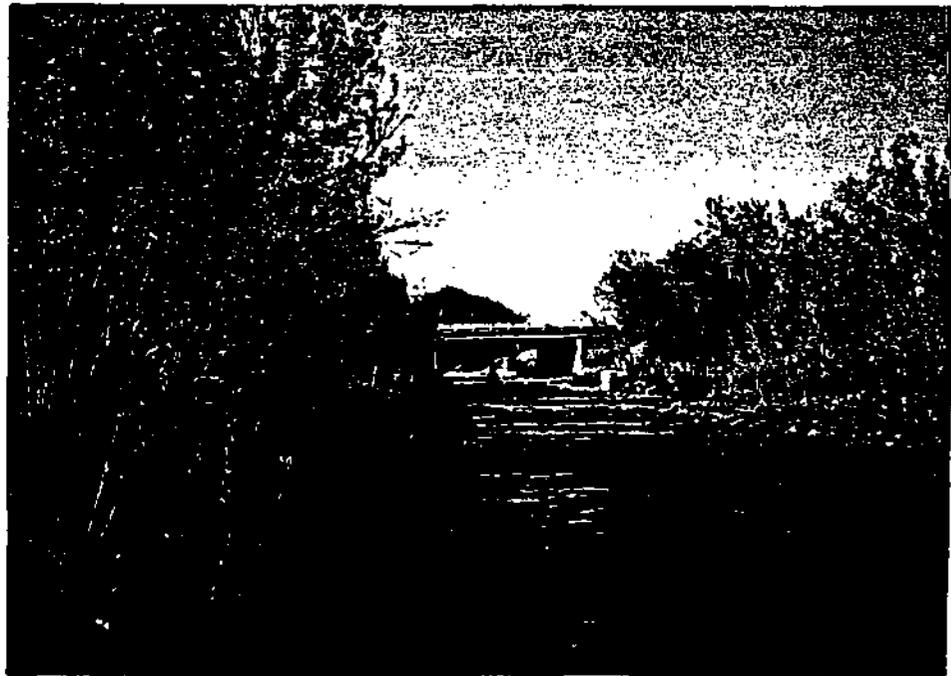
Photo No.
12

0.1 mile of wetland frontage (see photo #12). This sample point is located downstream of the mixing zone below the confluence. This mixing zone was obvious because of color differences in the creeks. Above the confluence Fountain Creek was a turbid, rust-brown color. Monument Creek was a turbid greenish-gray color (see photo #11). The mixing zone extended downstream from the Cimarron Street bridge.

Photographer/Witness Mark Lunsford
Date 5/17/94 Time _____ Direction North
Description Looking upstream toward Cimarron Street bridge from sample location GH-SE-6.
Scrub-shrub wetlands are present in this segment of Fountain Creek.

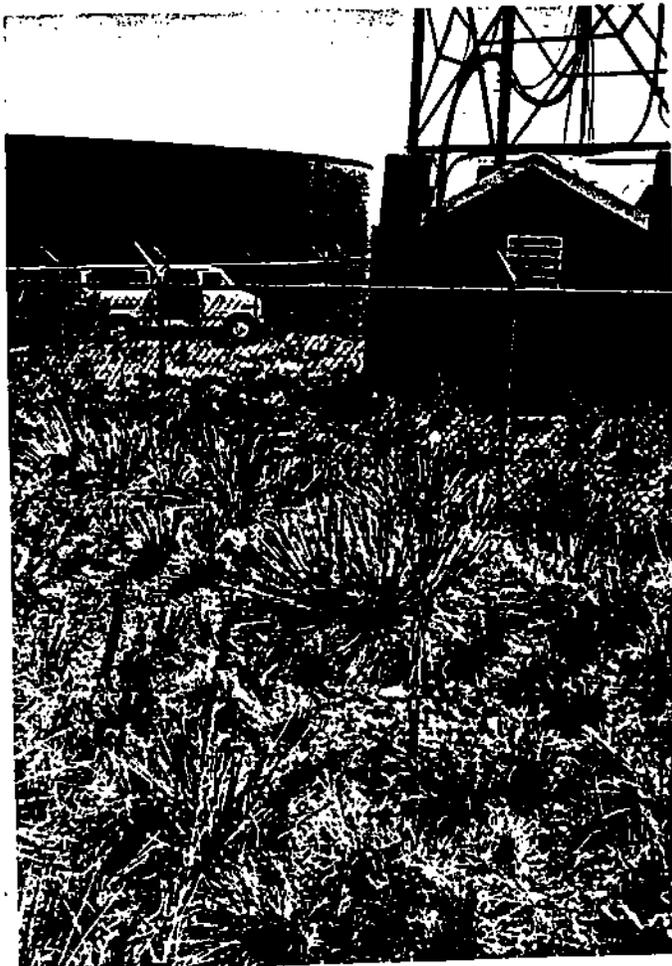
16

Photographer/Witness Mark Lunsford
Date 5/17/94 Time 1405 Direction SSE
Description View of background soil sample
(GH-SQ-1) location. The red building is at the
base of a radio tower. The City of Colorado
Springs "Little Mesa" water storage tank is in
the background.

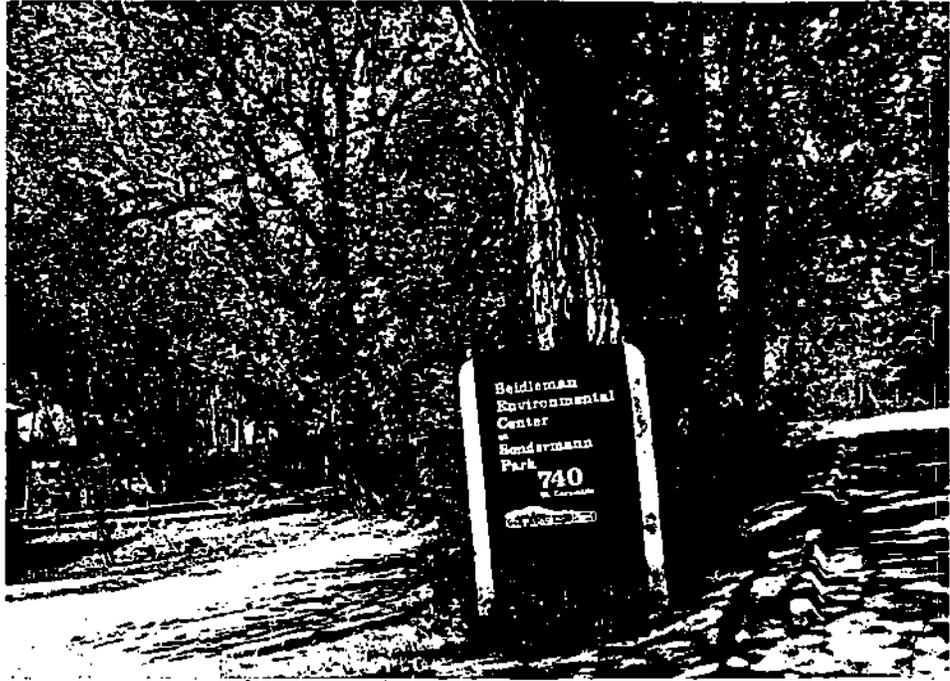
Photographer/Witness Wesley Hill
Date 5/17/94 Time 1035 Direction West
Description Entry sign to the Colorado Springs city park where background soil sample
GH-SO-2 was collected.

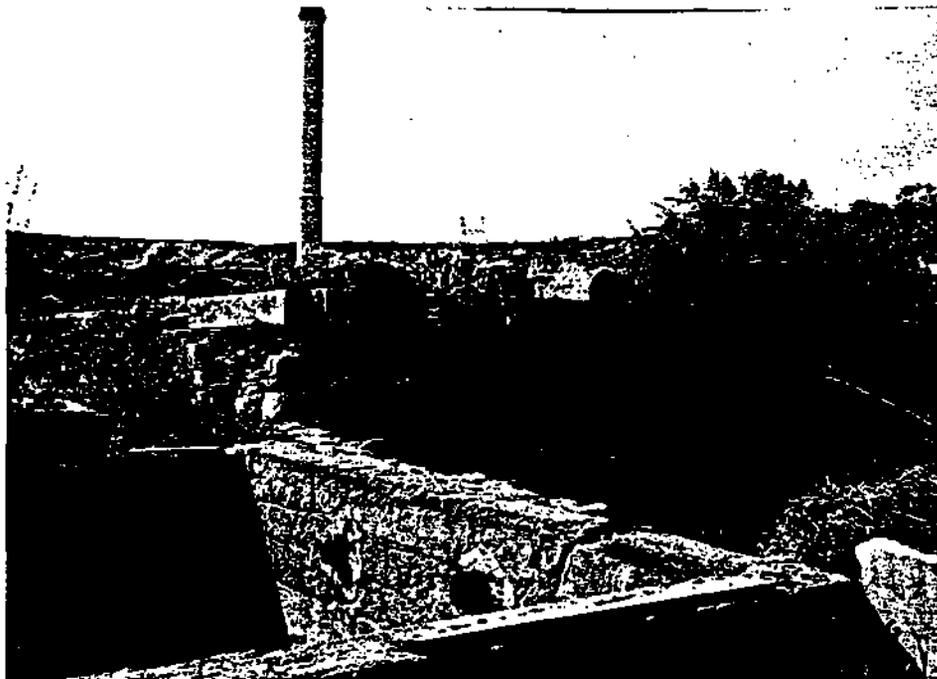
Photographer/Witness Mark Lunsford
Date 5/19/94 Time 0920 Direction ESE
Description Wall at center right is east wall of the filter basement in the "slime" room
of the millsite. Sample GH-SO-4 was collected near the east wall.

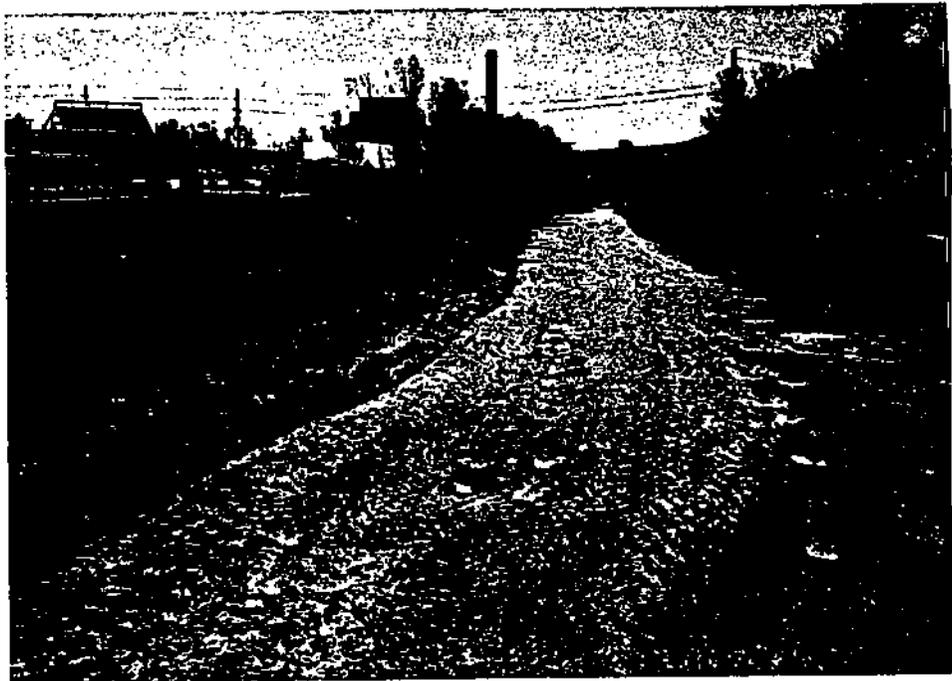
Photo No.
28

Photographer/Witness Mark Lunsford
Date 5/11/94 Time _____ Direction South
Description View of Monument Creek downstream (south) from RR bridge north of confluence with Fountain Creek. Line of young willow trees on east bank (at left) demarcates edge of wetland fringe.
