Coastal Home Inspections LLC

Property Inspection Report

309 Elwood Pl., Gulfport, MS 39507
Inspection prepared for: Ken Lefebvre
Date of Inspection: 3/10/2018 Time: 1:00pm
Age of Home: 51yrs Size: 2104 sq ft
Weather: Partly Cloudy

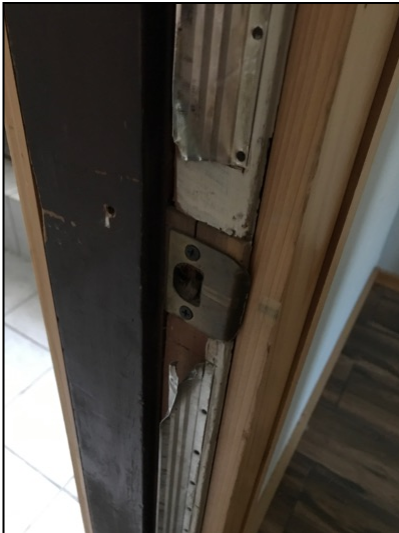
Door jam damaged leading from living room to fireplace room.

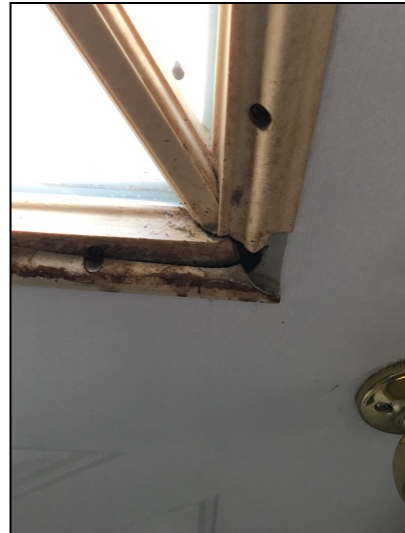
Window casing in door leading to open patio damaged.

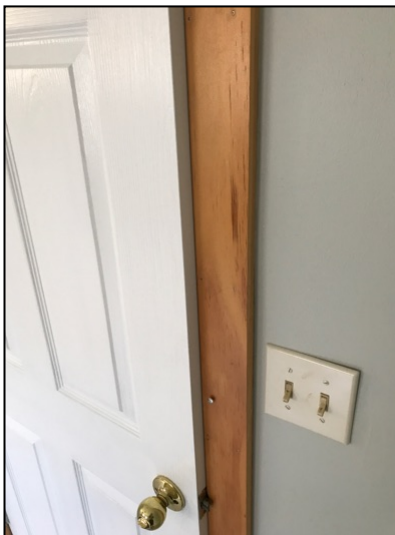
Door to room behind garage doesn't close.

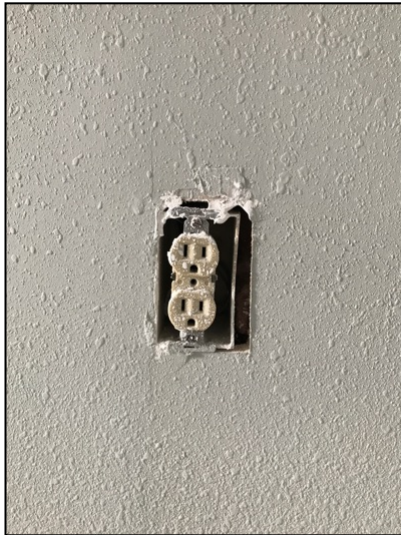
Some receptacles were painted over.

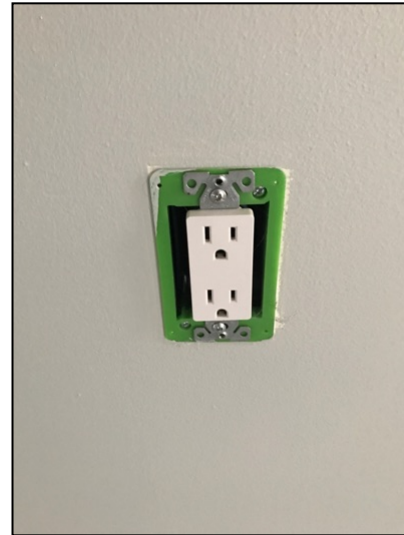
Missing outlet covers in room behind garage and room with fireplace.

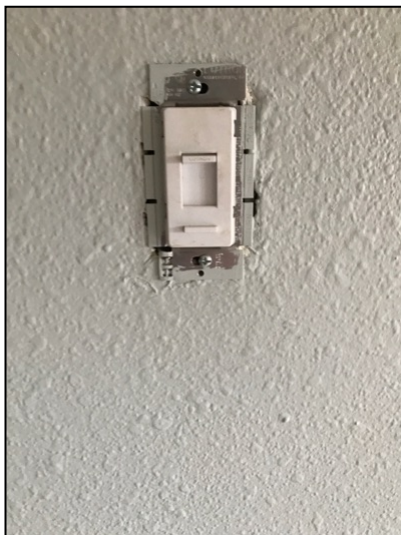
Switch cover plates missing on hallway light.

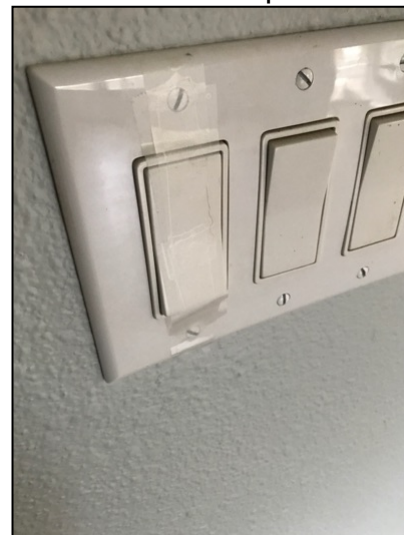
Tape over switch by front door.

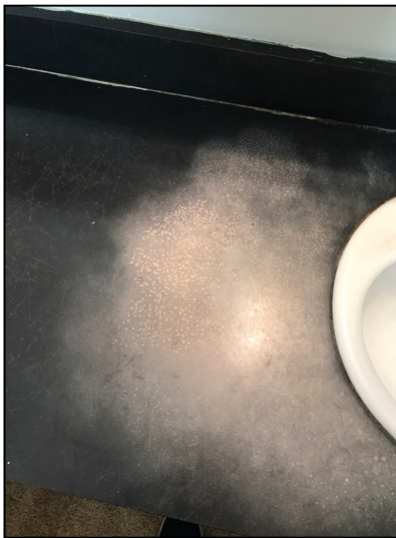
The counter tops appear to be worn and may have reached the end of their useful life.

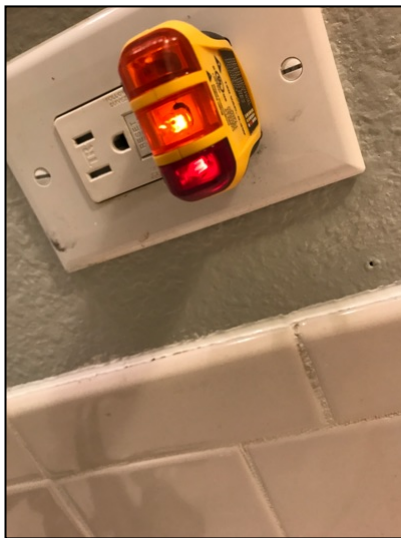
Hot-neutral reversed outlets present. This means that the black and white wires in the circuit have been reversed.

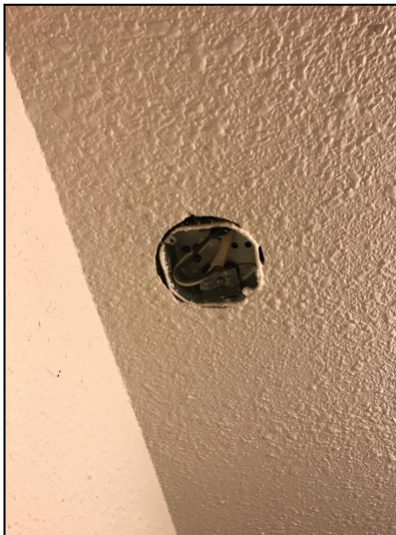
Open junction box.

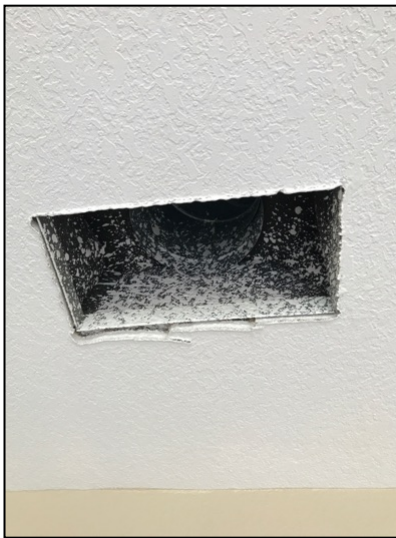
There is a missing vent air grill noted in area behind garage.

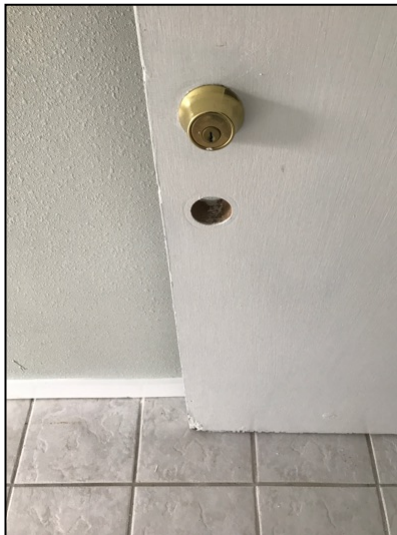
<p>Doorknob is missing.</p>		
Page 24 Item: 6	Fire Door	<ul style="list-style-type: none"> • The door between the garage & house is not a fire rated door. This may not have been required when originally built. Fire doors are fundamental to the integrity of fire barriers which provide resistance to the spread of fire, smoke, and toxic gasses. This means that should a fire occur in the garage, this door does not afford protection until fire-rescue people arrive. This door should be replaced with a fire rated door.
Page 24 Item: 7	Garage Door Condition	<ul style="list-style-type: none"> • Could not operate with normal opener. May be due to lack of electricity.

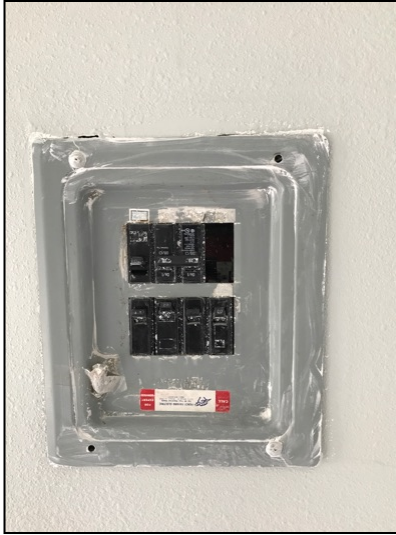
Sub panel door missing on sub panel behind garage.

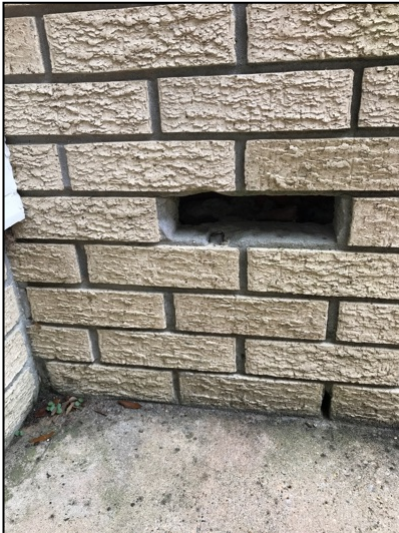
Brick missing by front door.

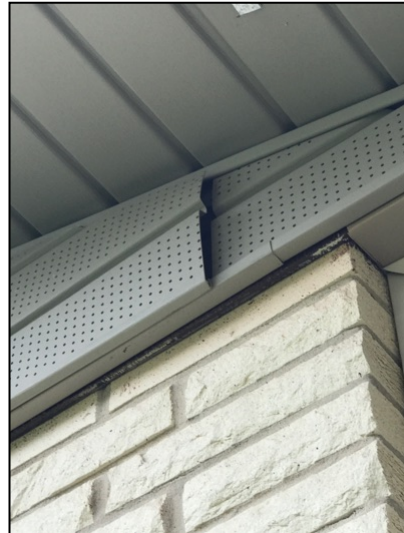
Some siding needs to be reset at front gable.

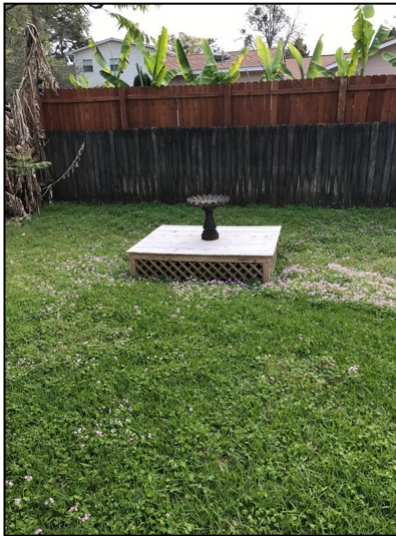
Possible drainage/clean out issues with "structure" built over drain.

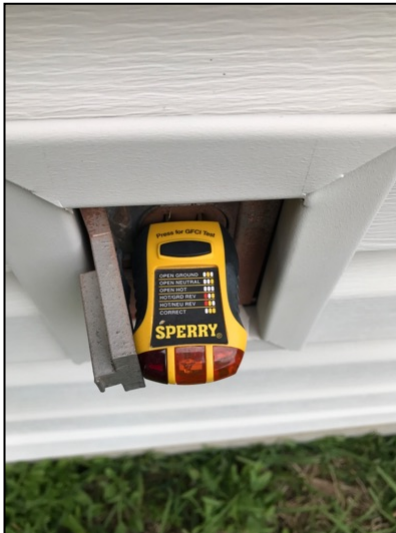
Outlet at rear of house not working. Outlet on non-enclosed patio section not GFCI protected.

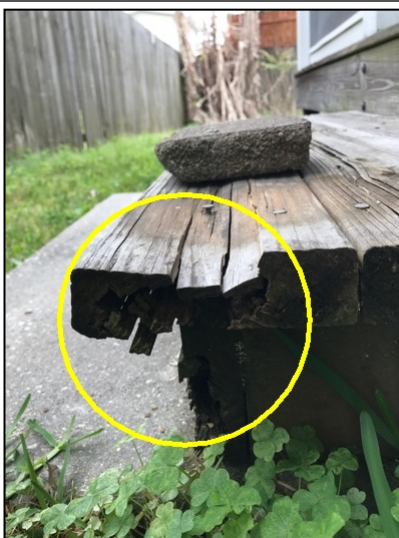
Rotted wood on steps East side of patio.

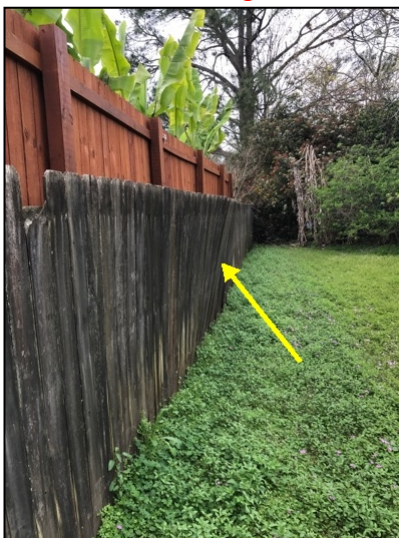
Fence leaning in areas.

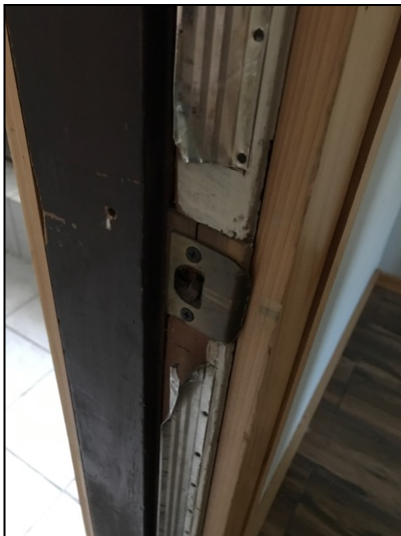
Door jam damaged leading from living room to fireplace room.

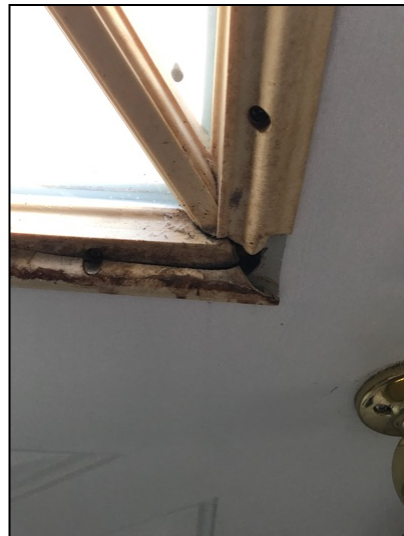
Window casing in door leading to open patio damaged.

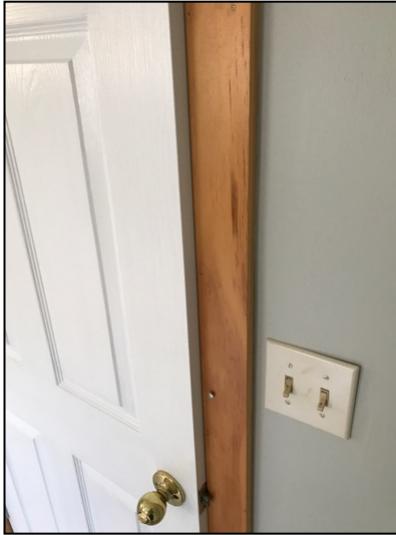
Door to room behind garage doesn't close.

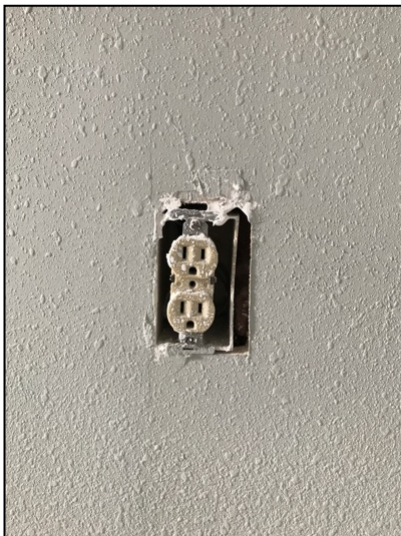
Some receptacles were painted over.

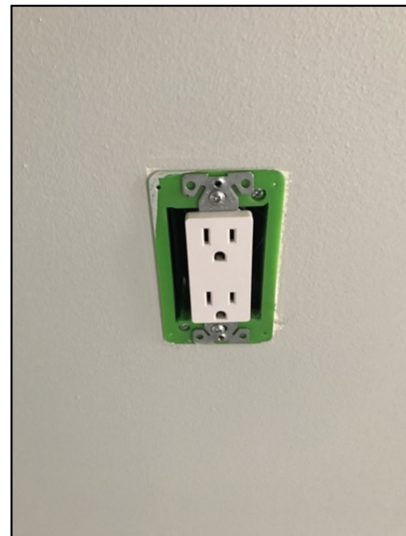
Missing outlet covers in room behind garage and room with fireplace.

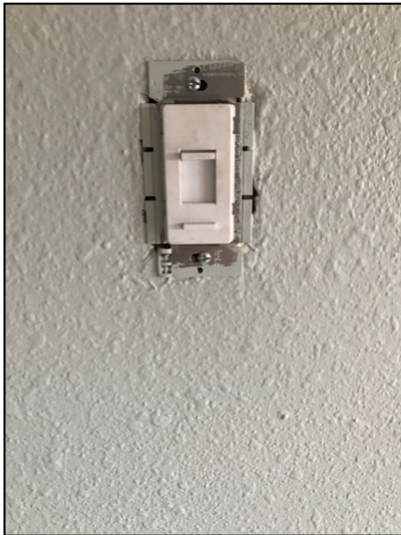
Switch cover plates missing on hallway light.

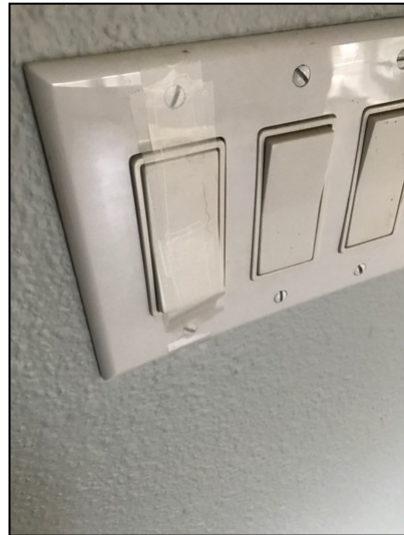
Tape over switch by front door.

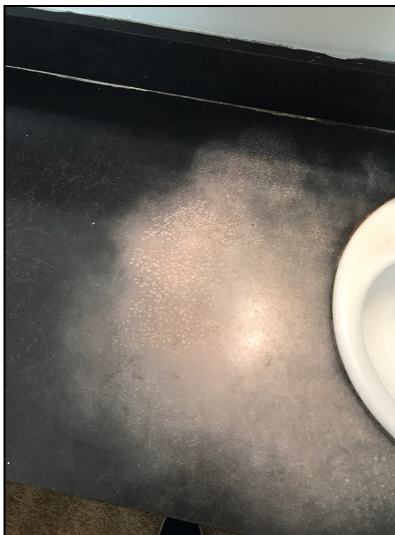
The counter tops appear to be worn and may have reached the end of their useful life.

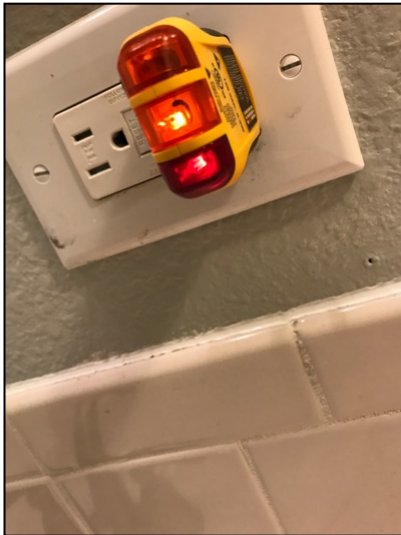
Hot-neutral reversed outlets present. This means that the black and white wires in the circuit have been reversed.

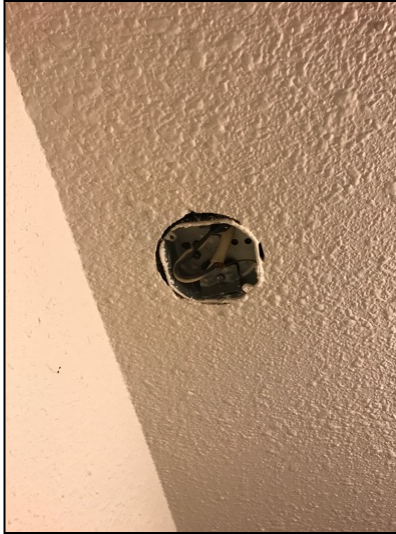
Open junction box.

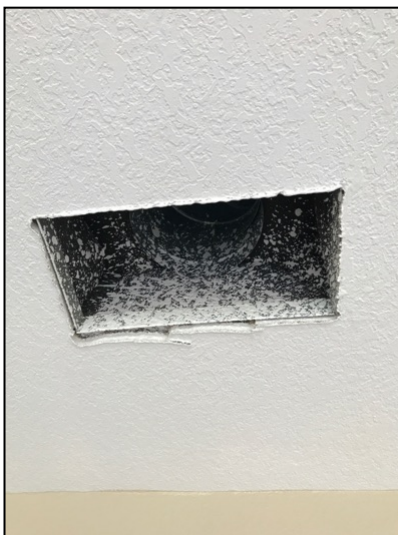
There is a missing vent air grill noted in area behind garage.

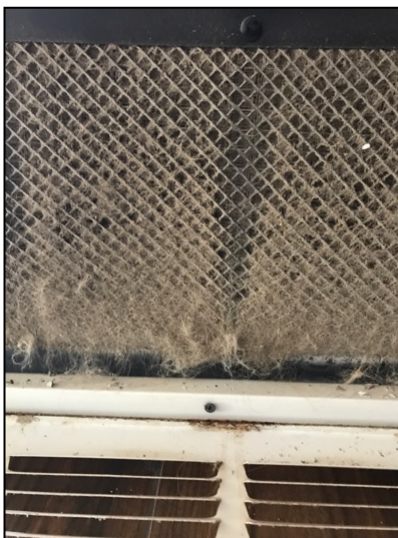
- Furnace filter dirty. Needs replacement.

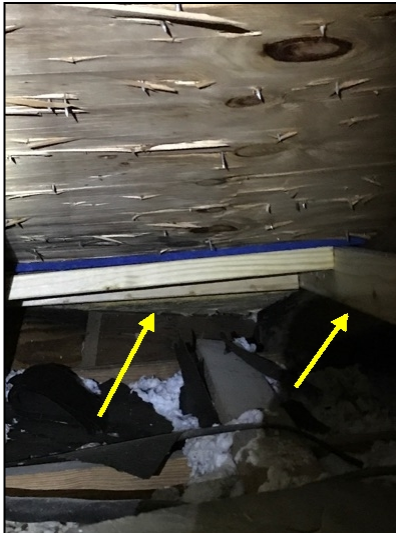
There were no major deficiencies of the roof structure at the time of inspection. There was signs of past repairs.

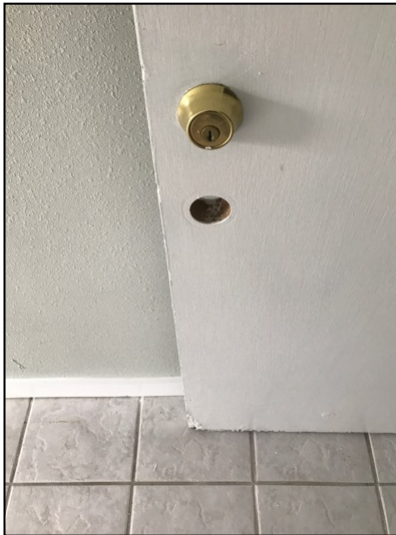
Doorknob is missing.

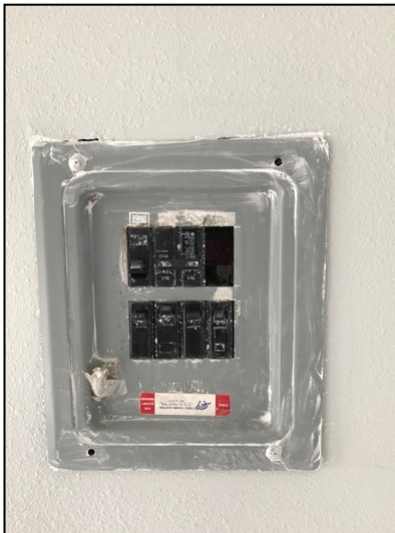
Sub panel door missing on sub panel behind garage.

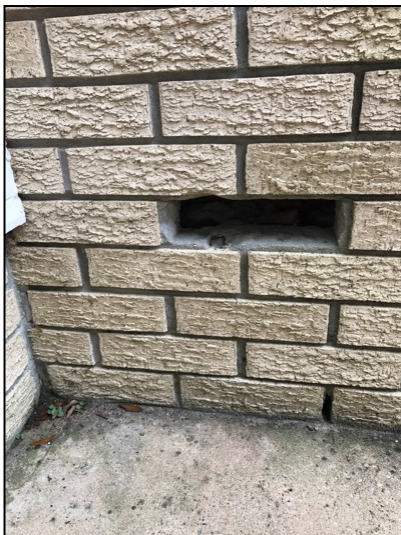
Brick missing by front door.

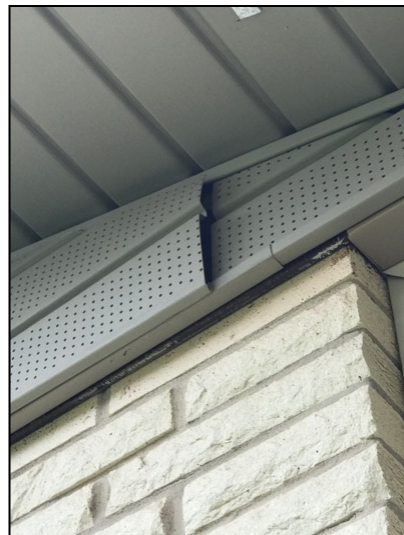
Some siding needs to be reset at front gable.

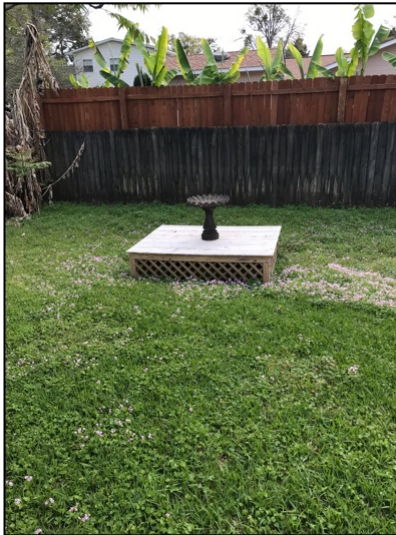
Possible drainage/clean out issues with “structure” built over drain.

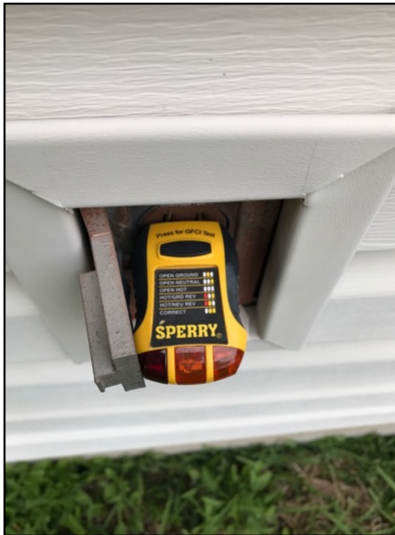
Outlet at rear of house not working. Outlet on non-enclosed patio section not GFCI protected.

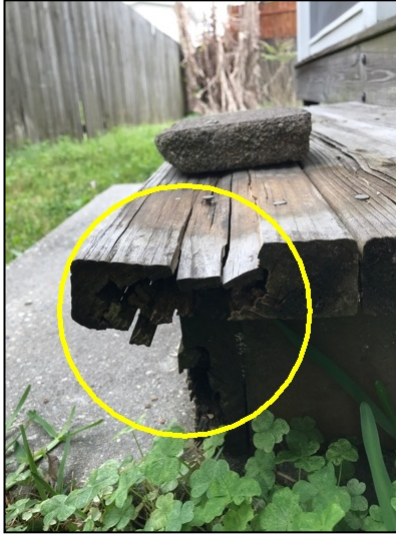
Rotted wood on steps East side of patio.

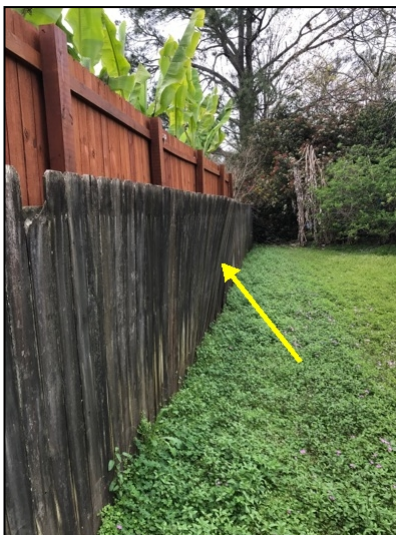
Fence leaning in areas.
