### Statement of Conditions that Affect EIFS Homes

The following is a case study of three homes. Two of these homes underwent the typical repairs as described previously. The third home shows what can happen even with proper sealant joints installed.

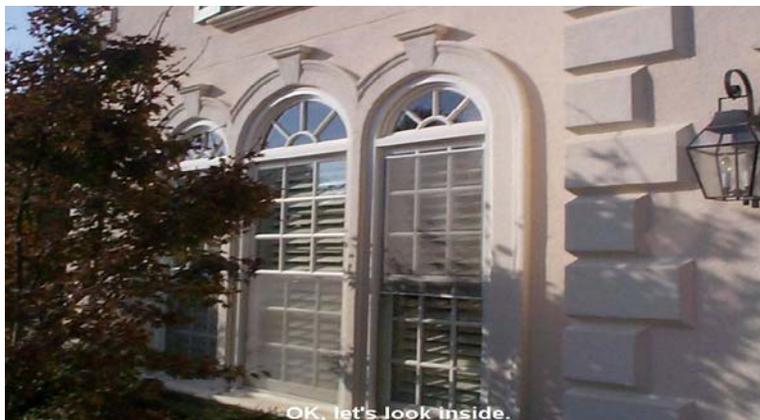
On the front left elevation of this home you will notice a triple-ganged set of double hung windows.

If you could inspect these windows, you would observe no metal head flash, but the overhang of the EIFS trim offers protection to the headers. You would also observe good working EIFS to wood sealant joints. If you looked at the window unit itself, you would not be able to detect any problems.

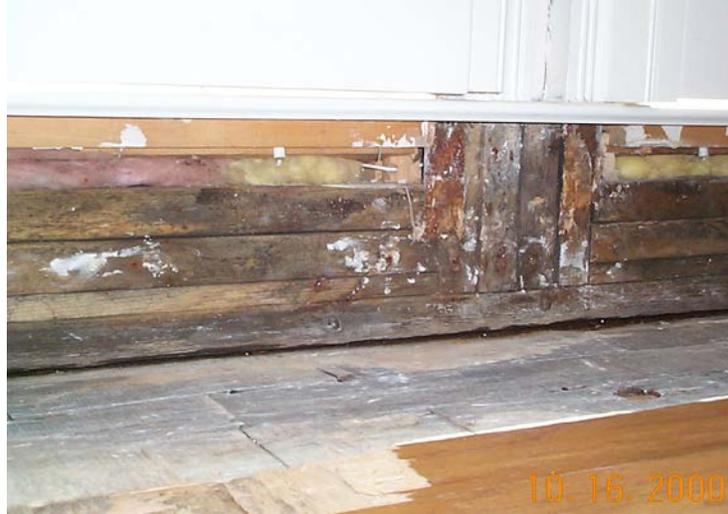
The complaint of the owner was very obvious.

He had discovered that his hardwood floor under the windows had rotted away. Once he discovered the problem, he removed the base board under the windows and found additional water damage beginning to take place in the framing. Notice the growth of mold on the framing and subfloor.

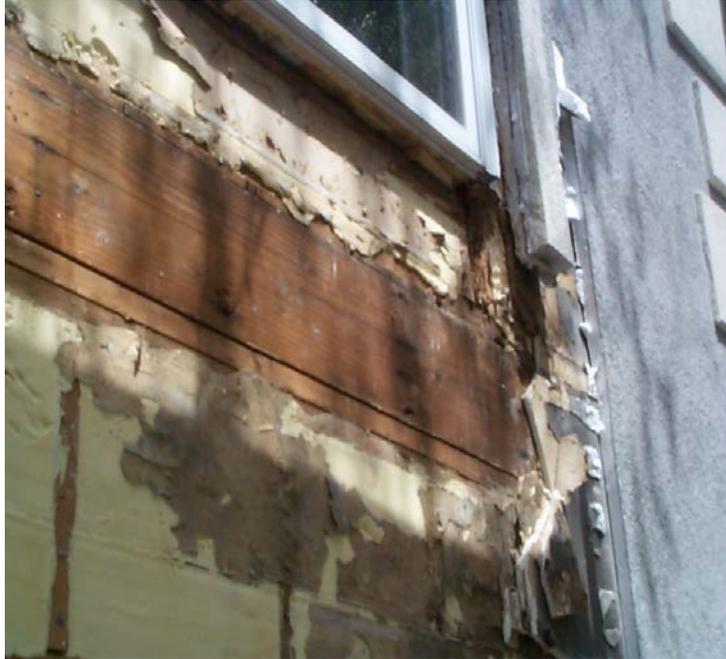
Several months ago the homeowner decided to sell and was informed by their realtor that the home would have to be raised 8" above grade in order to get a termite contract. As this work was under way it became apparent that there was a problem under the front windows that were replaced four years ago. The problem occurred under both the upper and lower window units.

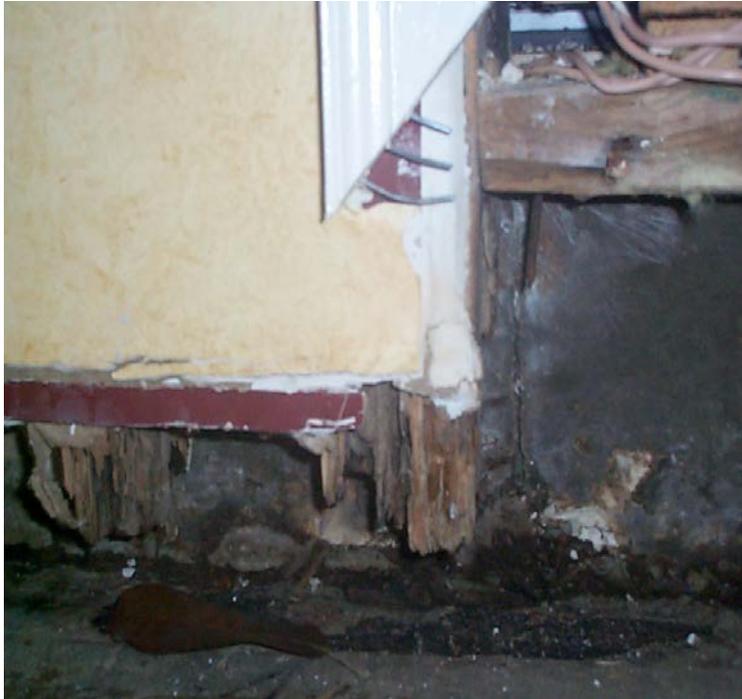
Again the hardwood flooring and framing under the first floor window was deteriorated.

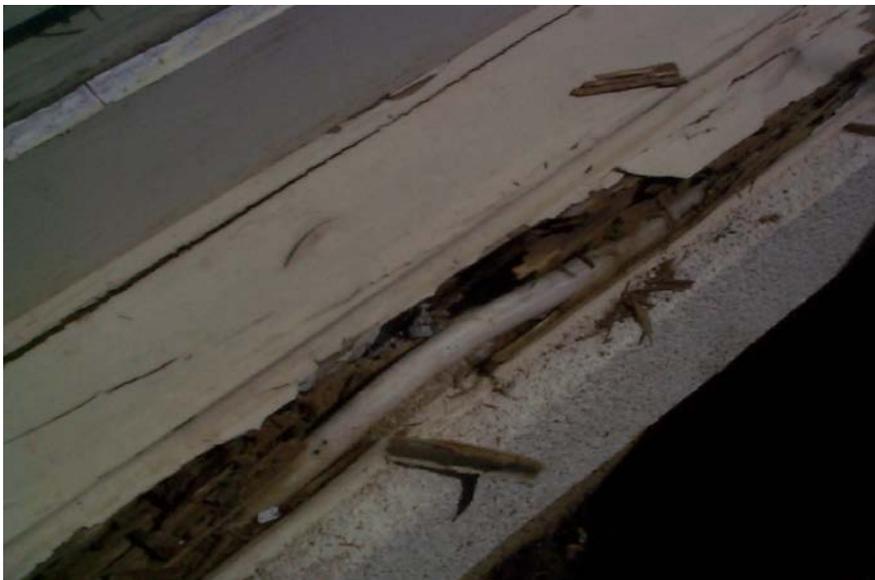
As you can observe from the photo, again the windows rotted out around the backer rodded sealant joint. This was due to water infiltrating the wall through the window and not through the EIFS or its sealant joints.

Other than moisture problems that did occur below the windows, these three homes have another common factor. All three have been retrofitted with the Flashpans and treated with a spore block material. The Flashpan will drain any moisture that gets into the wall cavity to the exterior. It allows for ventilation to the otherwise sealed area under the window and the window can be treated with a spore block inhibitor annually.
