# Structural Integrity Reserve Report

## **Ocean Villas at St. Augustine Beach Condominiums**

850 A1A Beach Boulevard  
St. Augustine, Florida 32080

November 15, 2024

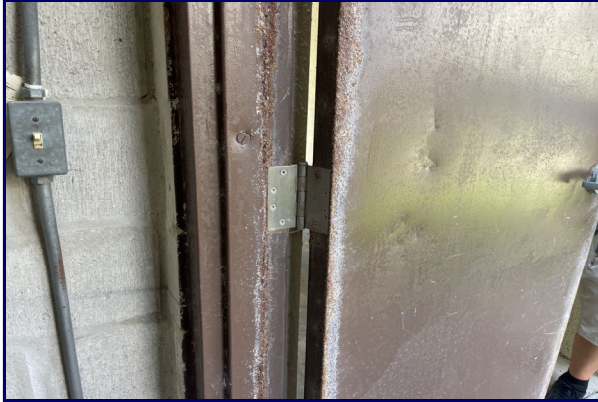
**Photograph 5.7:** Steel utility door with corrosion.

There are (3) hollow steel door assemblies that provide access to the (3) elevator equipment rooms. These doors and jamb assemblies are corroded and have significant section loss. These assemblies have a limited useful life in the salt-air environment. In these conditions, metal doors typically have a useful life of less than 20-years. As such, replacement of the doors with like kind fiberglass, composite-jamb units should be anticipated in the near term.

10.1	Unit Doors	Responsibility of individual unit owner												
10.2	Utility dors - steel painted, replace with fiberglass	Three elevator equipment room doors are showing significant corrosion. Replace in the near term.	20	1984	41	1	3	EA	\$ 2,500.00	\$ 7,500.00	\$ 7,500.00	\$ 375.00		
TOTAL										\$ 7,500.00	\$ 7,500.00	\$ 375.00		
11	Additional items with maintenance or replacement cost > \$10k and which the failure to replace or maintain negatively affects other items in the reserve study.

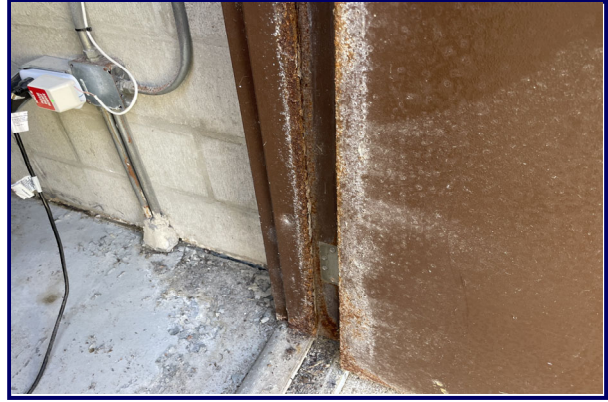
**Photograph 5.8:** Door jamb corrosion.

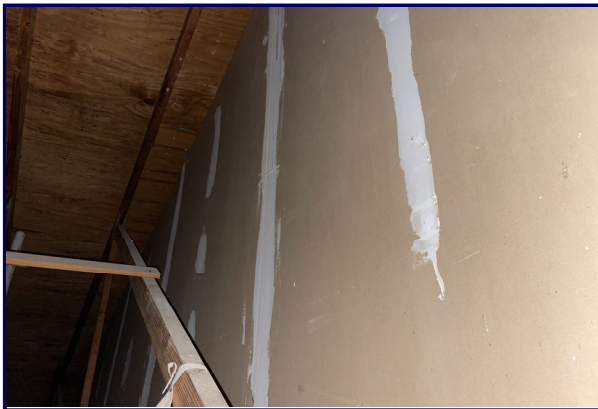
**Photograph 5.9:** Typical unit attic fire wall partition.

Fireproofing generally consists of rated CMU partition walls between units and gypsum sheathed draft stops within the attic spaces above each unit separation wall. The components and construction of the fire-rated walls is not known and cannot be determined without destructive testing. Alta has not been provided with any information regarding deterioration of the rated wall assemblies. Fire-rated wall assemblies are not typically considered to be elements that have

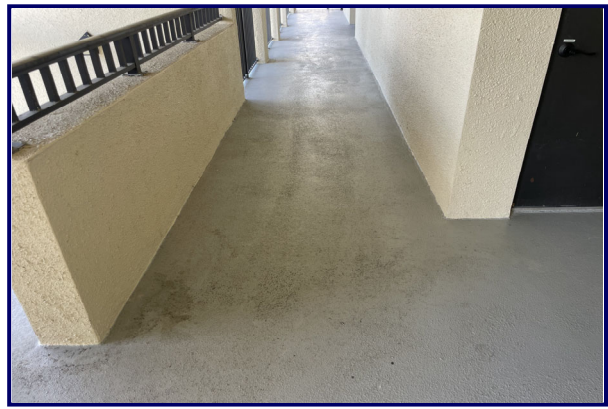
**Photograph 5.10:** Building corridor with polyurethane deck coating.

The balcony decks are surfaced with a polyurethane deck coating. The deck coating was reportedly applied in 2023. Exposed deck coatings typically have a useful life of 10-years or less. As such, their replacement is anticipated during the evaluation period.

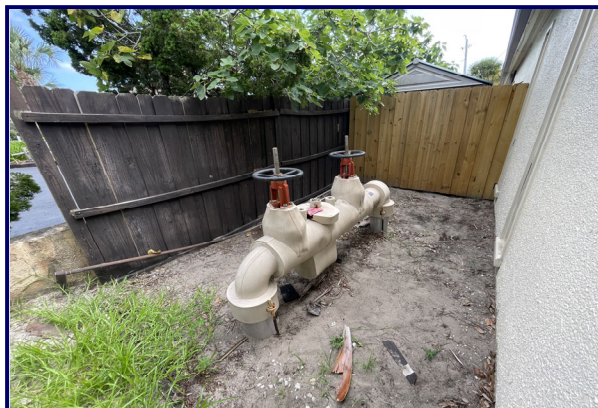
**Photograph 5.11:** Primary backflow preventer.

Plumbing systems are protected by a primary main backflow prevention device. This device had all of the seals and gaskets replaced in November of 2024. These repairs are expected to last 25-years. With regular maintenance and periodic part replacement, these devices provide a service life of 30 to 50-years.

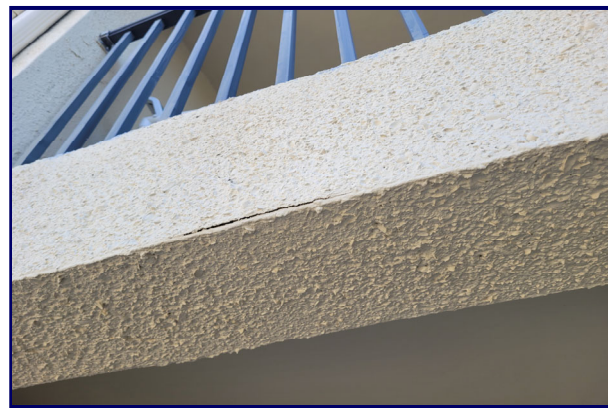
**Photograph 5.12:** Corridor beam spall.

The site visit and inspection revealed structural concrete components experiencing cracking and spalling in numerous locations. The concrete distress is associated with the corrosion-induced expansion of steel reinforcing bars embedded in the concrete elements due to long-term exposure to the salt-air environment. A repair project is currently underway to address the identified concrete spalls. Following completion of the concrete repairs, which is presumably already funded, Alta recommends an ongoing program of maintenance and repairs with an annual budget allowance of at least \$25,000 to address future spalls as they become apparent. This allowance should be adjusted each year for inflation.

2.1	Concrete repair reserve	Reserve for spalling and structural distress - assume \$20,000.00 allowance per year	1	2024	25	0	1	EA	\$ 25,000.00	\$ 25,000.00	\$ 25,000.00	\$ 25,000.00	2025	\$ 625,000.00
TOTAL										\$ 25,000.00	\$ 25,000.00	\$ 25,000.00		
3	Fireproofing

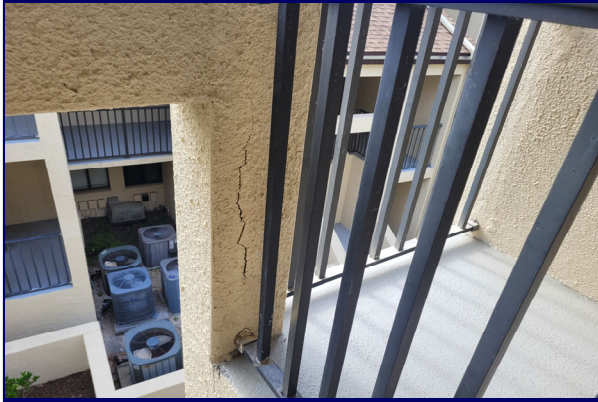
**Photograph 5.13:** Column crack.

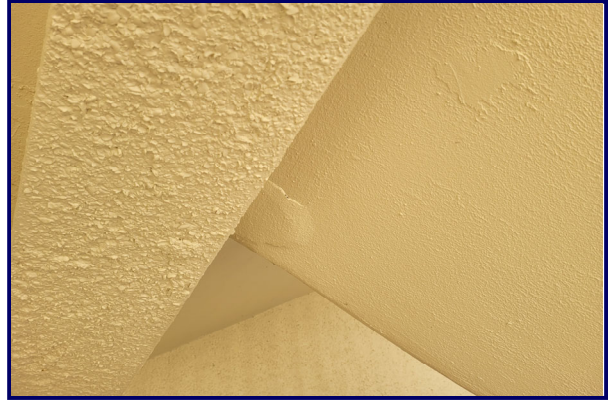
**Photograph 5.14:** Concrete stair spall.

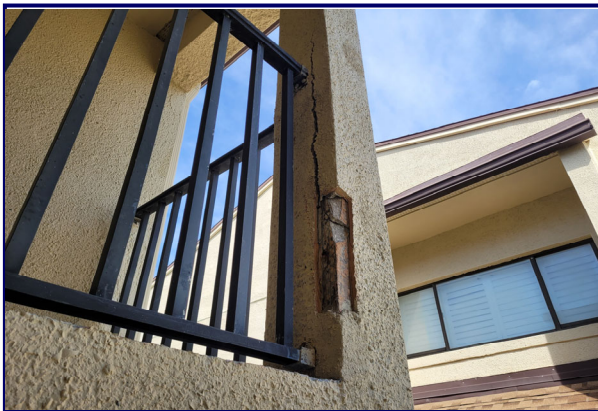
**Photograph 5.15:** Column spall.

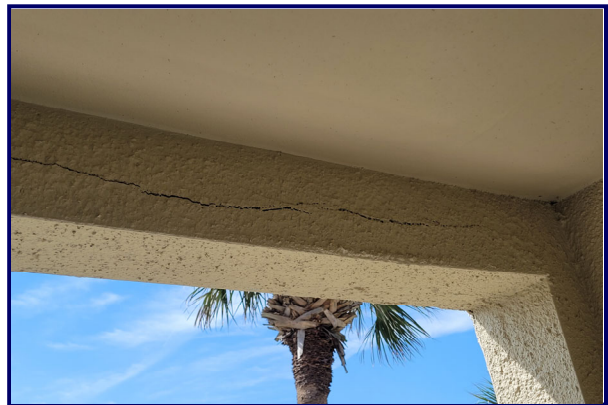
**Photograph 5.16:** Balcony beam spall.

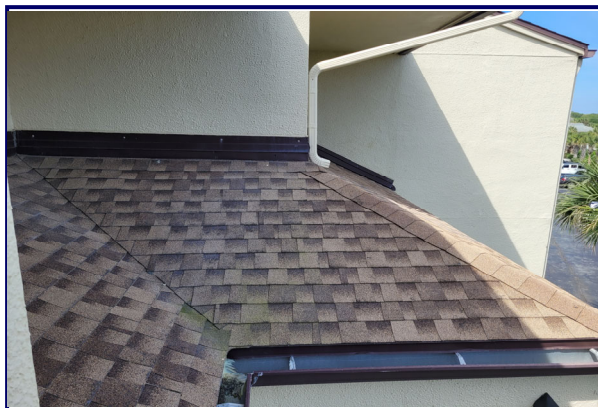
**Photograph 5.17:** Architectural shingle roofing.

The roof claddings were replaced in 2017. The visual appearance of the roof covering is consistent with its age. The roof covering was not detached or distressed at the observed locations. The performance in terms of leaks reported is the best measure of their condition. Roof leaks were not reported.

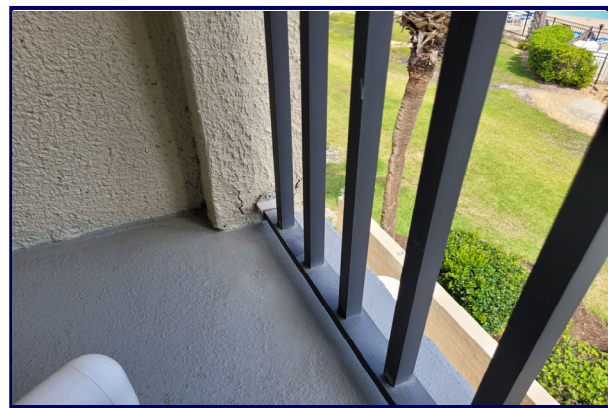
**Photograph 5.18:** Spall at rail base.
