MIT Diving and Coating

Inspection Supplemental Report and Additional Information

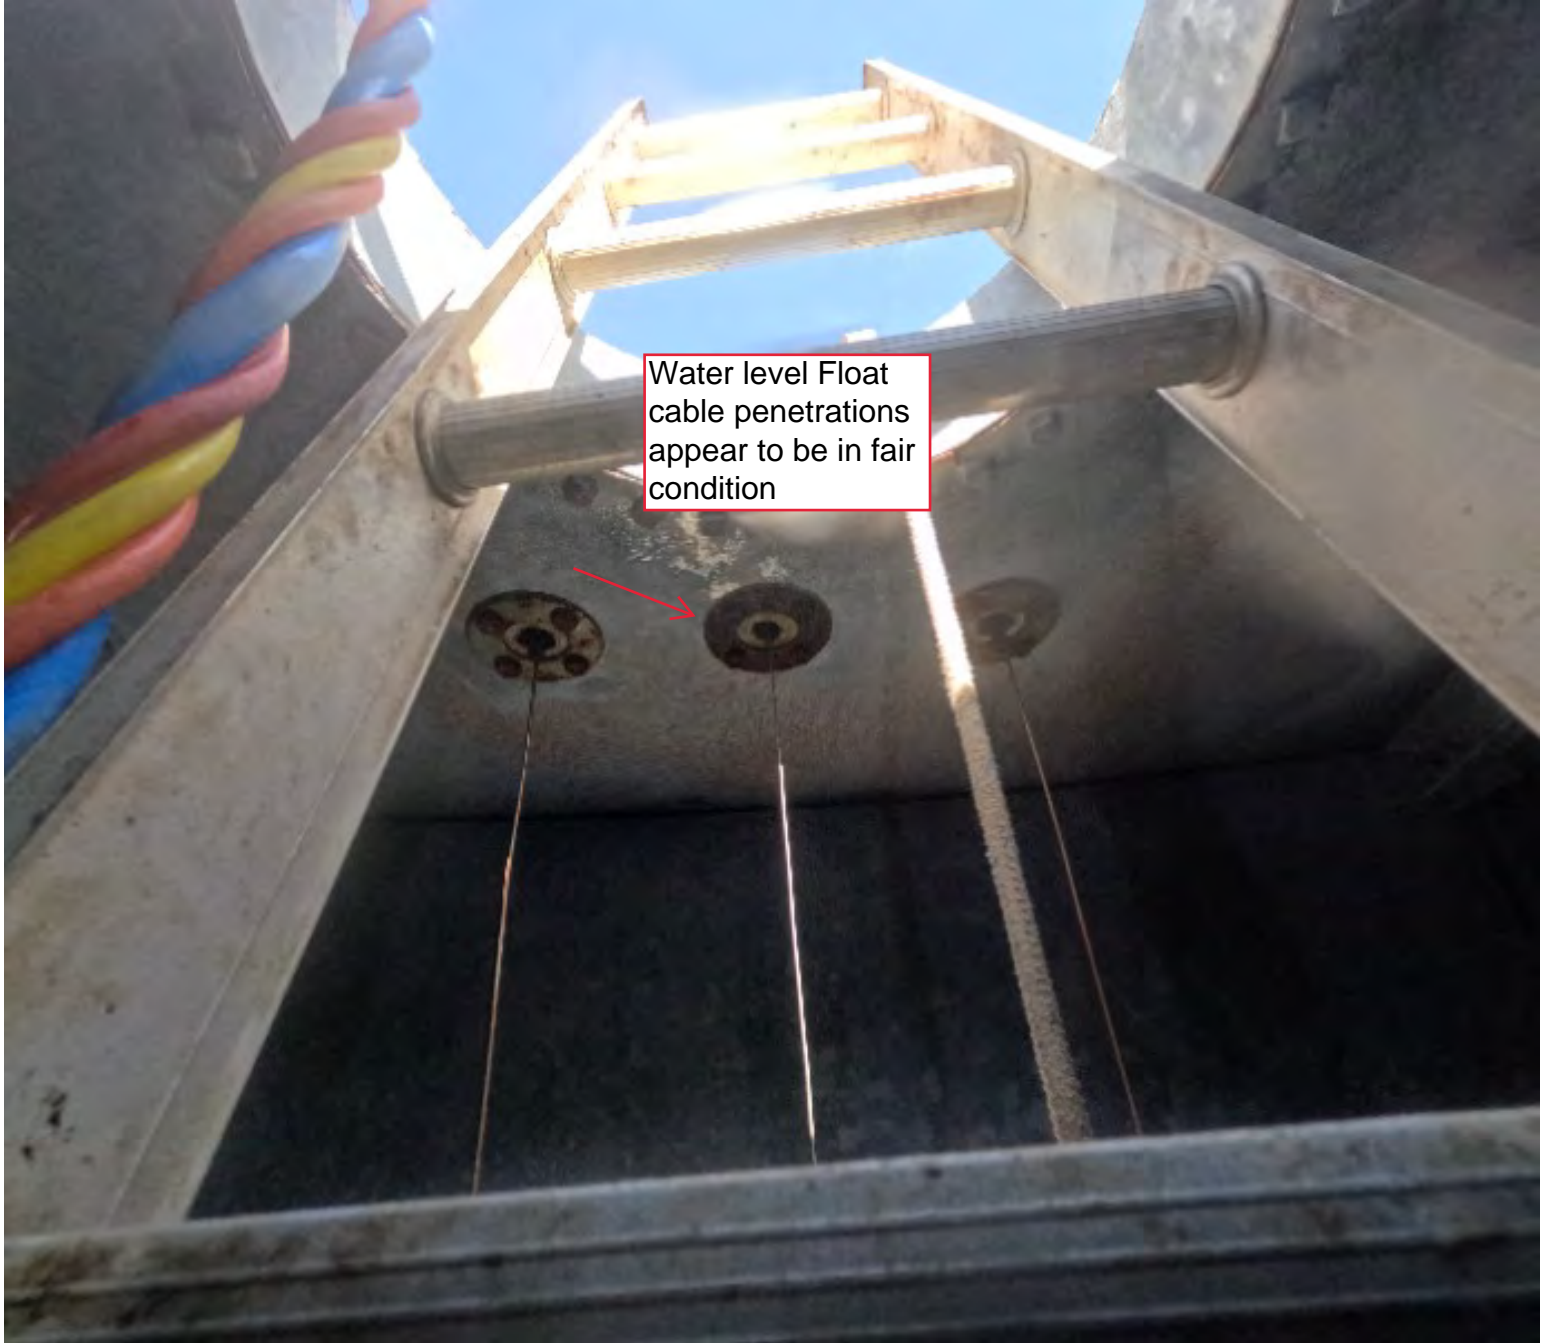
Water level Float
cable penetrations
appear to be in fair
condition

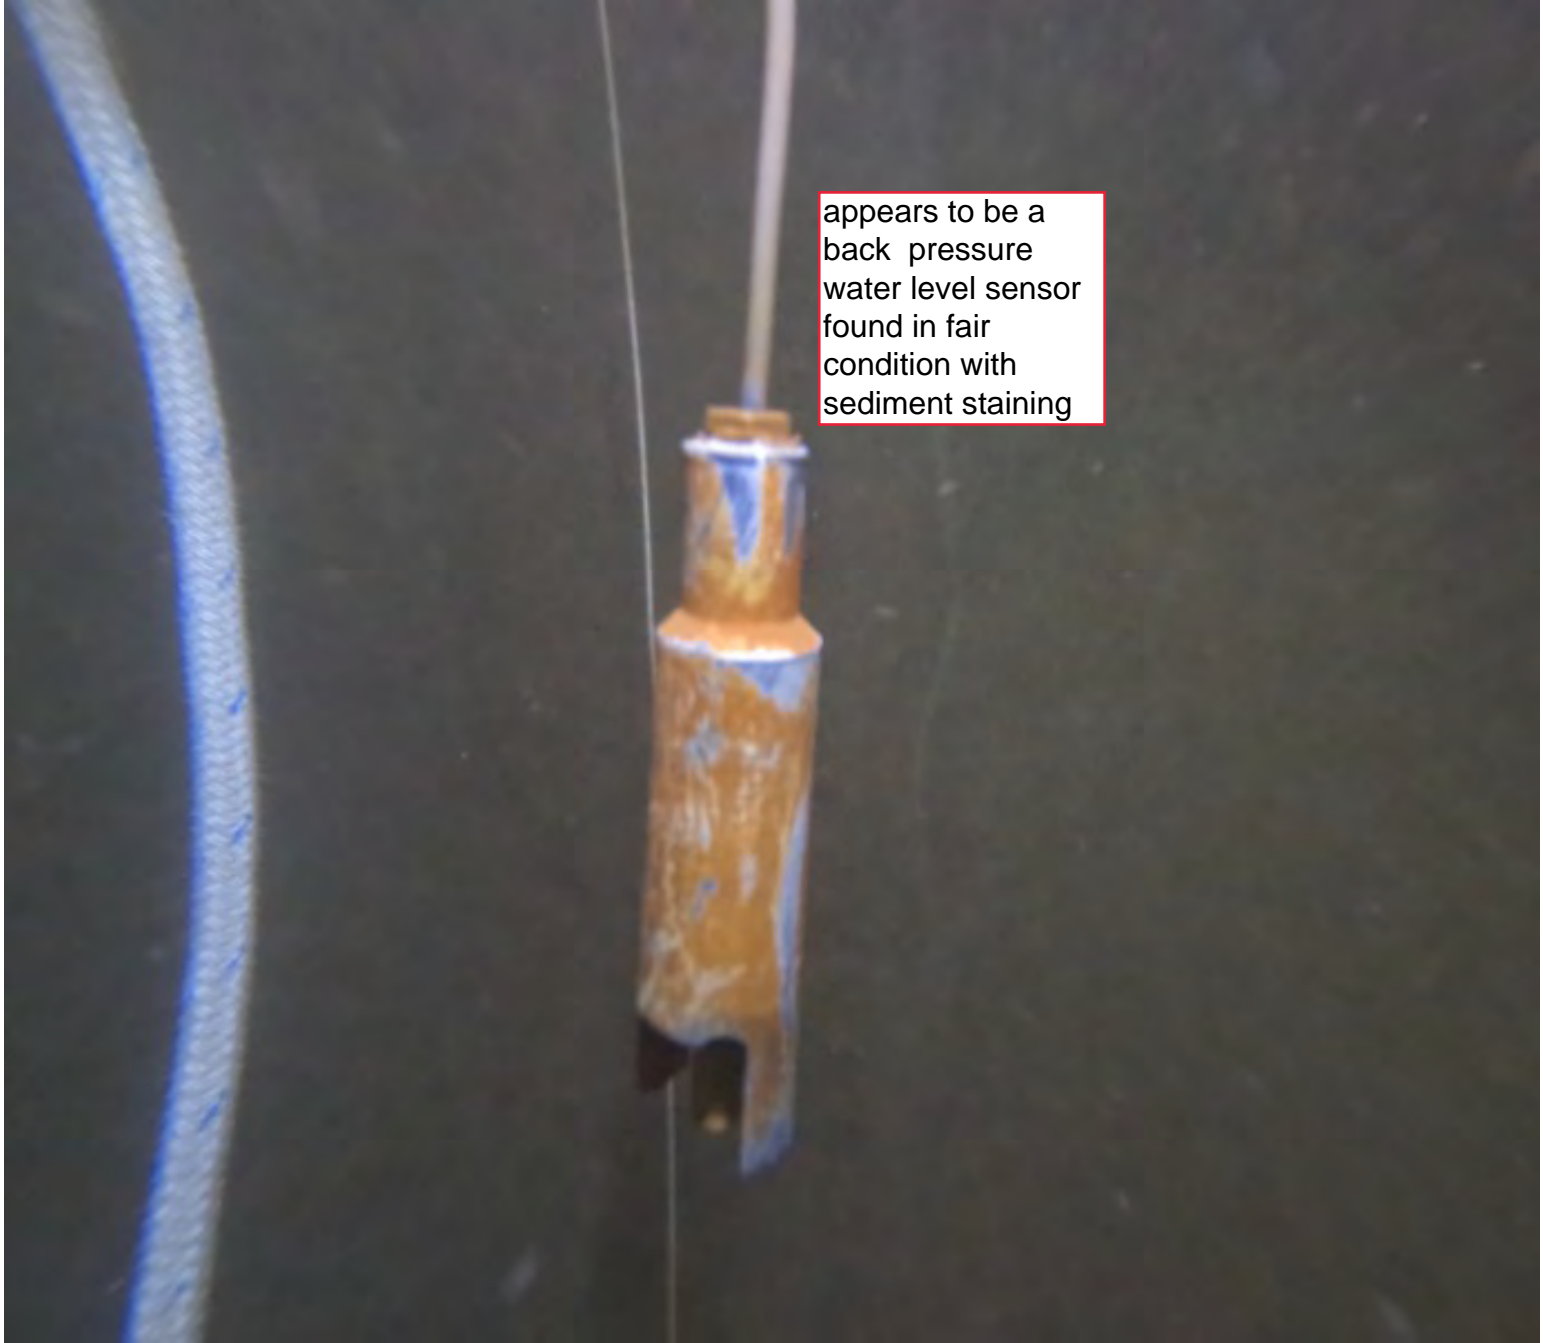
appears to be a
back pressure
water level sensor
found in fair
condition with
sediment staining

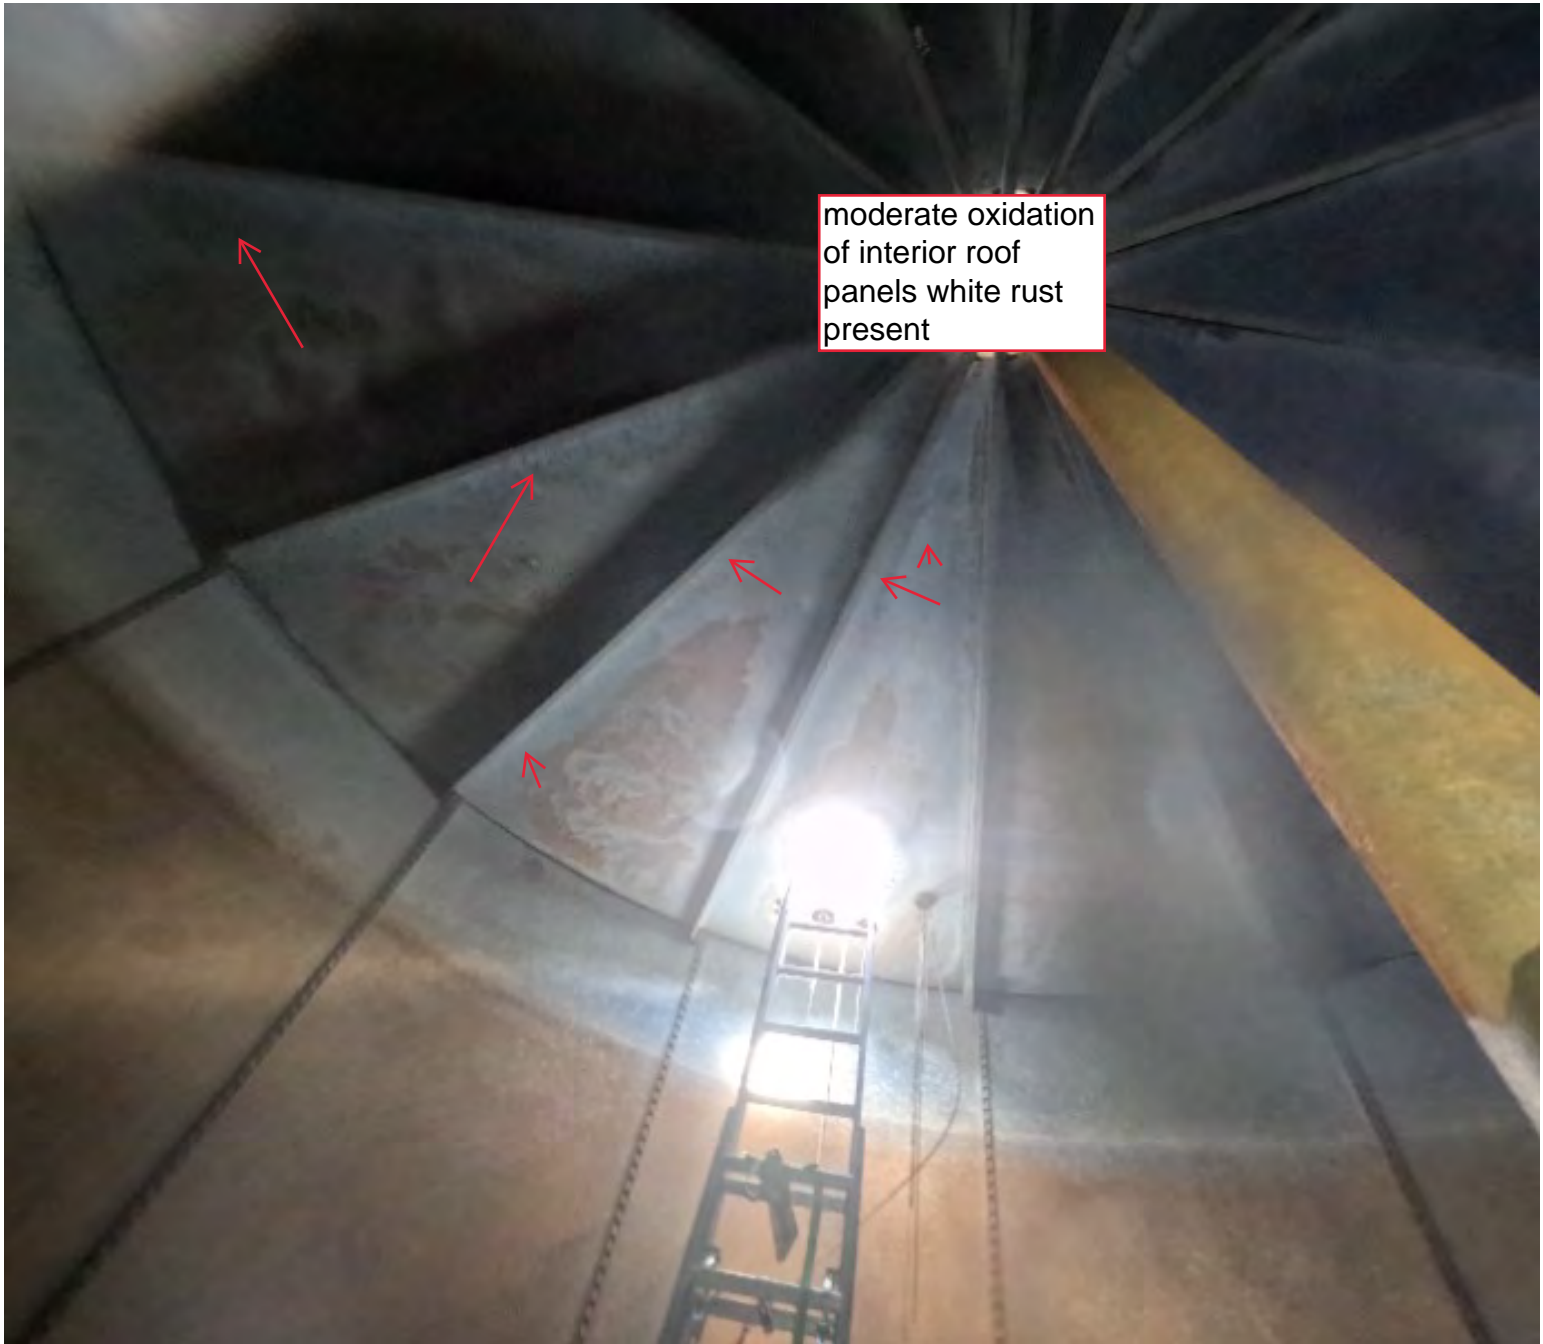
moderate oxidation
of interior roof
panels white rust
present

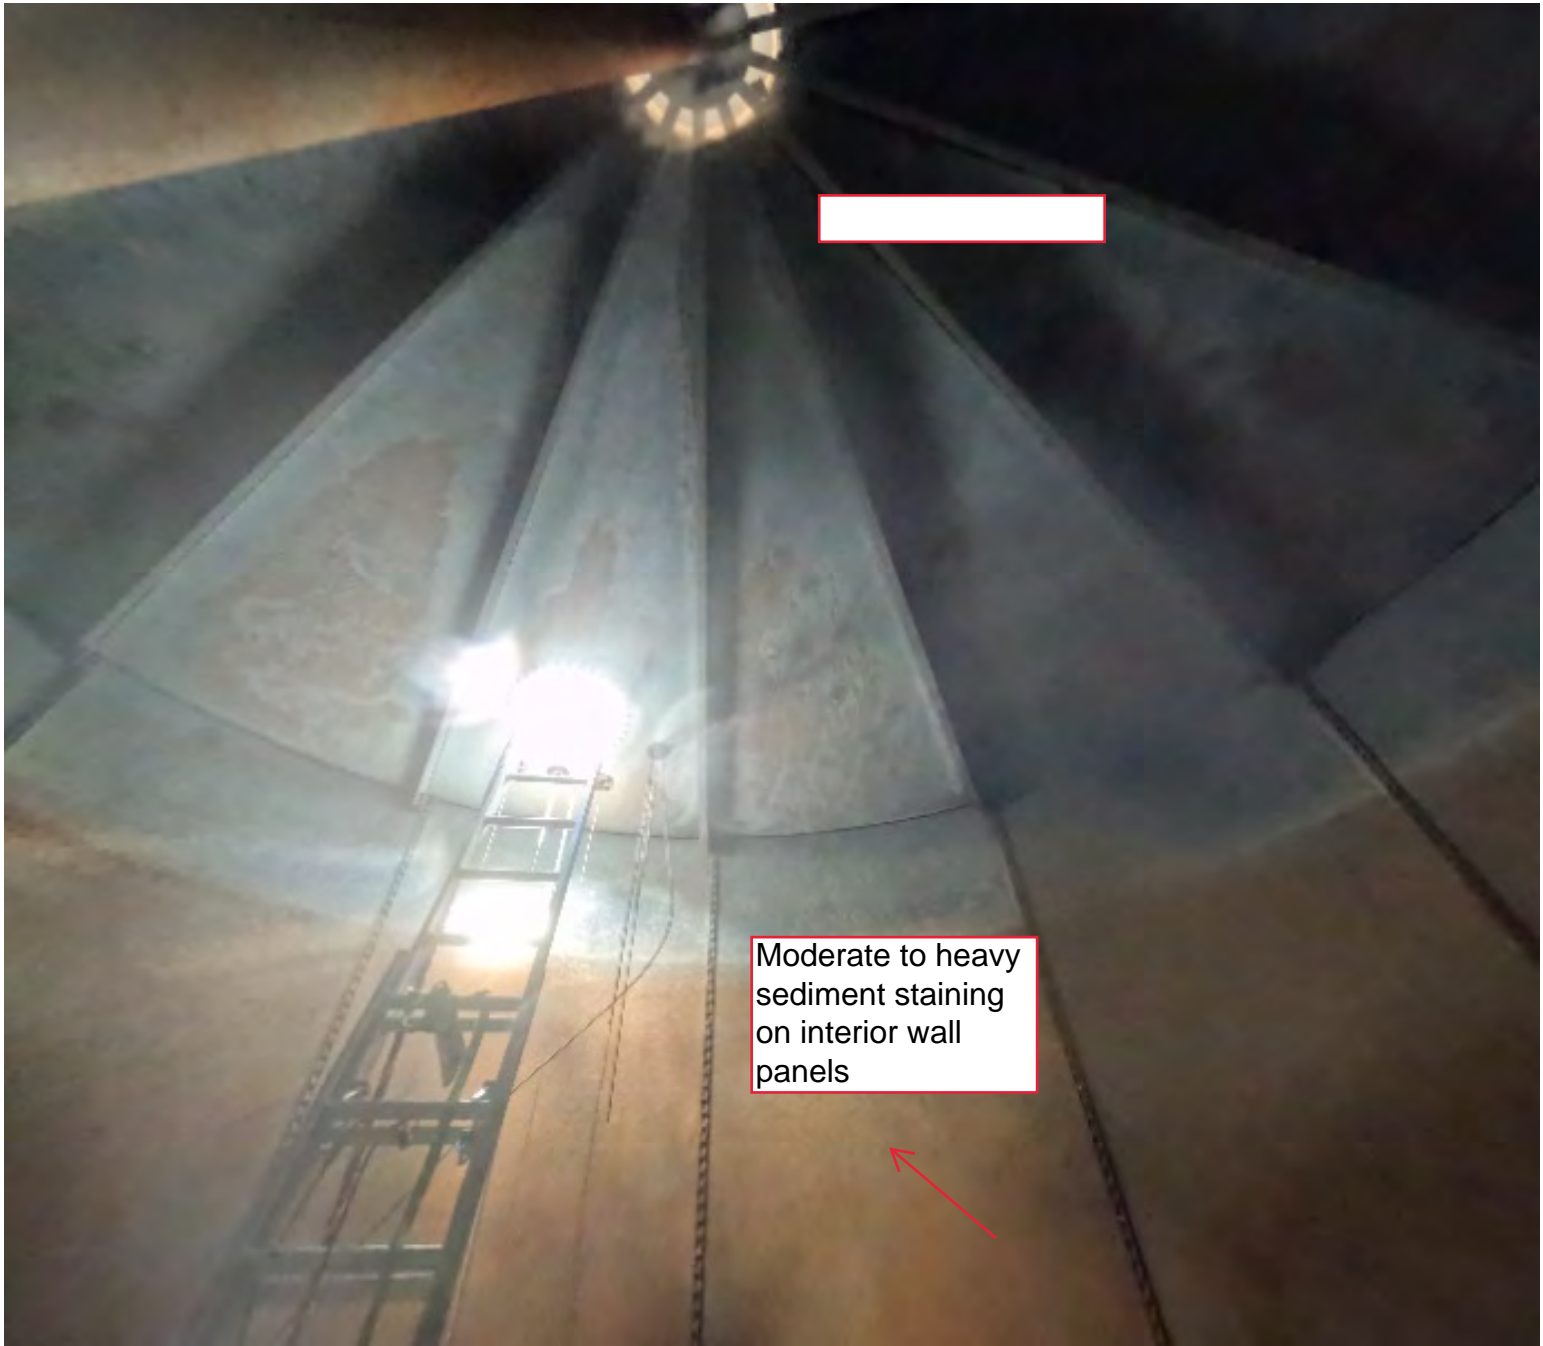
Moderate to heavy sediment staining on interior wall panels

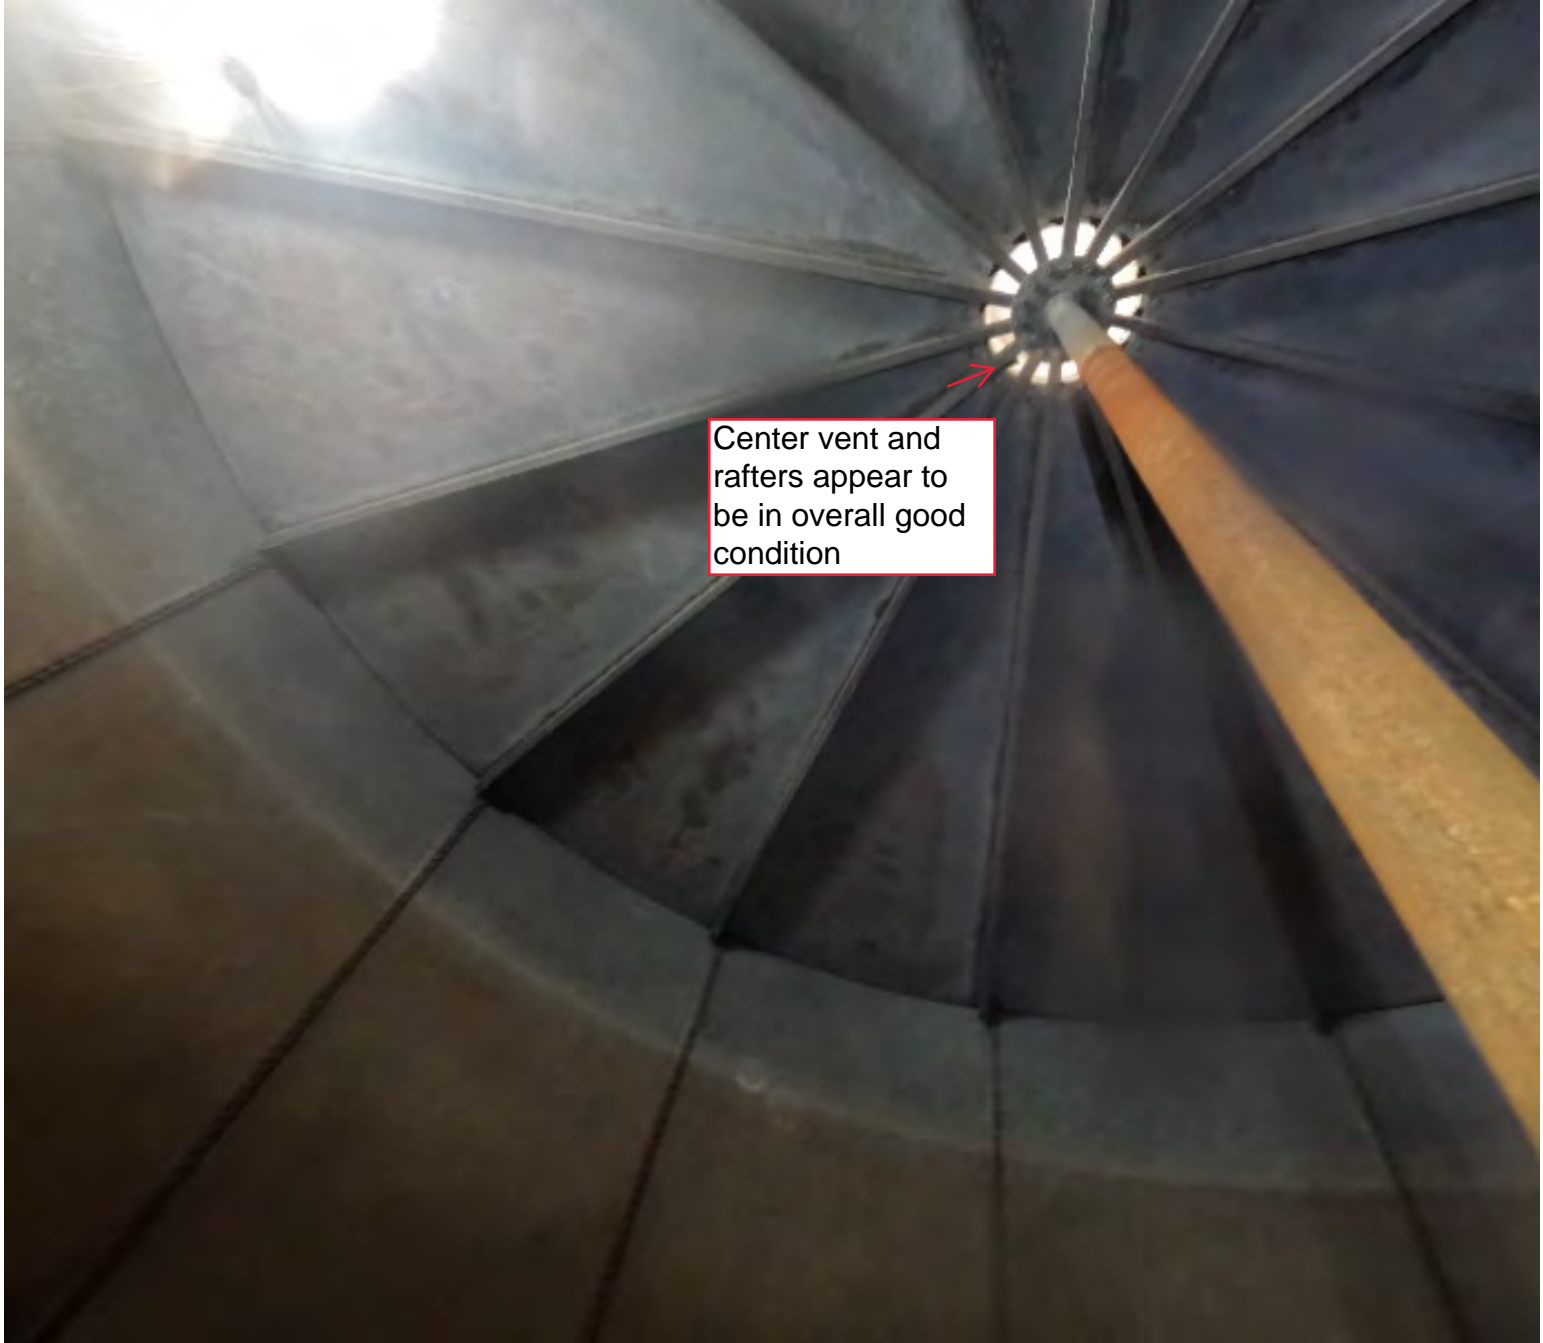
Center vent and rafters appear to be in overall good condition

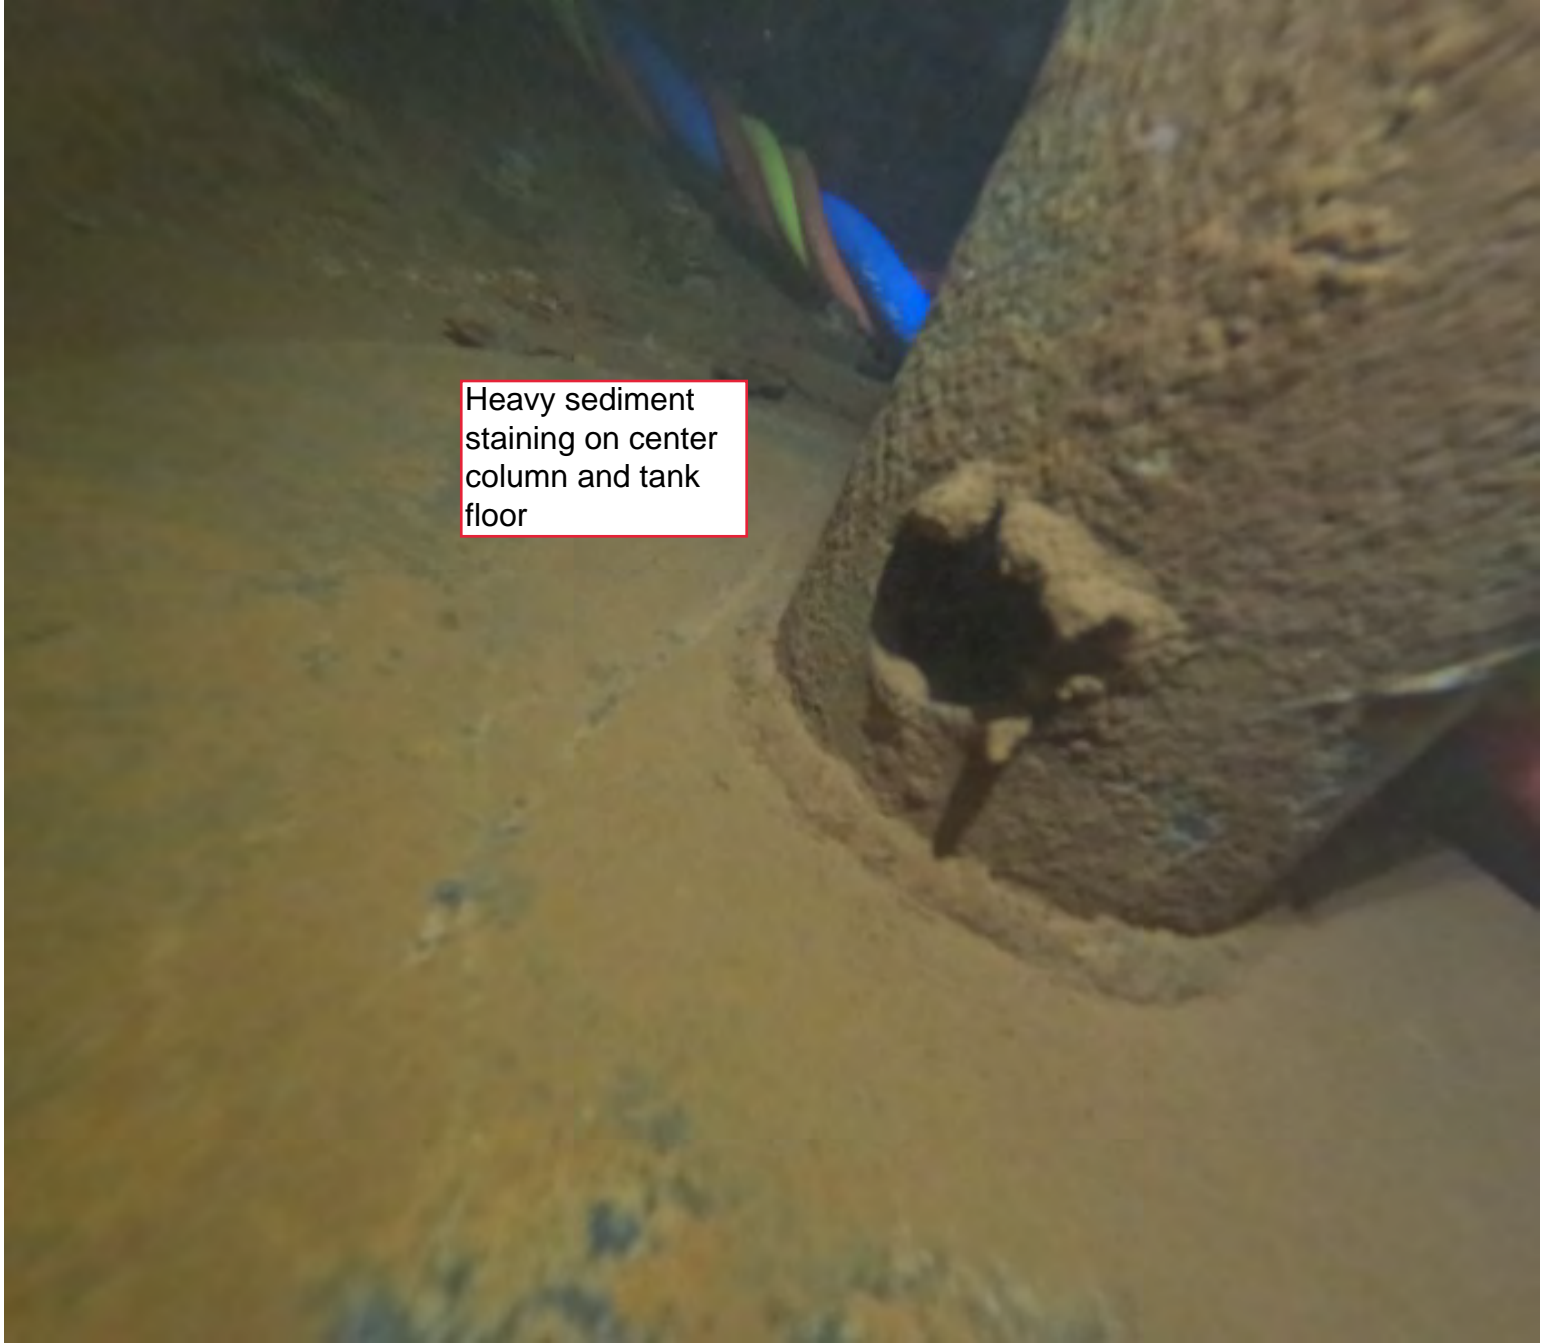
Heavy sediment staining on center column and tank floor

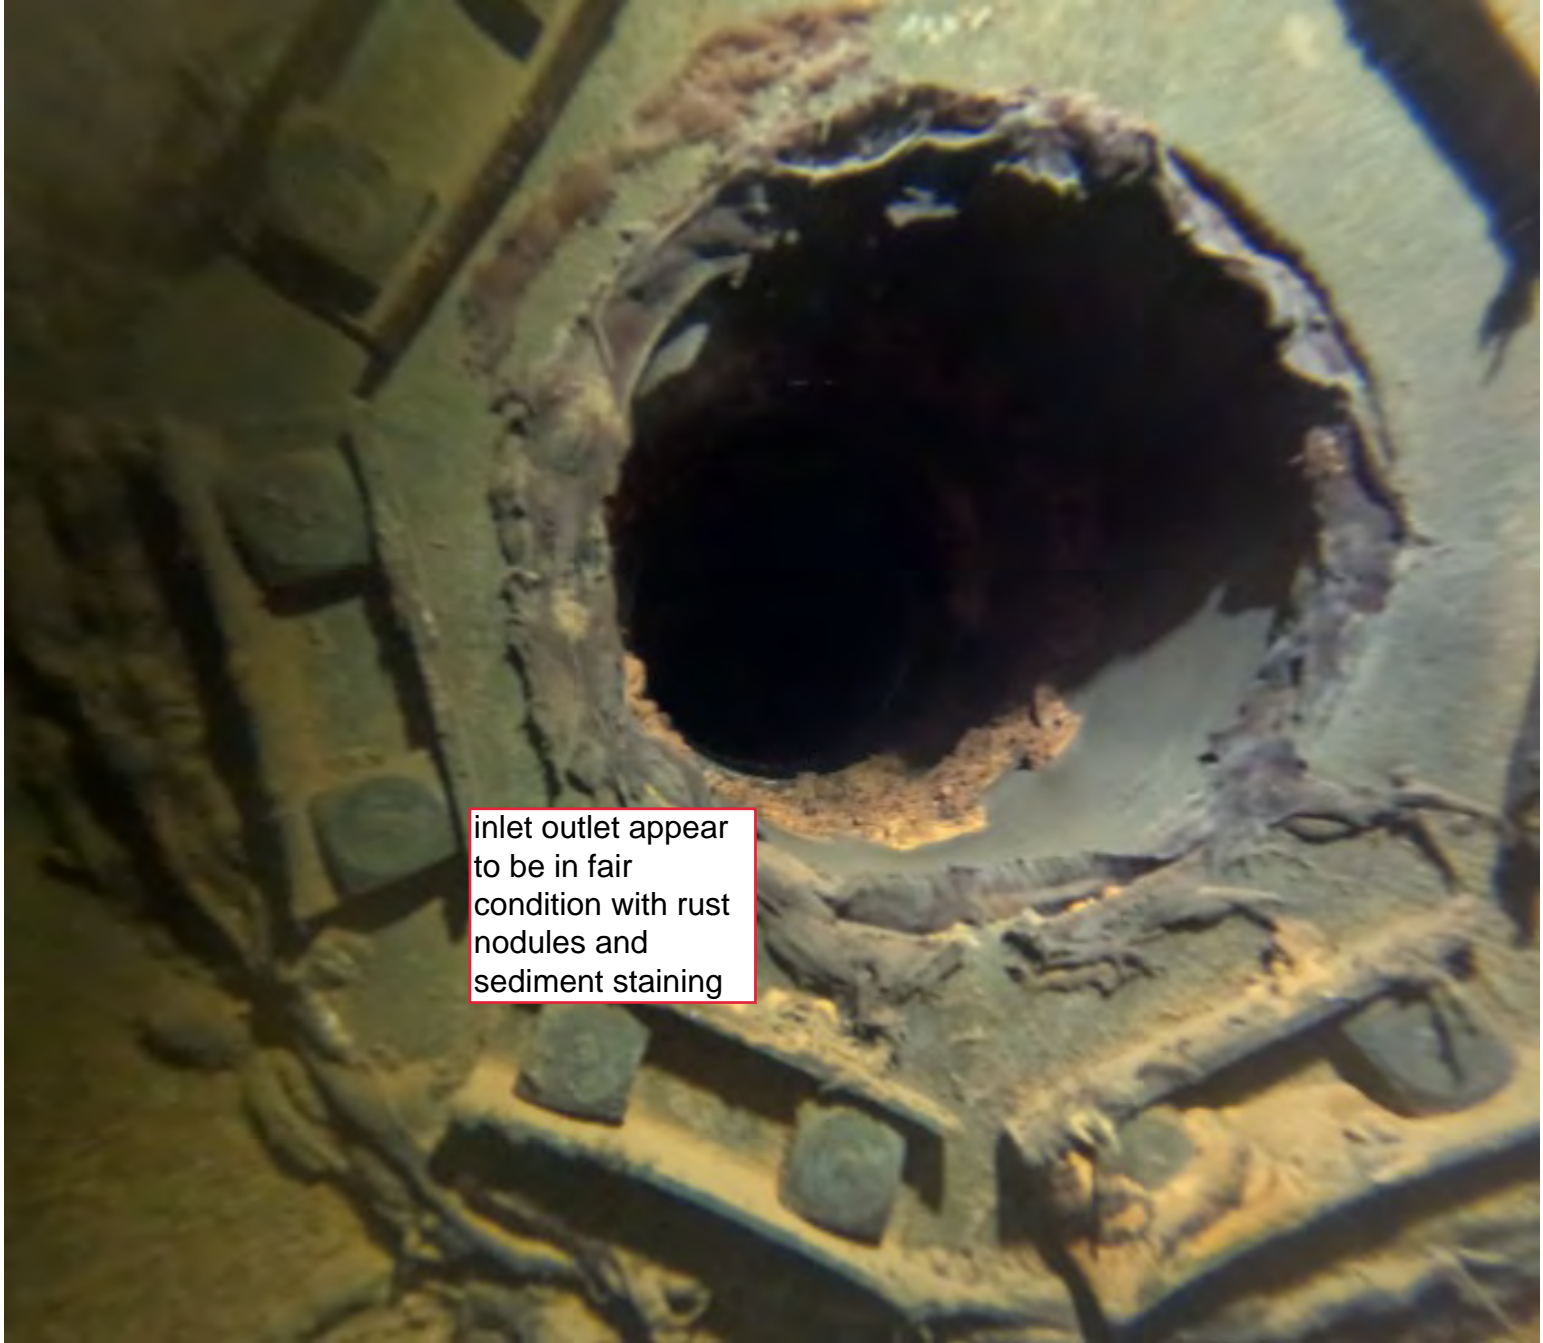
inlet outlet appear
to be in fair
condition with rust
nodules and
sediment staining

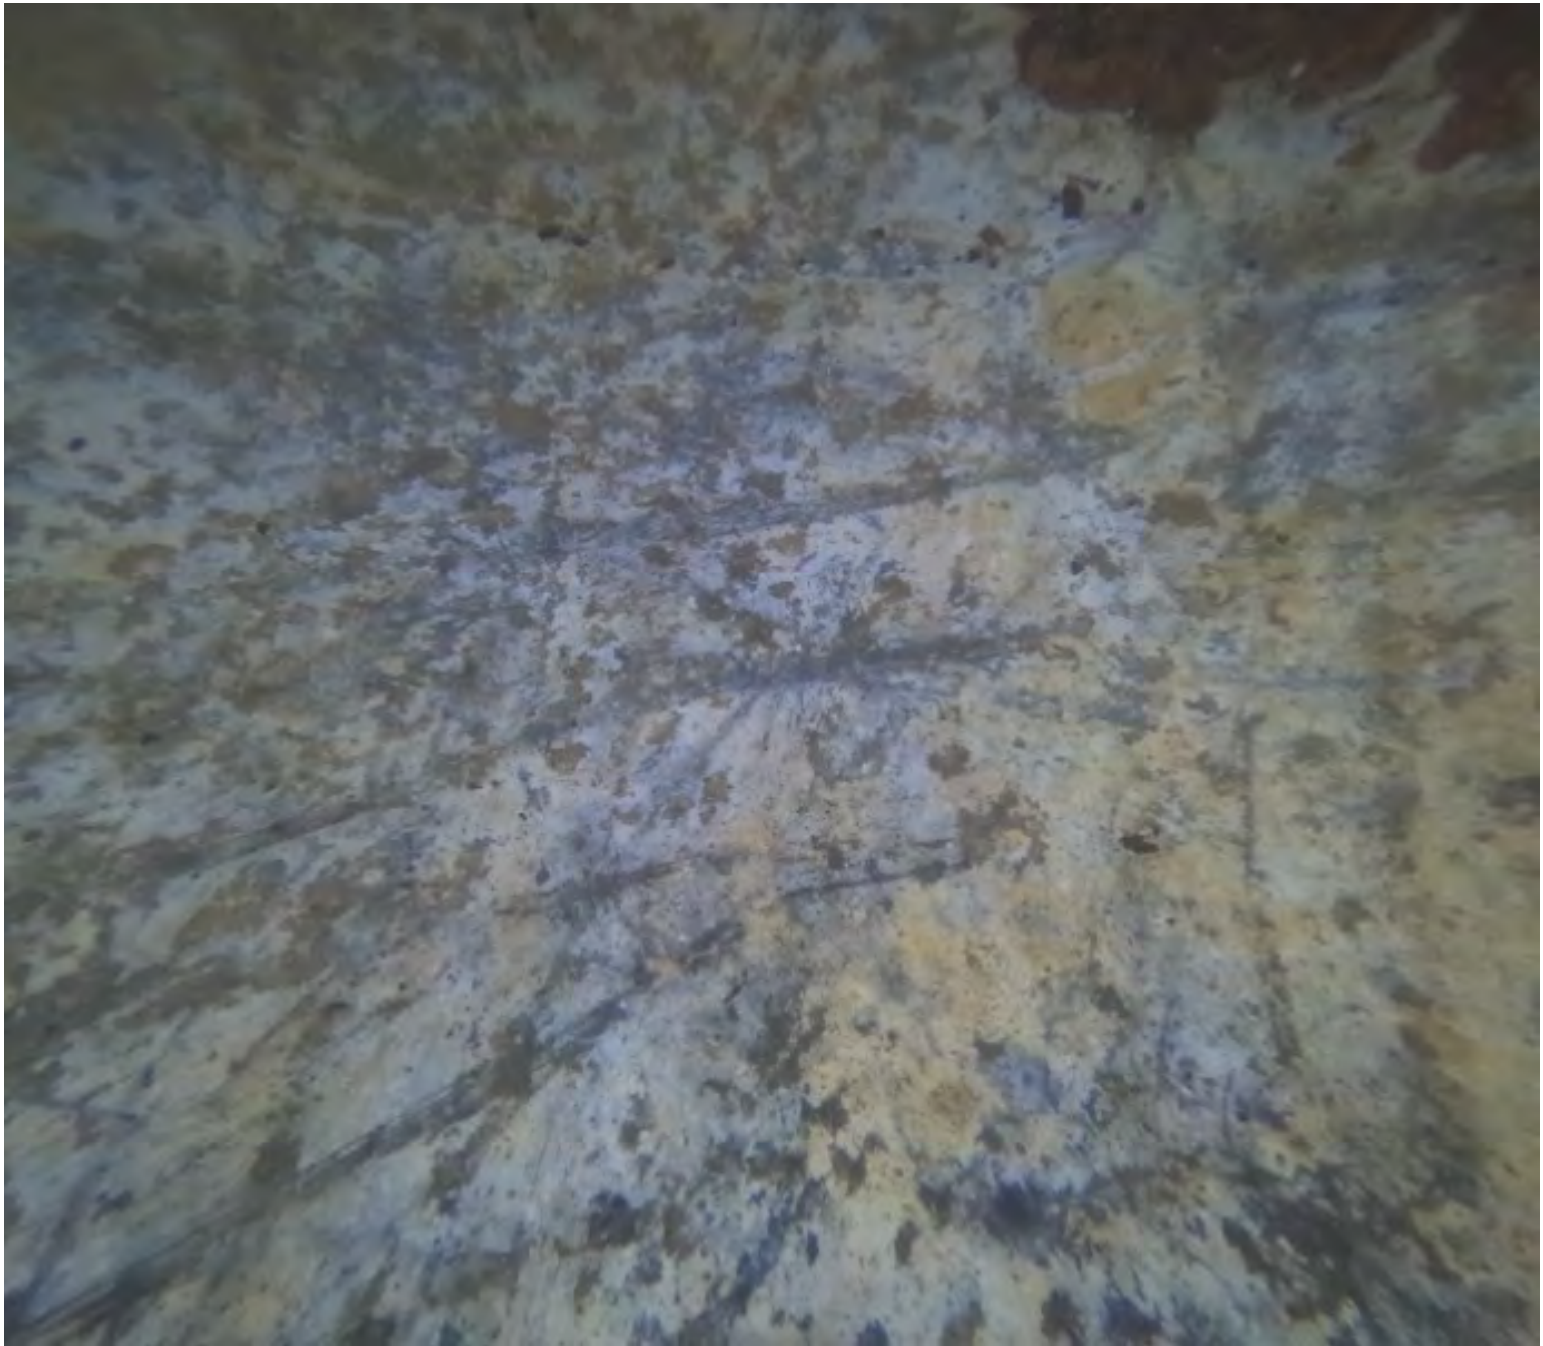
Rust nodules
present on wall
penetration

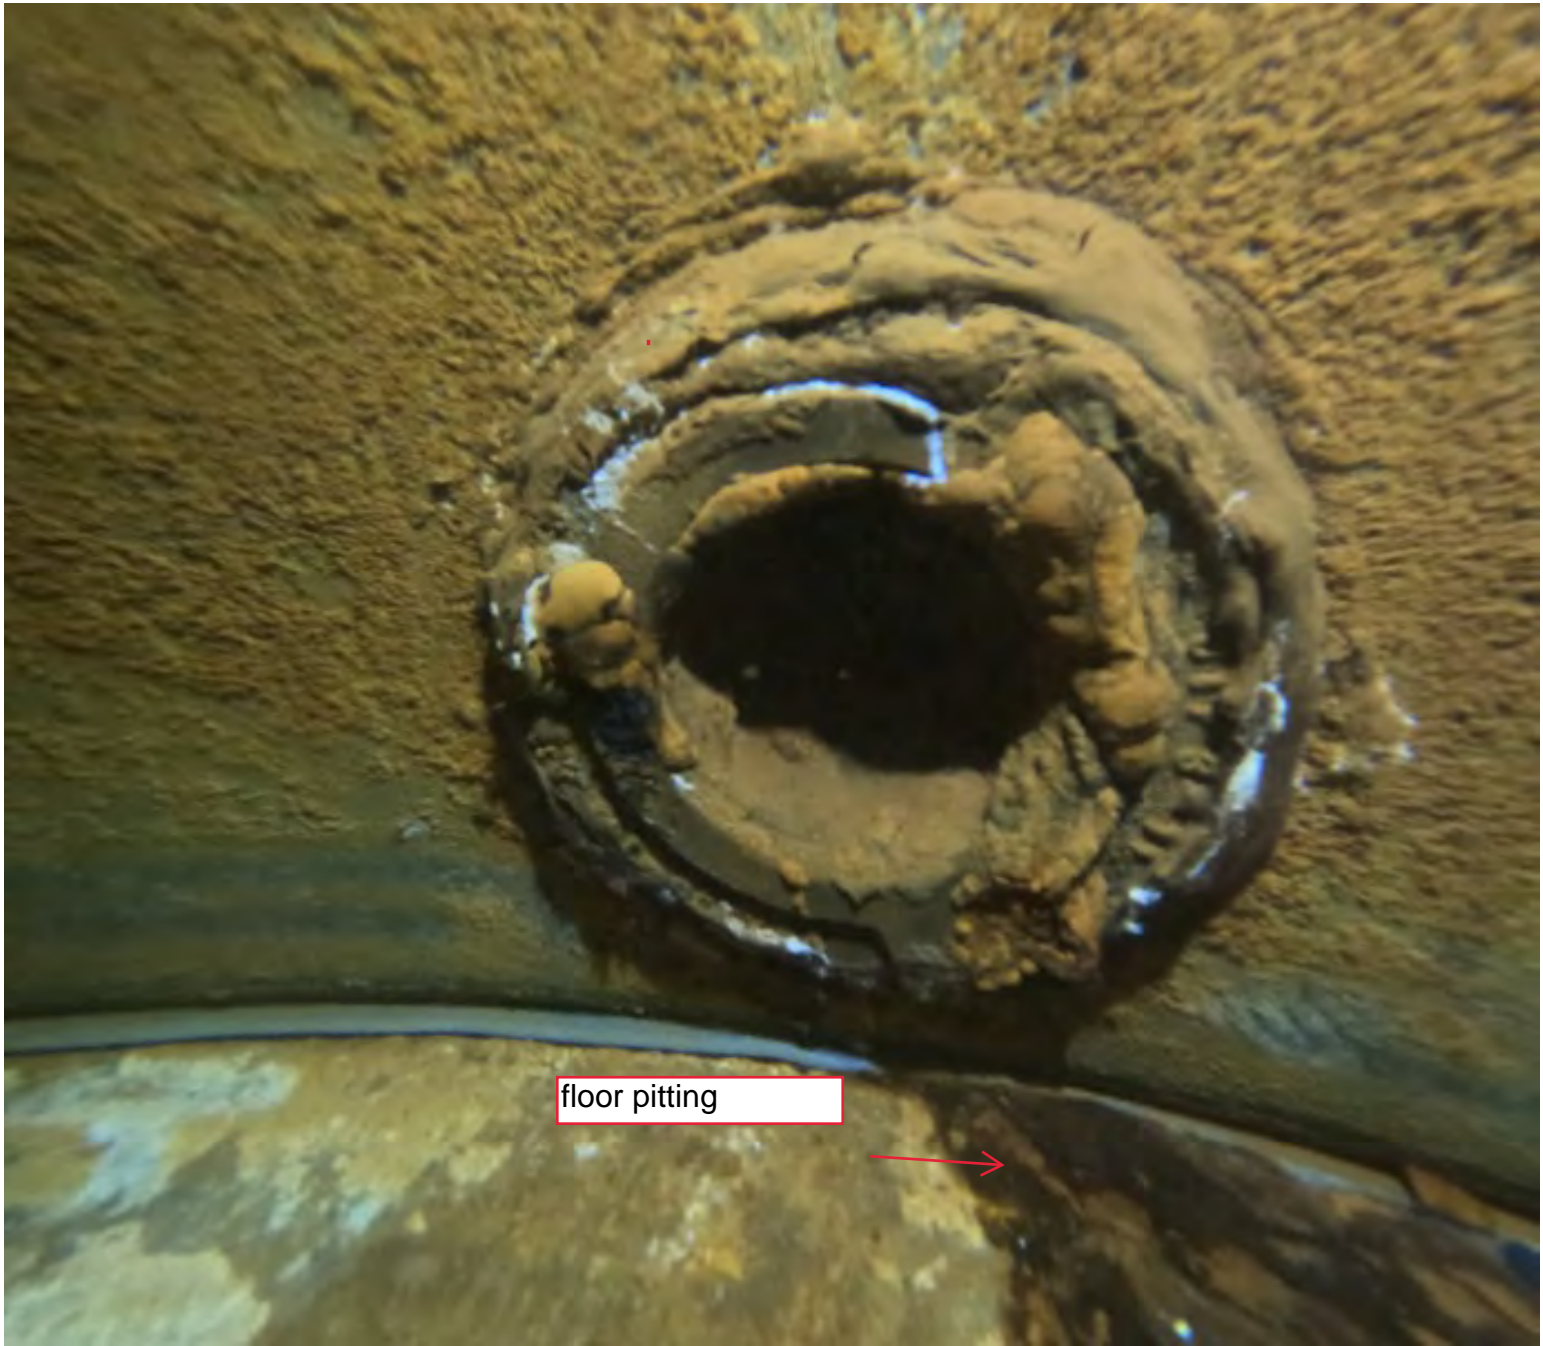
floor pitting

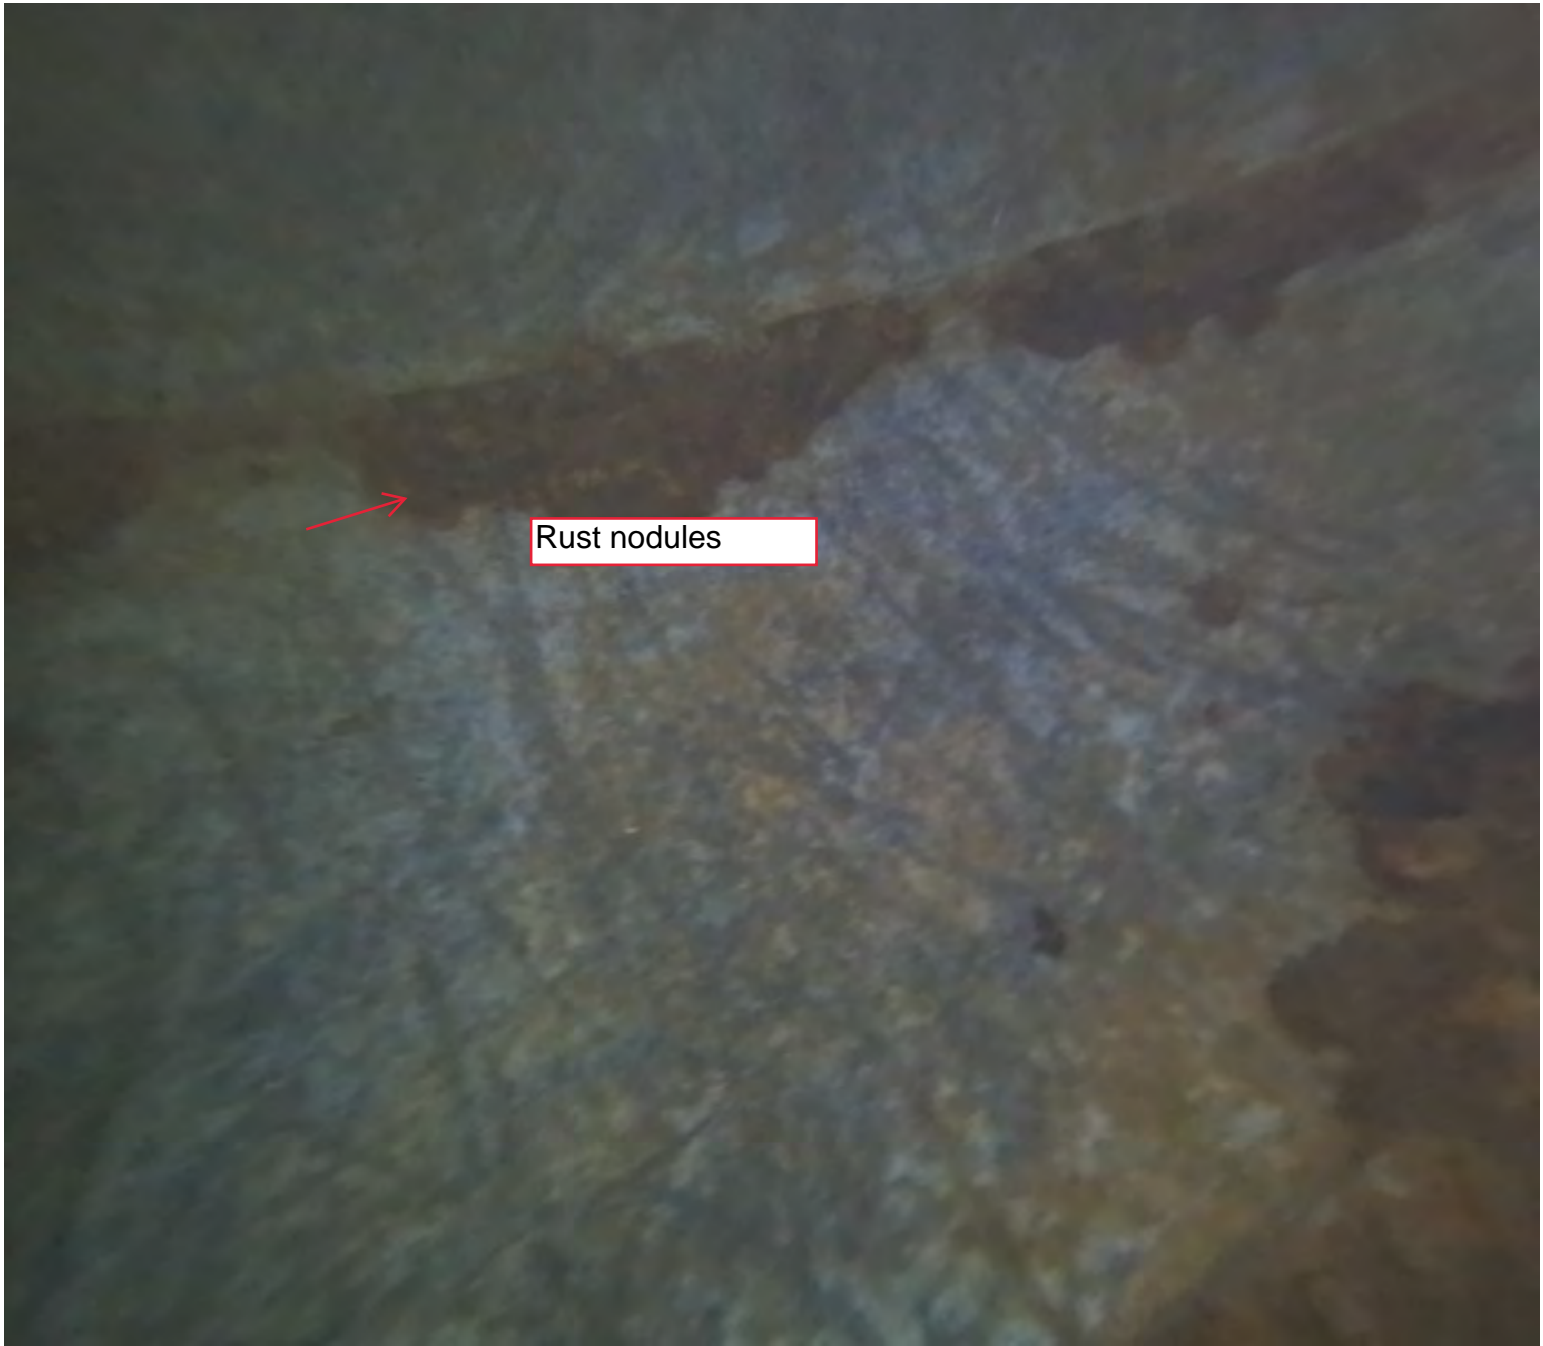
Rust nodules

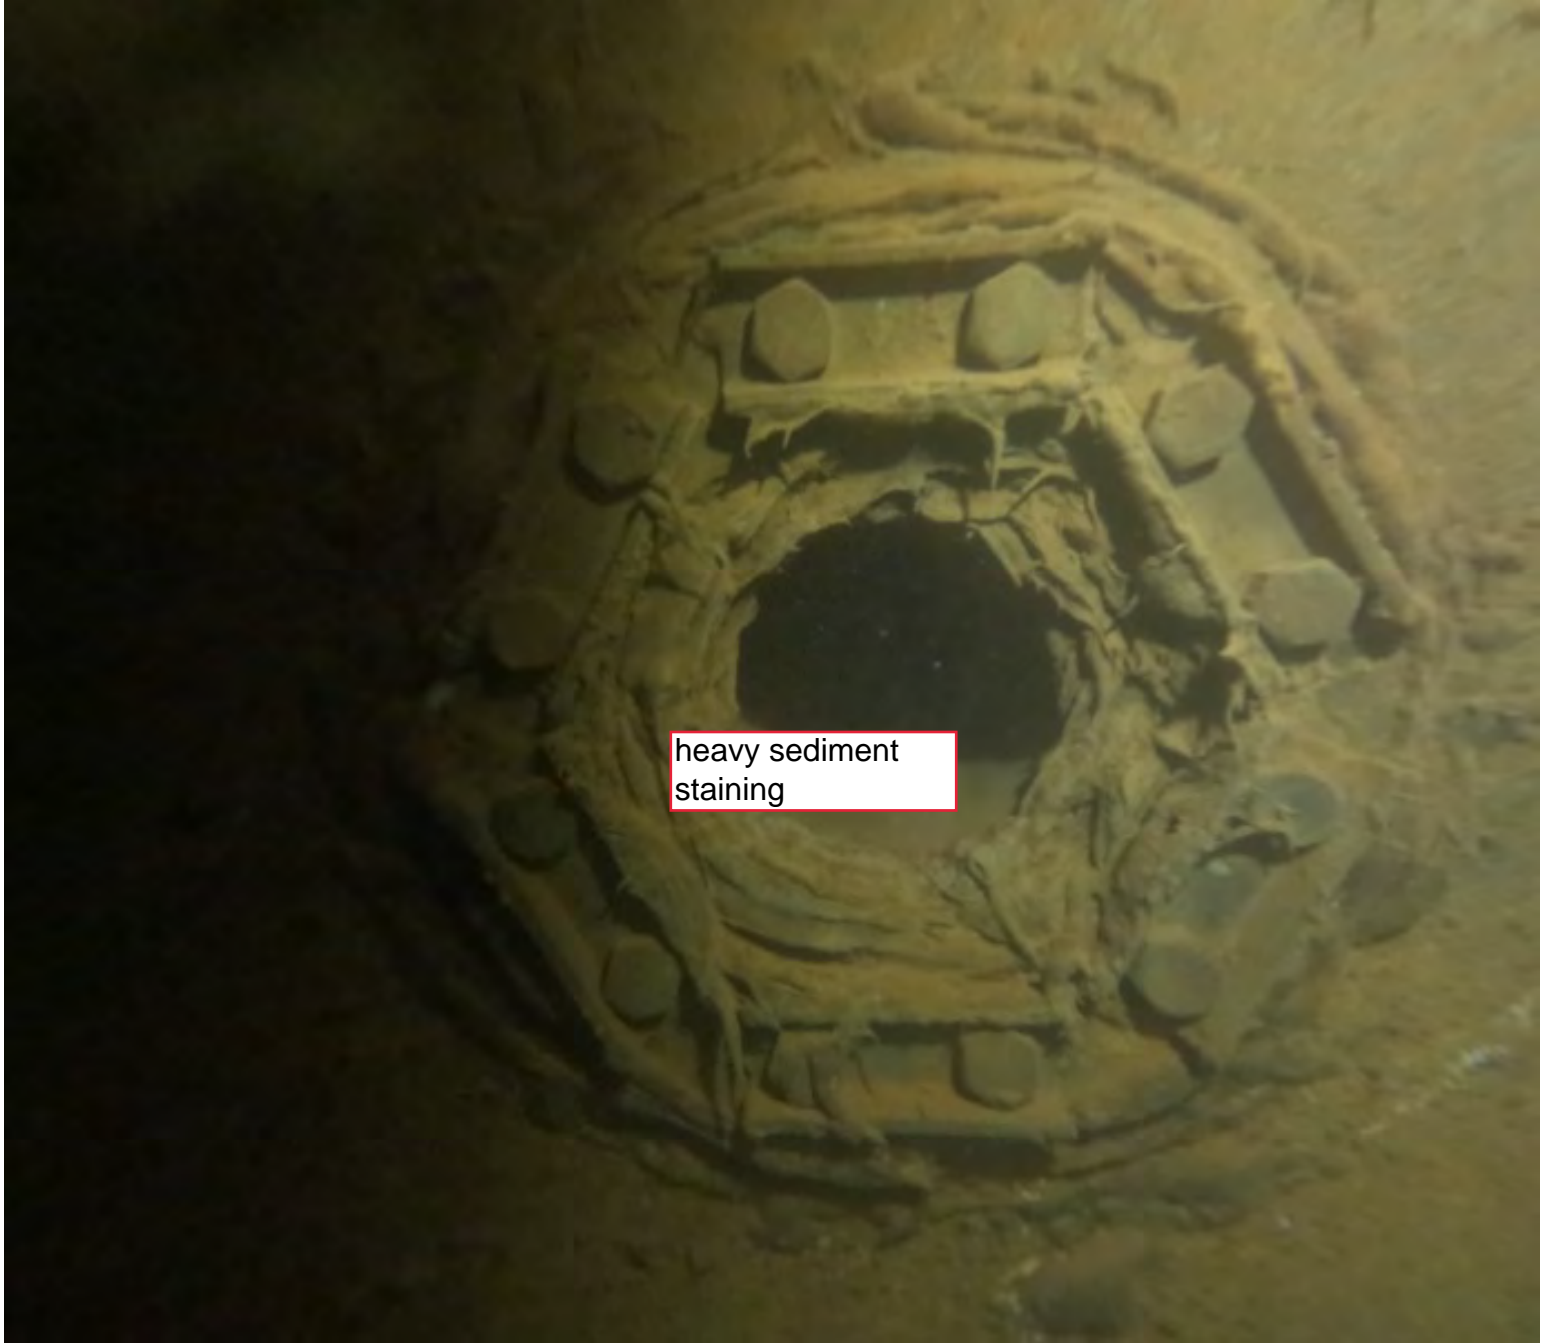
heavy sediment
staining
