MIT Diving and Coating

Inspection Supplemental Report and Additional Information

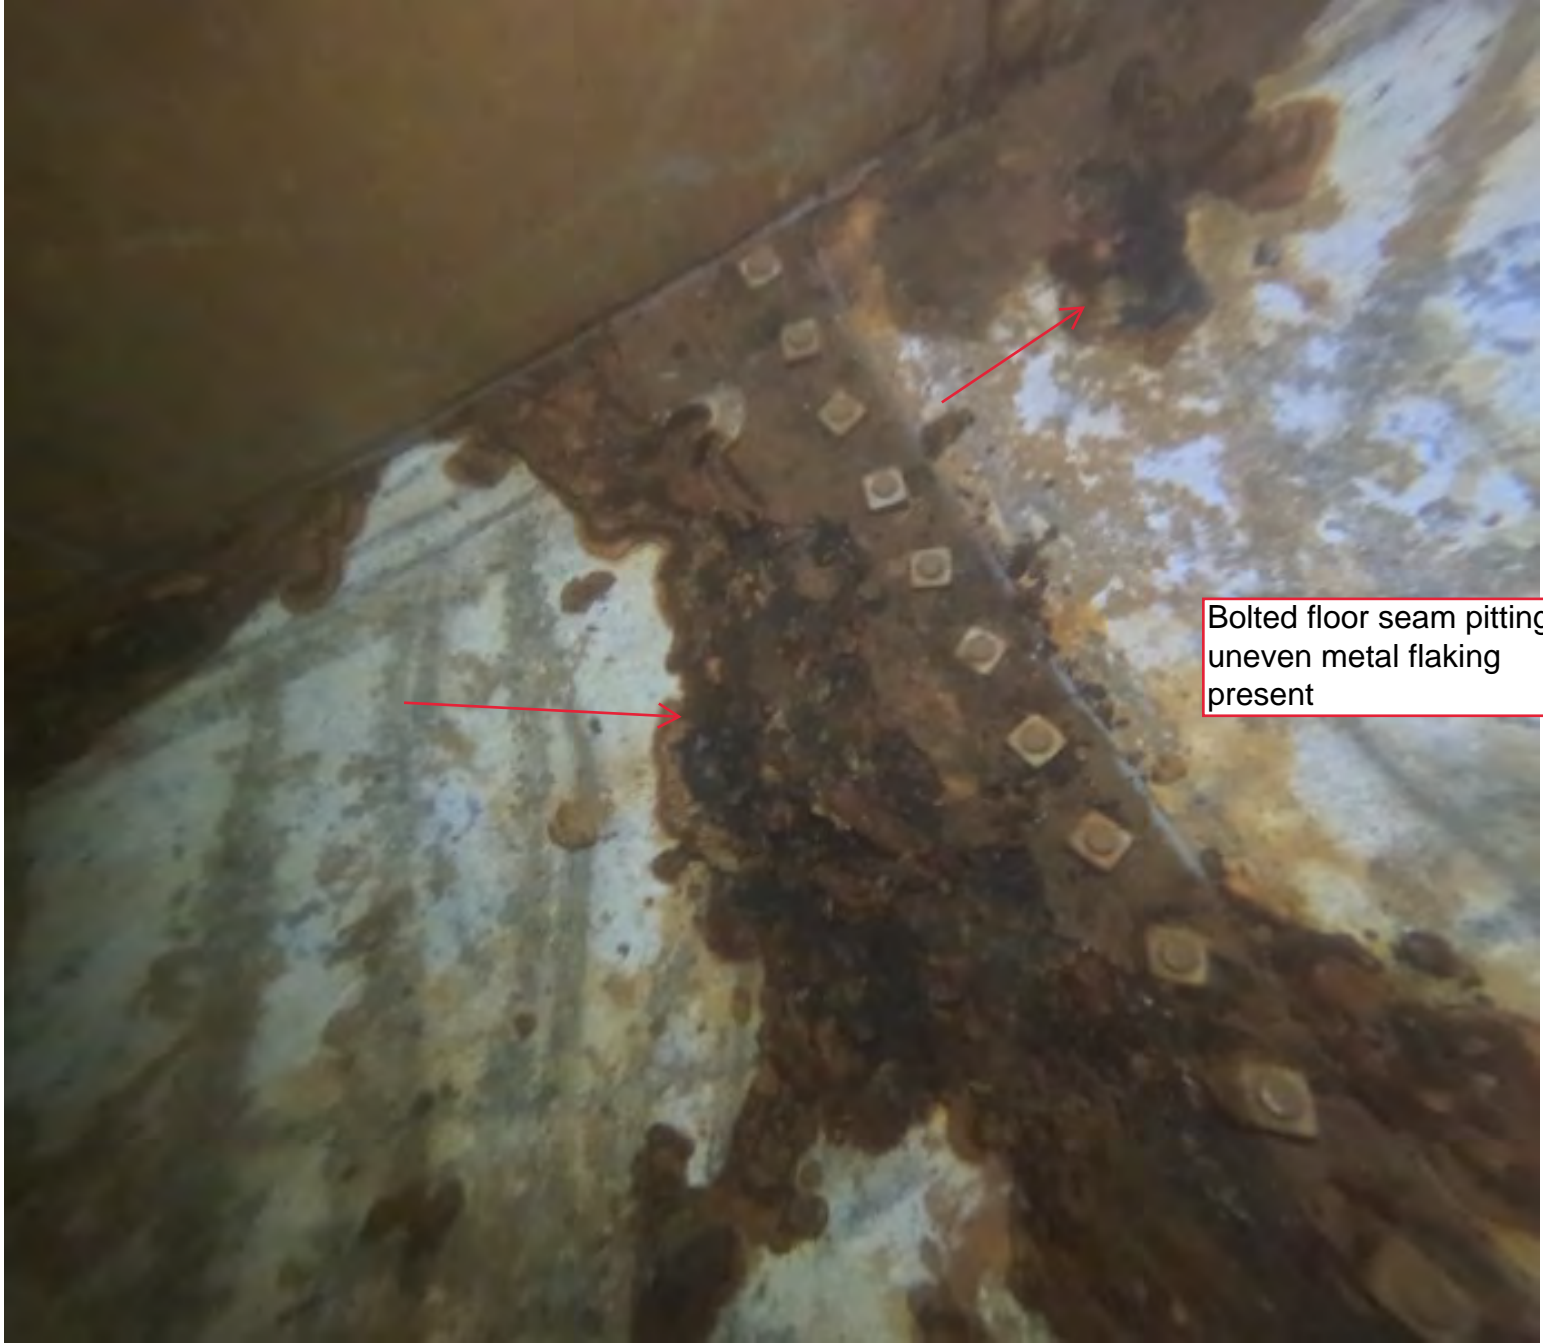
Bolted floor seam pitting
uneven metal flaking
present

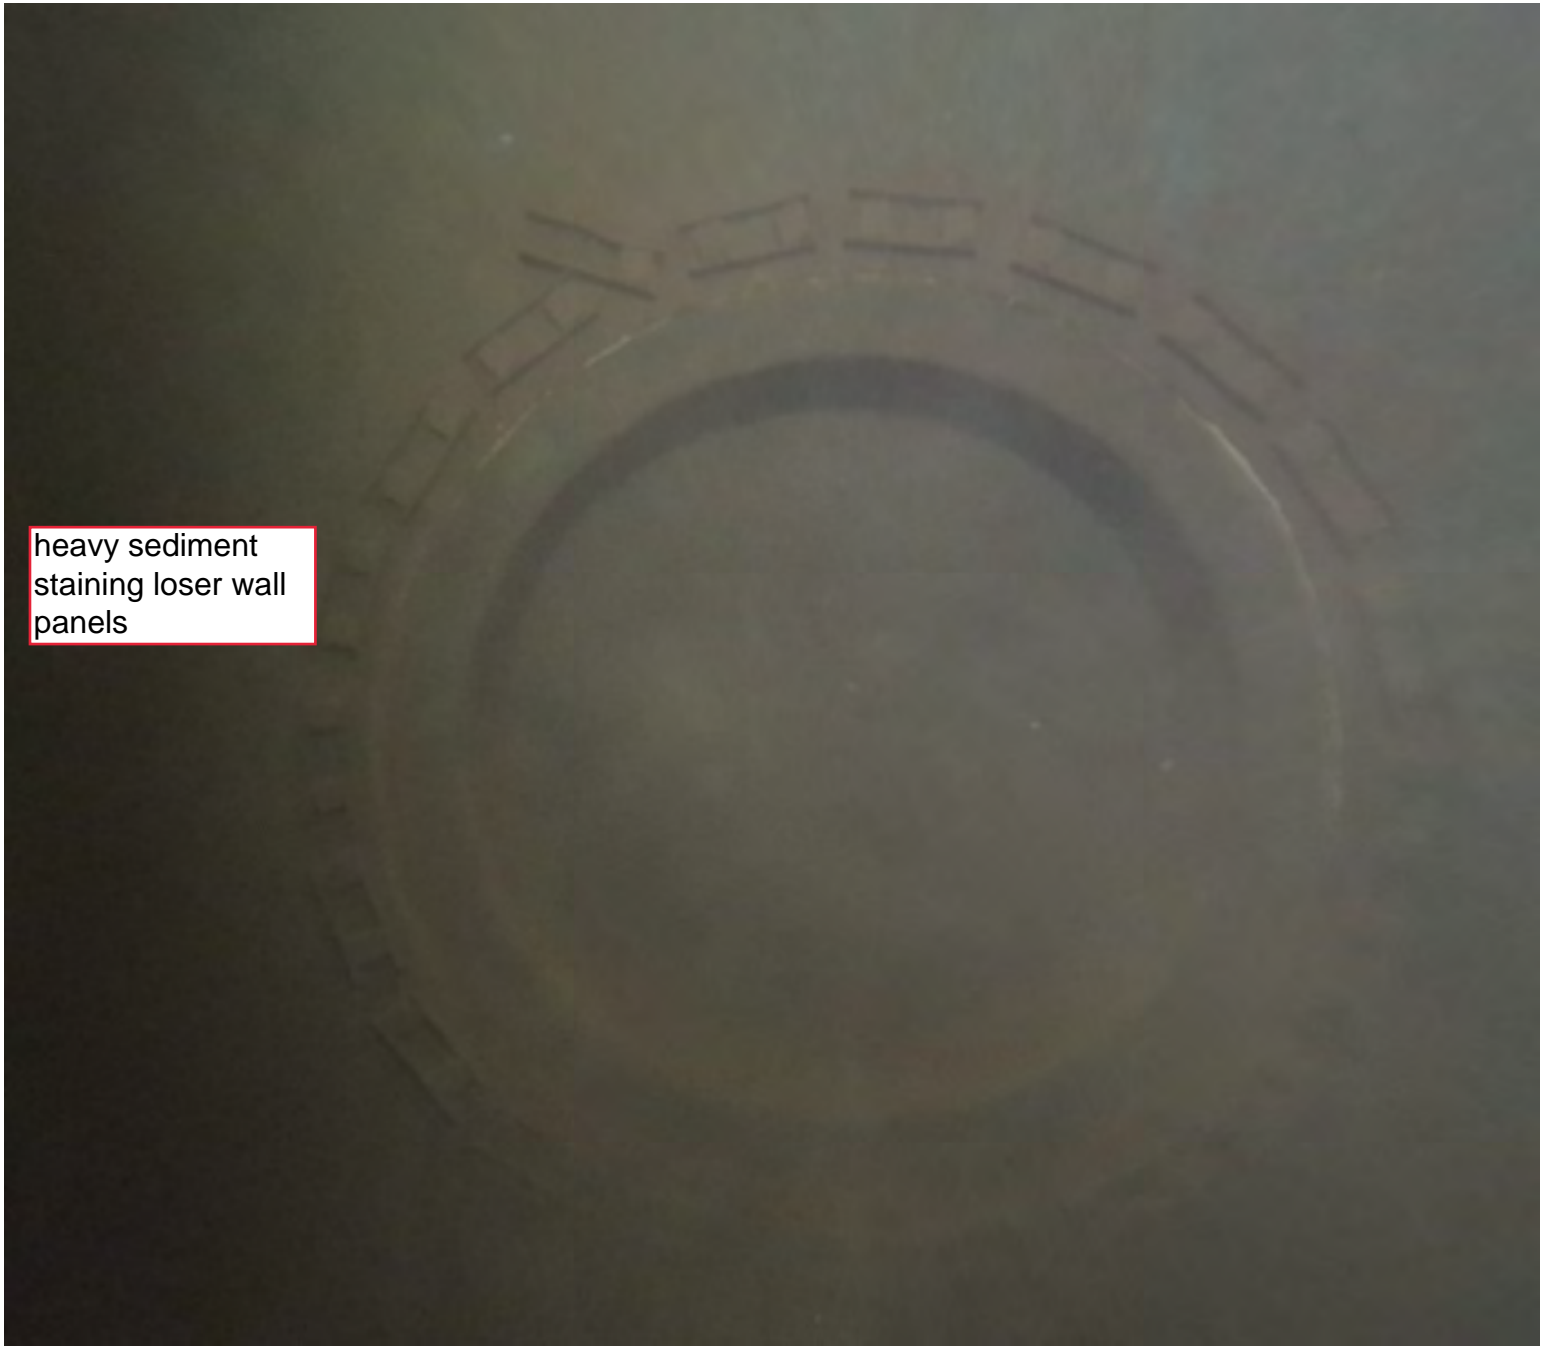
heavy sediment
staining inner wall
panels
