LISCOTT CUSTOM HOMES, LTD.
PROPOSED RESIDENCE
LOT 5, BLOCK 16, WHISPERING PINES RANCH SUB #8
CTL | THOMPSON PROJECT NO. SU01733.000-120
C:\Users\briggeler\AppData\Local\Box\Box Edit\Documents\DD1R3HfME+YwHUzVwXGvg==\SU01733.000 - 120 - R1.docx

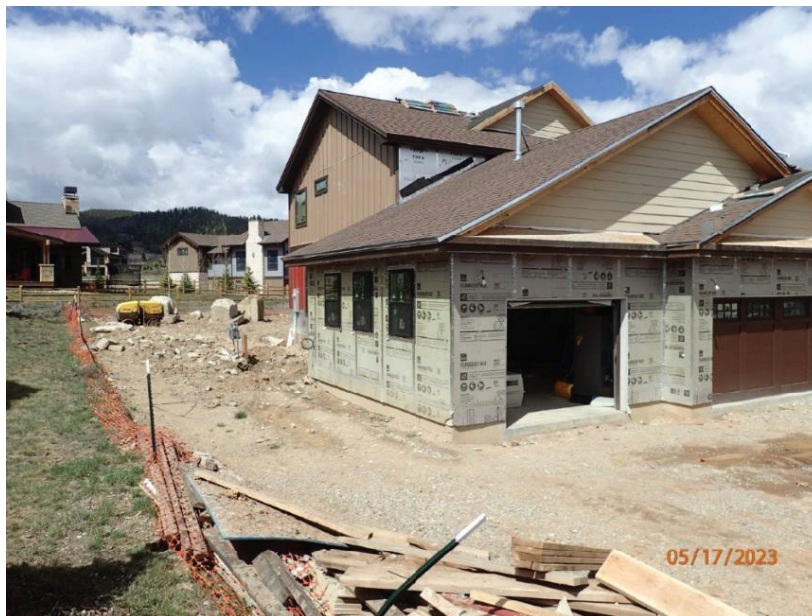
May 17, 2023, Disc OBS1, Photograph 4, DLC, 101 Mule Deer Court, no drainage swale in place to direct water away from the foundation.

1. The ground surface surrounding the exterior of the building should be sloped to drain away from the building in all directions. We recommend providing a slope of at least 12 inches in the first 10 feet in landscape areas. There are instances where this slope cannot be achieved. A slope of 6 inches in the first 10 feet should be used as a minimum. We recommend a slope of at least 3 inches in the first 10 feet in paved areas. A swale should be provided around the uphill side of the building to divert surface runoff.

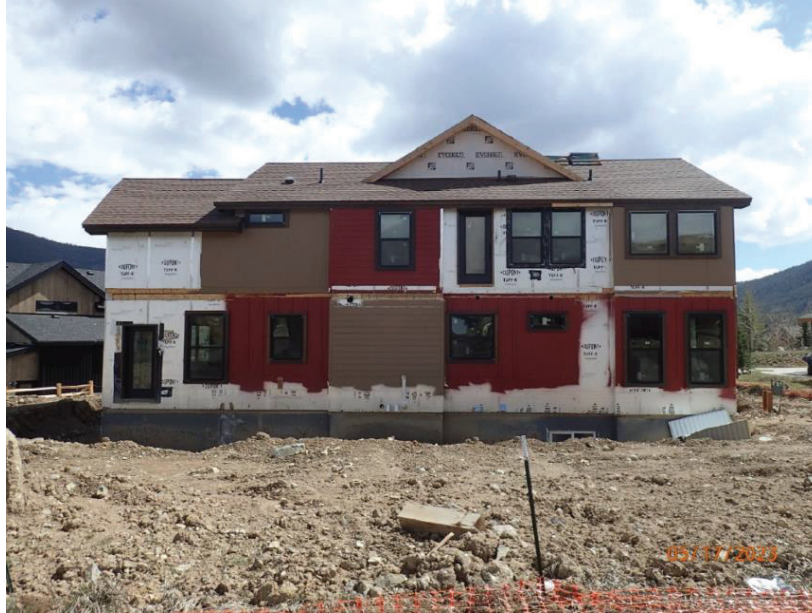
May 17, 2023, Disc OBS1, Photograph 8, DLC, 101 Mule Deer Court, spoil materials piled without a swale to direct water off the site.

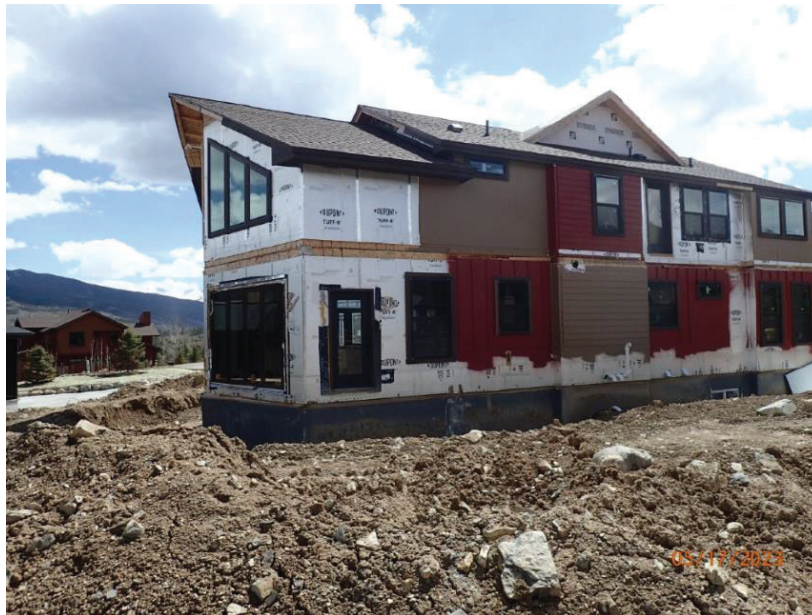
May 17, 2023, Disc OBS1, Photograph 9, DLC, 101 Mule Deer Court, spoil materials piled without a swale to direct water off the site.

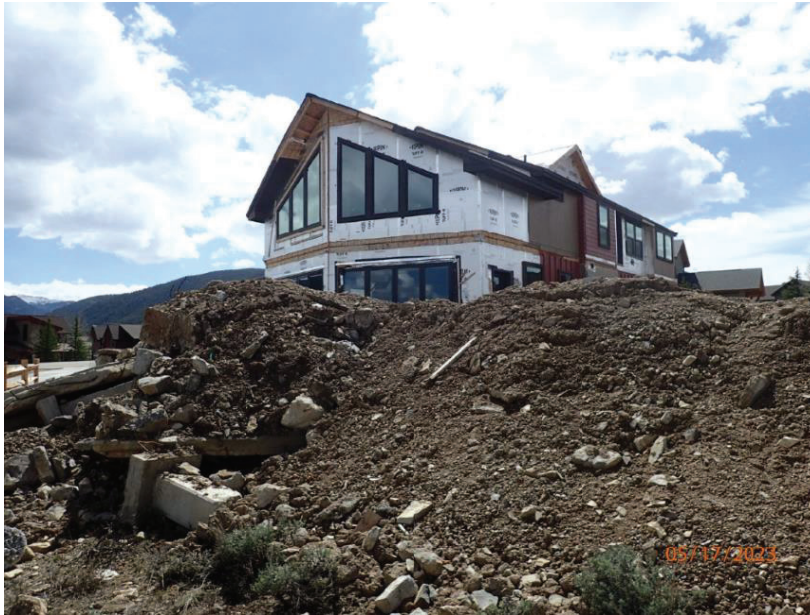
May 17, 2023, Disc OBS1, Photograph 10, DLC, 101 Mule Deer Court, spoil materials piled without a swale to direct water off the site.

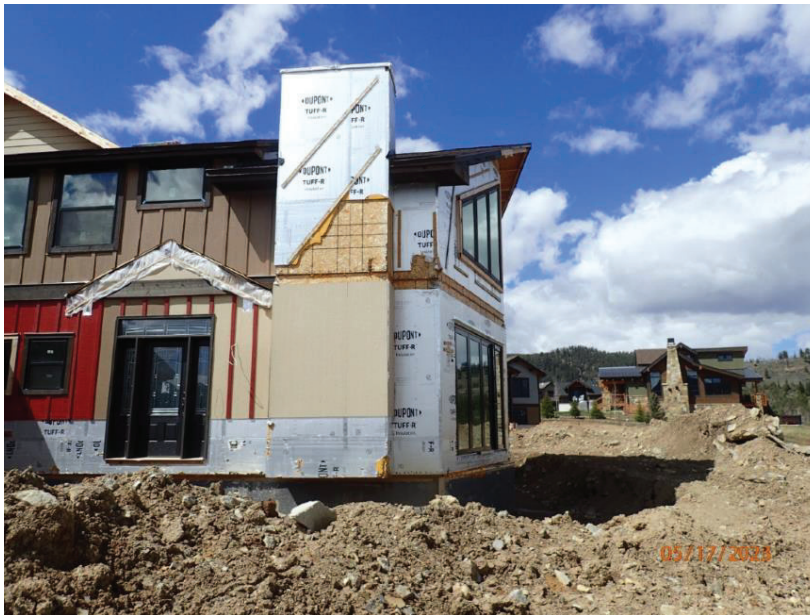
May 17, 2023, Disc OBS1, Photograph 12, DLC, 101 Mule Deer Court, spoil materials piled without a swale to direct water off the site.

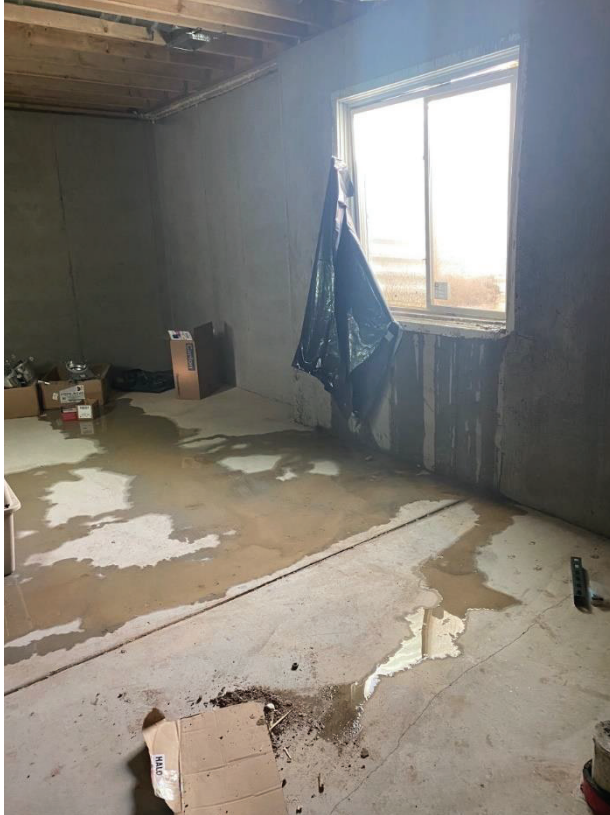
Owner provided photo showing water coming through the basement window.

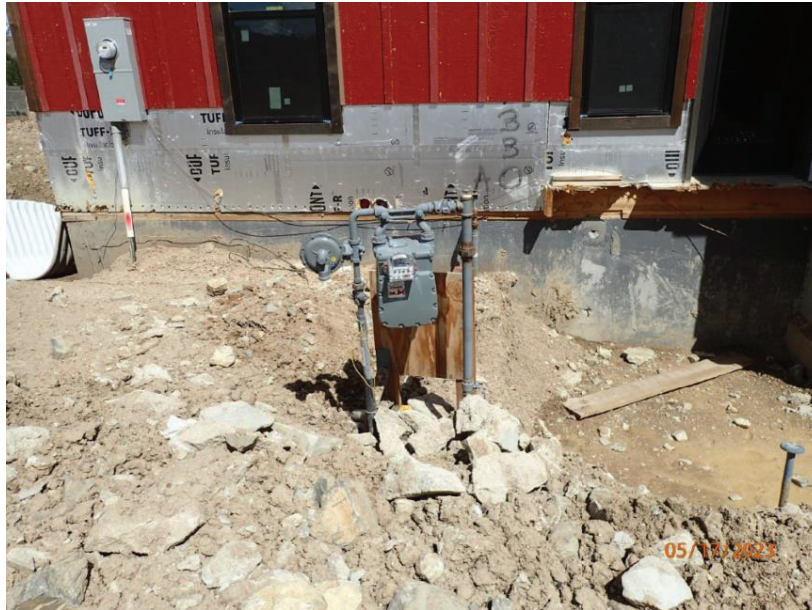
As a result of the improper backfill and compaction, the footings and foundations for the porches and other attached structures had experienced excess settling and had to be removed. In addition, some of the out-of-plumb wall conditions appear related to the contractor's backfill efforts (noted in the offset framing at the sill plate). These items will be reconstructed after the proper backfill and compaction has been achieved.

May 17, 2023, Disc OBS1, Photograph 23, DLC, 101 Mule Deer Court, improper backfill and poor support of gas meter and line at south elevation.

The backfilling and compaction should have been done by placing the fill materials in lifts of approximately 6- to 10-inches then use a smaller roller type compactor. This will result in proper consolidation of the materials and compaction. Use of the smaller roller type equipment will also minimize the potential for damage to the foundation wall by reducing the imposed excess surcharge loads placed on the wall.

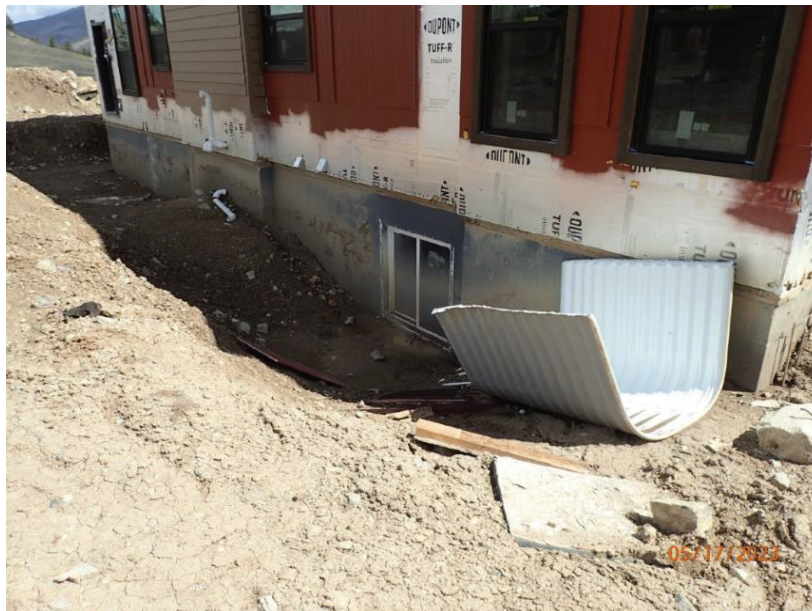
May 17, 2023, Disc OBS1, Photograph 29, DLC, 101 Mule Deer Court, backfilling along west elevation.

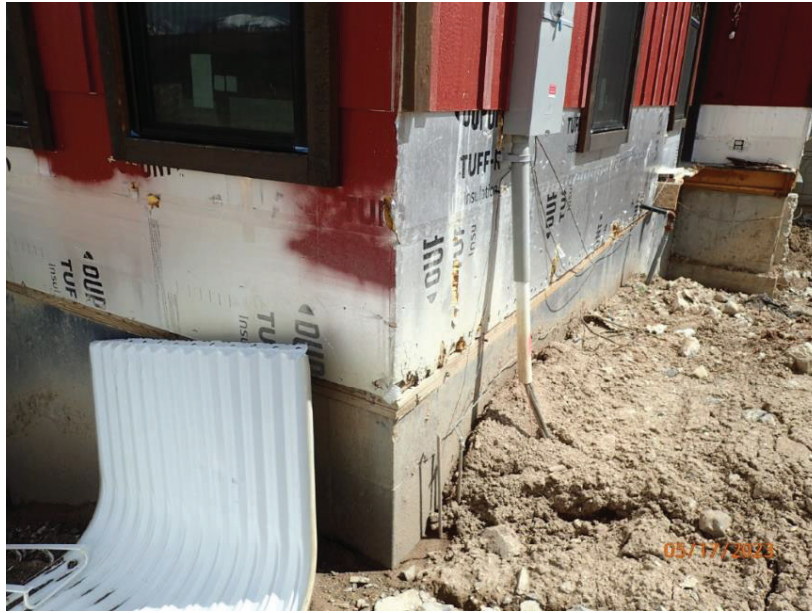
May 17, 2023, Disc OBS1, Photograph 31, DLC, 101 Mule Deer Court, improper backfill at southwest corner of structure.

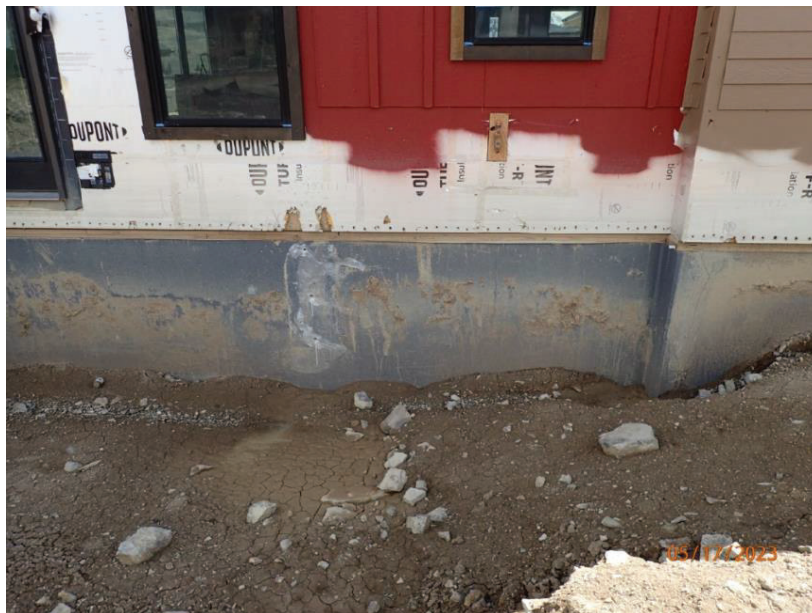
May 17, 2023, Disc OBS1, Photograph 37, DLC, 101 Mule Deer Court, backfilling along west elevation.

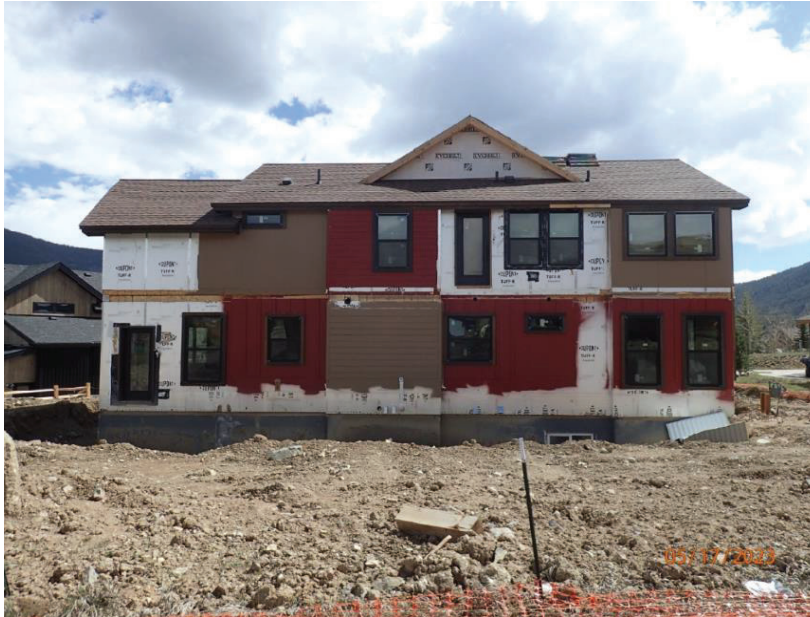
May 17, 2023, Disc OBS1, Photograph 8, DLC, 101 Mule Deer Court, incomplete exterior siding installation at west elevation.

As stated elsewhere in this report, in order to address all of the issues related to the siding and its related components, it is CTETS’s opinion that full removal and replacement of all siding components is necessary. It is also CTETS’s opinion that any costs associated with these repairs are the responsibility of Liscott.

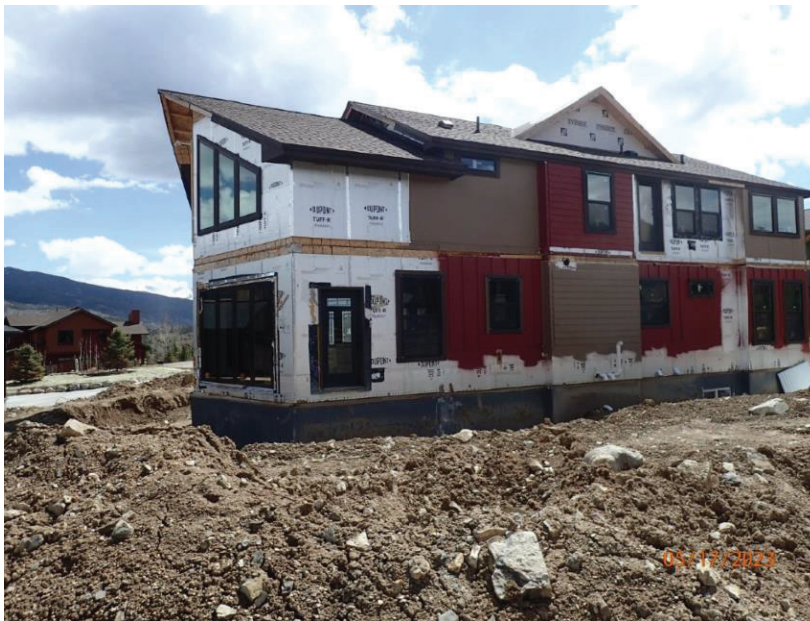
May 17, 2023, Disc OBS1, Photograph 9, DLC, 101 Mule Deer Court, incomplete siding installation at northeast elevation.

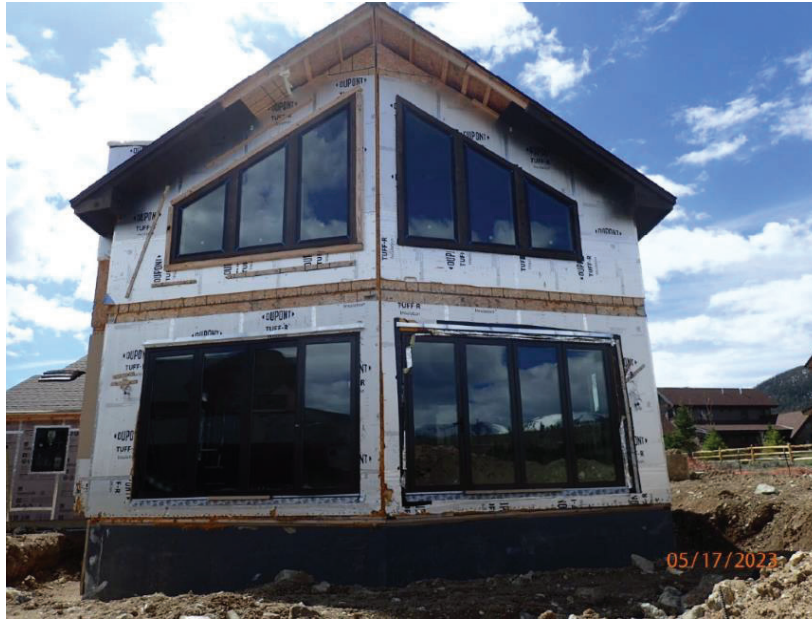
May 17, 2023, Disc OBS1, Photograph 11, DLC, 101 Mule Deer Court, incomplete siding installation at north elevation.

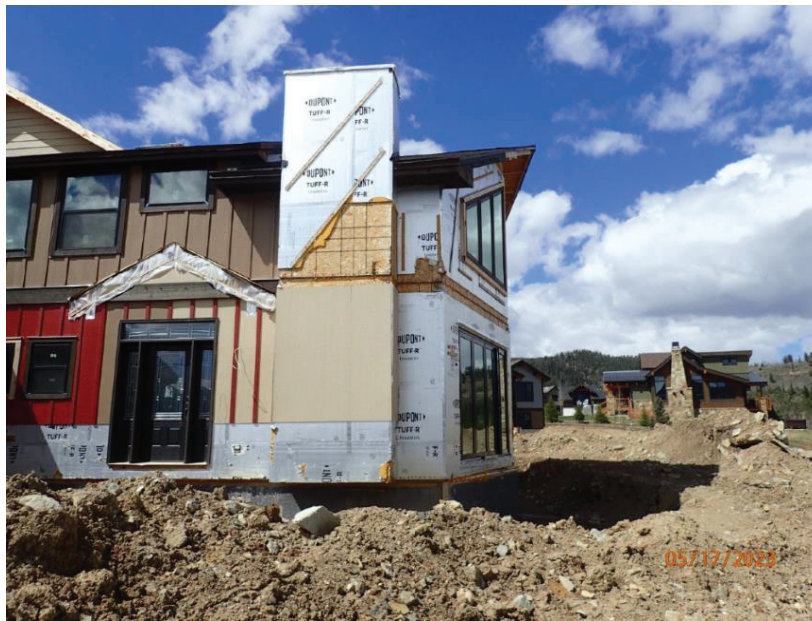
May 17, 2023, Disc OBS1, Photograph 12, DLC, 101 Mule Deer Court, incomplete siding installation at east elevation.

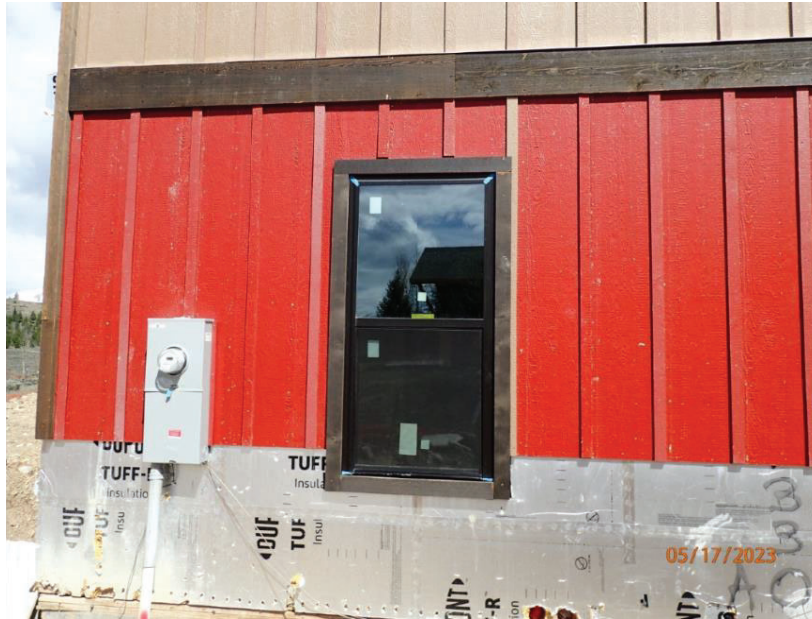
May 17, 2023, Disc OBS1, Photograph 26, DLC, 101 Mule Deer Court, incomplete exterior finish installation at south elevation.

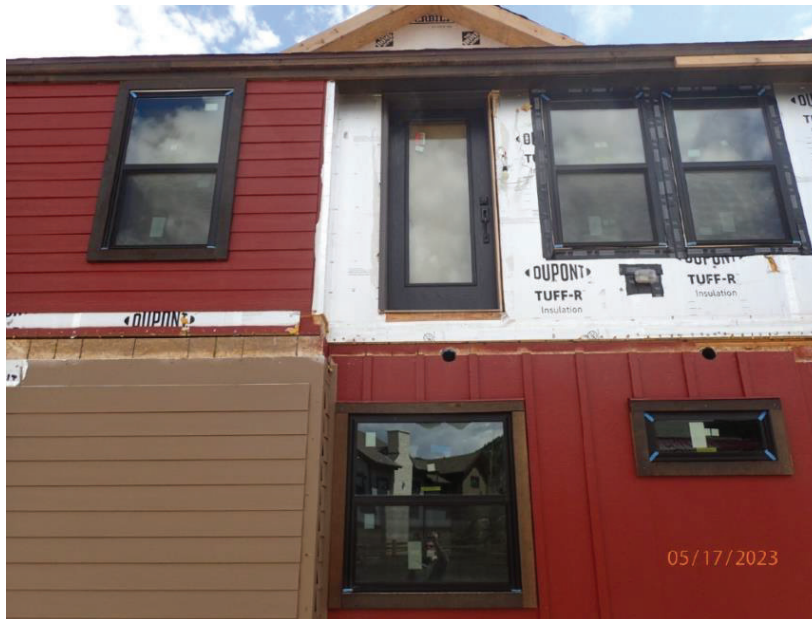
May 17, 2023, Disc OSB1, Photograph 35, DLC, 101 Mule Deer Court, exterior deck not constructed and incomplete siding installation on west elevation.

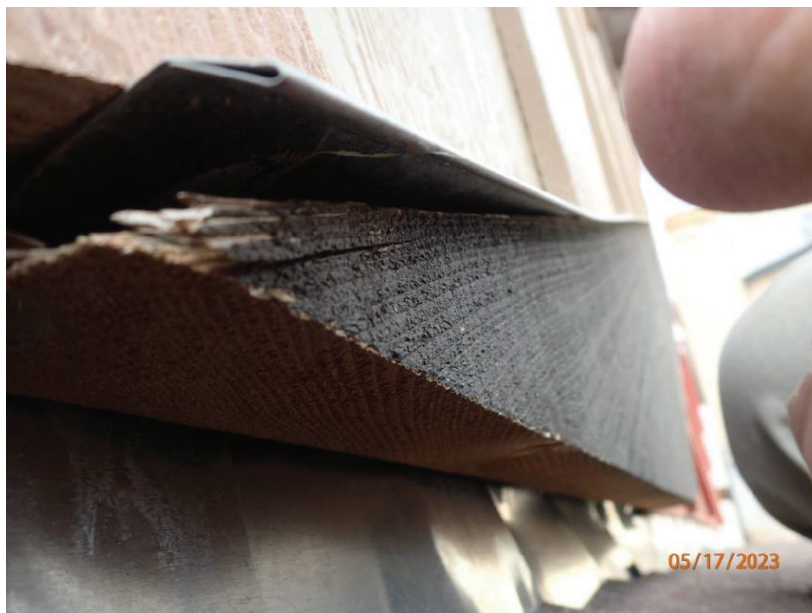
As constructed, the siding and trim at the Property contain untreated cut ends that are in violation of the manufacturers' requirements. The as-built untreated edges will promote moisture absorption and result in premature deterioration of the products in the forms of swelling, delamination, strength loss, and probable biogrowth. These issues are compounded where untreated cut ends are placed without compliant clearance to adjacent surfaces and flashings, as may be discussed in other sections of this report.

May 17, 2023, Disc OBS1, Photograph 274, DLC, 101 Mule Deer Court, untreated cut ends and cut siding edges.

It is CTETS's opinion that, due to this condition being present at all locations where the siding and trim have been installed, the only reasonable remedy to these conditions would be to fully remove and replace all siding and trim installed on the Project.

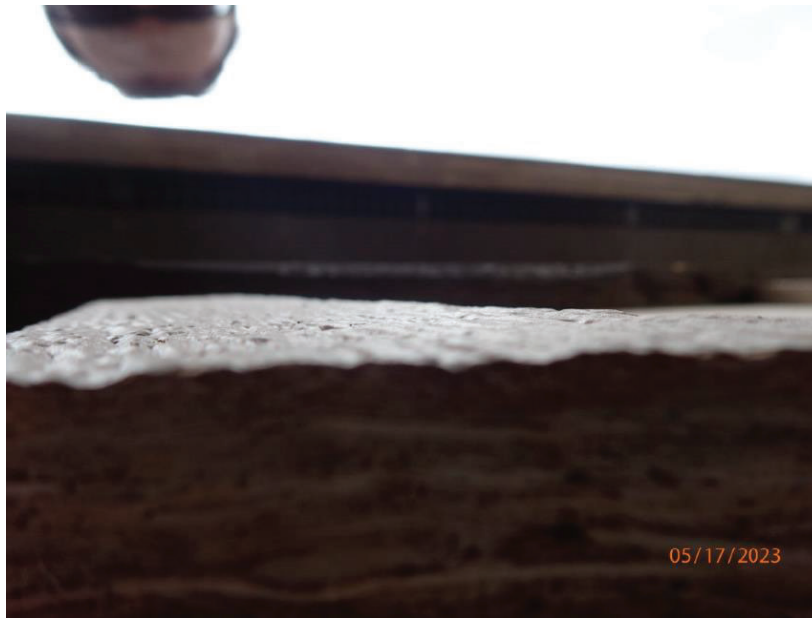
May 17, 2023, Disc OBS1, Photograph 275, DLC, 101 Mule Deer Court, untreated cut ends of vertical batten.

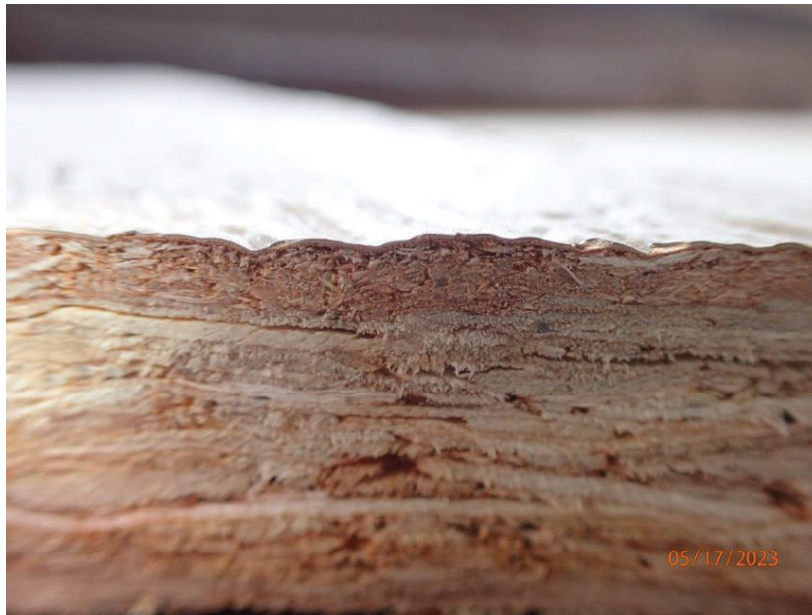
May 17, 2023, Disc OBS1, Photograph 276, DLC, 101 Mule Deer Court, untreated cut ends of vertical batten.

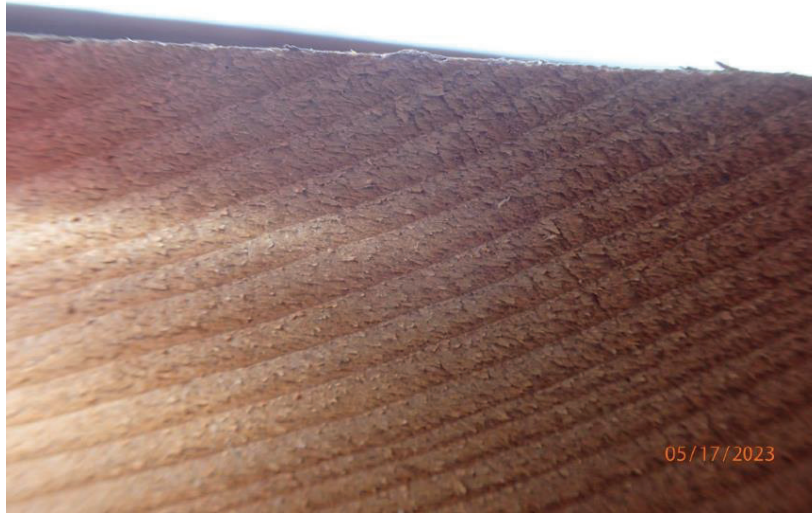
May 17, 2023, Disc OBS1, Photograph 277, DLC, 101 Mule Deer Court, untreated cut ends of vertical batten.

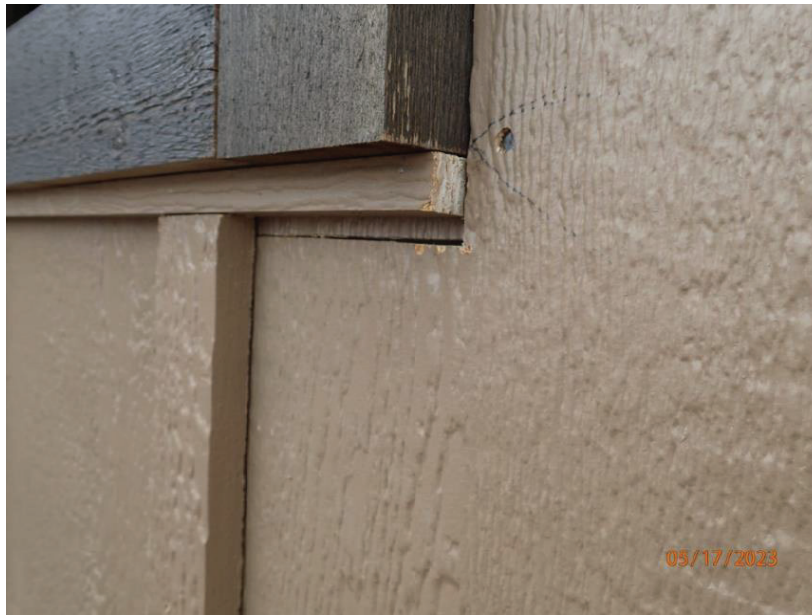
May 17, 2023, Disc OBS1, Photograph 280, DLC, 101 Mule Deer Court, untreated cut ends and short cut siding below upper level windows. The small piece of trim is used to fill to undercut panel below the window.

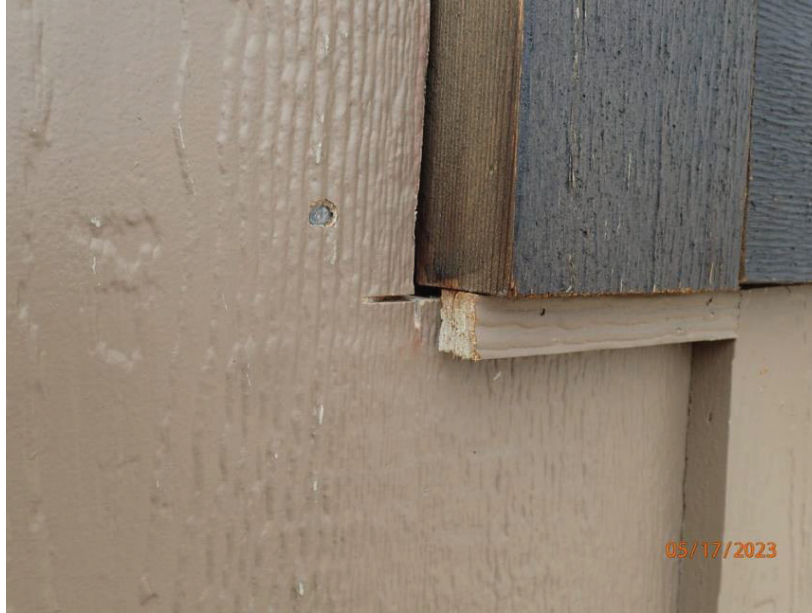
May 17, 2023, Disc OSB1, Photograph 281, DLC, 101 Mule Deer Court, untreated cut ends and short cut siding below upper level windows. The small piece of trim is used to fill to undercut panel below the window. Also overcut mark from the saw blade. This requires filling and sealing.

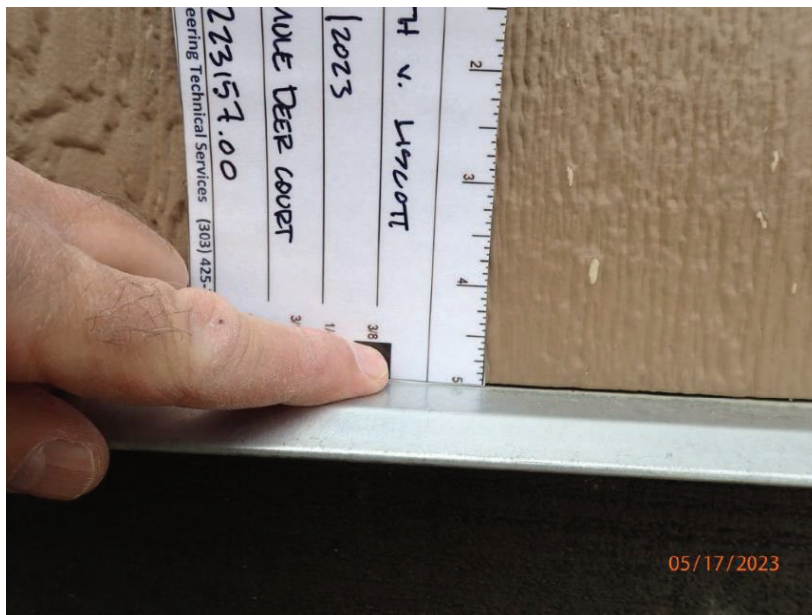
Where non-compliant clearance between claddings and flashings exists, the as-built condition falls short of the prescriptive requirements of the relevant codes, design, industry standards, and manufacturer requirements, and therefore, the contractor and subcontractors who performed the work are responsible for any costs associated with the repairs required to resolve these conditions.

May 17, 2023, Disc OBS1, Photograph 272, DLC, 101 Mule Deer Court, non-compliant clearance between siding and thru-wall flashing. Flashing also installed flat.

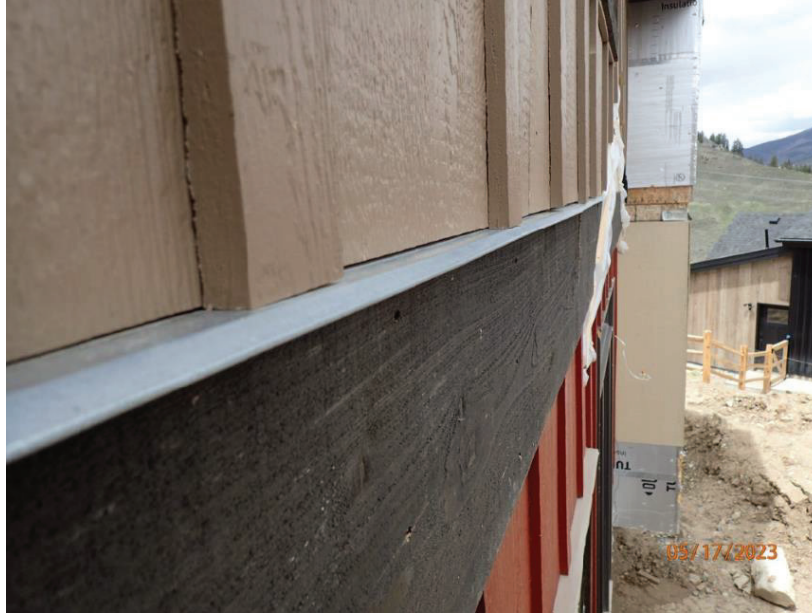
May 17, 2023, Disc OBS1, Photograph 273, DLC, 101 Mule Deer Court, non-compliant clearance between siding and thru-wall flashing. Flashing also installed flat, minimum of five-degree slope is required.

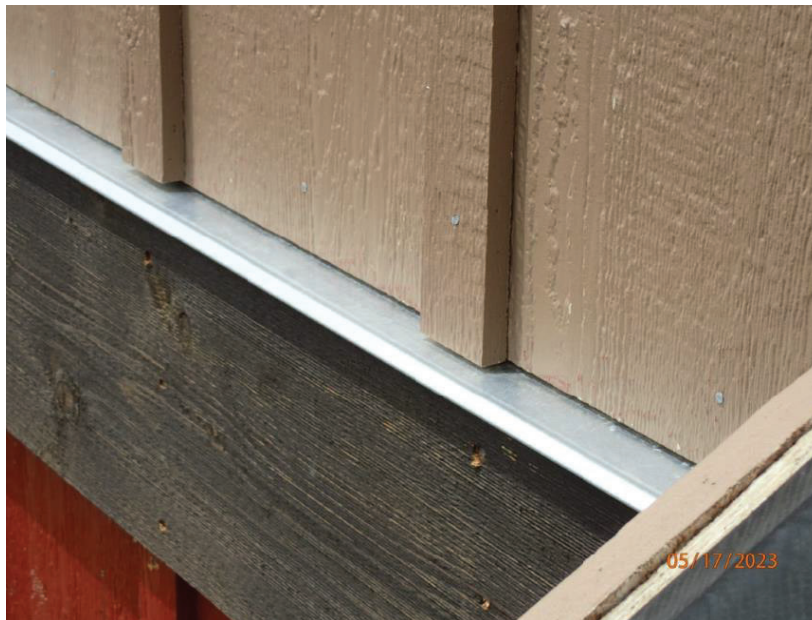
May 17, 2023, Disc OBS1, Photograph 310, DLC, 101 Mule Deer Court, non-compliant clearance between siding and thru-wall flashing. Flashing also installed flat, minimum of five-degree slope is required.

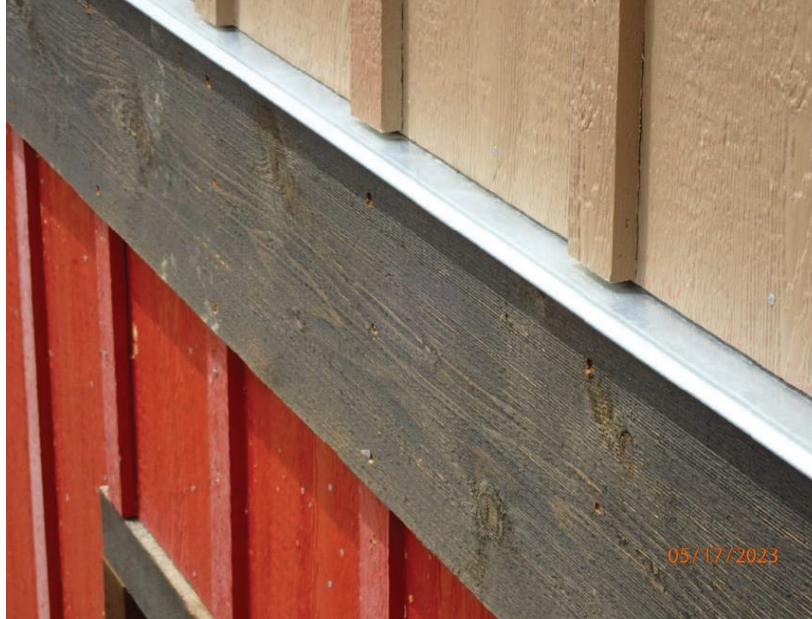
May 17, 2023, Disc OBS1, Photograph 311, DLC, 101 Mule Deer Court, non-compliant clearance between siding and thru-wall flashing. Flashing also installed flat, minimum of five-degree slope is required.

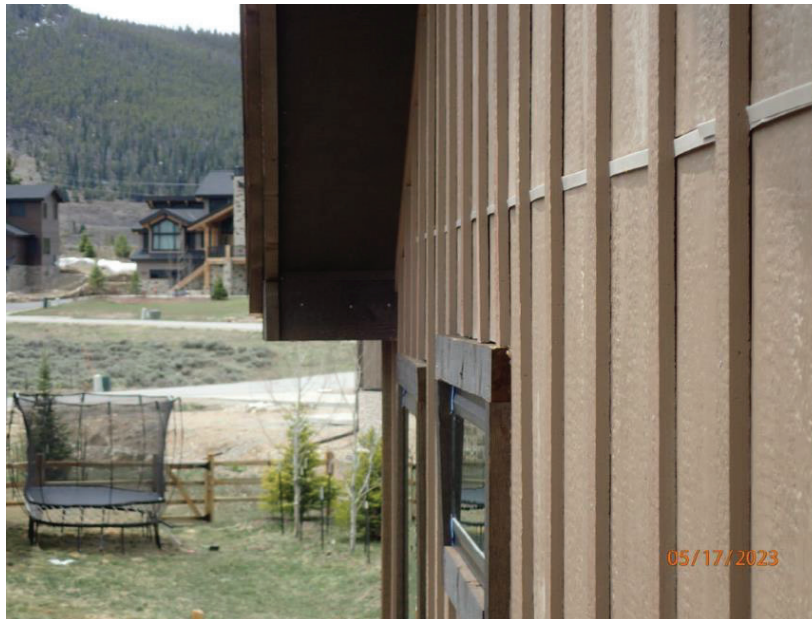
May 17, 2023, Disc OBS1, Photograph 312, DLC, 101 Mule Deer Court, missing flashing at window head and non-compliant thru-wall flashing between horizontal joint in vertical panel siding.

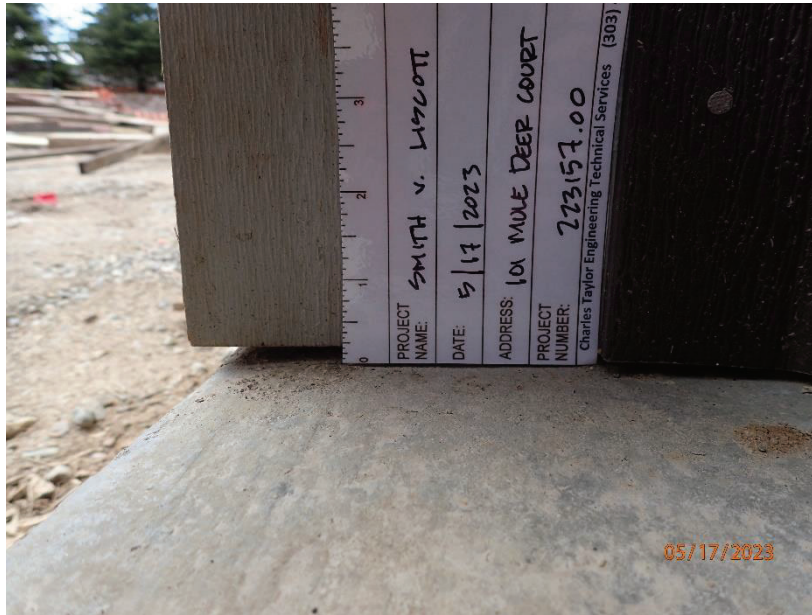
Where non-compliant clearance from siding and trim to adjacent surfaces exists, the as-built condition falls short of the prescriptive requirements of the relevant codes, design, industry standards, and manufacturer requirements and, therefore, the contractor and subcontractors who performed the work are responsible for any costs associated with the repairs required to resolve these conditions.

May 17, 2023, Disc OBS1, Photograph 87, DLC, 101 Mule Deer Court, trim tight to concrete at garage door jamb.

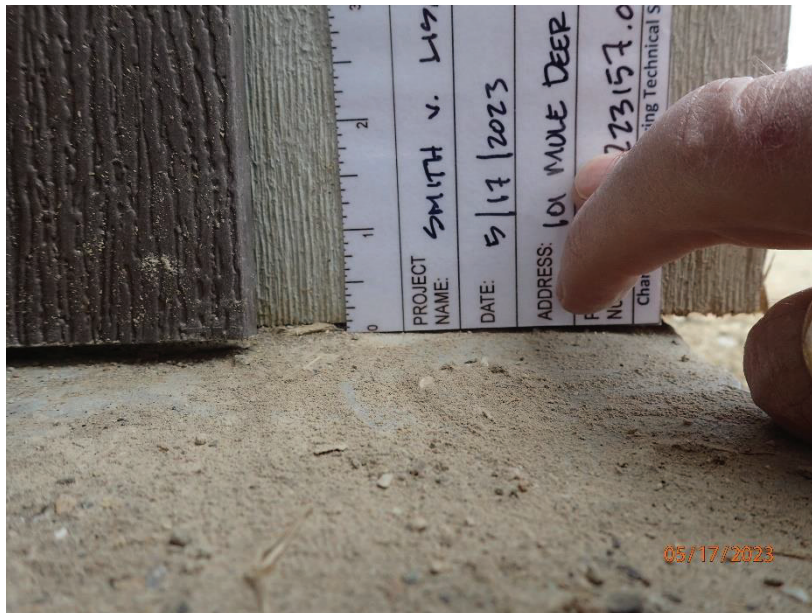
May 17, 2023, Disc OBS1, Photograph 88, DLC, 101 Mule Deer Court, trim tight to concrete at garage door jamb.

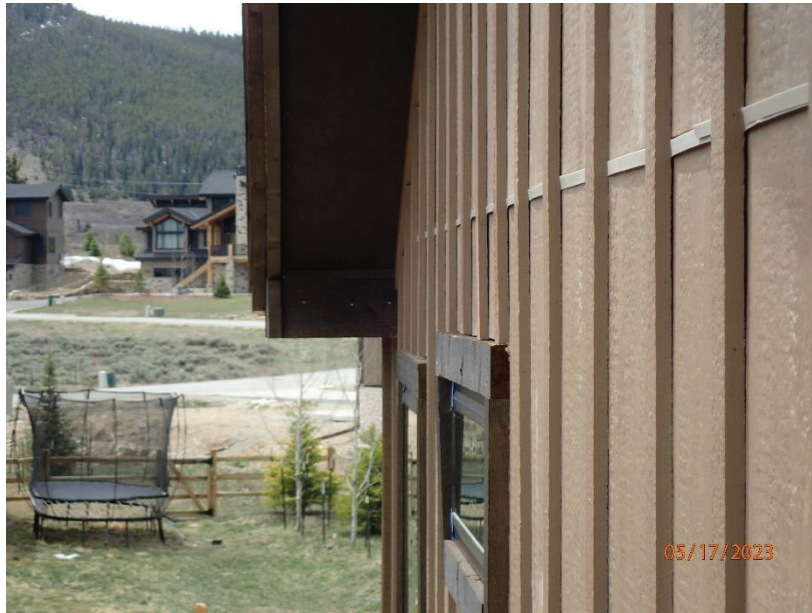
May 17, 2023, Disc OBS1, Photograph 312, DLC, 101 Mule Deer Court, missing head flashing at window.

It is CTETS’s opinion that any costs associated with these repairs or replacement are the responsibility of Liscott.

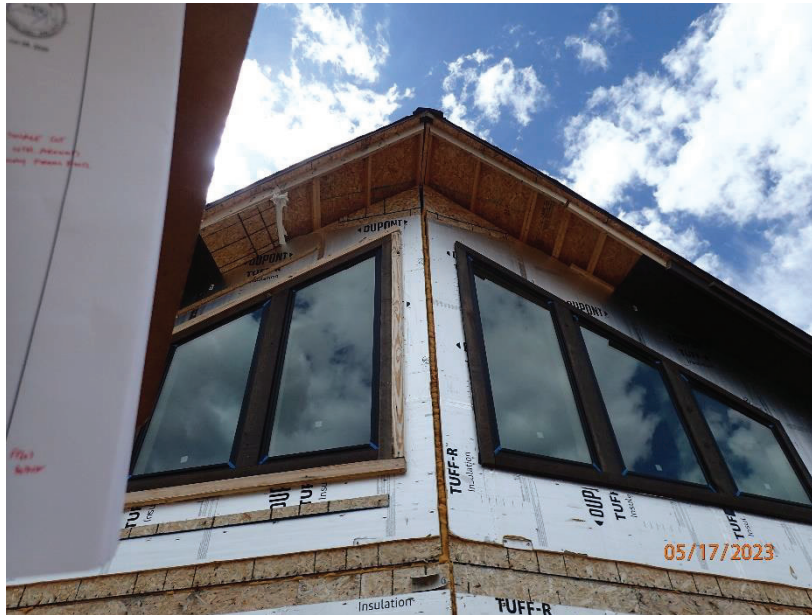
May 17, 2023, Disc OBS1, Photograph 50, DLC, 101 Mule Deer Court, missing soffit.

It is CTETS’s opinion that Liscott is responsible for any costs to complete this work, as well as any potential costs to remove the birds and their droppings from the attic. These costs may also include removal and replacement of any damaged insulation or framing components.

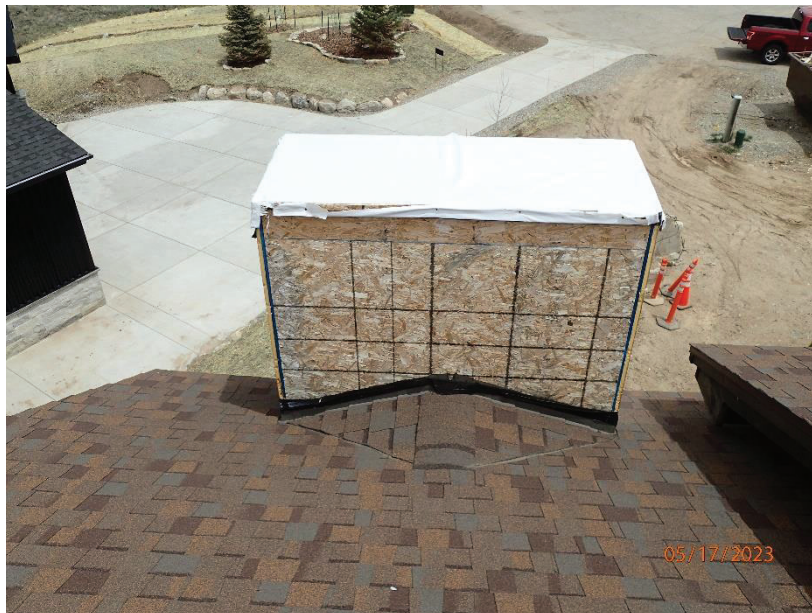
May 17, 2023, Disc OBS1, Photograph 291, DLC, 101 Mule Deer Court, missing weather protection, WRB, trim and siding.

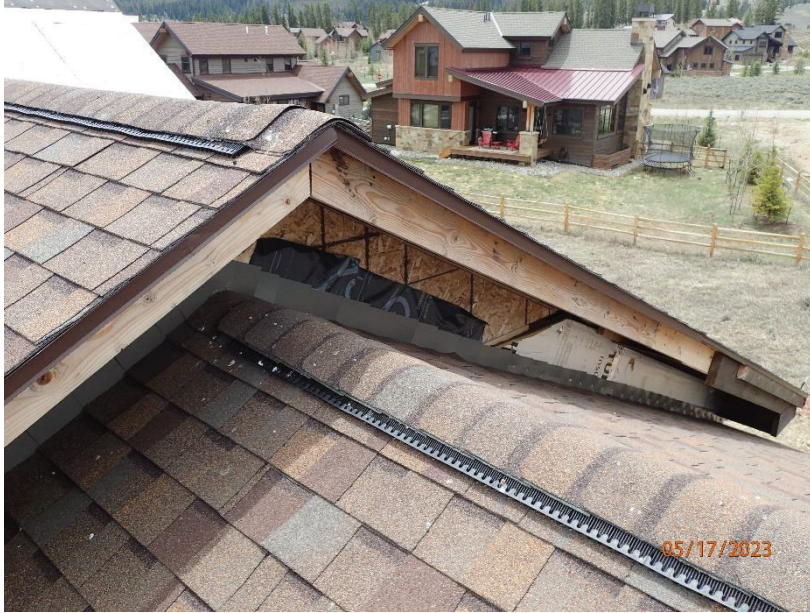
May 17, 2023, Disc OBS1, Photograph 292, DLC, 101 Mule Deer Court, missing trim and siding.

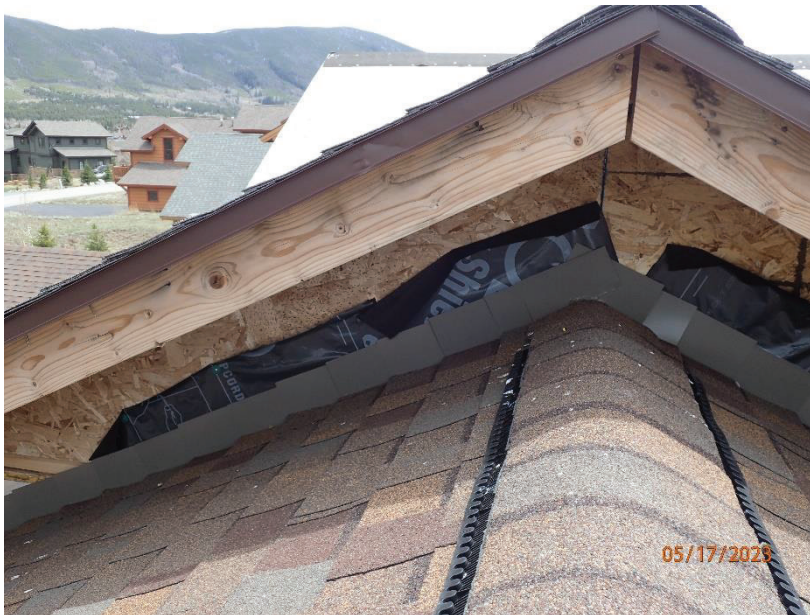
May 17, 2023, Disc OBS1, Photograph 293, DLC, 101 Mule Deer Court, missing trim and siding.

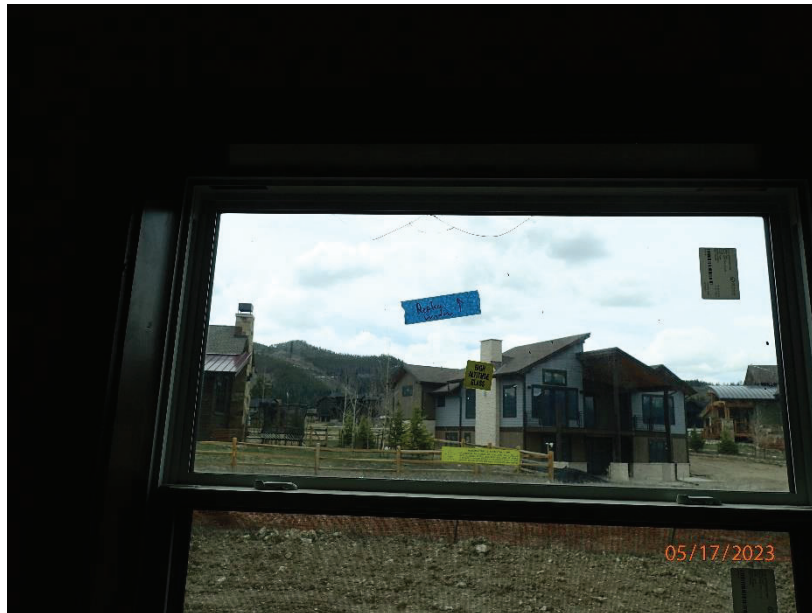
May 17, 2023, Disc OBS1, Photograph 319, DLC, 101 Mule Deer Court, broken window at first floor bath.
