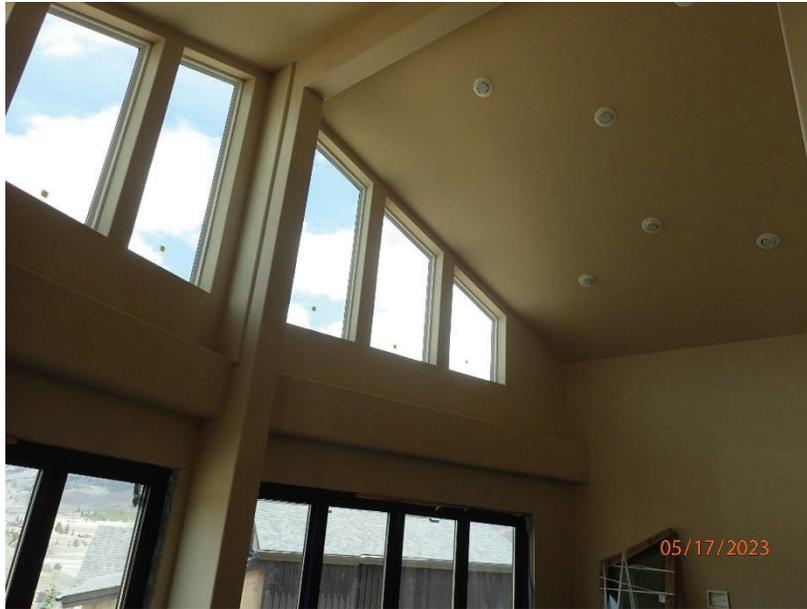
May 17, 2023, Disc OBS1, Photograph 160, DLC, 101 Mule Deer Court, broken window at clerestory.

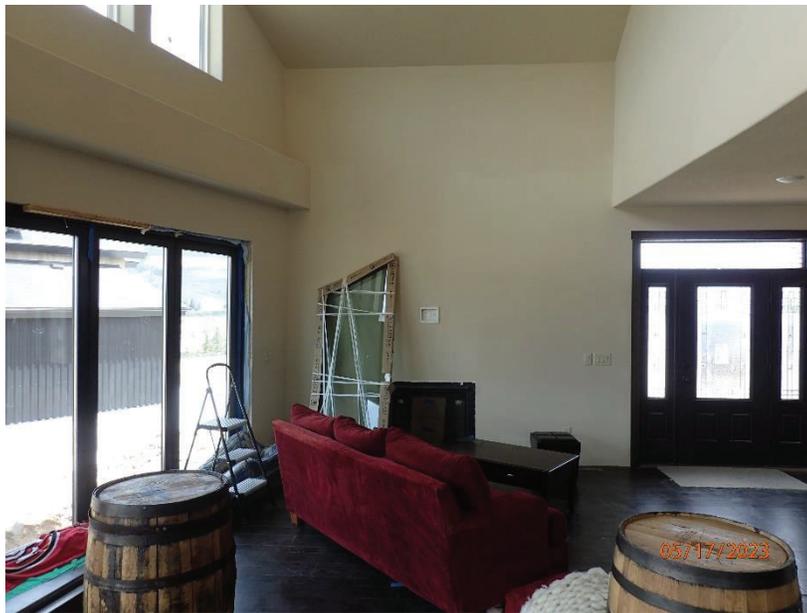
May 17, 2023, Disc OBS1, Photograph 161, DLC, 101 Mule Deer Court, replacement window.

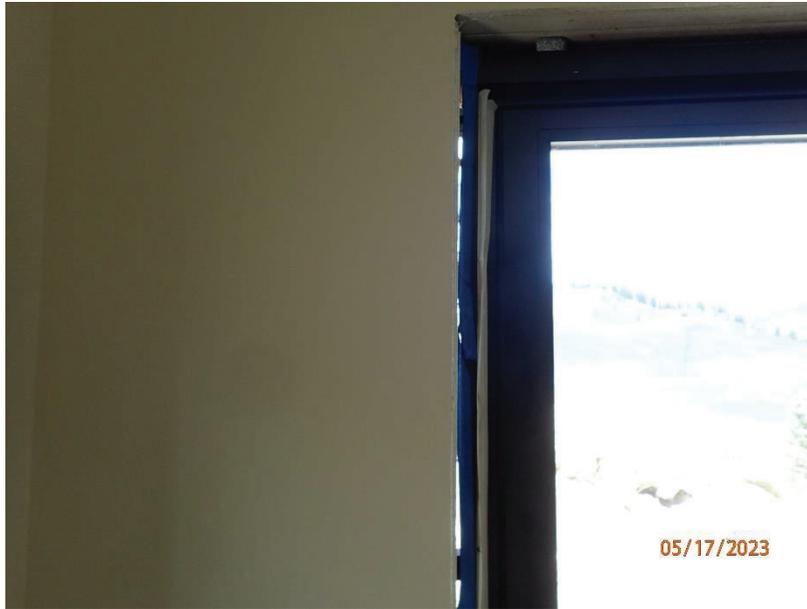
May 17, 2023, Disc OBS1, Photograph 169, DLC, 101 Mule Deer Court, gap at window.

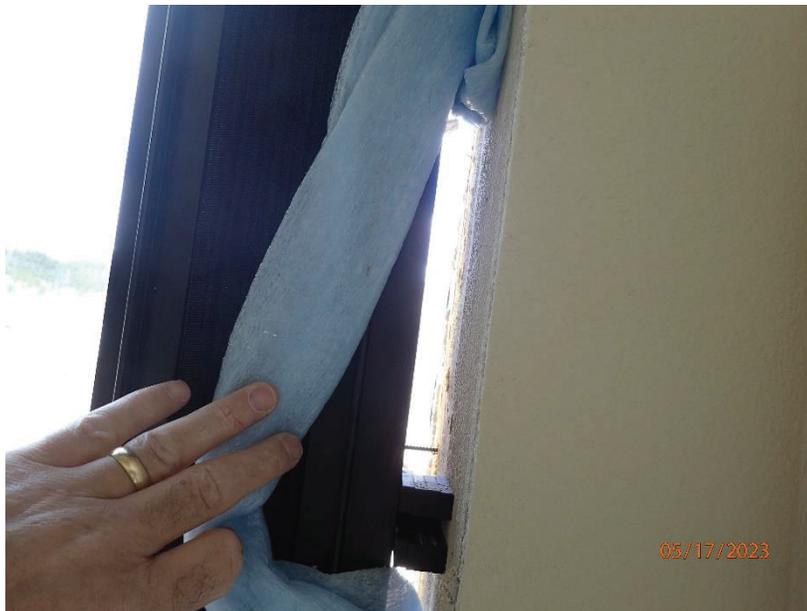
May 17, 2023, Disc OBS1, Photograph 170, DLC, 101 Mule Deer Court, gap at window.

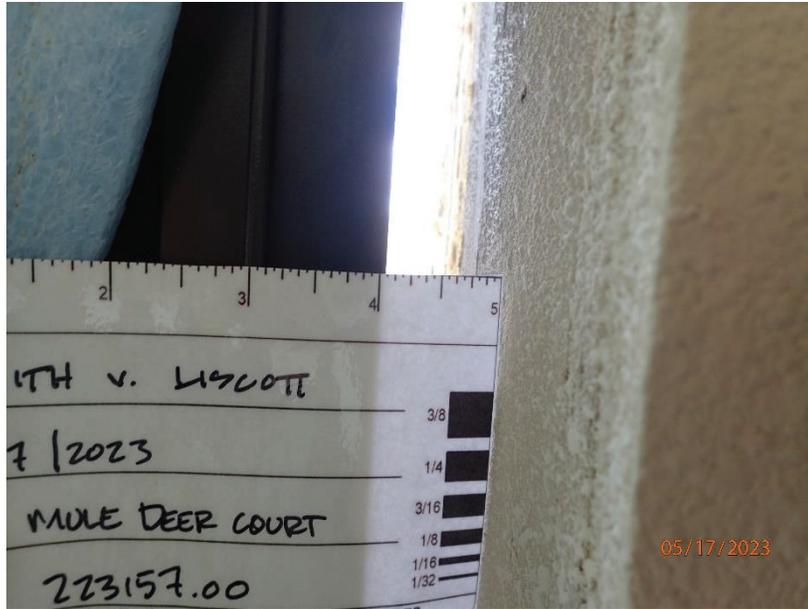
May 17, 2023, Disc OBS1, Photograph 171, DLC, 101 Mule Deer Court, gap at window.

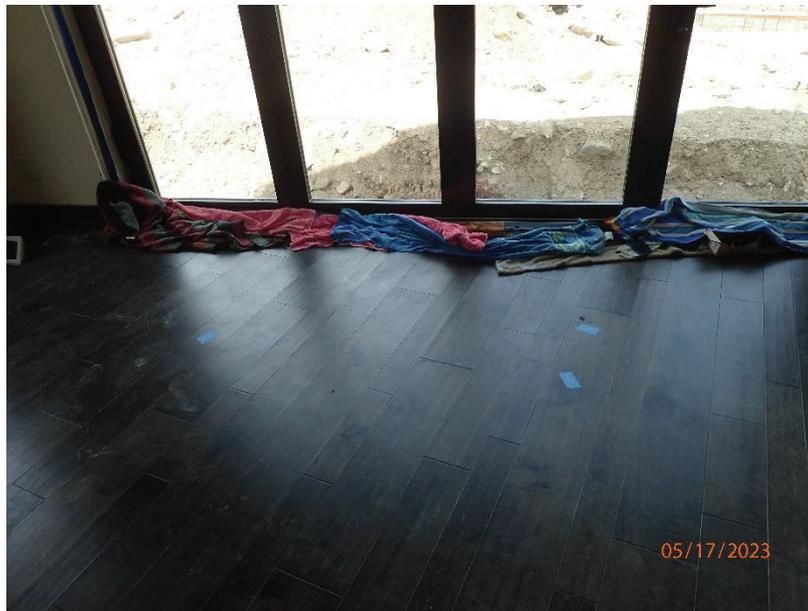
May 17, 2023, Disc OBS1, Photograph 172, DLC, 101 Mule Deer Court, water infiltration at broken window.

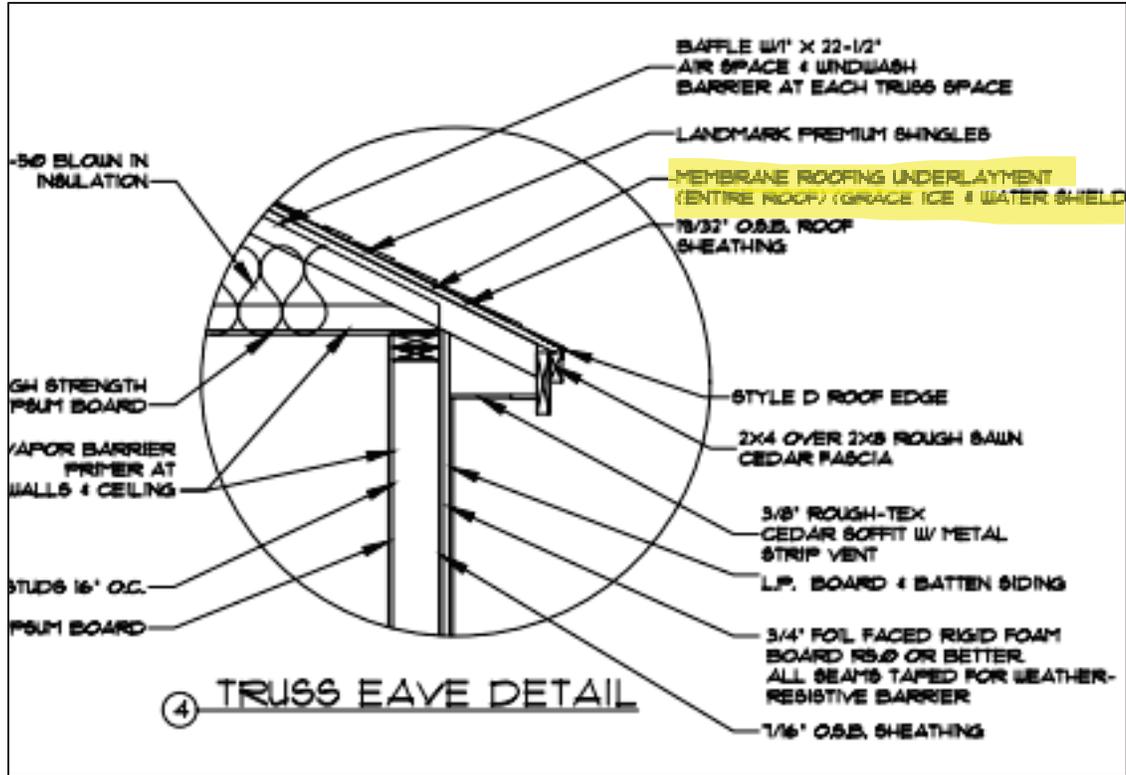
Detail 4/S2.1 of the Heritage Homes drawings call for Grace Ice & Water Shield membrane underlayment across the entire roof surface. Destructive removal of the existing shingles was not performed to verify the installation of this material. However, it can be reasonably assumed that based on the condition of the dormer roofing installation, the roofing crews did not use the Grace Ice & Water Shield but, instead, used a felt type underlayment material.

Heritage Homes detail 4/S2.1 callout for full coverage Grace Ice & Water Shield.

Based on these observations, it is CTETS's position that the shingle roofing, non-compliant underlayment, and damaged OSB sheathing will need to be removed to allow for installation of the membrane underlayment across the full surface of the roof surfaces. Full removal and replacement of the OSB sheathing down to the dormer framing is also required. Due to Liscott's failure to properly construct these items, it is CTETS's opinion that all costs associated with this work is the responsibility of Liscott.

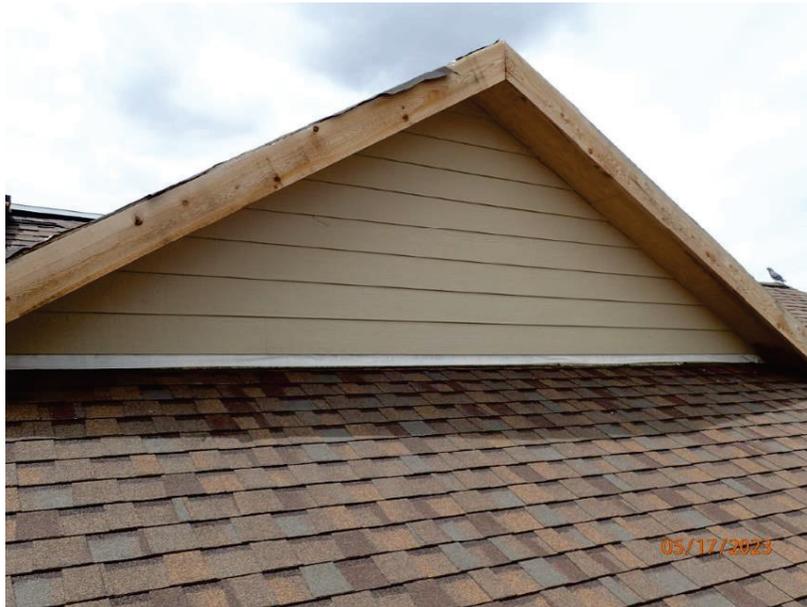
May 17, 2023, Disc OBS1, Photograph 284, DLC, 101 Mule Deer Court, incomplete roofing at dormers. Missing drip edge metal.

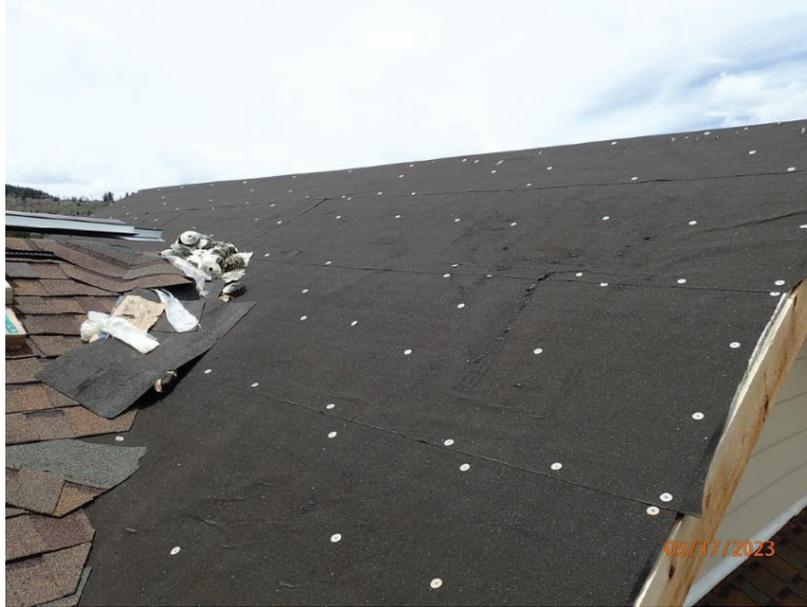
May 17, 2023, Disc OBS1, Photograph 285, DLC, 101 Mule Deer Court, incorrect underlayment materials. Heritage Homes drawings call for full coverage Grace Ice & Water Shield.

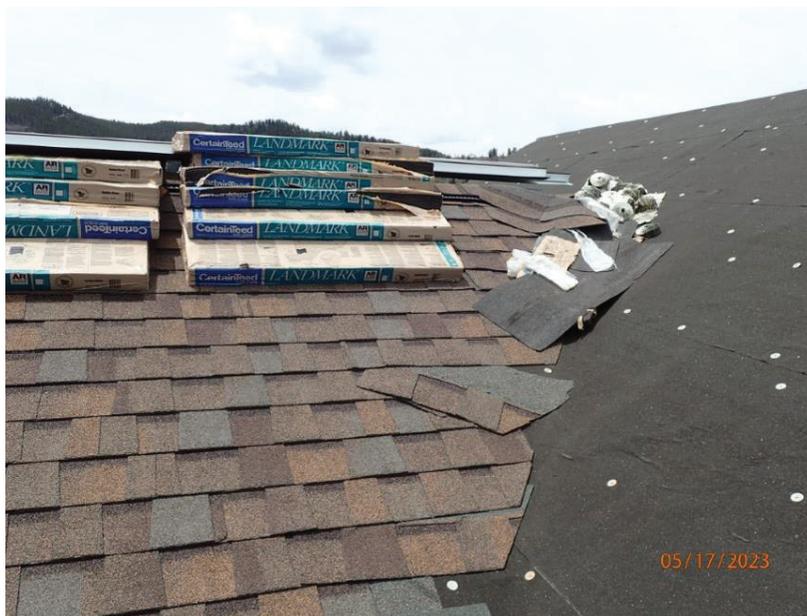
May 17, 2023, Disc OBS1, Photograph 286, DLC, 101 Mule Deer Court, incomplete roofing at upper roof and dormer.

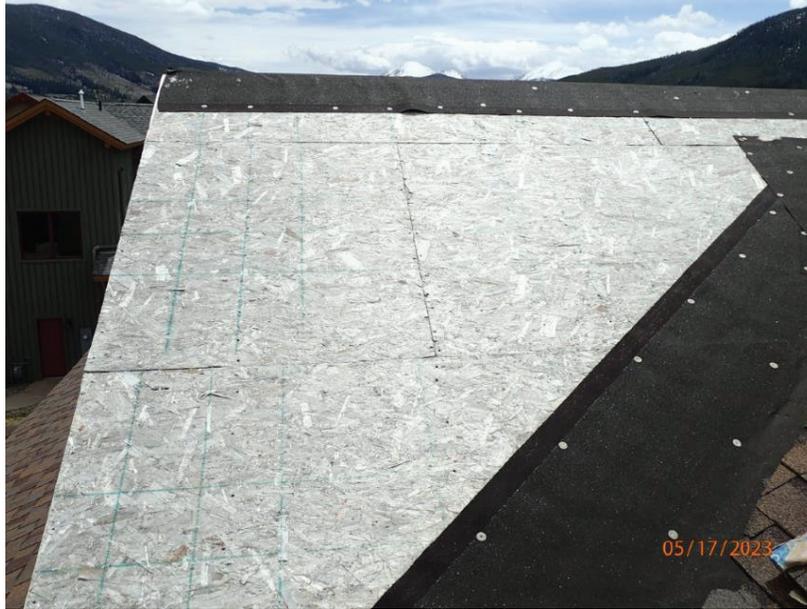
There were also large areas of the dormer roofs where the OSB underlayment was still exposed. This OSB had been left exposed for such a long time that fibers were delaminating.

May 17, 2023, Disc OBS1, Photograph 289, DLC, 101 Mule Deer Court, exposed OSB at upper roof dormer. OSB is starting to swell and delaminate.

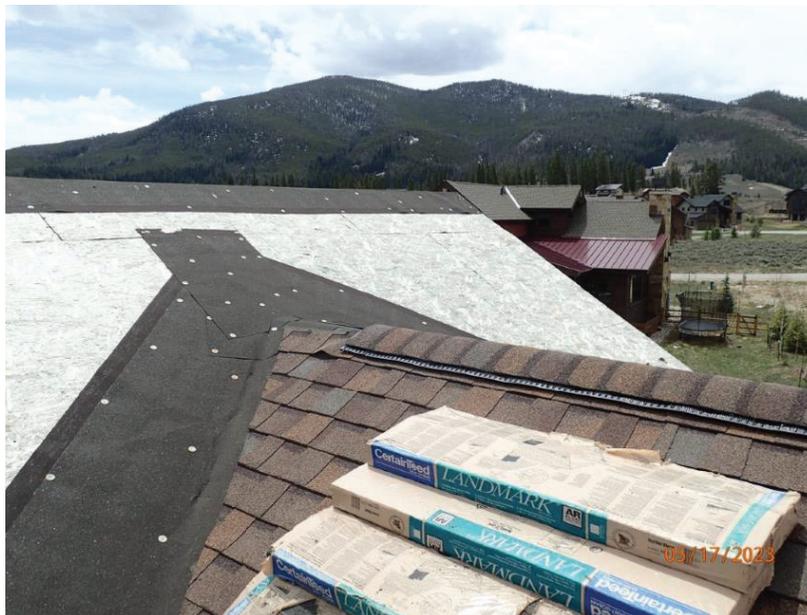
May 17, 2023, Disc OBS1, Photograph 290, DLC, 101 Mule Deer Court, exposed OSB at upper roof dormer. OSB is starting to swell and delaminate.

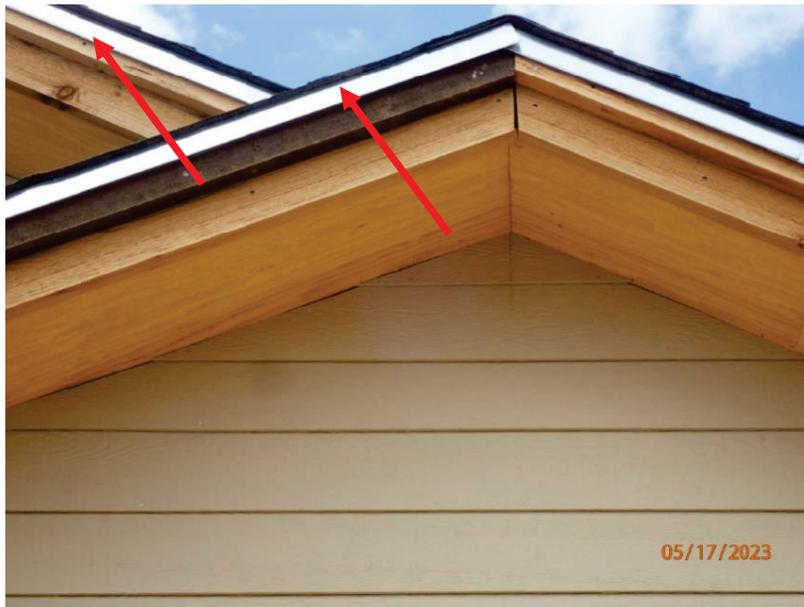
The Heritage Homes drawings also call for the drip edge material to be of a finished color that is to be determined. Liscott's roofing crews installed a bare or unprimed galvanized metal drip edge. This material will have to be removed and replaced with the remainder of the roofing work.

May 17, 2023, Disc OBS1, Photograph 85, DLC, p101 Mule Deer Court, incorrect drip edge metal installed. Design call for a pre-finished material.

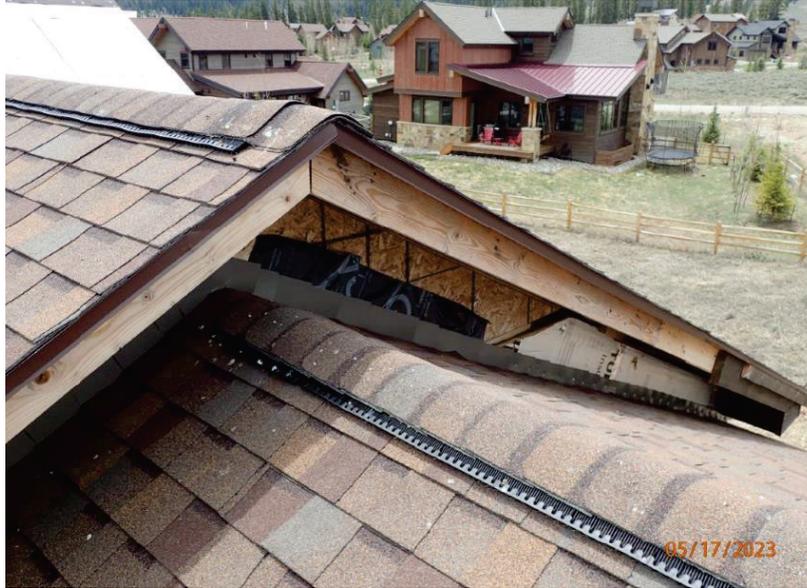
May 17, 2023, Disc OBS1, Photograph 292, DLC, 101 Mule Deer Court, correct color drip edge material installation.

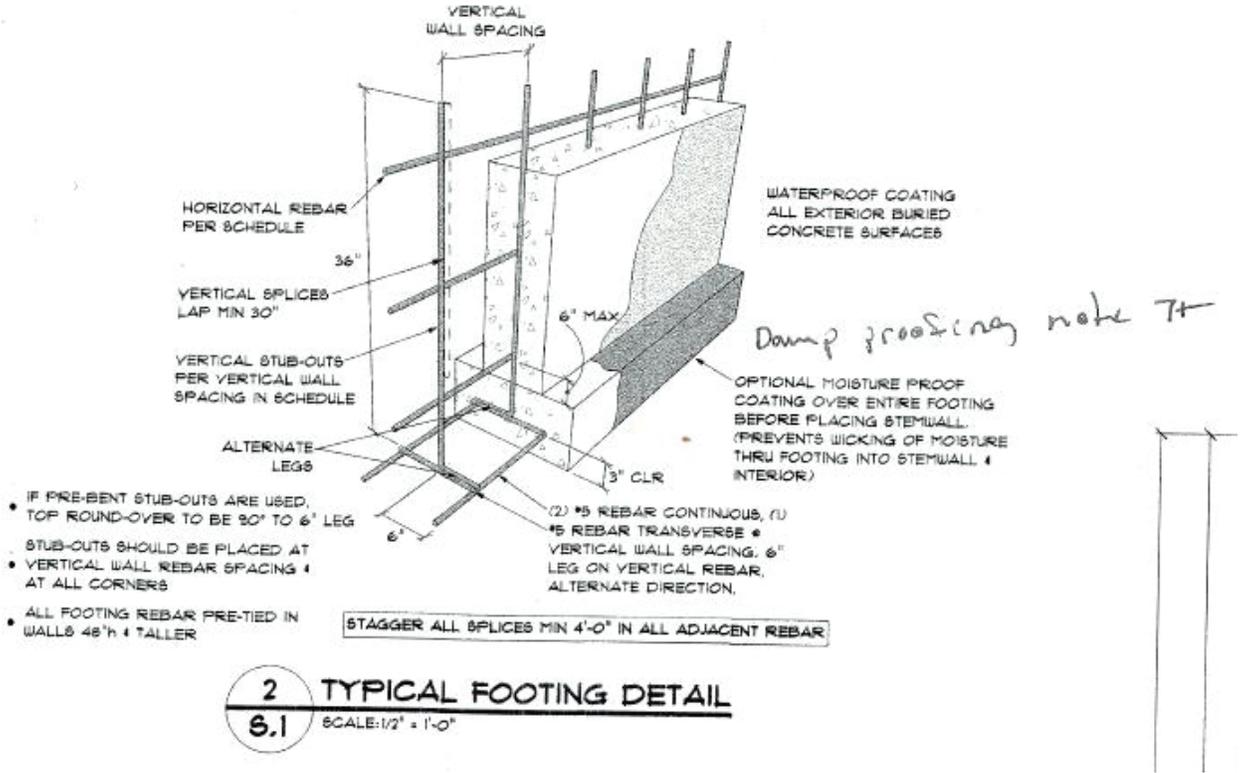
Sheet S.1 by Insight Engineering indicated that Waterproof Coating was required. The Summit County plan review noted damp proofing note 74. CTETS has not confirmed any information that modified the engineer's requirement for waterproofing.

It is CTETS’s opinion that this is due to a failure by Liscott to install the correct material initially; therefore, any costs associated with the installation of the correct material are the responsibility of Liscott.

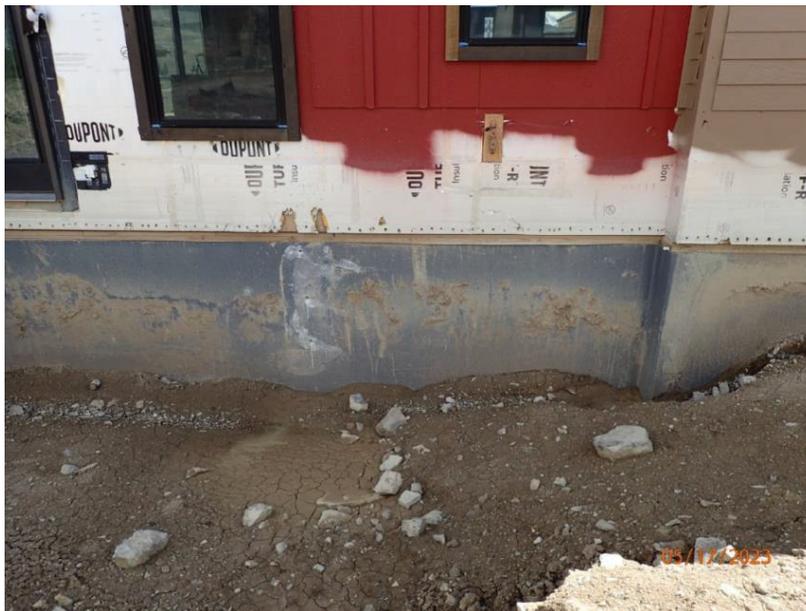
The materials originally used for the foundation waterproofing were incorrect. The crews used a foundation damp proofing material instead of a waterproofing material. The damp proofing material does not perform or provide the same level of protection as would a waterproofing material. Further investigation is required to determine if there are any compatibility issues between the damp proofing and the waterproofing material. During the site observation, the Owners had paid for the application of a waterproofing material and will now incur additional costs to have the correct product installed. CTETS was not able to confirm the manufacturer of the product used for this application. At the time of the site observation, CTETS was not able to confirm the manufacturer of the product used for this application.

May 17, 2023, Disc OBS1, Photograph 37, 101 Mule Deer Court, the incorrect waterproofing materials applied to the foundation walls.

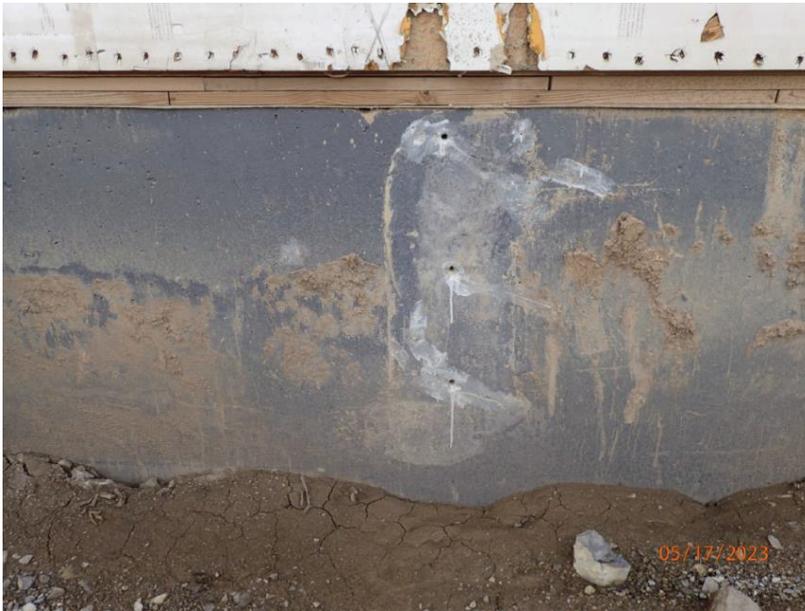
May 17, 2023, Disc OBS1, Photograph 38, 101 Mule Deer Court, the incorrect waterproofing materials were applied to the foundation walls.

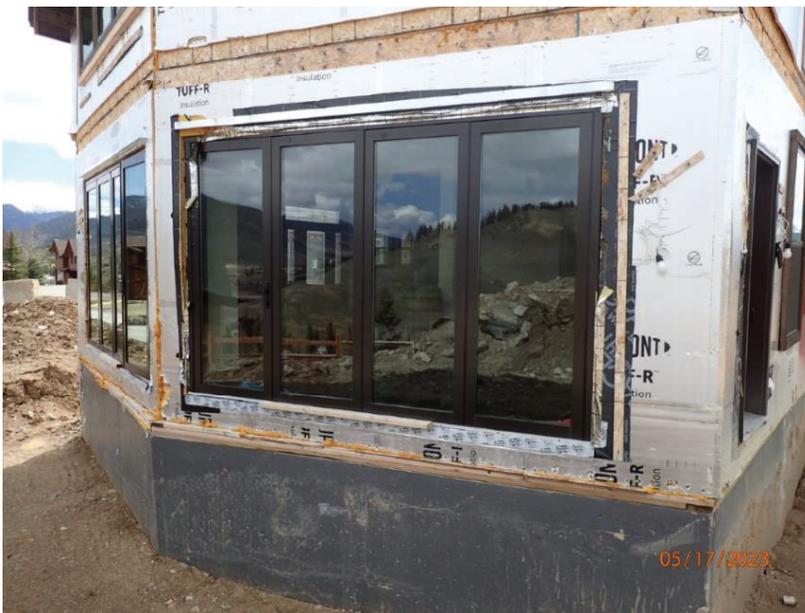
May 17, 2023, Disc OBS1, Photograph 46, 101 Mule Deer Court, the incorrect waterproofing materials were applied to the north elevation foundation walls.

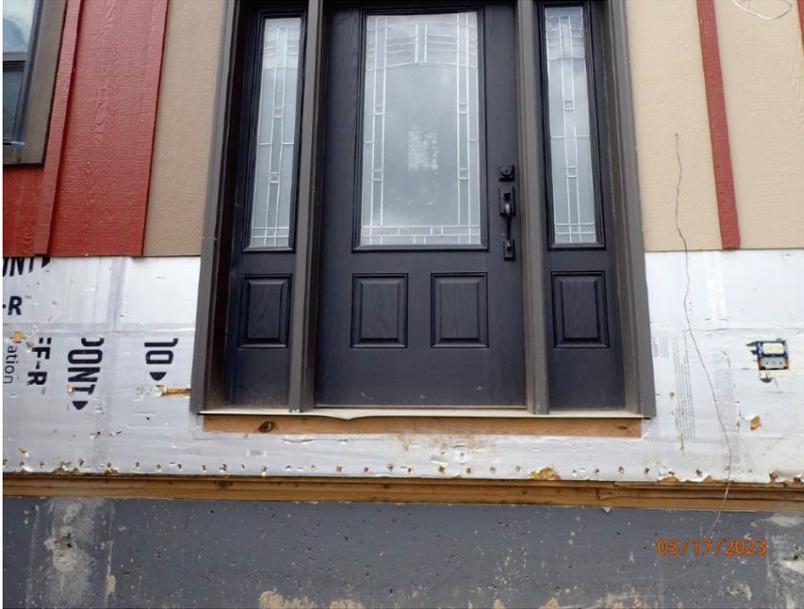
May 17, 2023, Disc OBS1, Photograph 74, 101 Mule Deer Court, the incorrect waterproofing materials were applied to the east elevation foundation walls.

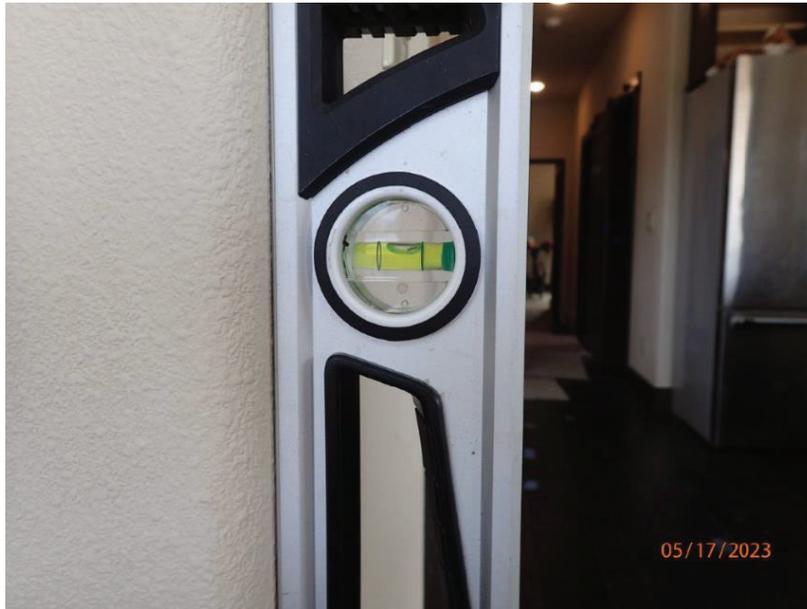
It is CTETS's opinion that this is a result of the issues with the levelness of the structure as well as Liscott's failure to review the areas prior to the commencement of drywall installation to ensure that finished work would be constructed plumb and square. Any costs associated with the necessary repairs are the responsibility of Liscott.

May 17, 2023, Disc OSB1, Photograph 166, DLC, 101 Mule Deer Court, west side of column in kitchen area using a 2-foot electronic level.

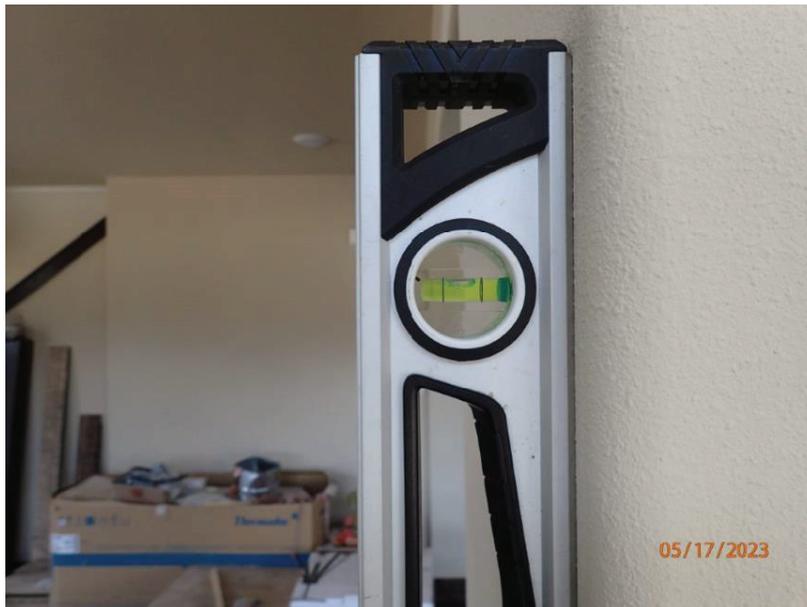
May 17, 2023, Disc OSB1, Photograph 167, DLC, 101 Mule Deer Court, east side of column in kitchen area using a 2-foot electronic level.

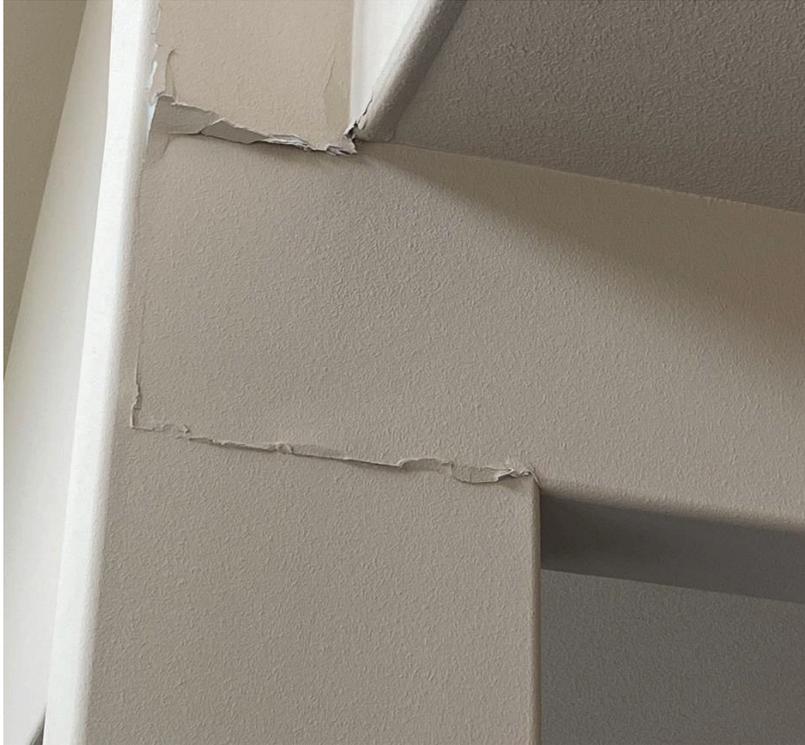
Owner provided photo showing damage to the drywall at the column in the Living/Dining area.

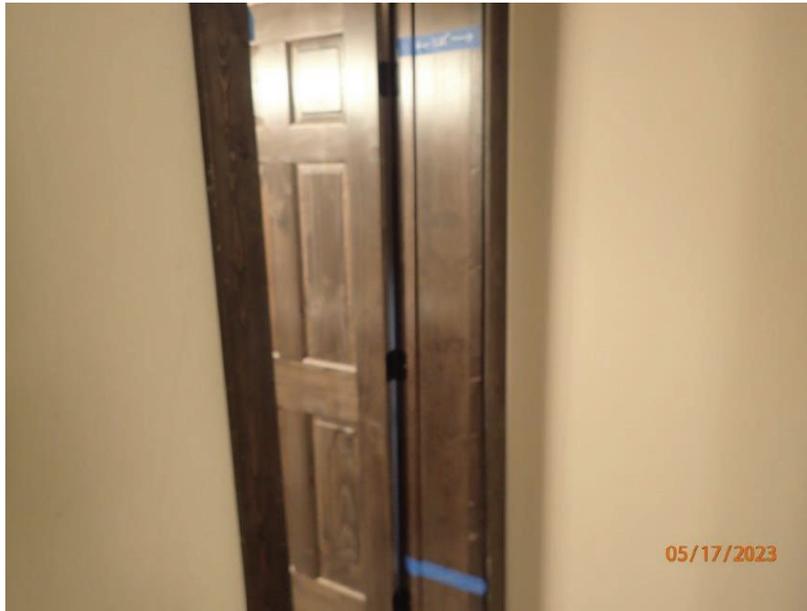
As an example, the opening at bathroom #4 on the second floor and shown in photos 235, 236, 238, and 239 show the overall width of the opening 10-5/8-inches at the top and 11-5/8-inches at the bottom. The tapered shim at this opening measures 1-1/8-inches at the top and 2-1/8-inches at the bottom. The dimensions for all of the other openings can be seen in the rest of the photos taken at the other openings and noted on the site observation drawings included with this report.

May 17, 2023, Disc OSB1, Photograph 235, DLC, 101 Mule Deer Court, overall view at master bedroom closet.

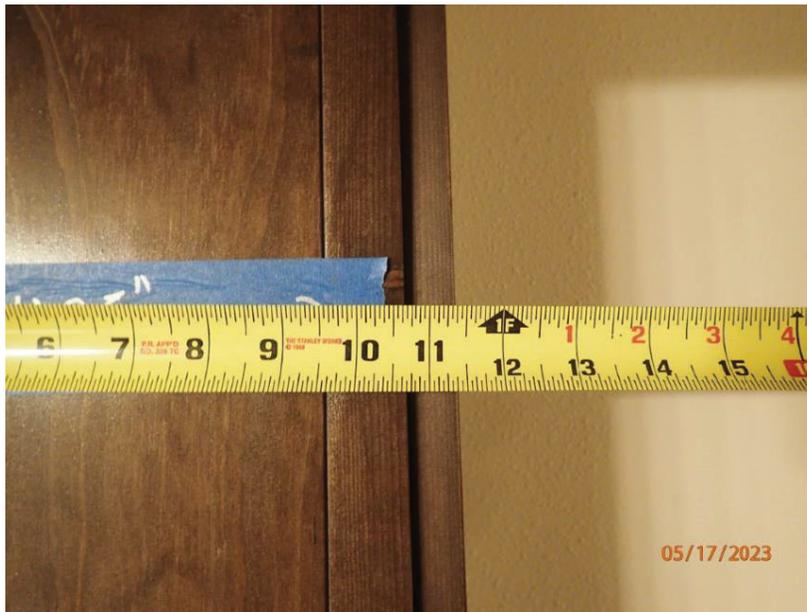
May 17, 2023, Disc OBS1, Photograph 236, DLC, 101 Mule Deer Court, width dimension at top of door frame – approx. 10-5/8-inch.

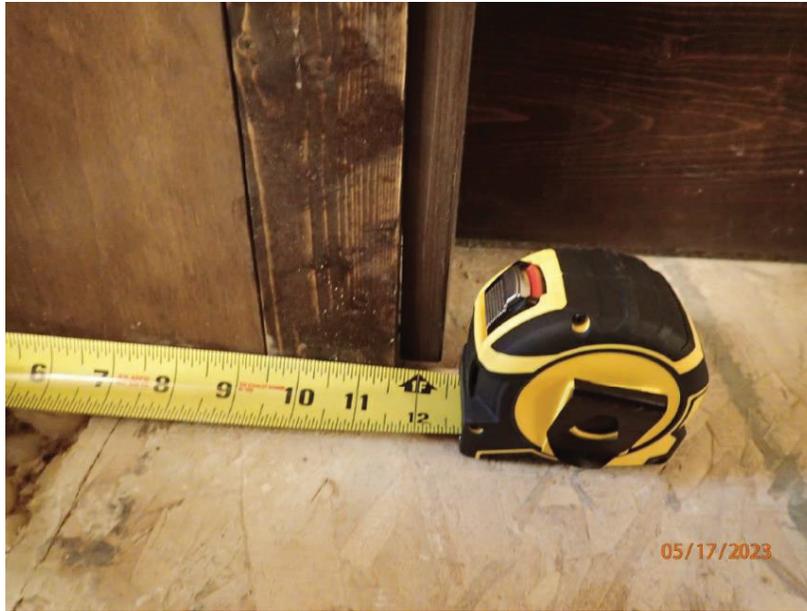
May 17, 2023, Disc OBS1, Photograph 237, DLC, 101 Mule Deer Court, width dimension at bottom of door frame – approx. 11-1/8-inch.

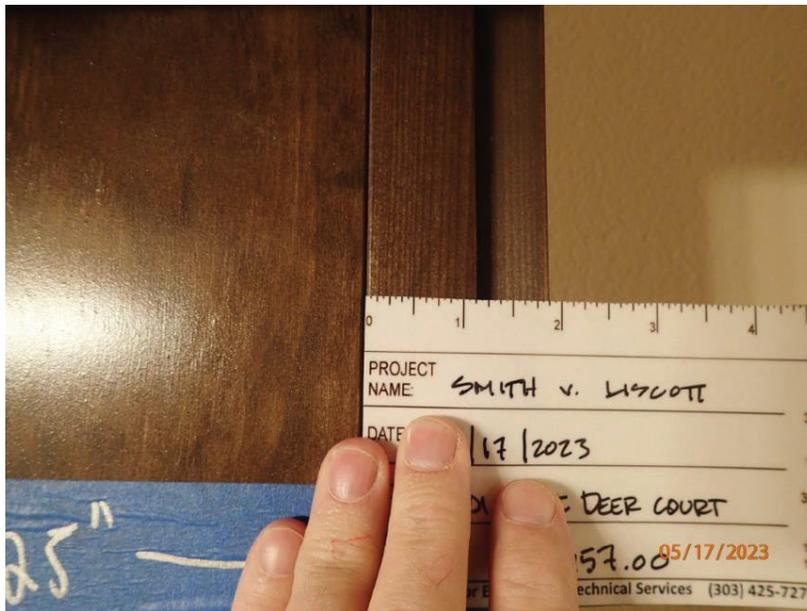
May 17, 2023, Disc OBS1, Photograph 238, DLC, 101 Mule Deer Court, tapered wood filler at top of door frame – approx. 1-1/8-inch.

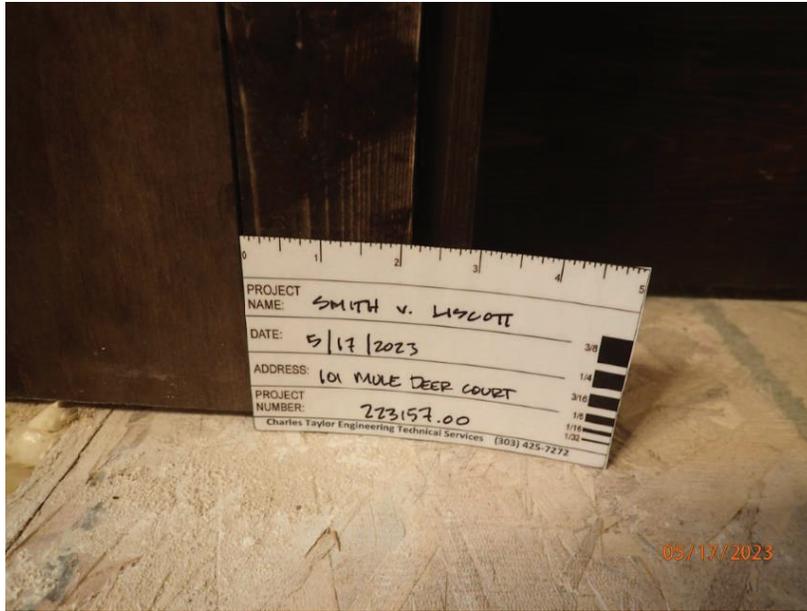
May 17, 2023, Disc OBS1, Photograph 239, DLC, 101 Mule Deer Court, tapered wood filler at bottom of door frame – approx. 2-1/8-inch.

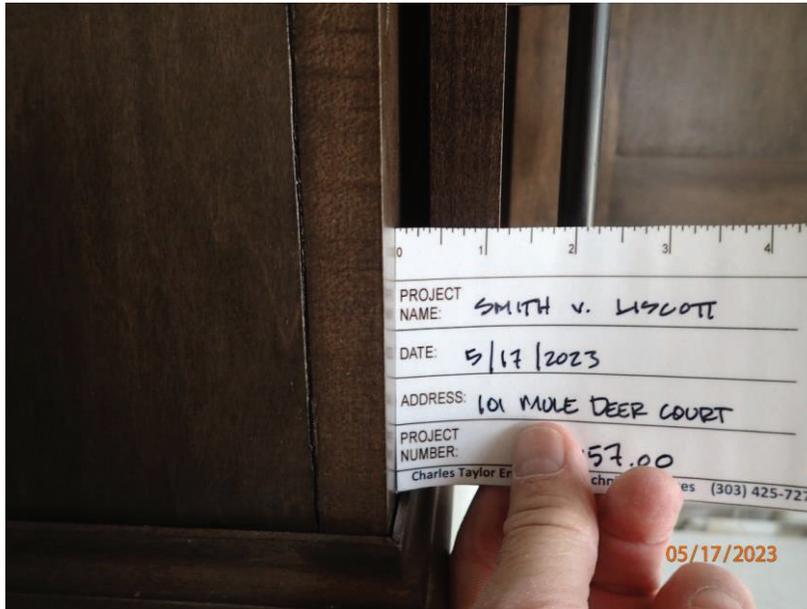
It is CTETS’s opinion that Liscott failed to provide proper environmental conditions which resulted in the noted damage to the finish components; therefore, any costs required to adjust, repair, or replace the affected components is the responsibility of Liscott.

May 17, 2023, Disc OBS1, Photograph 151, DLC, 101 Mule Deer Court, warped kitchen cabinet door at bottom – gap 3/8-inch.

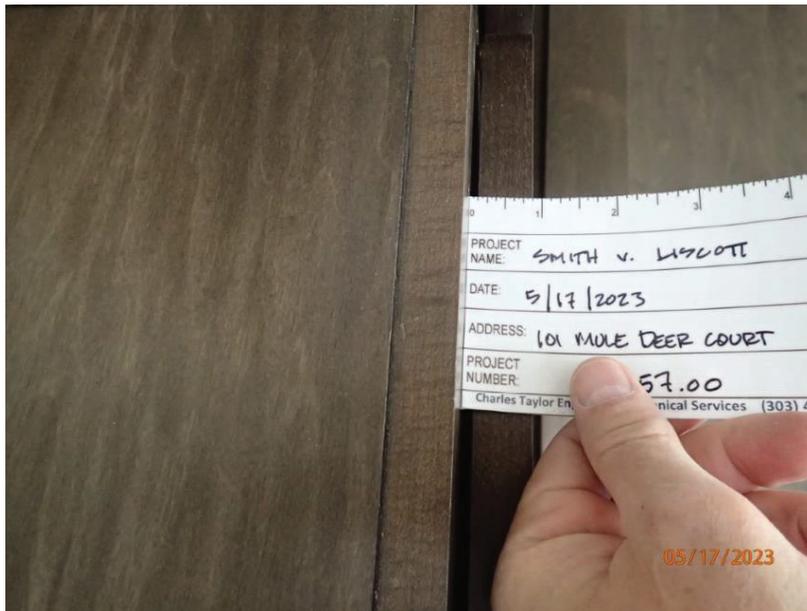
May 17, 2023, Disc OBS1, Photograph 152, DLC, 101 Mule Deer Court, warped kitchen cabinet door at top – gap 1/8-inch.

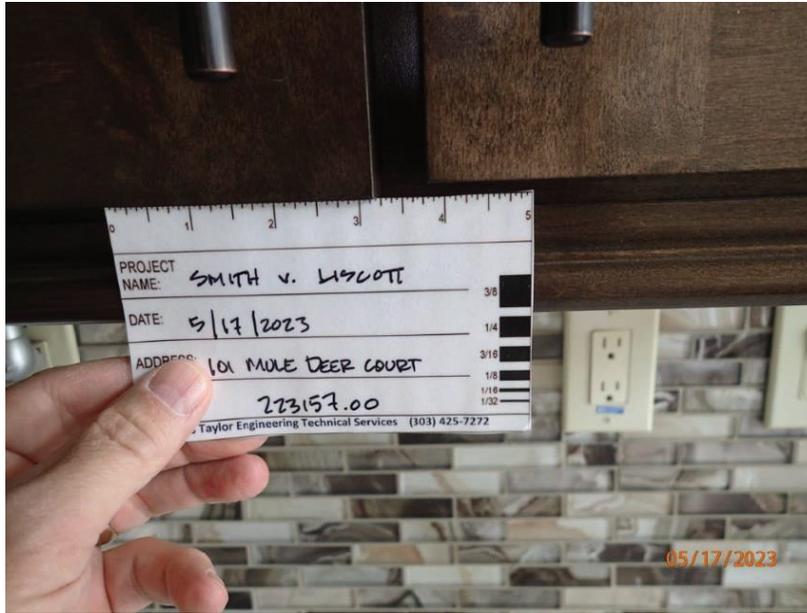
May 17, 2023, Disc OBS1, Photograph 153, DLC, 101 Mule Deer Court, mis-aligned kitchen cabinet doors.

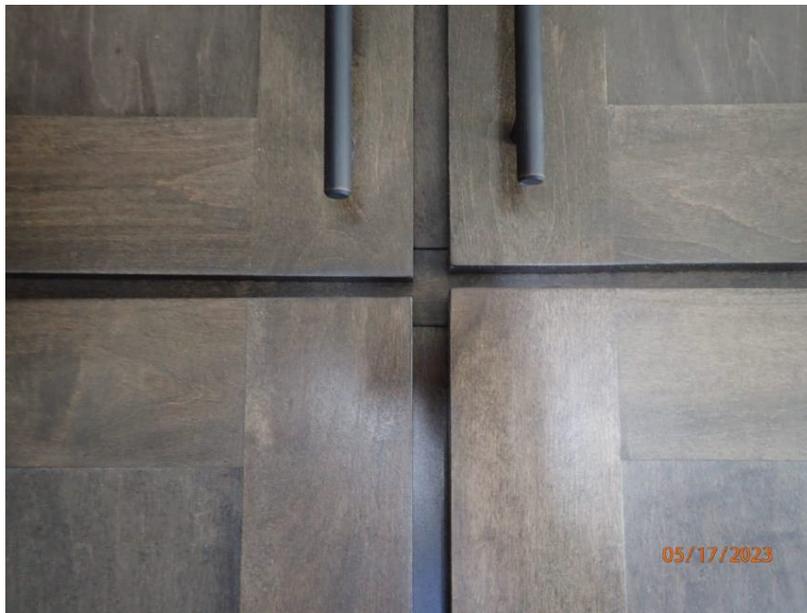
May 17, 2023, Disc OBS1, Photograph 154, DLC, 101 Mule Deer Court, mis-aligned kitchen cabinet doors.

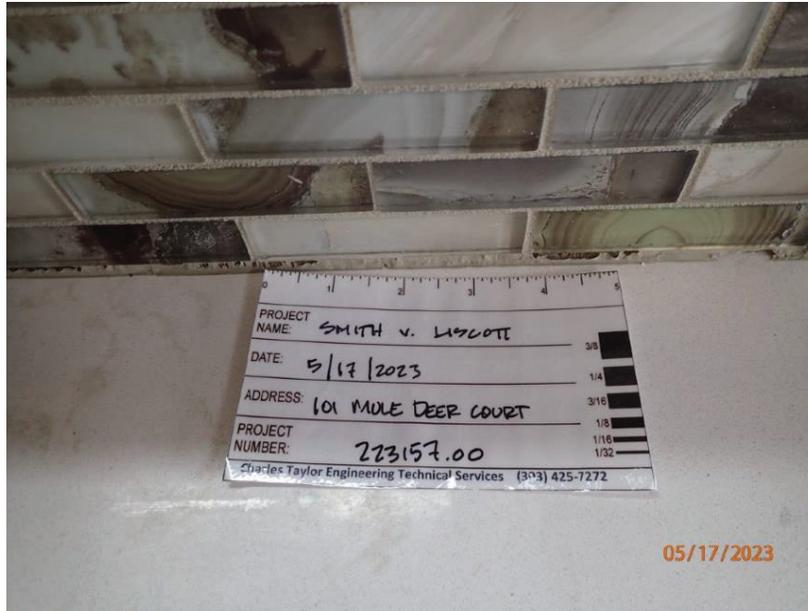
May 17, 2023, Disc OBS1, Photograph 155, DLC, 101 Mule Deer Court, base cabinet pulled away from west kitchen wall.

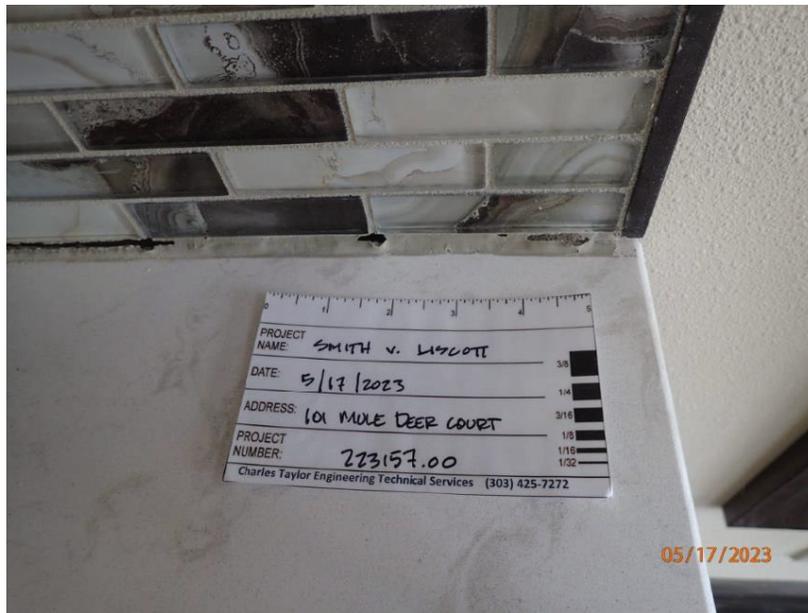
May 17, 2023, Disc OBS1, Photograph 156, DLC, 101 Mule Deer Court, base cabinet pulled away from west kitchen wall.

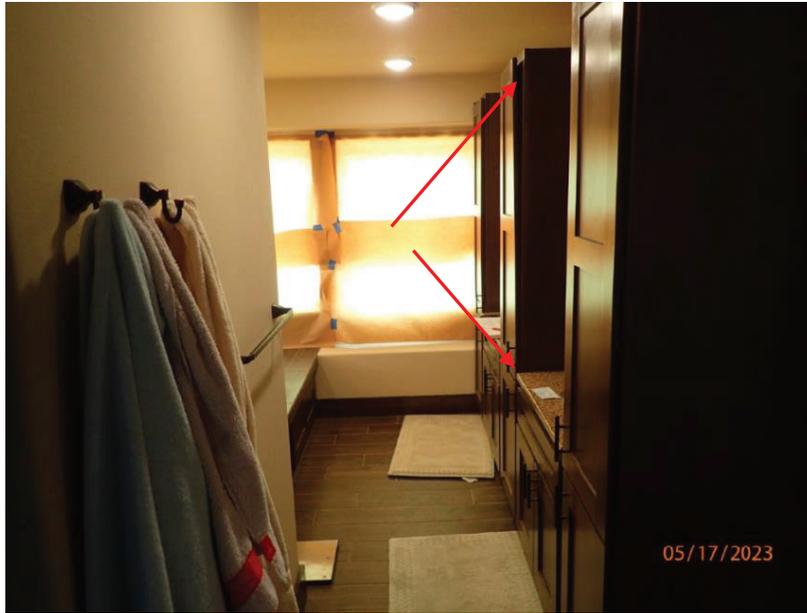
May 17, 2023, Disc OBS1, Photograph 268, DLC, 101 Mule Deer Court, overall view into master bathroom.

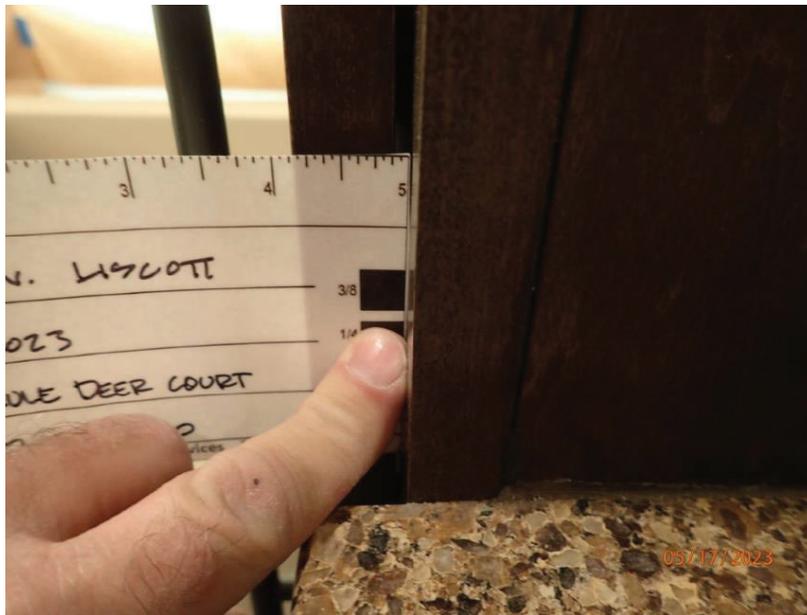
May 17, 2023, Disc OBS1, Photograph 269, DLC, 101 Mule Deer Court, warped cabinet door at bottom - 1/8-inch.

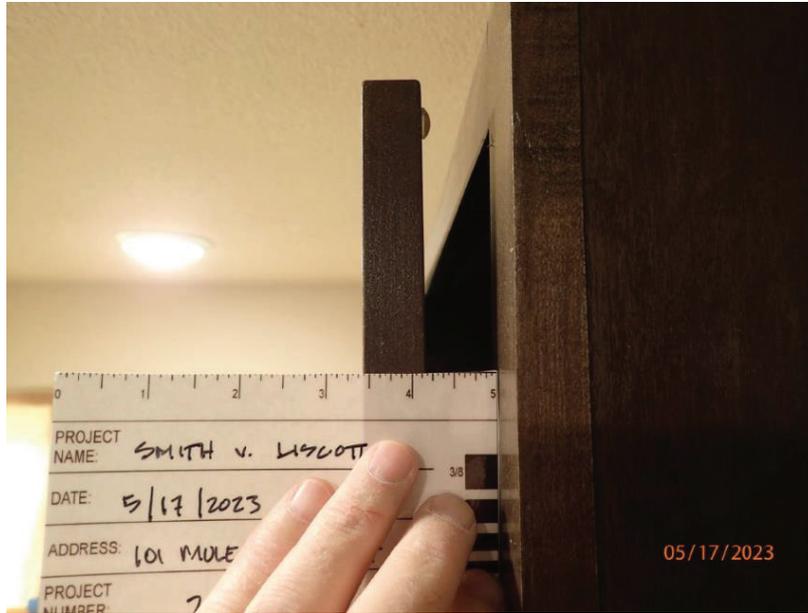
May 17, 2023, Disc OBS1, Photograph 270, DLC, 101 Mule Deer Court, warped cabinet door top – 13/16-inch.

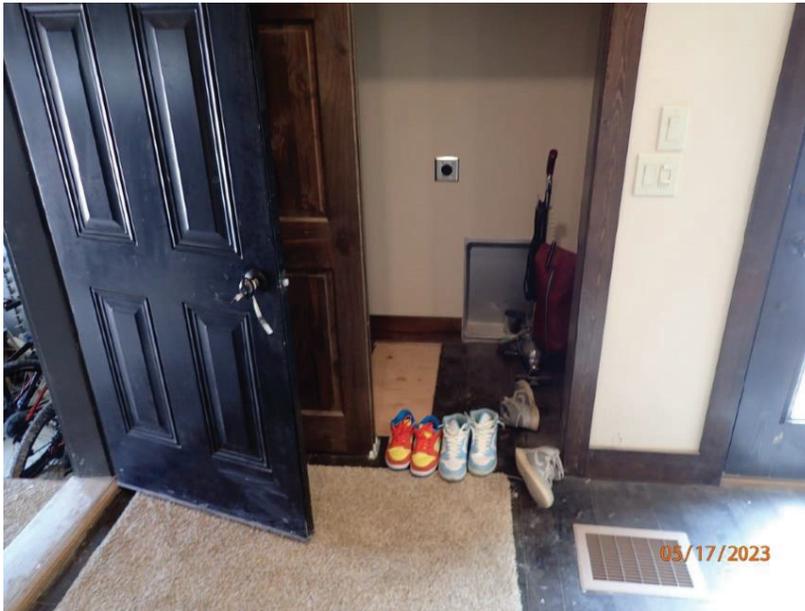
May 17, 2023, Disc OBS1, Photograph 215, DLC, 101 Mule Deer Court, view looking toward the laundry room at the south side of the kitchen.

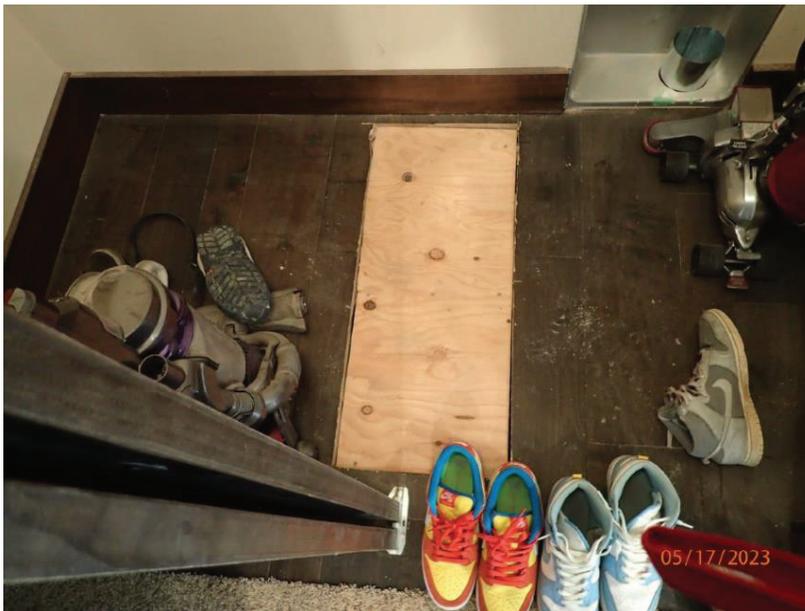
May 17, 2023, Disc OBS1, Photograph 216, DLC, 101 Mule Deer Court, area where flooring was removed as hole cut in the floor to access the water lines.

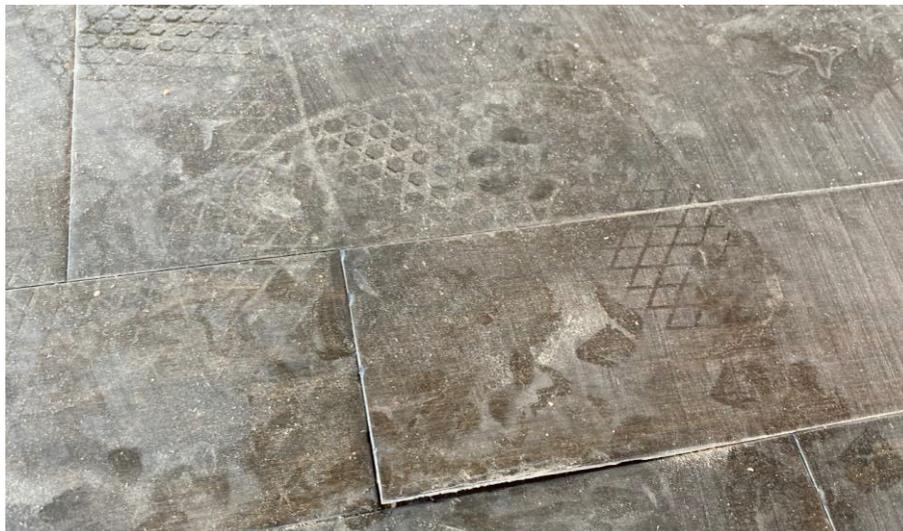
It is CTETS's opinion that this damage or other issues with the flooring is the result of Liscott's failure to install and maintain proper protective material to protect against damage and the subsequent work of other trades. Any costs to remove and replace or repair the flooring is the responsibility of Liscott.

Owner provided photo showing damage to the finished flooring surface due to Liscott's failure to maintain proper protection during construction.

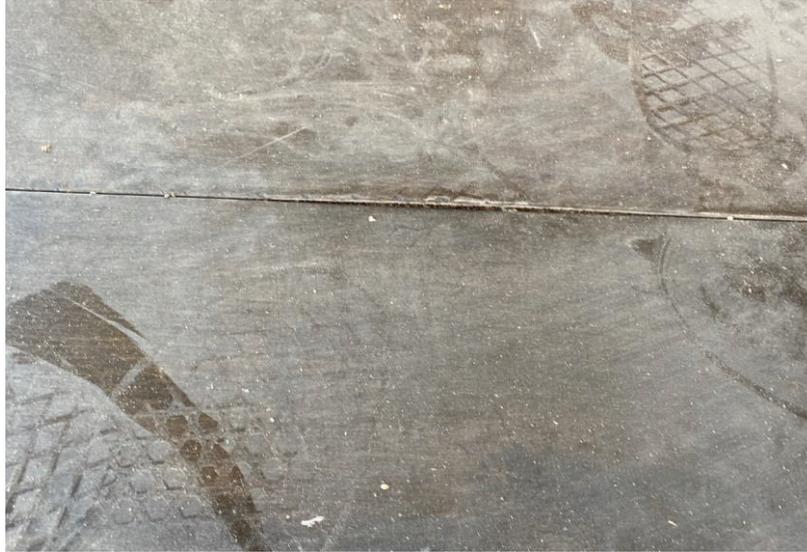
Owner provided photo showing damage to the finished flooring surface due to Liscott's failure to maintain proper protection during construction.
