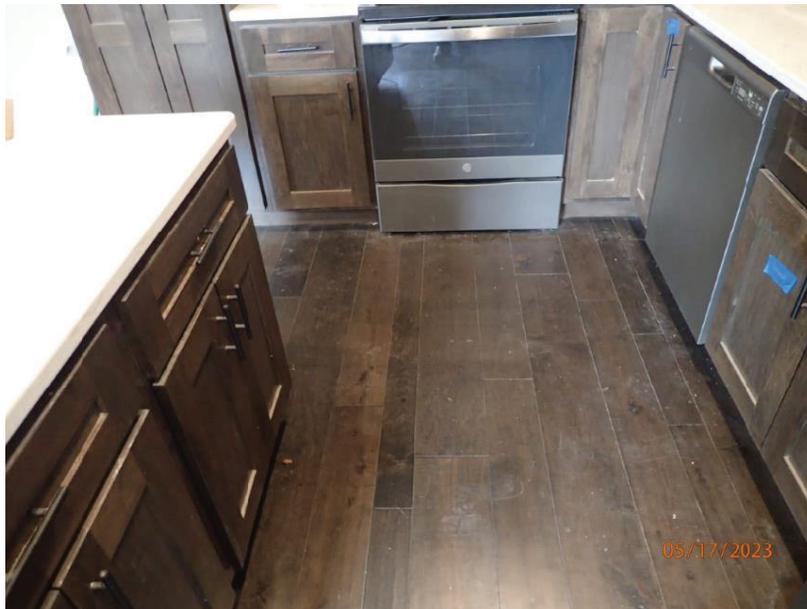
May 17, 2023, Disc OBS1, Photograph 212, DLC, 101 Mule Deer Court, unprotected finish flooring in the kitchen.

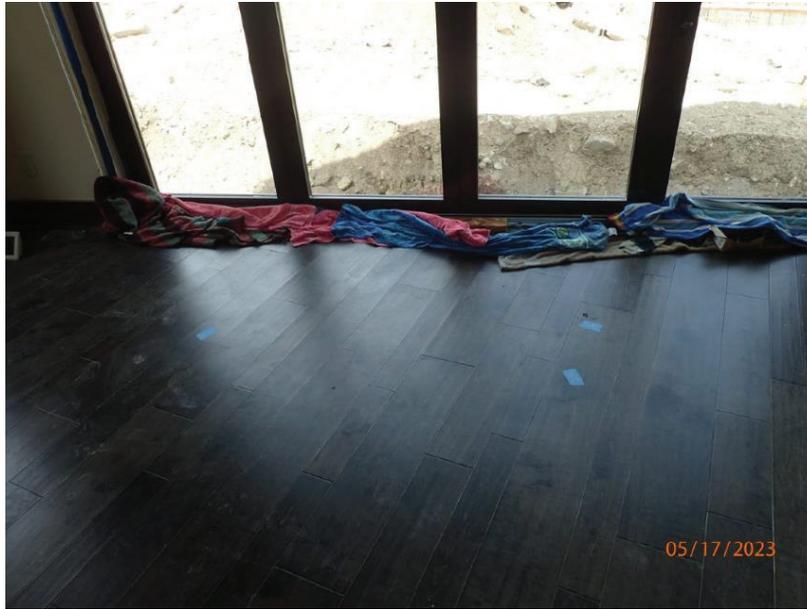
May 17, 2023, Disc OBS1, Photograph 172, DLC, 101 Mule Deer Court, unprotected finish flooring in the living/ dining room area. The blue tape marks locations of damage. The damage is related to the misaligned, and non-level foundation used to set the modular units.

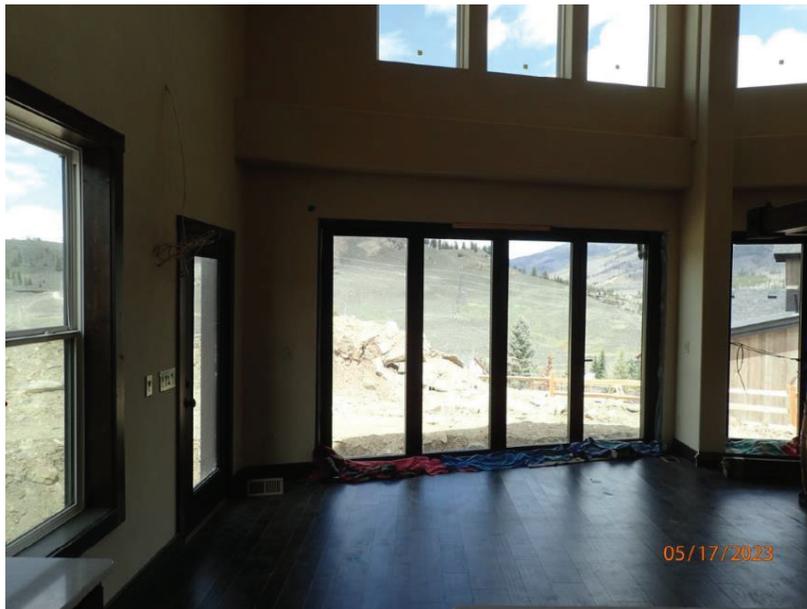
May 17, 2023, Disc OBS1, Photograph 157, DLC, 101 Mule Deer Court, unprotected finish flooring in the living/dining room area. The surface has an uneven appearance due to being in an uncontrolled environment.

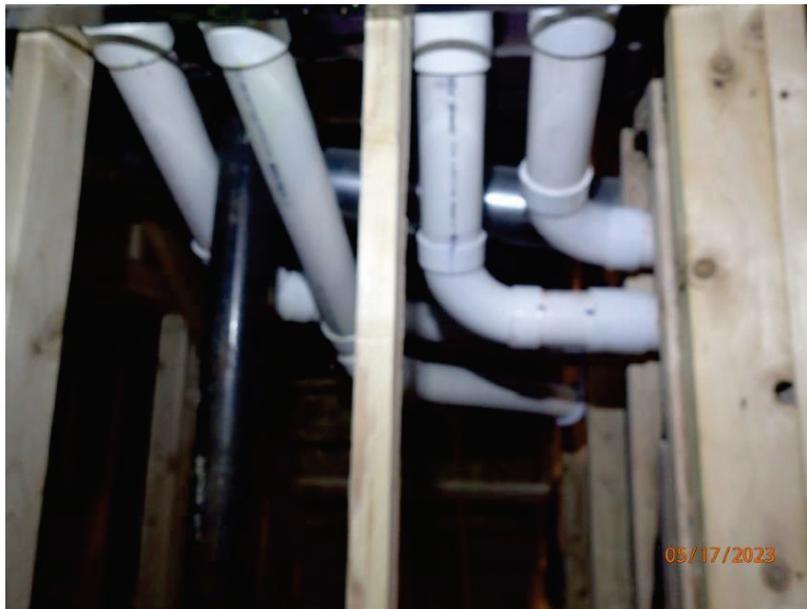
The original installation of the furnace vent piping was routed out through the south elevation exterior wall. This location placed the exterior vent piping below and in close proximity to the window above. The Owners had to pay additional funds to an HVAC contractor to remove this improper piping and re-route it to exit out the west elevation of the residence as shown in the photo below.

It is CTETS’s opinion that this required rework is a direct result of Liscott’s failure to properly manage the work to ensure that the vent piping was installed in compliance with the applicable codes so not to create a hazardous condition. The cost to perform this re-routing work is the responsibility of Liscott.

May 17, 2023, Disc OBS1, Photograph 138, DLC, 101 Mule Deer Court, re-routed furnace vent piping.

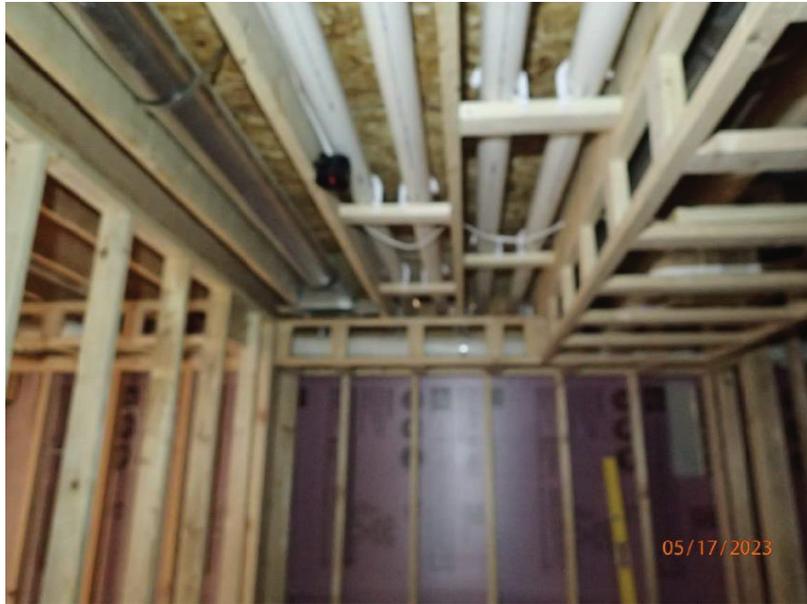
May 17, 2023, Disc OBS1, Photograph 139, DLC, 101 Mule Deer Court, re-routed furnace vent piping directed to the west elevation.

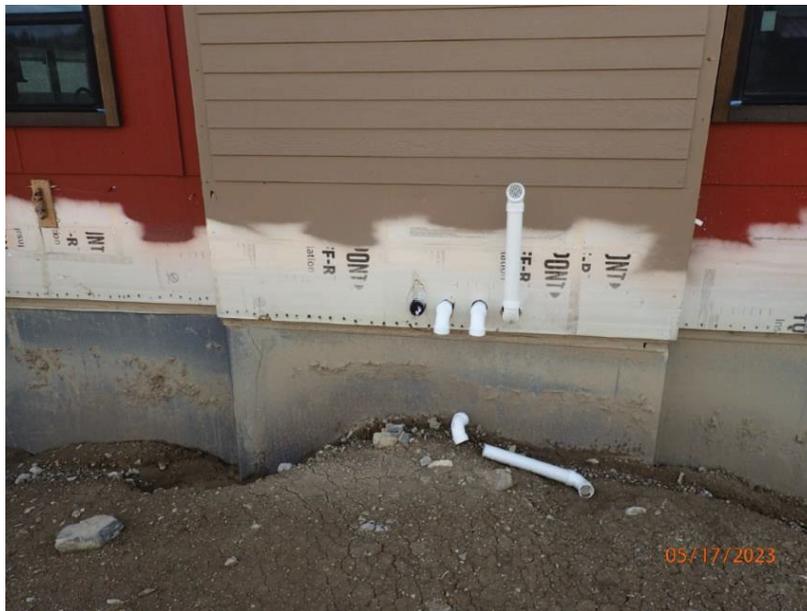
May 17, 2023, Disc OBS1, Photograph 36, DLC, 101 Mule Deer Court, re-routed furnace vent piping at the west elevation.

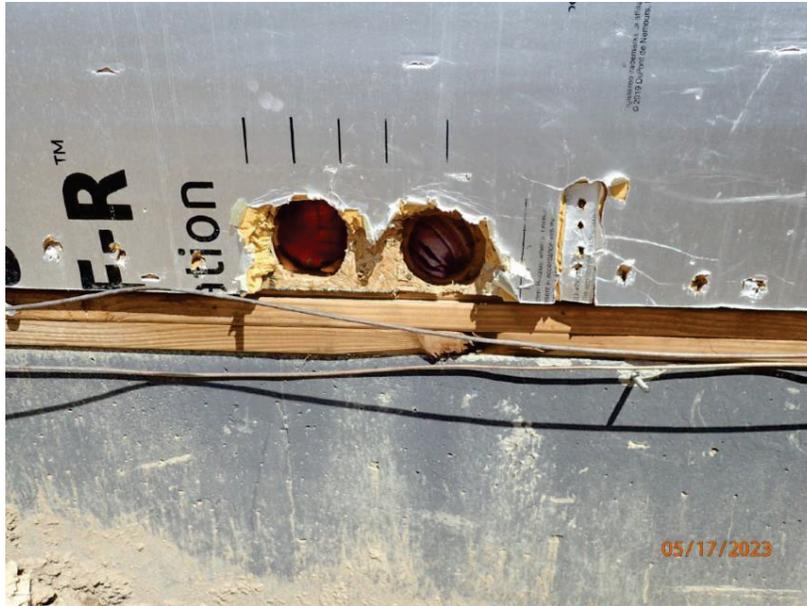
May 17, 2023, Disc OBS1, Photograph 25, DLC, 101 Mule Deer Court, previous location of the furnace vent piping at south elevation.

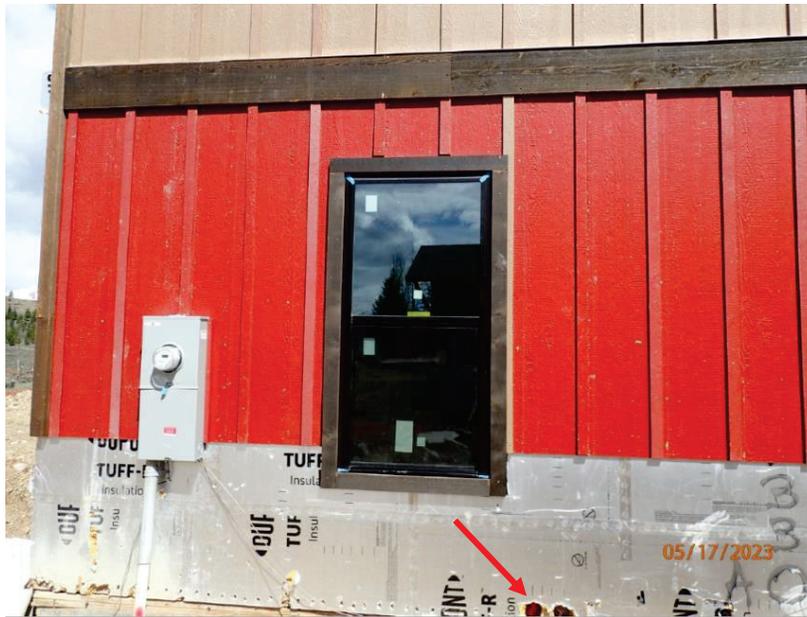
May 17, 2023, Disc OBS1, Photograph 26, DLC, 101 Mule Deer Court, previous vent piping location in close proximity to the window above.

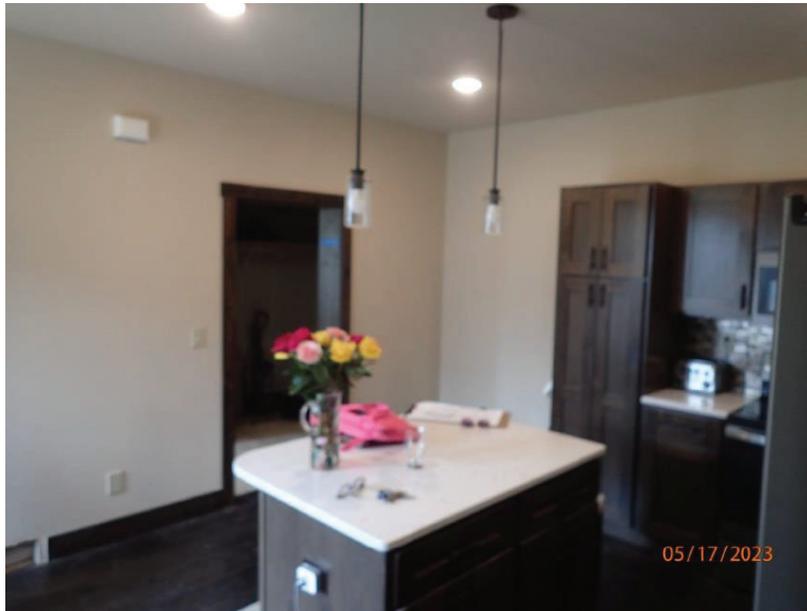
May 17, 2023, Disc OBS1, Photograph 210, DLC, 101 Mule Deer Court, pendant light fixture above the kitchen island installed by Owners.

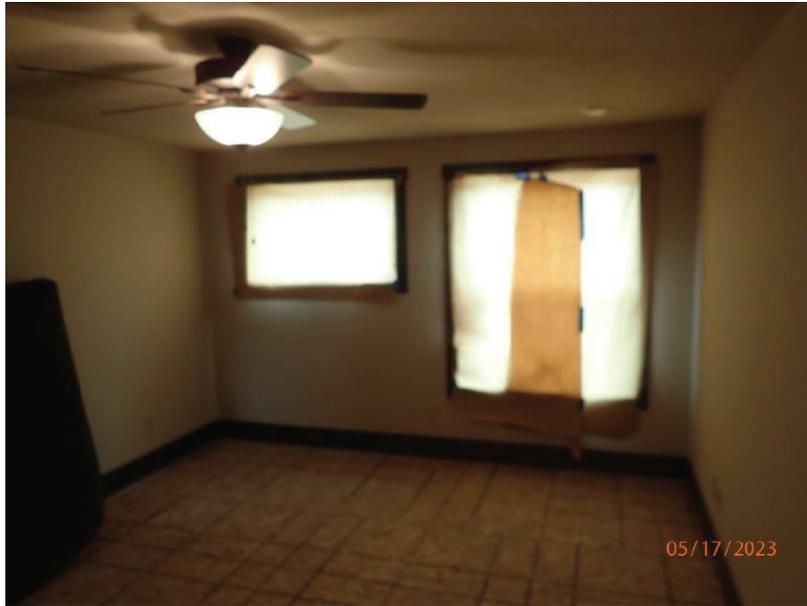
May 17, 2023, Disc OBS1, Photograph 231, DLC, 101 Mule Deer Court, ceiling fan and light fixture installed by Heritage Homes.

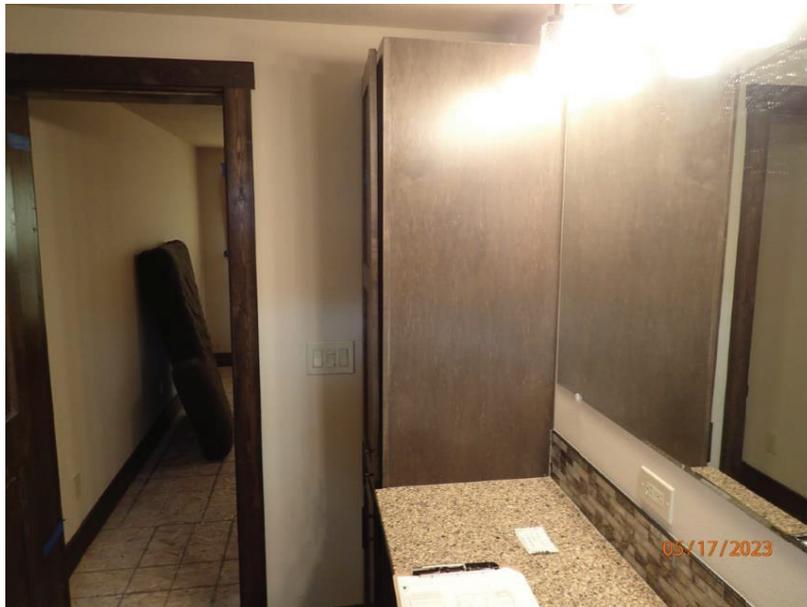
May 17, 2023, Disc OBS1, Photograph 243, DLC, 101 Mule Deer Court, bathroom vanity light fixture installed by the Owners.

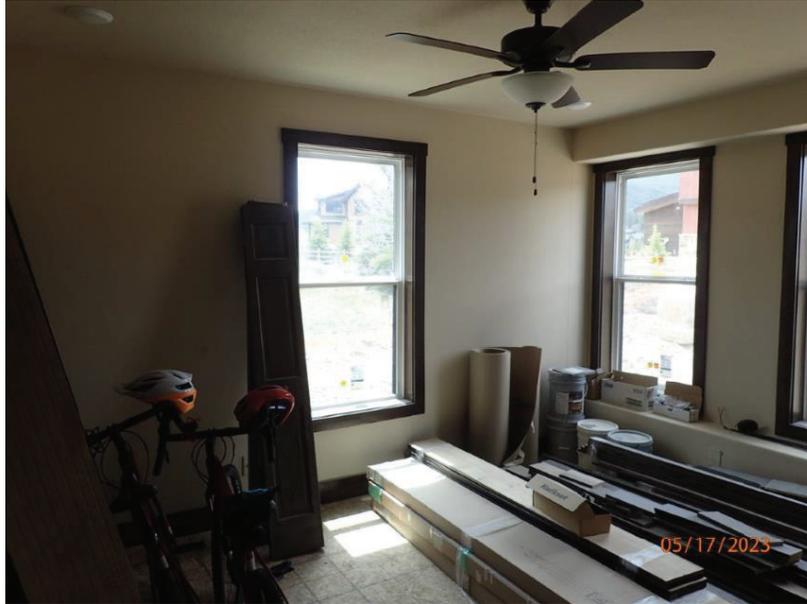
May 17, 2023, Disc OBS1, Photograph 200, DLC, 101 Mule Deer Court, ceiling fan and light fixture installed by Heritage Homes.

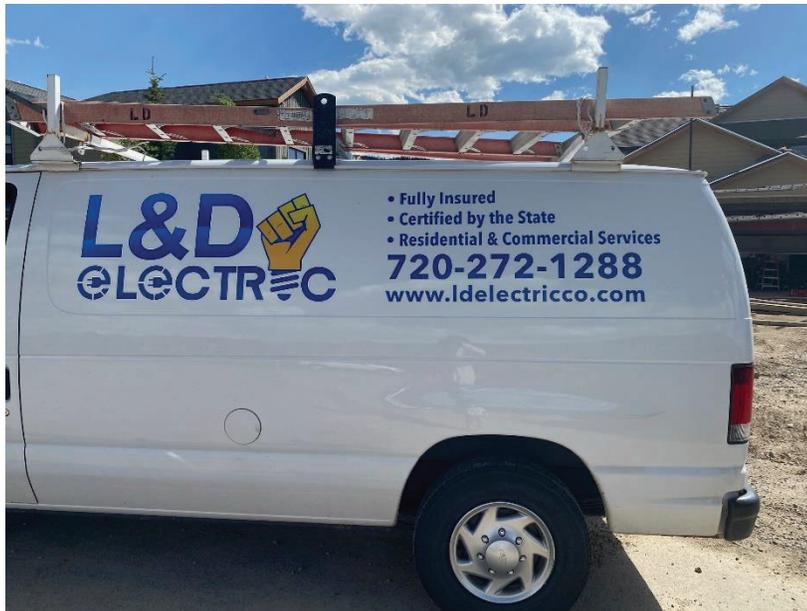
The Owners also noted during the site observation that they have photos of an electrician performing electrical work on the home who had not been authorized by the Owners to do so and who also was not shown on the building permit. A photo of this electrician’s van is included below.

Owner provided photograph showing that the electrician used on the site by Liscott was not the electrician noted on the permit.

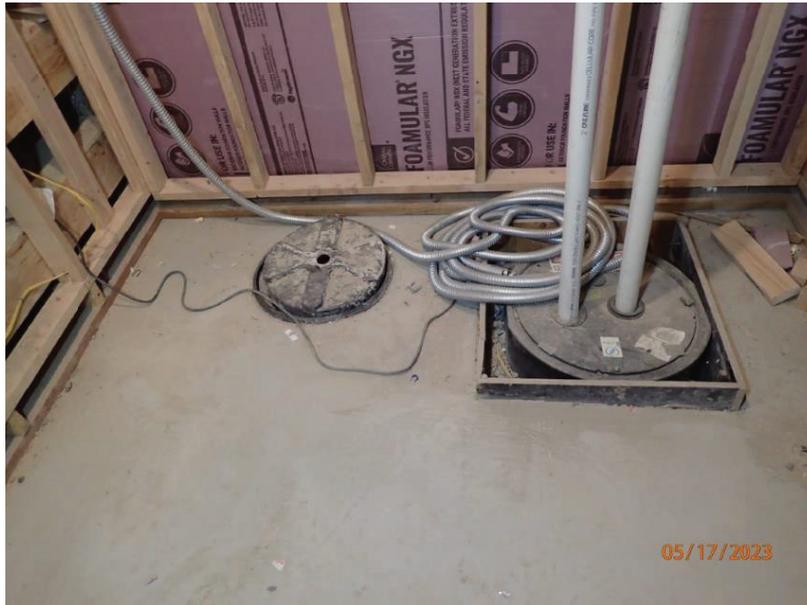
At the time of the site observation, it was noted that the sump pit and associated underground piping had been installed at the residence. At the time of the site observation, the sump pump had not been installed and properly piped to discharge to the exterior of the residence. The sump pit is installed and plumbed to receive water from the foundation drain, but no other work was performed in this area. This is an item of work that needs to be completed as part of the original scope of work. The CTL Thompson report prepared for Liscott required proper perimeter drainage.

May 17, 2023, Disc OBS1, Photograph 135, DLC, 101 Mule Deer Court, sump pit location in the basement mechanical room.

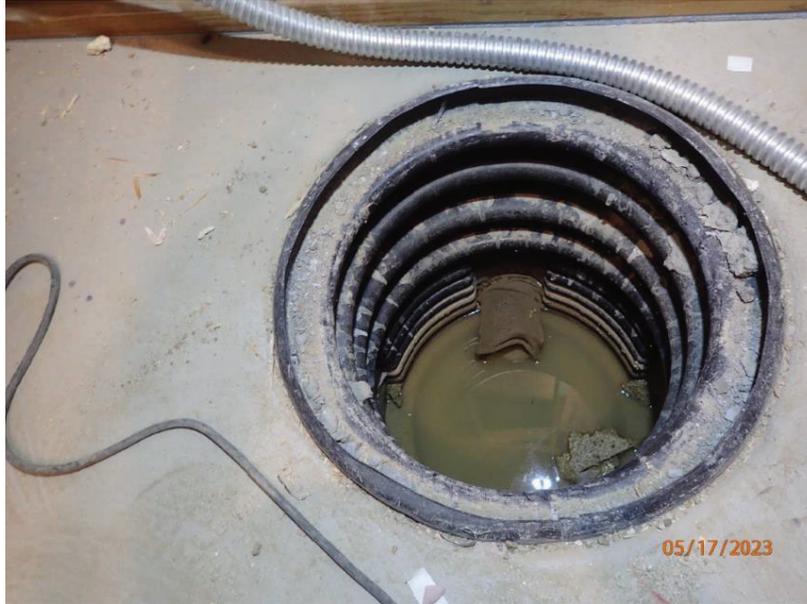
May 17, 2023, Disc OBS1, Photograph 136, DLC, 101 Mule Deer Court, sump pit location in the basement mechanical room. Pump has not been installed.

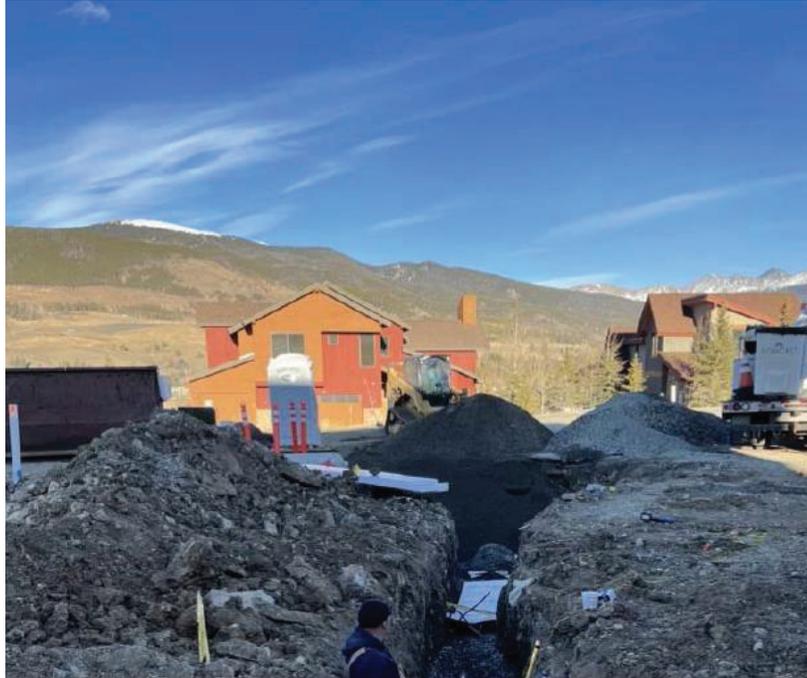
Screen capture of correspondence regarding the damage to the gas line.

As shown in the correspondence above, the costs from Xcel Energy to perform this repair work is \$5,652.69. CTETS understands that Liscott has denied any responsibility for this damage, and the associated costs to make the required repairs.

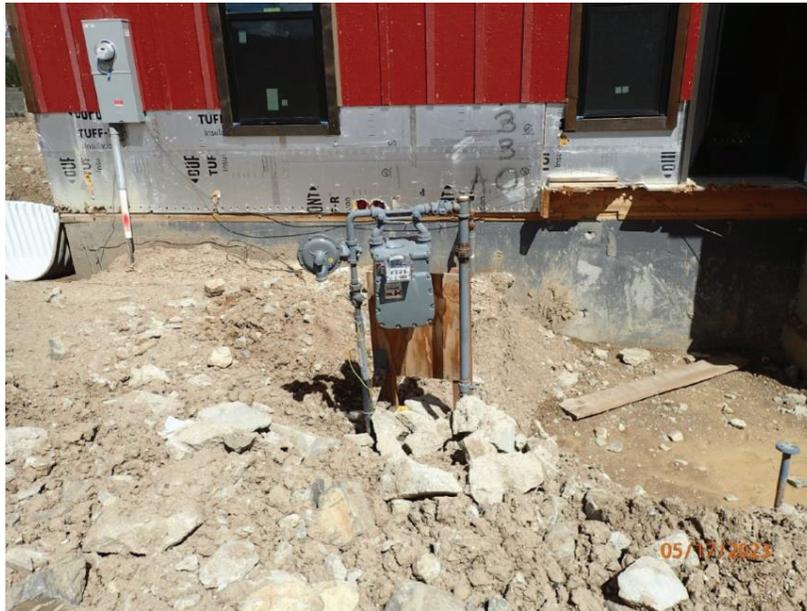
The gas line is showing indications of settlement where it enters the structure through the foundation wall. This appears to be the direct result of the settlement of the backfill materials previously placed by Liscott. Without proper support, the gas line could become further damaged and disconnected, resulting in a potential for a gas leak that would create a life safety condition for the occupants of the residence.

May 17, 2023, Disc OBS1, Photograph 23, DLC, 101 Mule Deer Court, gas meter at south elevation of the residence in poorly placed backfill zone.

The corrective work required to remedy this condition includes removal of the weight from the overlying soils, re-alignment of the piping, and properly supporting both the gas line and meter assemblies from further settlement and potential damage. The costs to repair or remediate this work is the responsibility of Liscott due to its failure to properly install the backfill and properly support the meter and gas line.

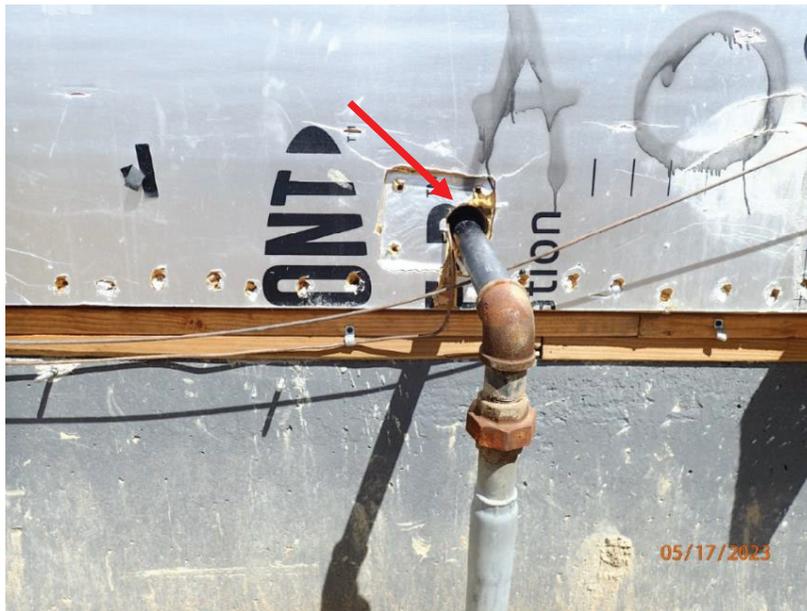
May 17, 2023, Disc OBS1, Photograph 24, DLC, 101 Mule Deer Court, gas line entry at south elevation of the residence. Line is being pulled down by pressure from the poorly compacted backfill material.

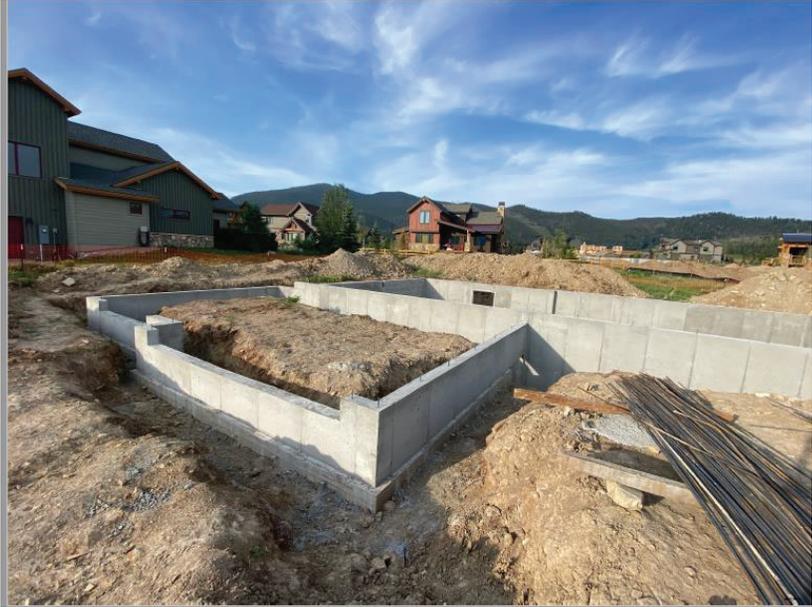
Owner provided photograph showing no coordinated drain or drywell was placed prior to the casting of the garage foundation.

It is CTETS’s opinion that the missing drain and piping installation is the result of Liscott’s failure to provide full-time qualified site supervision and proper management to ensure that the work was completed as required. Therefore, it is CTETS’s position that Liscott is responsible for the costs required to remove the concrete, install and tie-in the piping, install the drains, and replace the concrete.

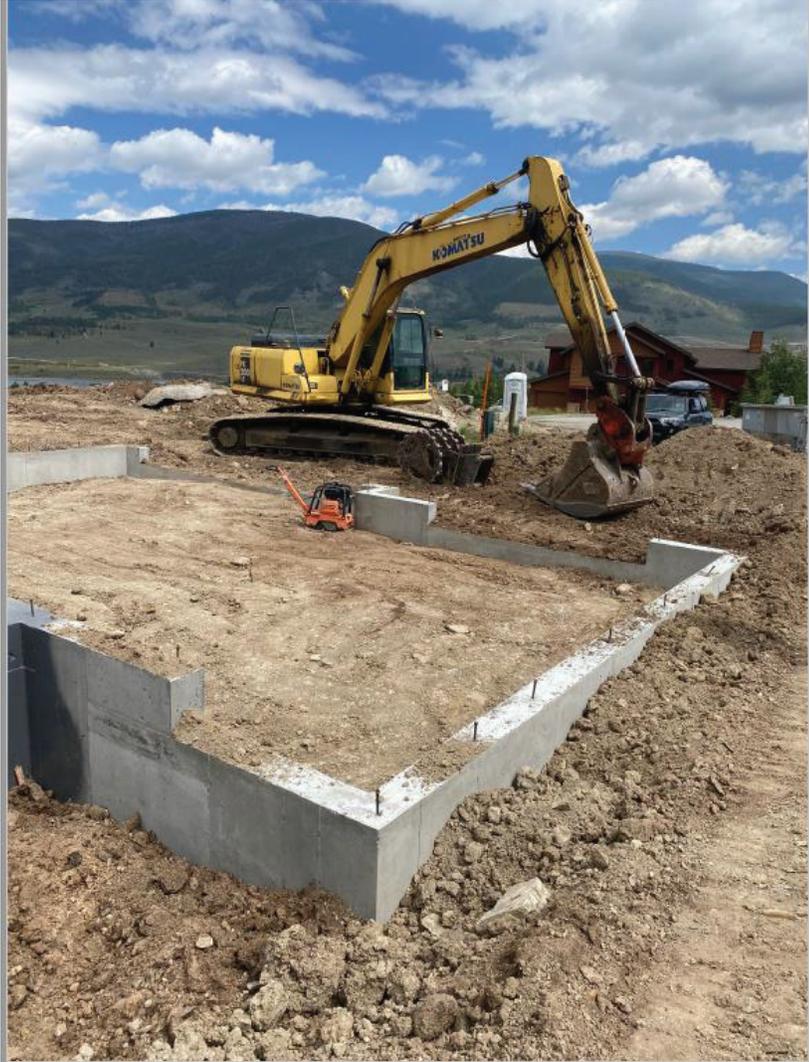
The garage was finished without any drain system.

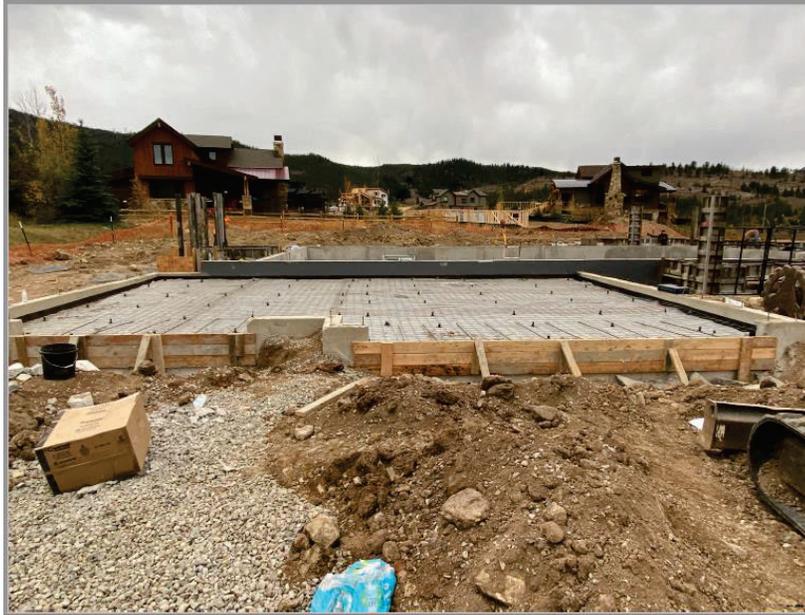
Garage floor formed and reinforcing placed without any drains or associated piping installed (Bates Number Smith\_000438).

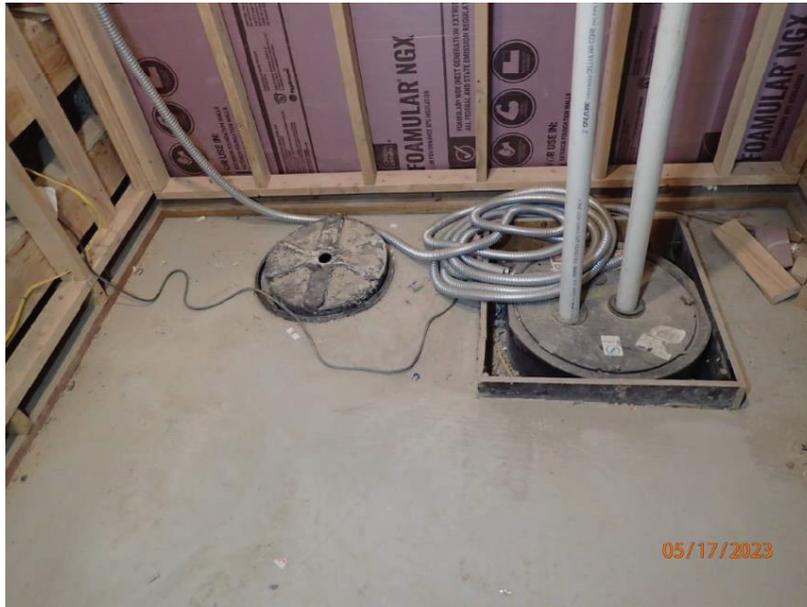
At the time of the site observation, it was noted that the radon system was not complete. The fan had not been installed, the pit had not been dug, and piping installed by Heritage was not properly connected and vented to the exterior of the residence by Liscott. The radon exhaust piping is currently terminated in the attic but was never installed through the roof by Liscott.

May 17, 2023, Disc OBS1, Photograph 135, DLC, 101 Mule Deer Court, radon system location in the basement. Owners paid to have the vent piping tied in at the basement ceiling.

This failure to complete this work is and any costs associated with its completion is the responsibility of Liscott.

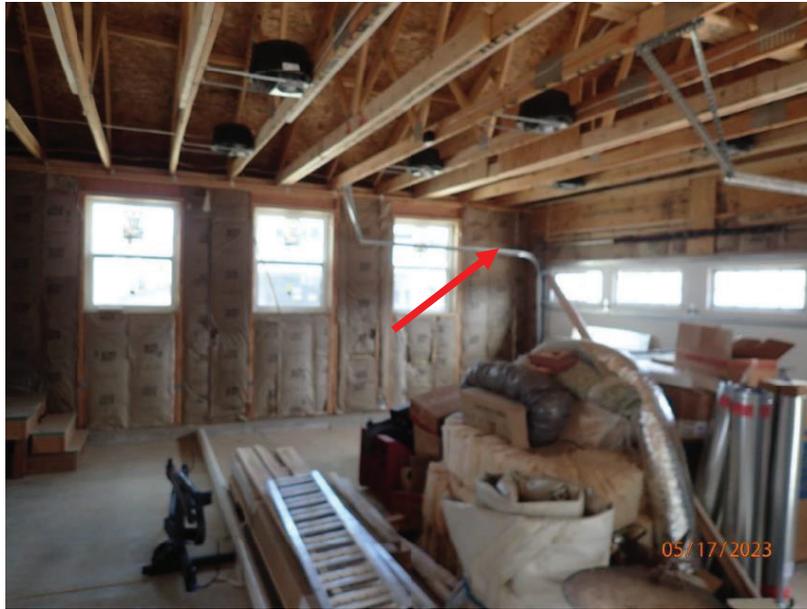
At the time of the site visit, it was noted that the garage door openers have not been installed. The Owner stated that this item had been previously billed by Liscott and paid for by the Owners.

May 17, 2023, Disc OBS1, 101, DLC, 101 Mule Deer Court, garage door openers have not been installed. These were paid for by the Owners.

At this point, it is CTETS’s opinion that Liscott should be responsible for a full refund of these costs.

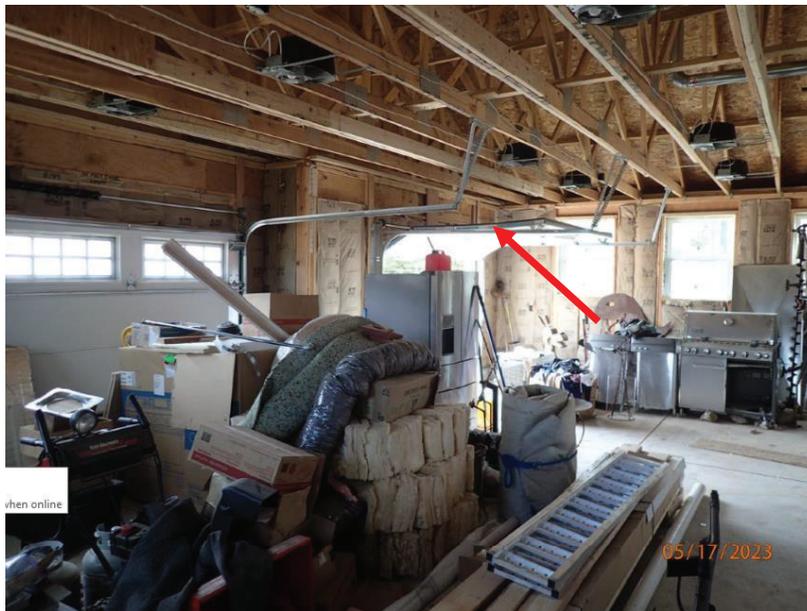
May 17, 2023, Disc OBS1, Photograph 102, DLC, 101 Mule Deer Court, garage door openers have not been installed. These were paid for by the Owners and have not been delivered by Liscott.
