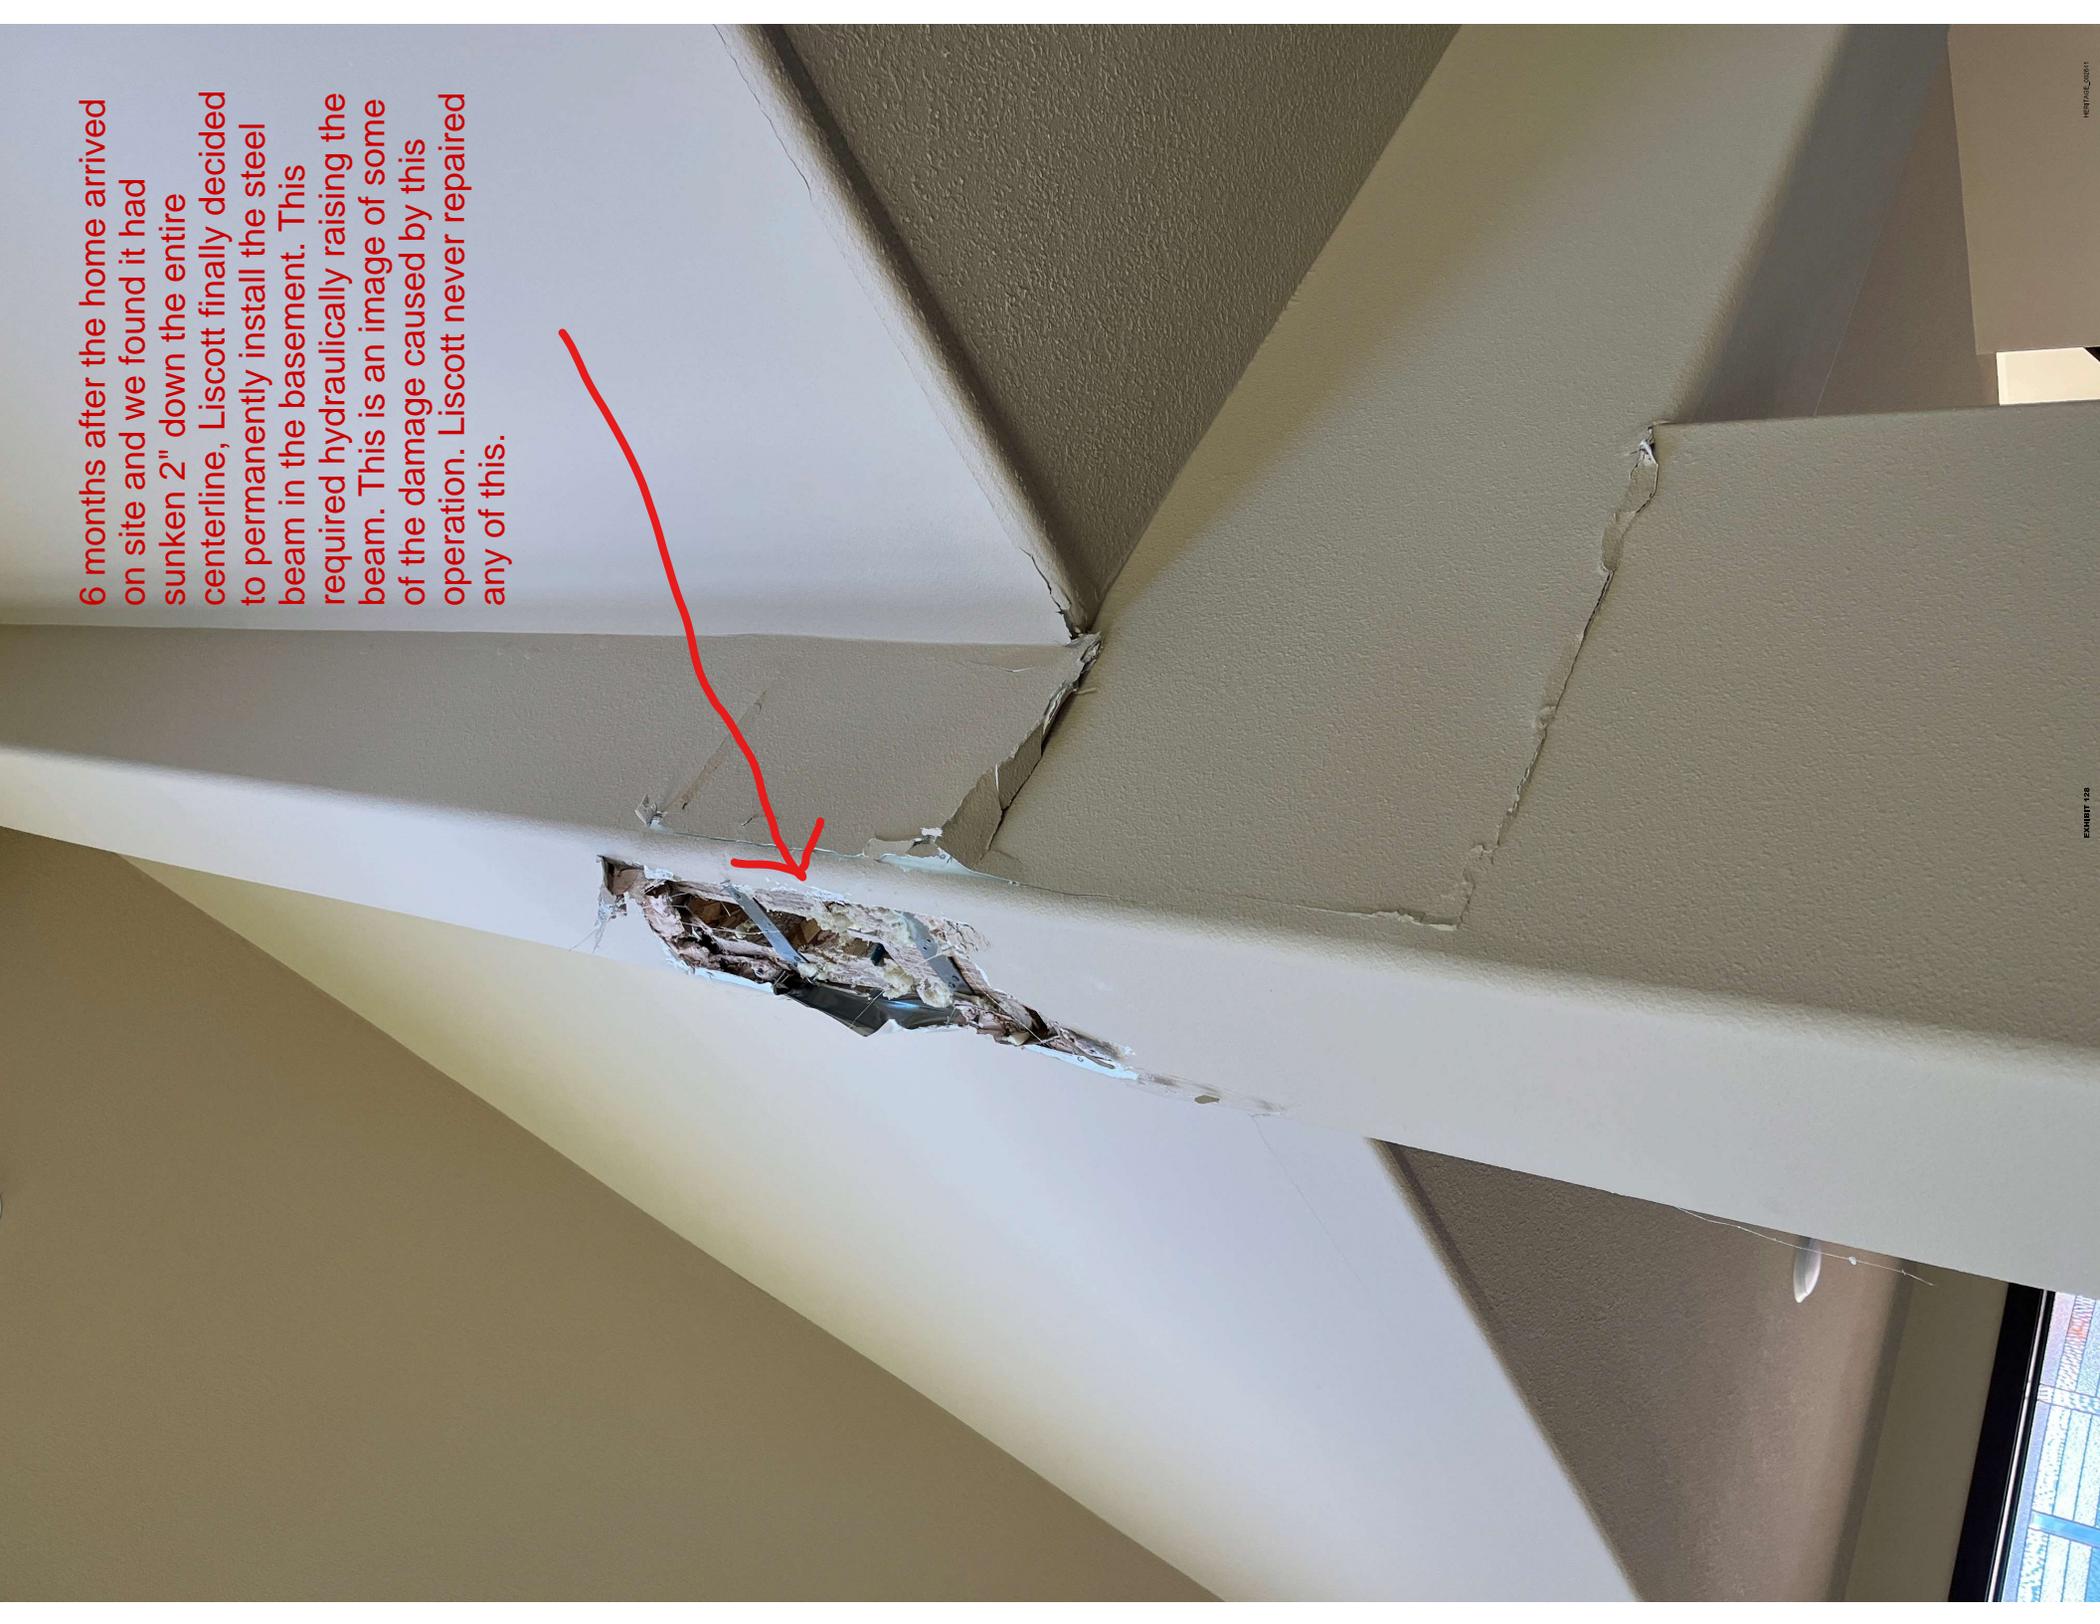
6 months after the home arrived on site and we found it had sunken 2" down the entire centerline, Liscott finally decided to permanently install the steel beam in the basement. This required hydraulically raising the beam. This is an image of some of the damage caused by this operation. Liscott never repaired any of this.

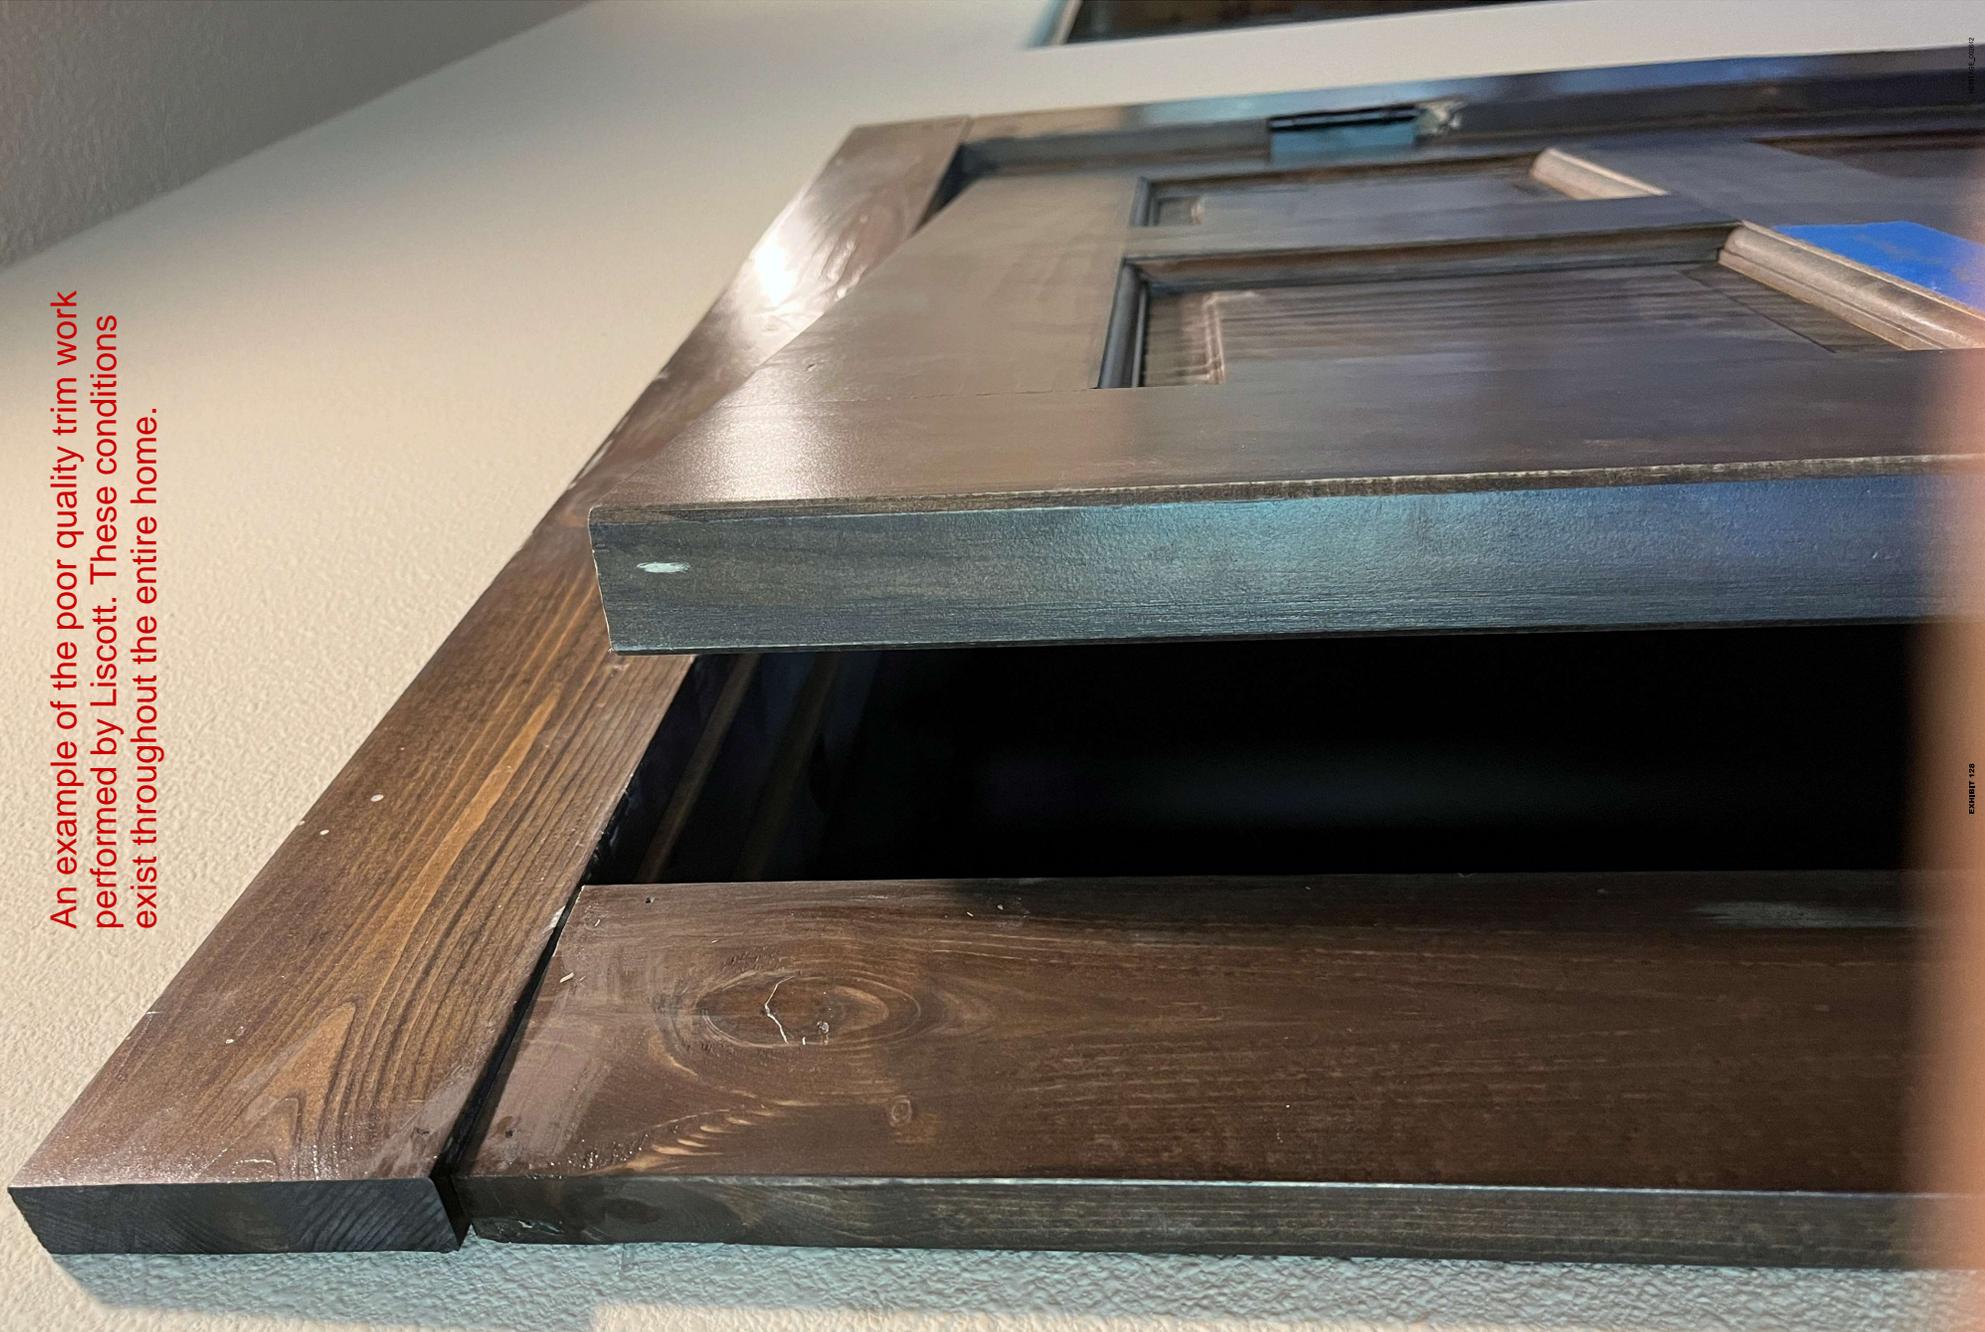
An example of the poor quality trim work performed by Liscott. These conditions exist throughout the entire home.

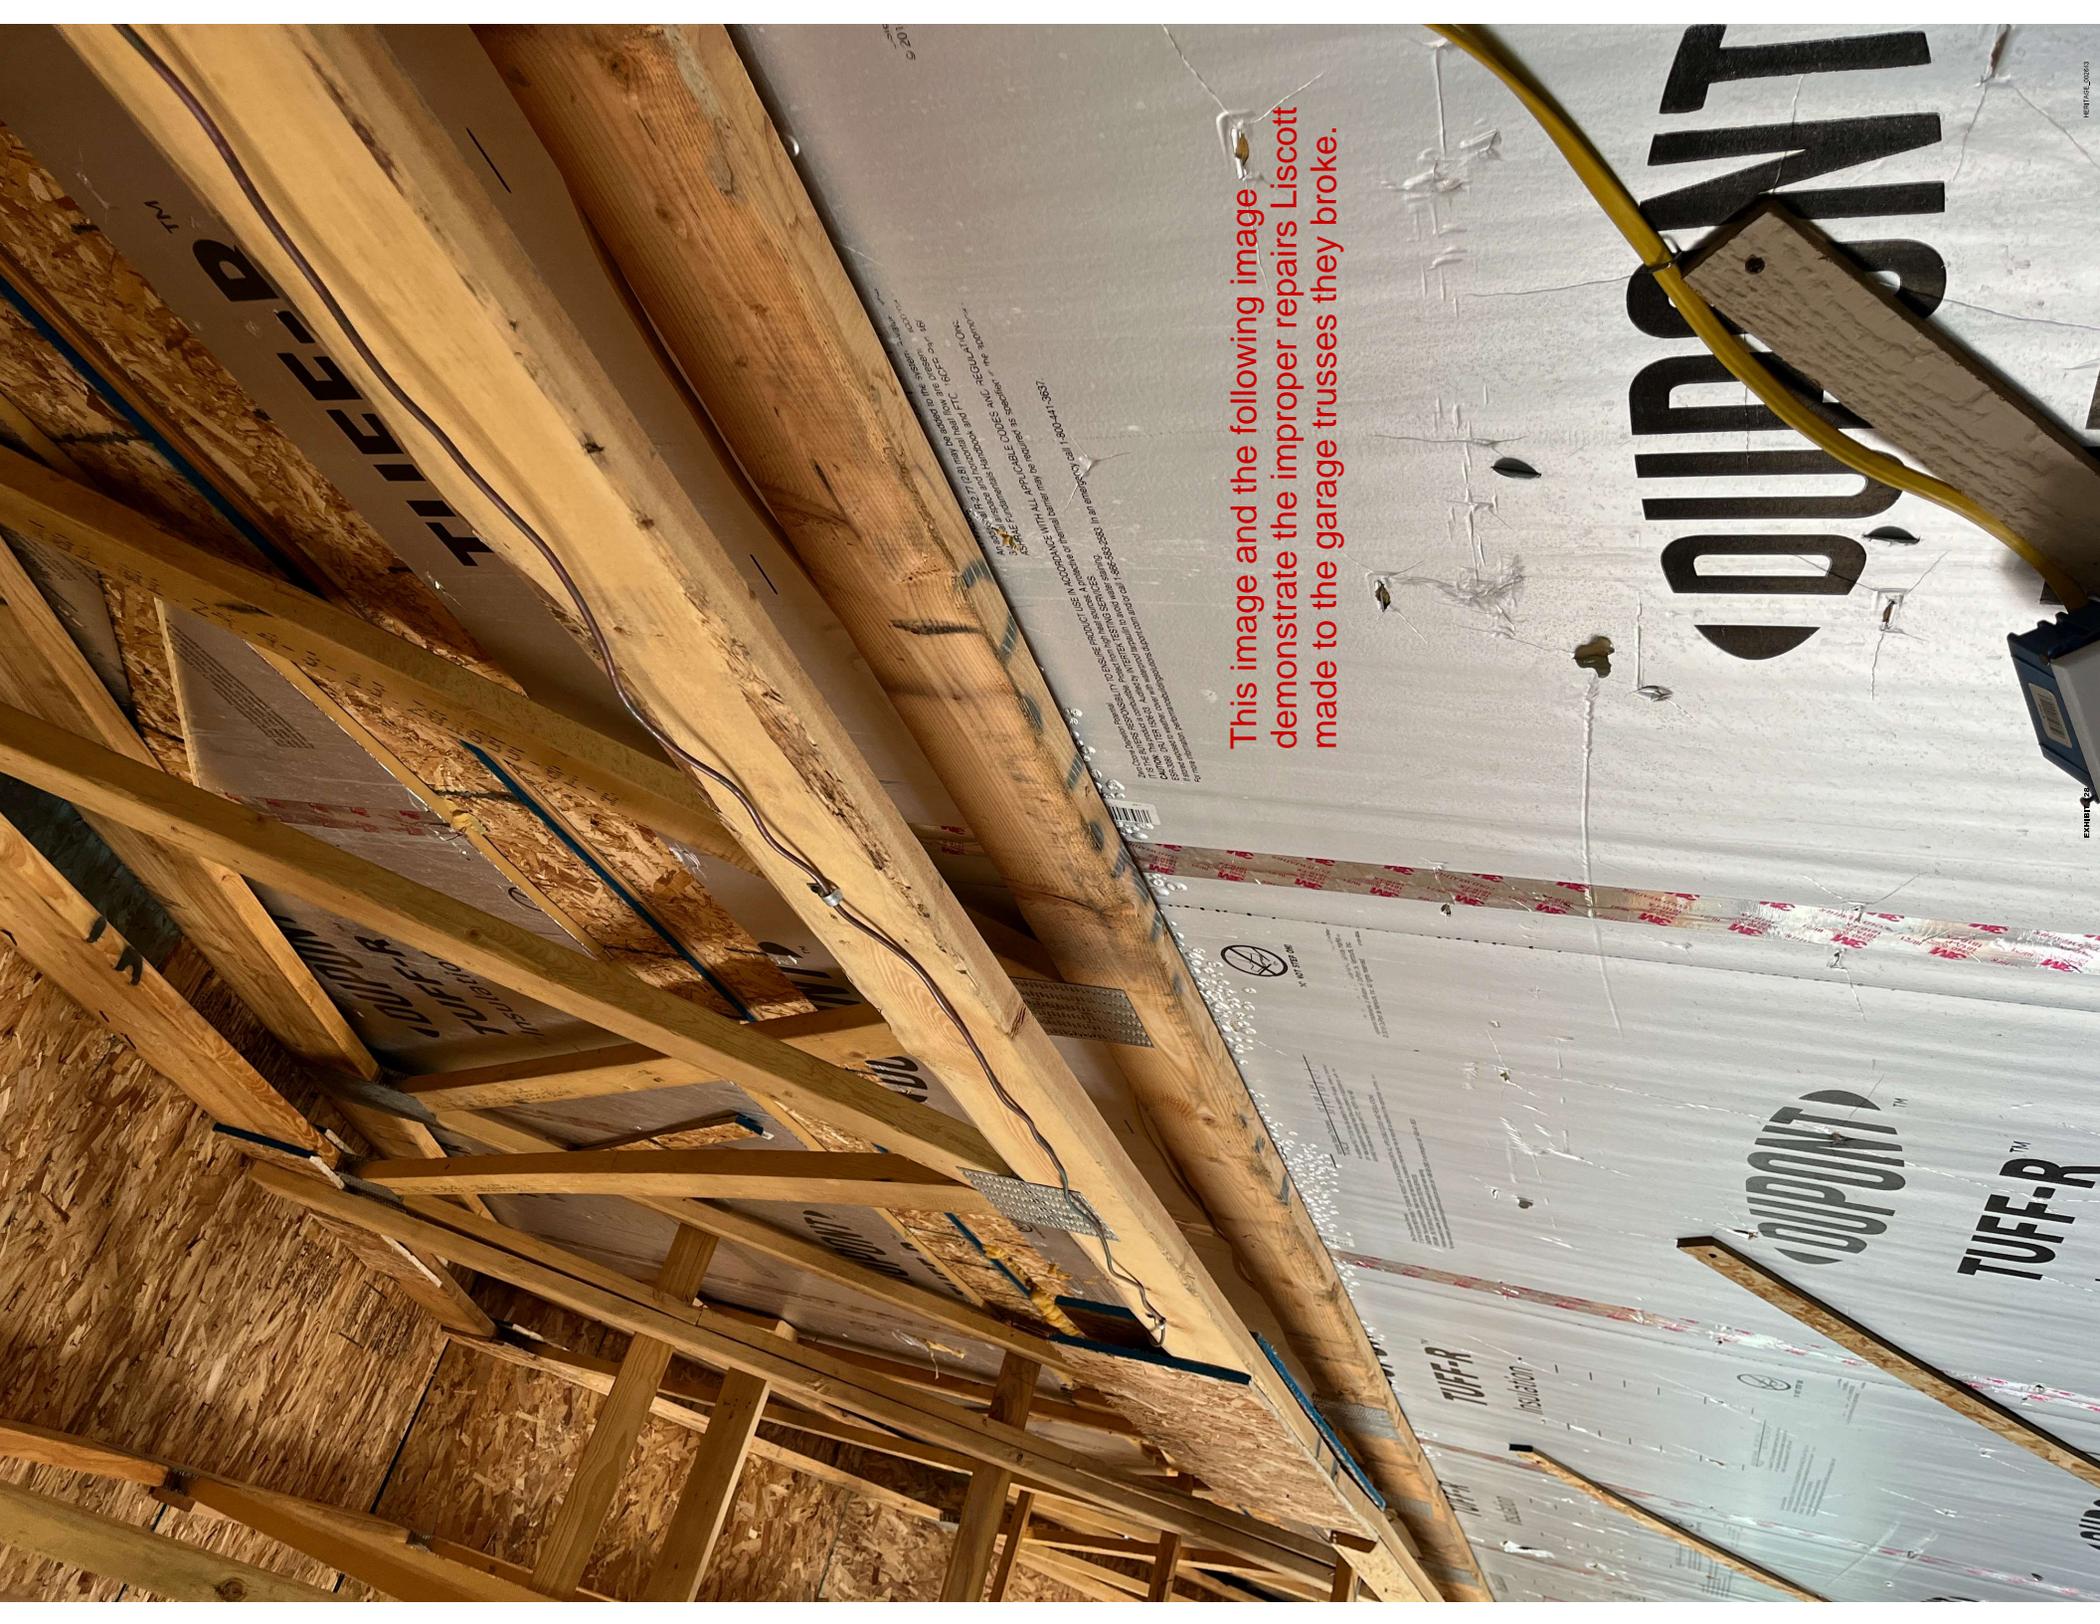
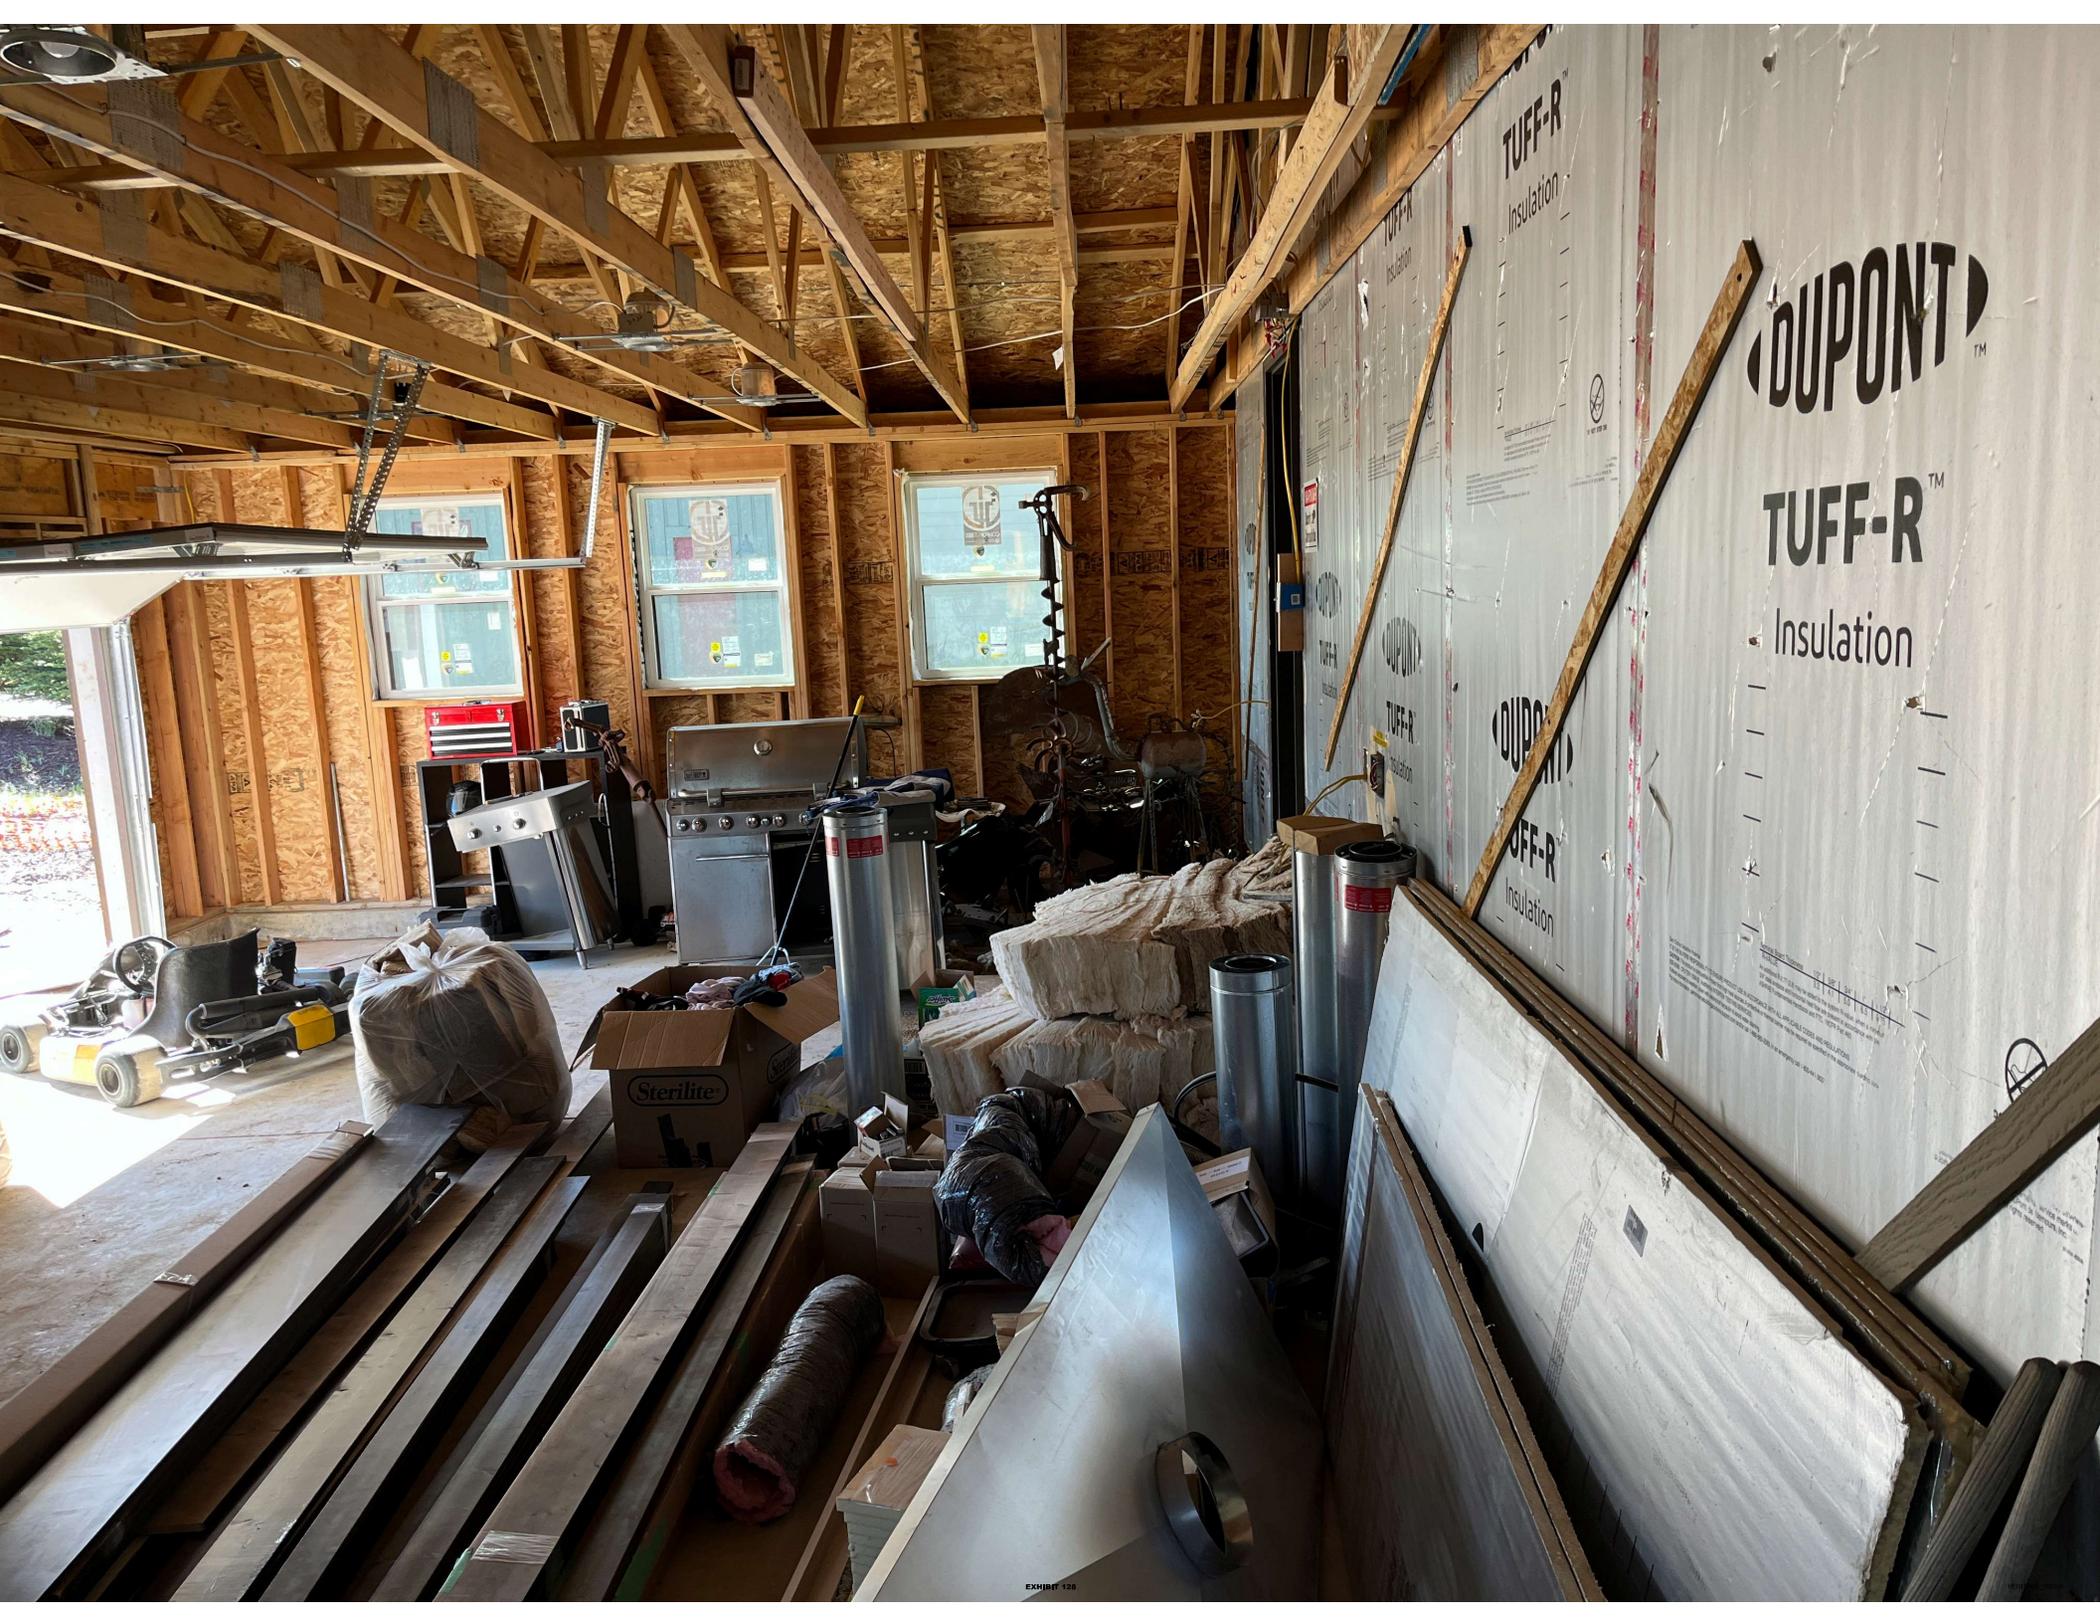
This image and the following image demonstrate the improper repairs Liscott made to the garage trusses they broke.
