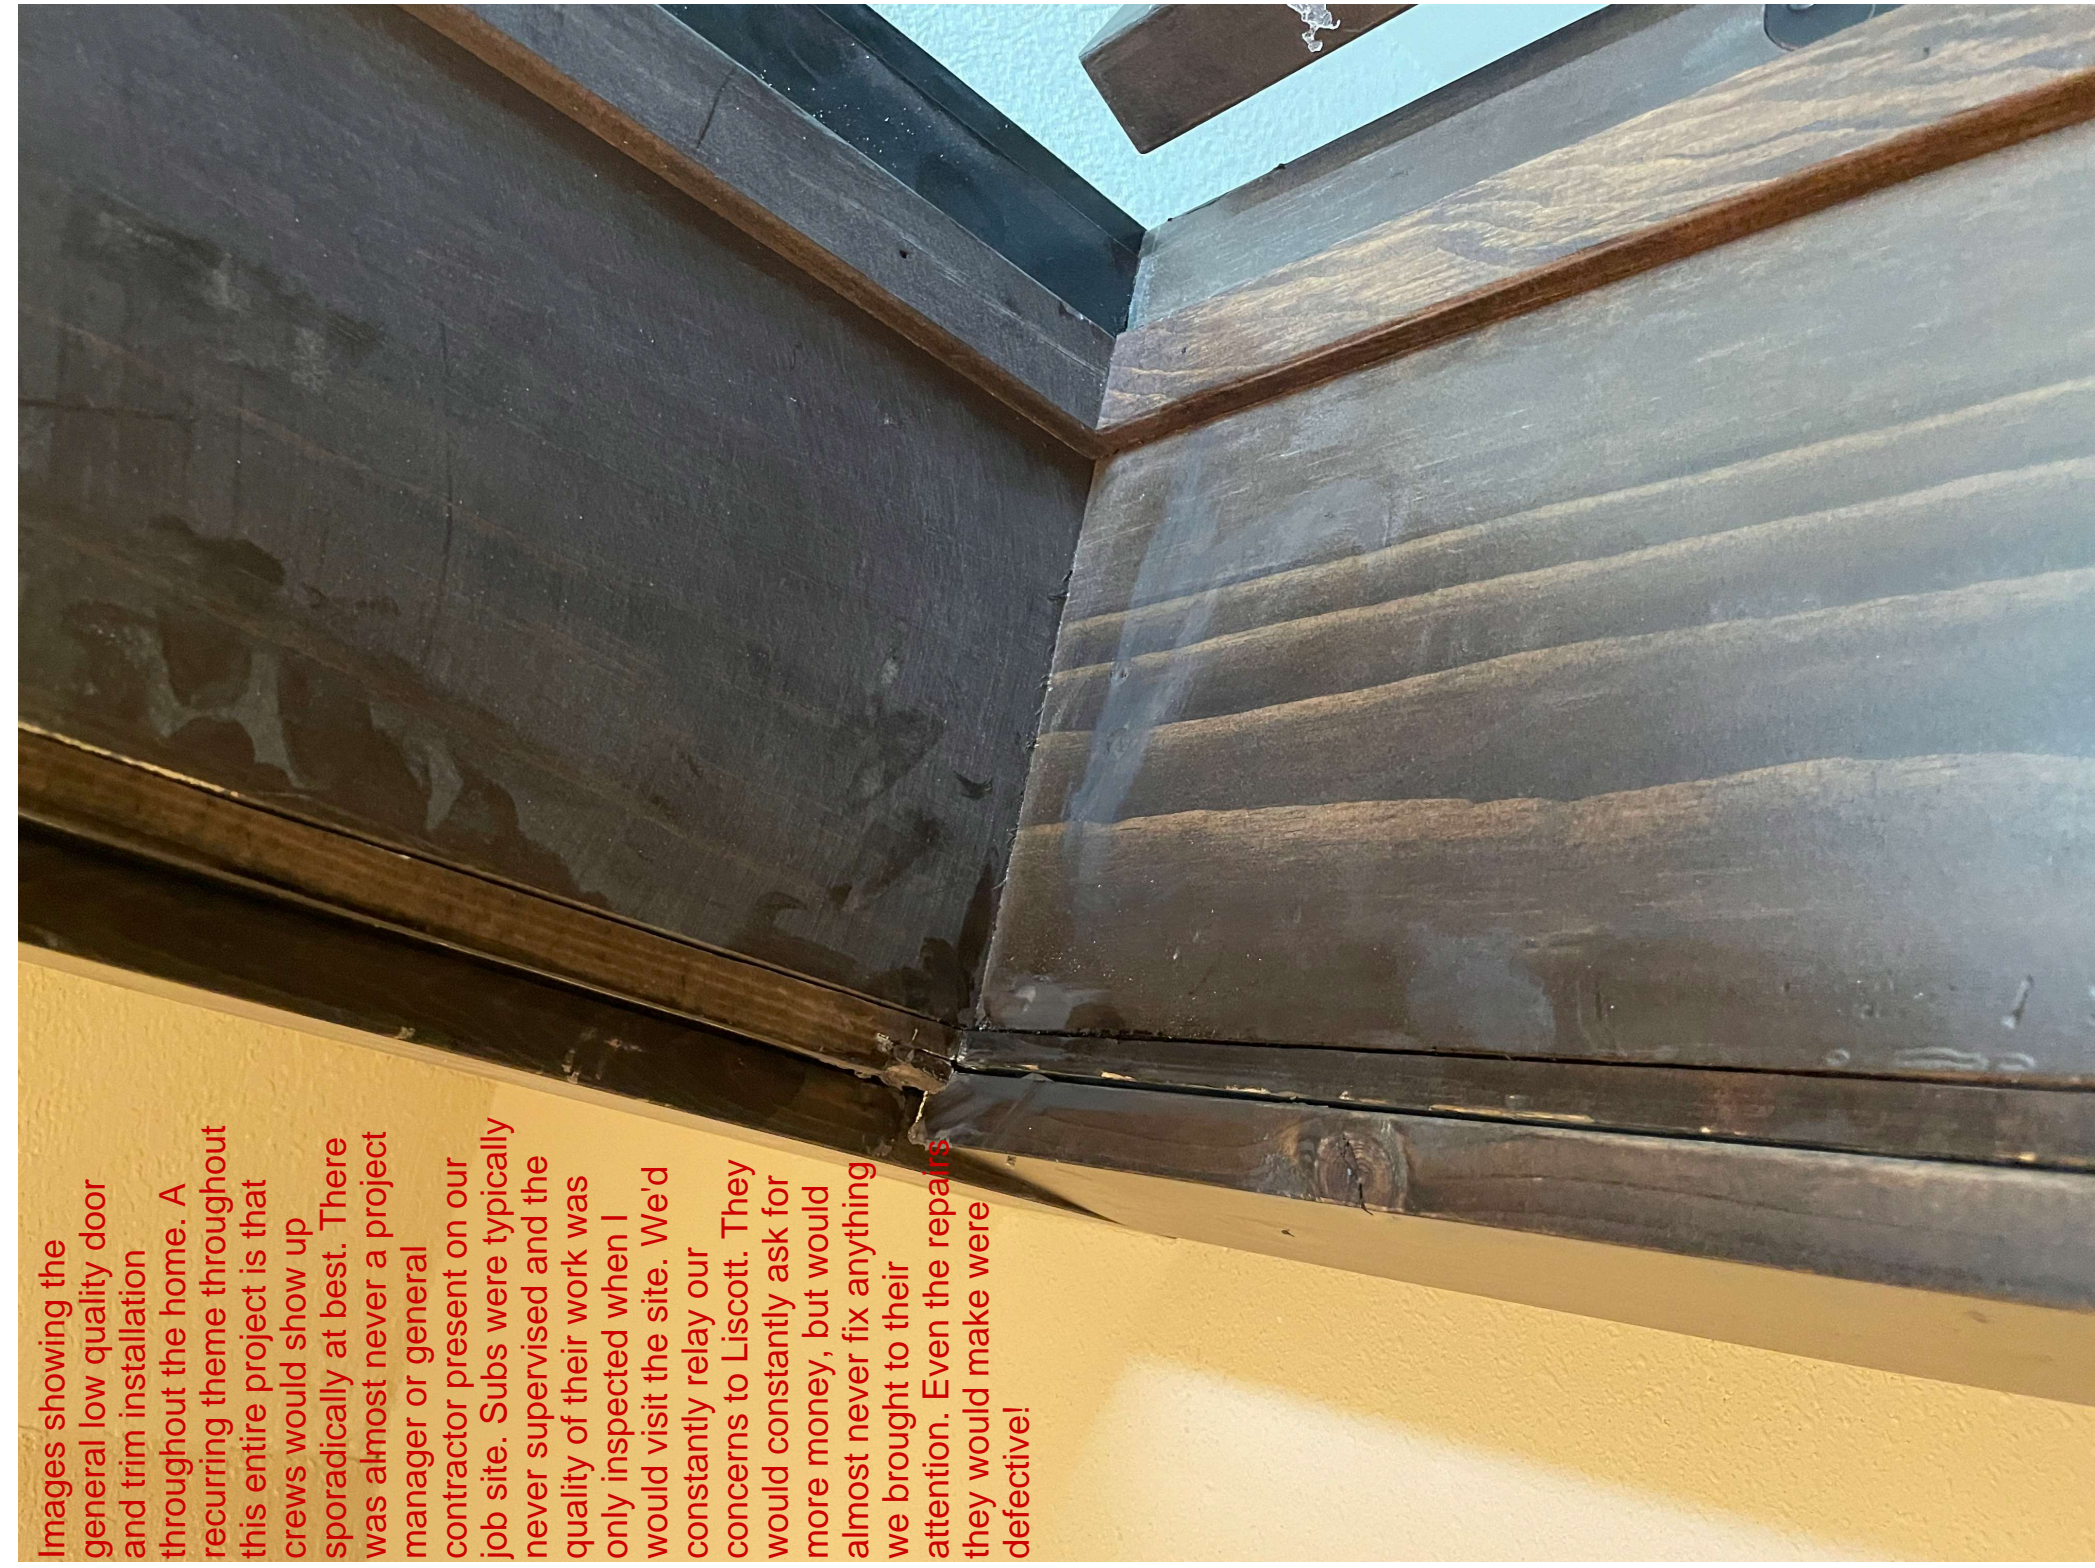
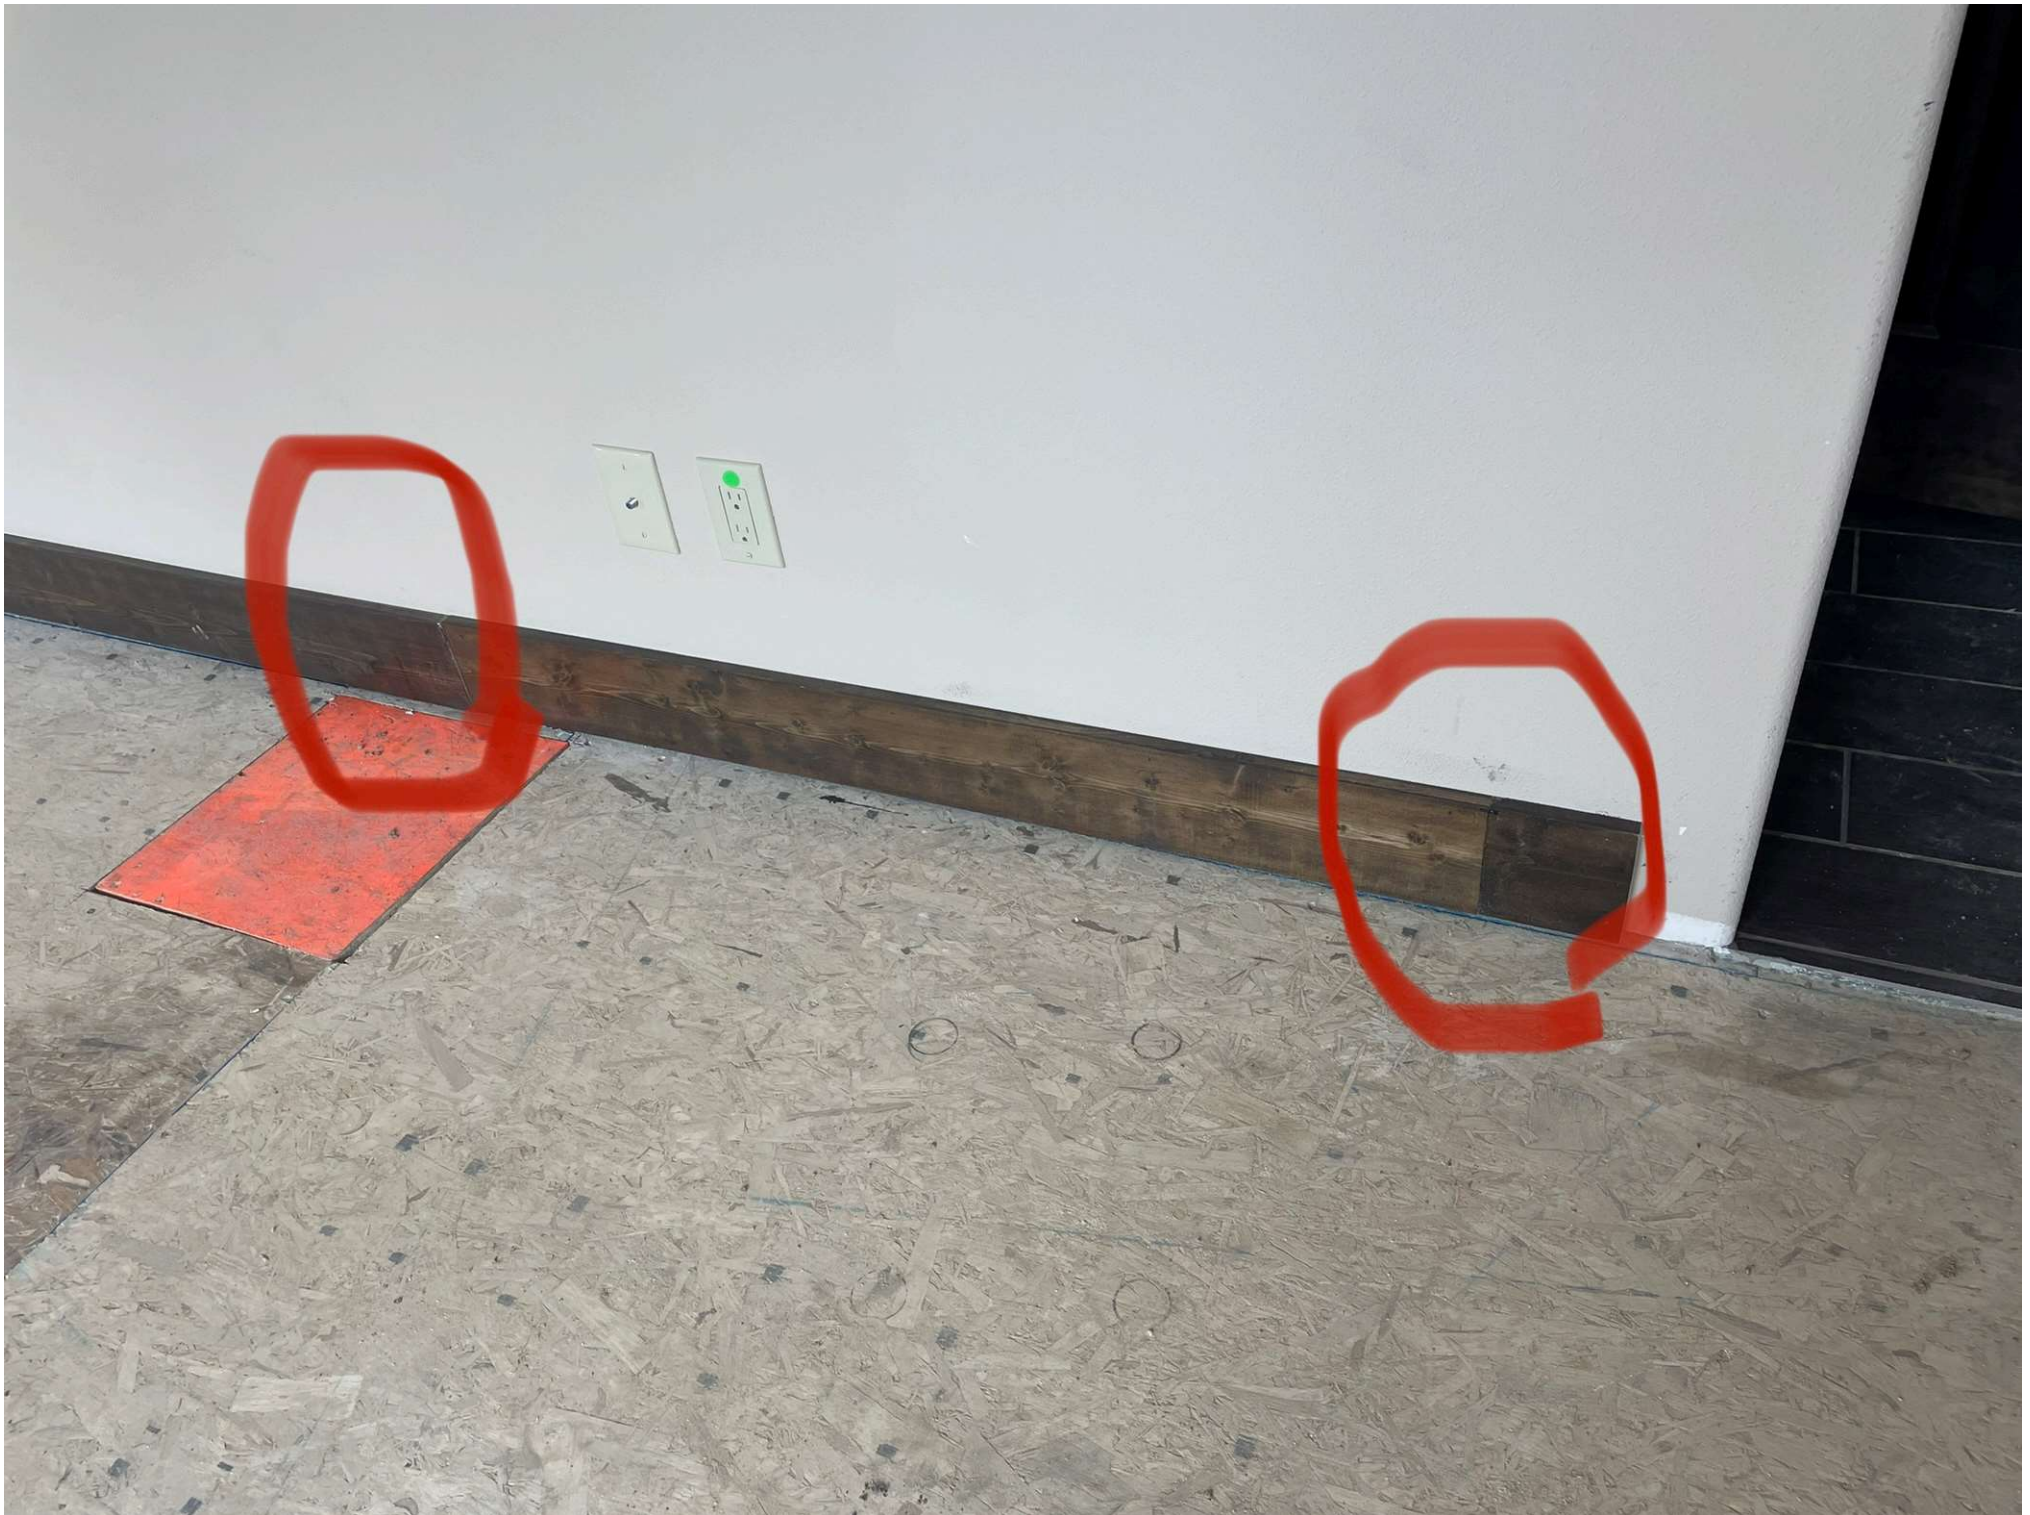
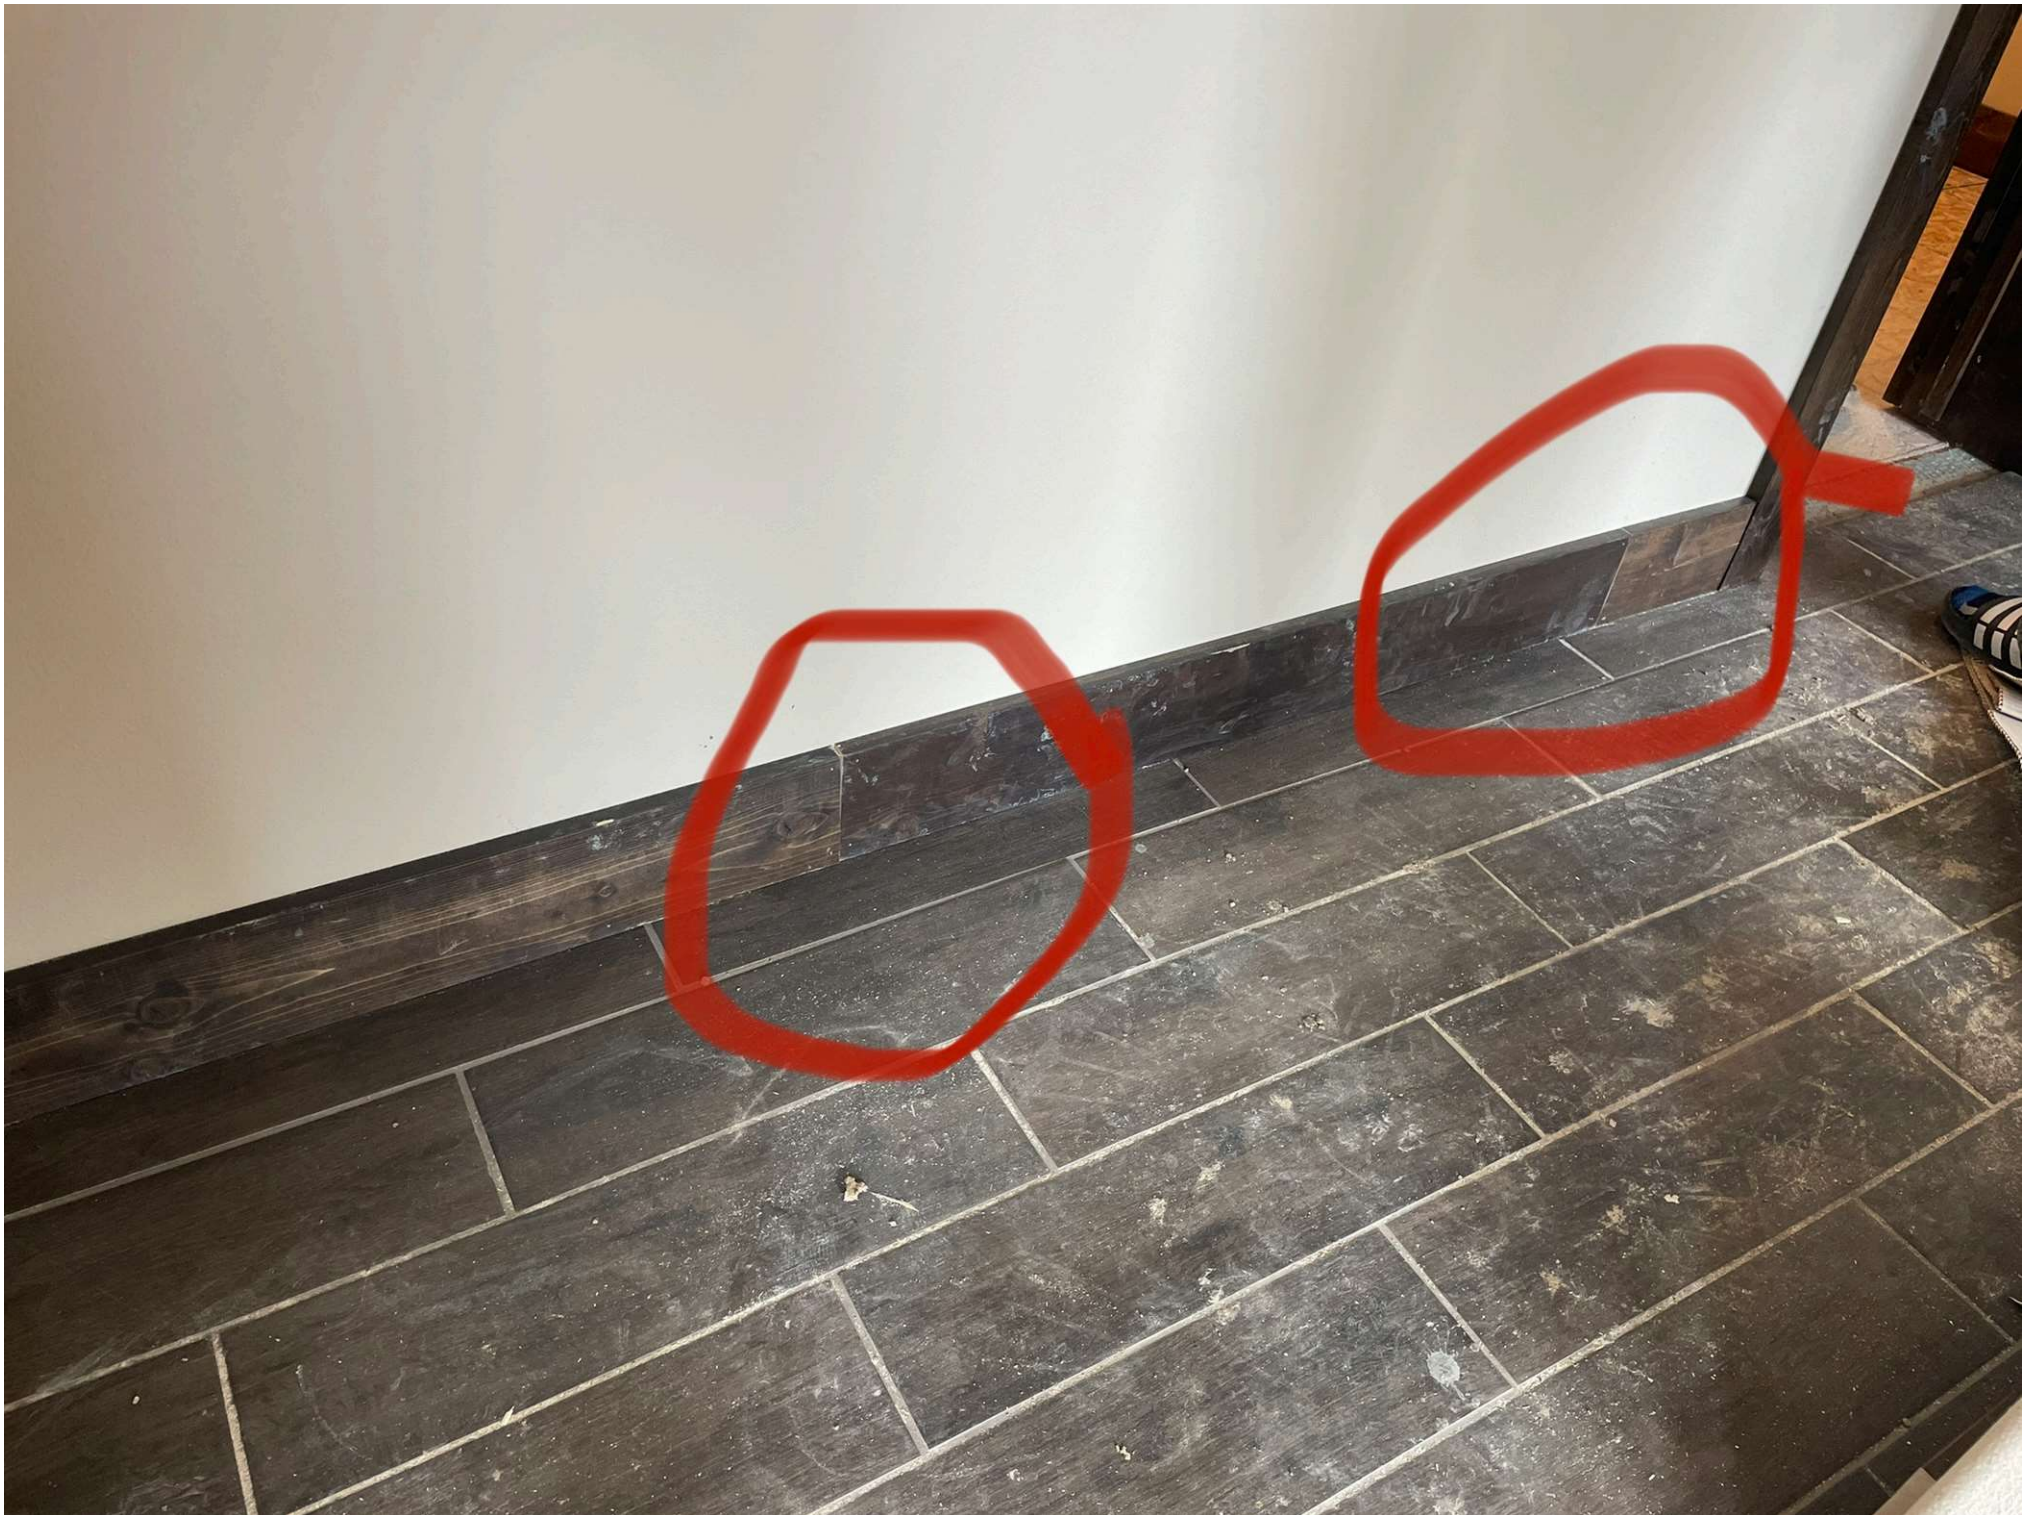
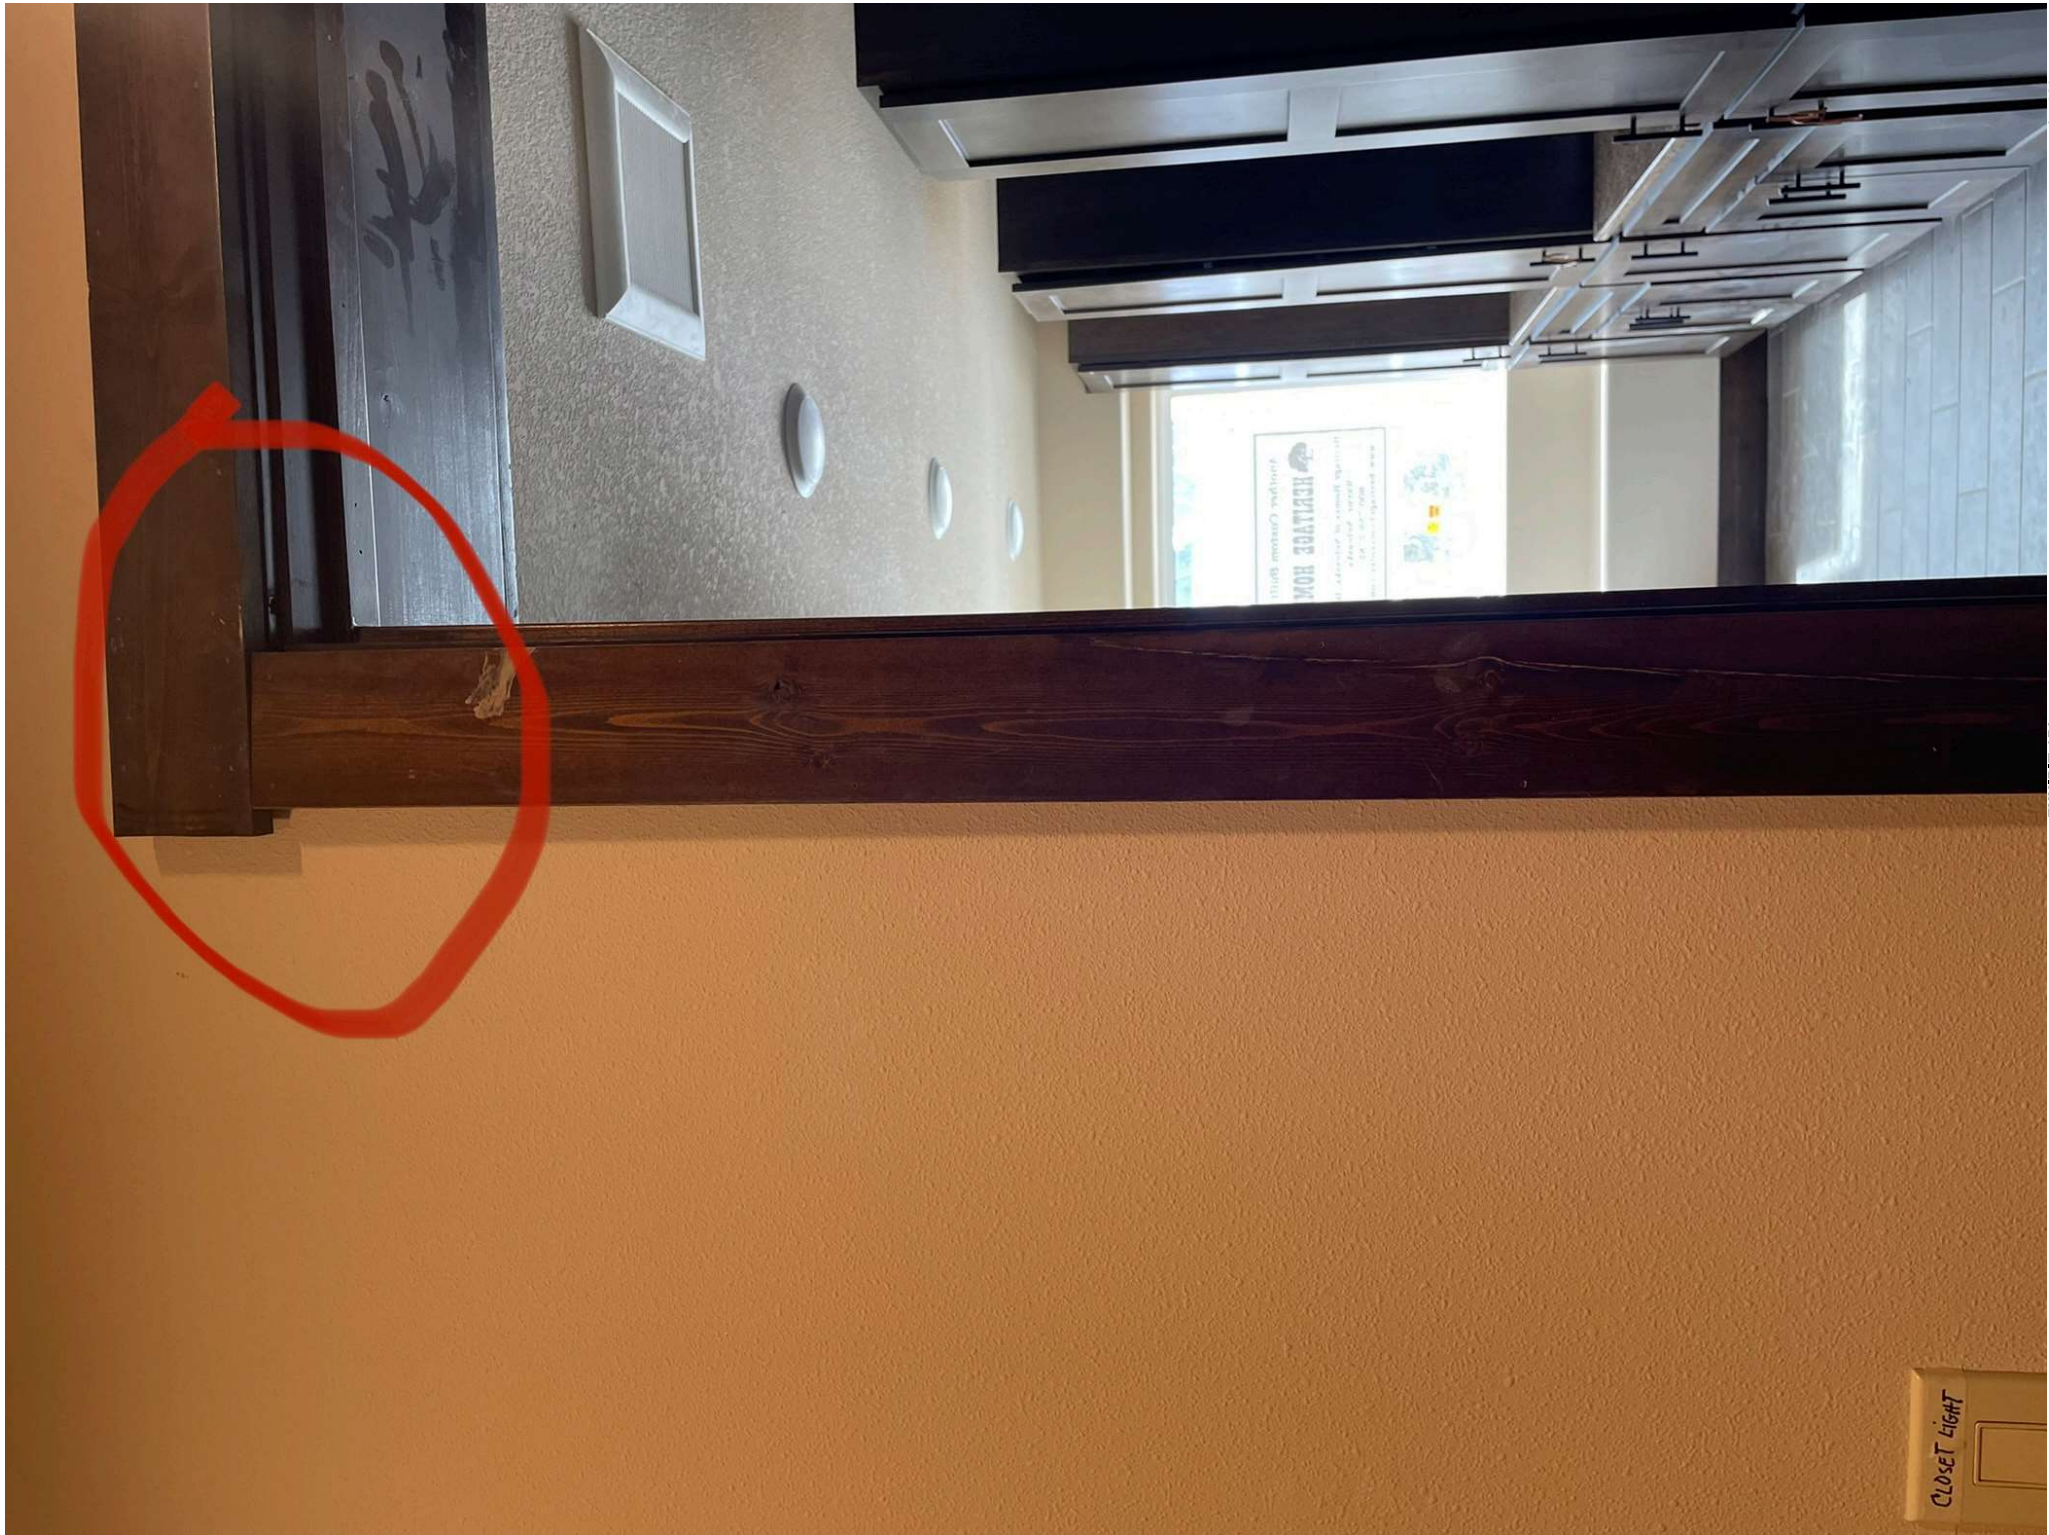
Images showing the general low quality door and trim installation throughout the home. A recurring theme throughout this entire project is that crews would show up sporadically at best. There was almost never a project manager or general contractor present on our job site. Subs were typically never supervised and the quality of their work was only inspected when I would visit the site. We'd constantly relay our concerns to Liscott. They would constantly ask for more money, but would almost never fix anything we brought to their attention. Even the repairs they would make were defective!
