Additional photos showing the terrible quality of Liscott's door and trim installation.

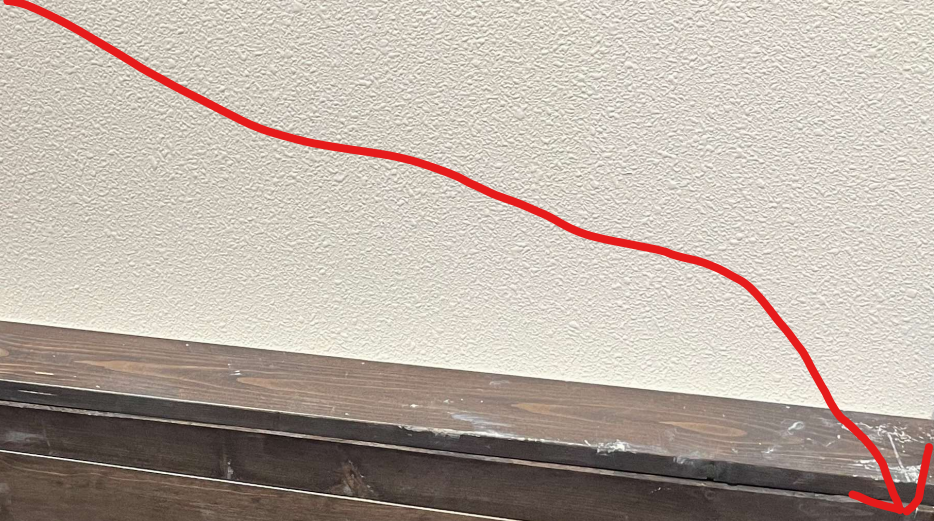
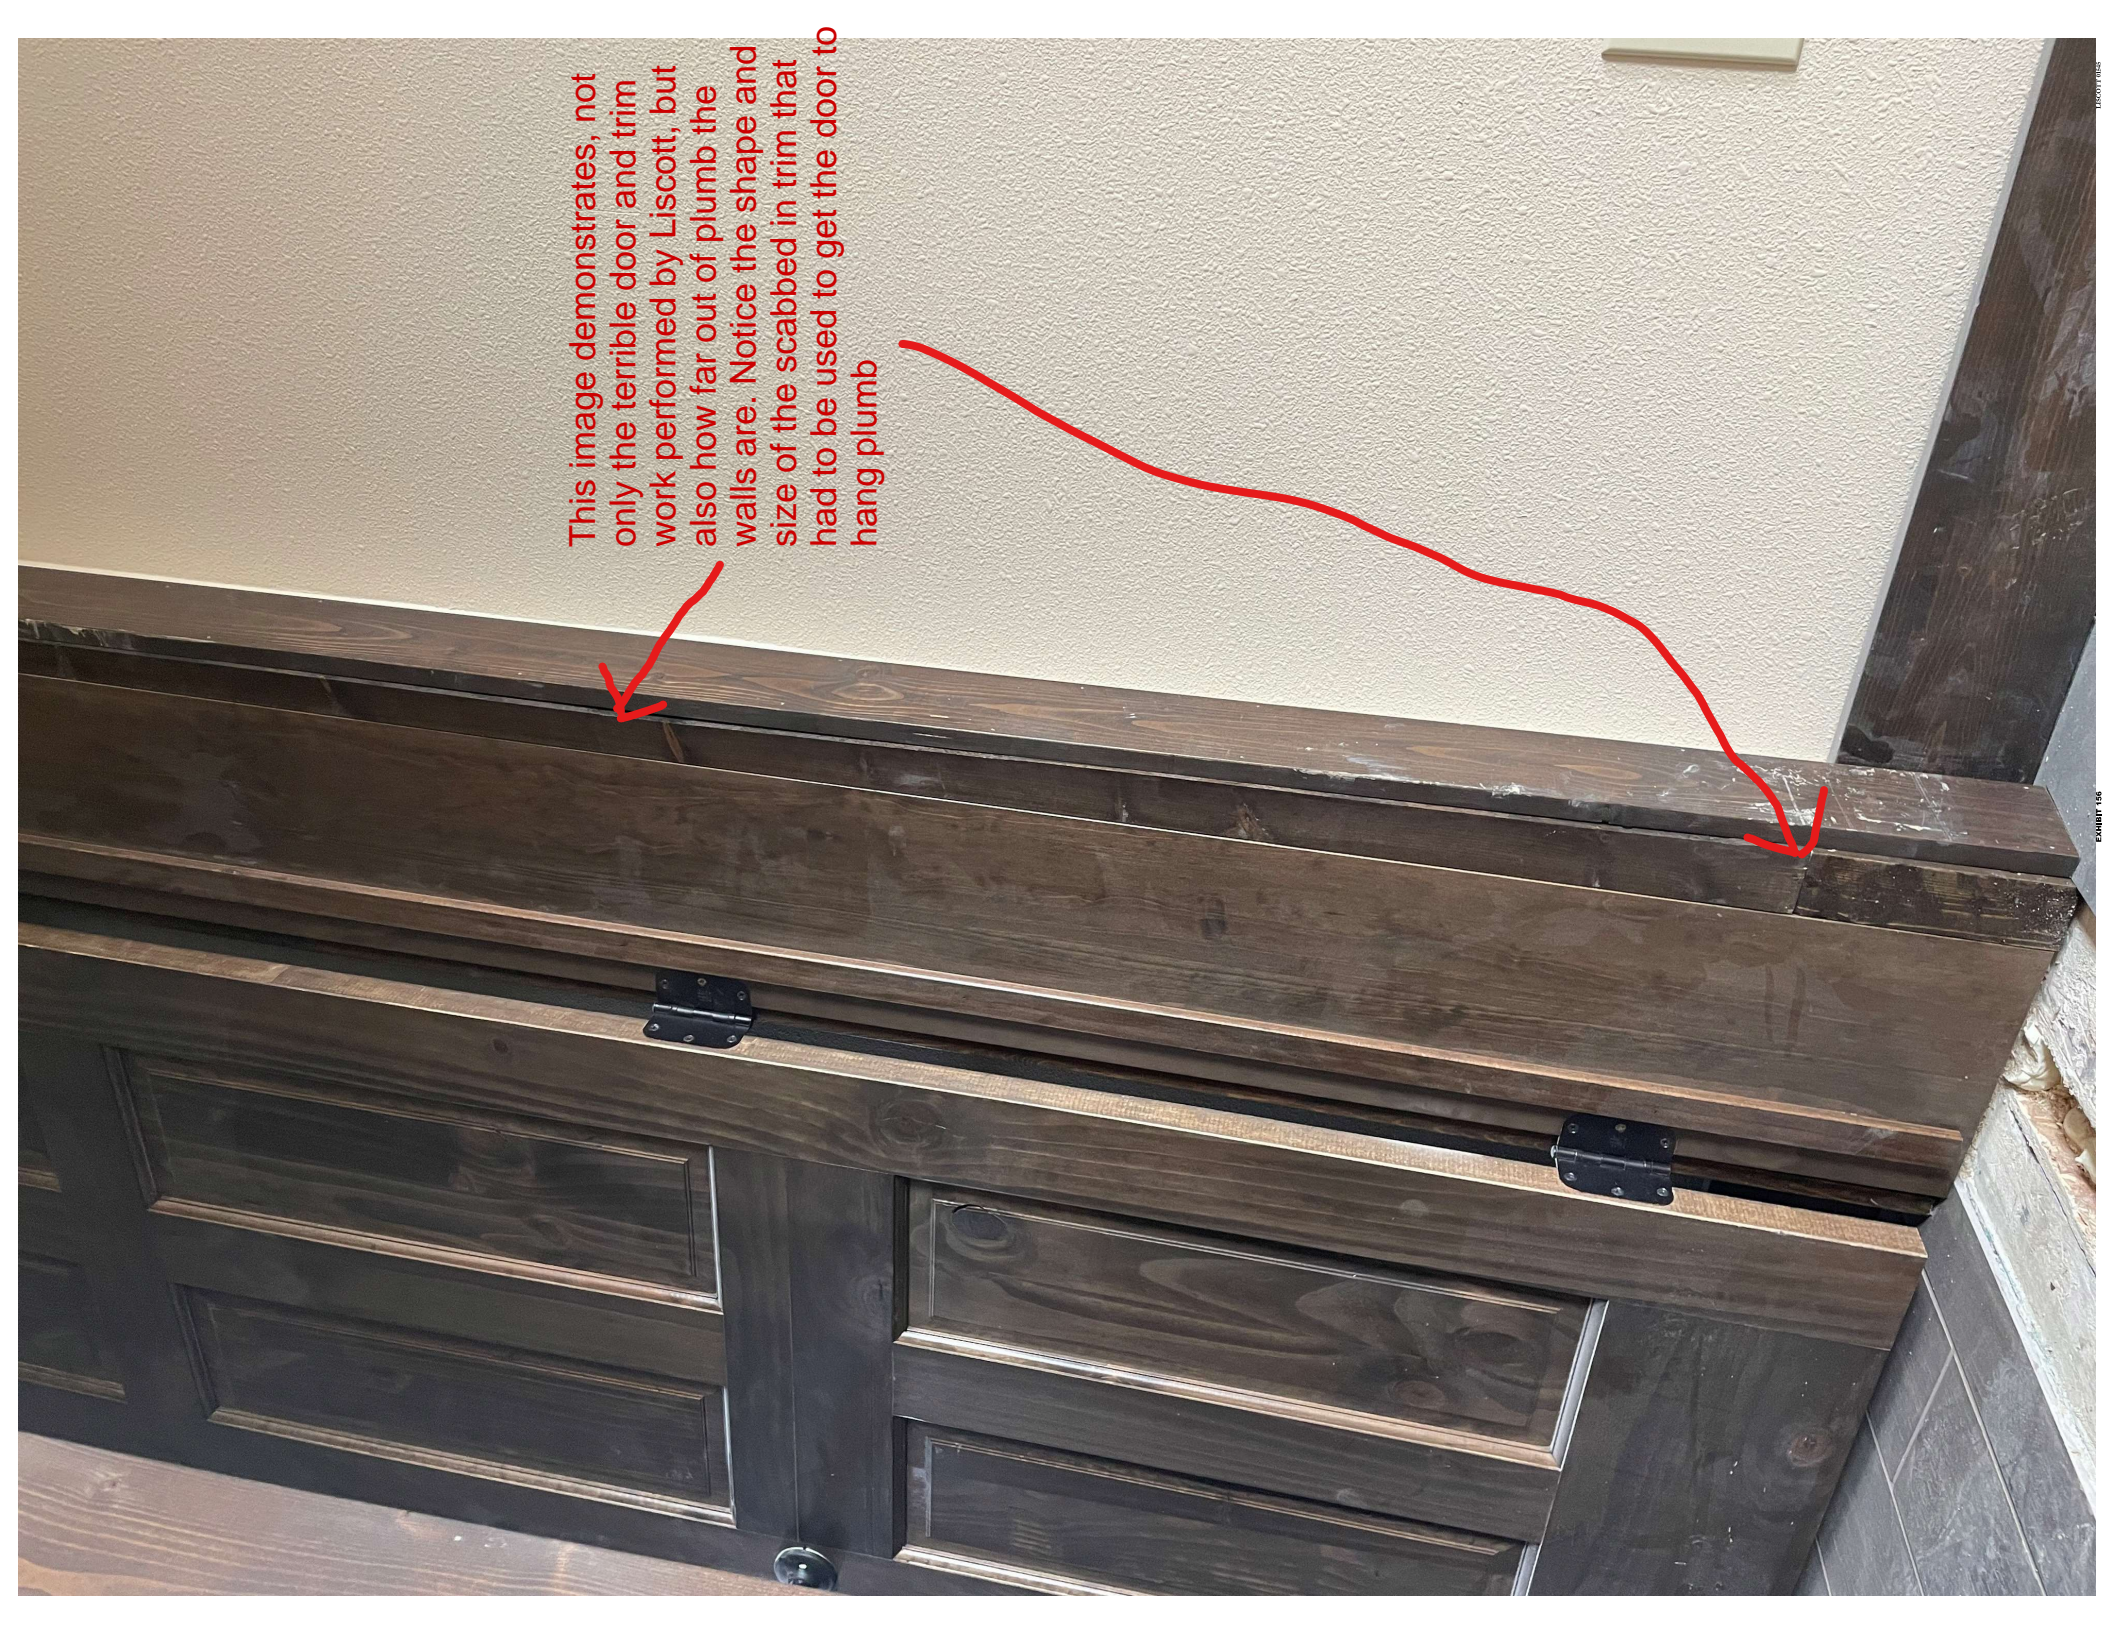
This image demonstrates, not only the terrible door and trim work performed by Liscott, but also how far out of plumb the walls are. Notice the shape and size of the scabbled in trim that had to be used to get the door to hang plumb
