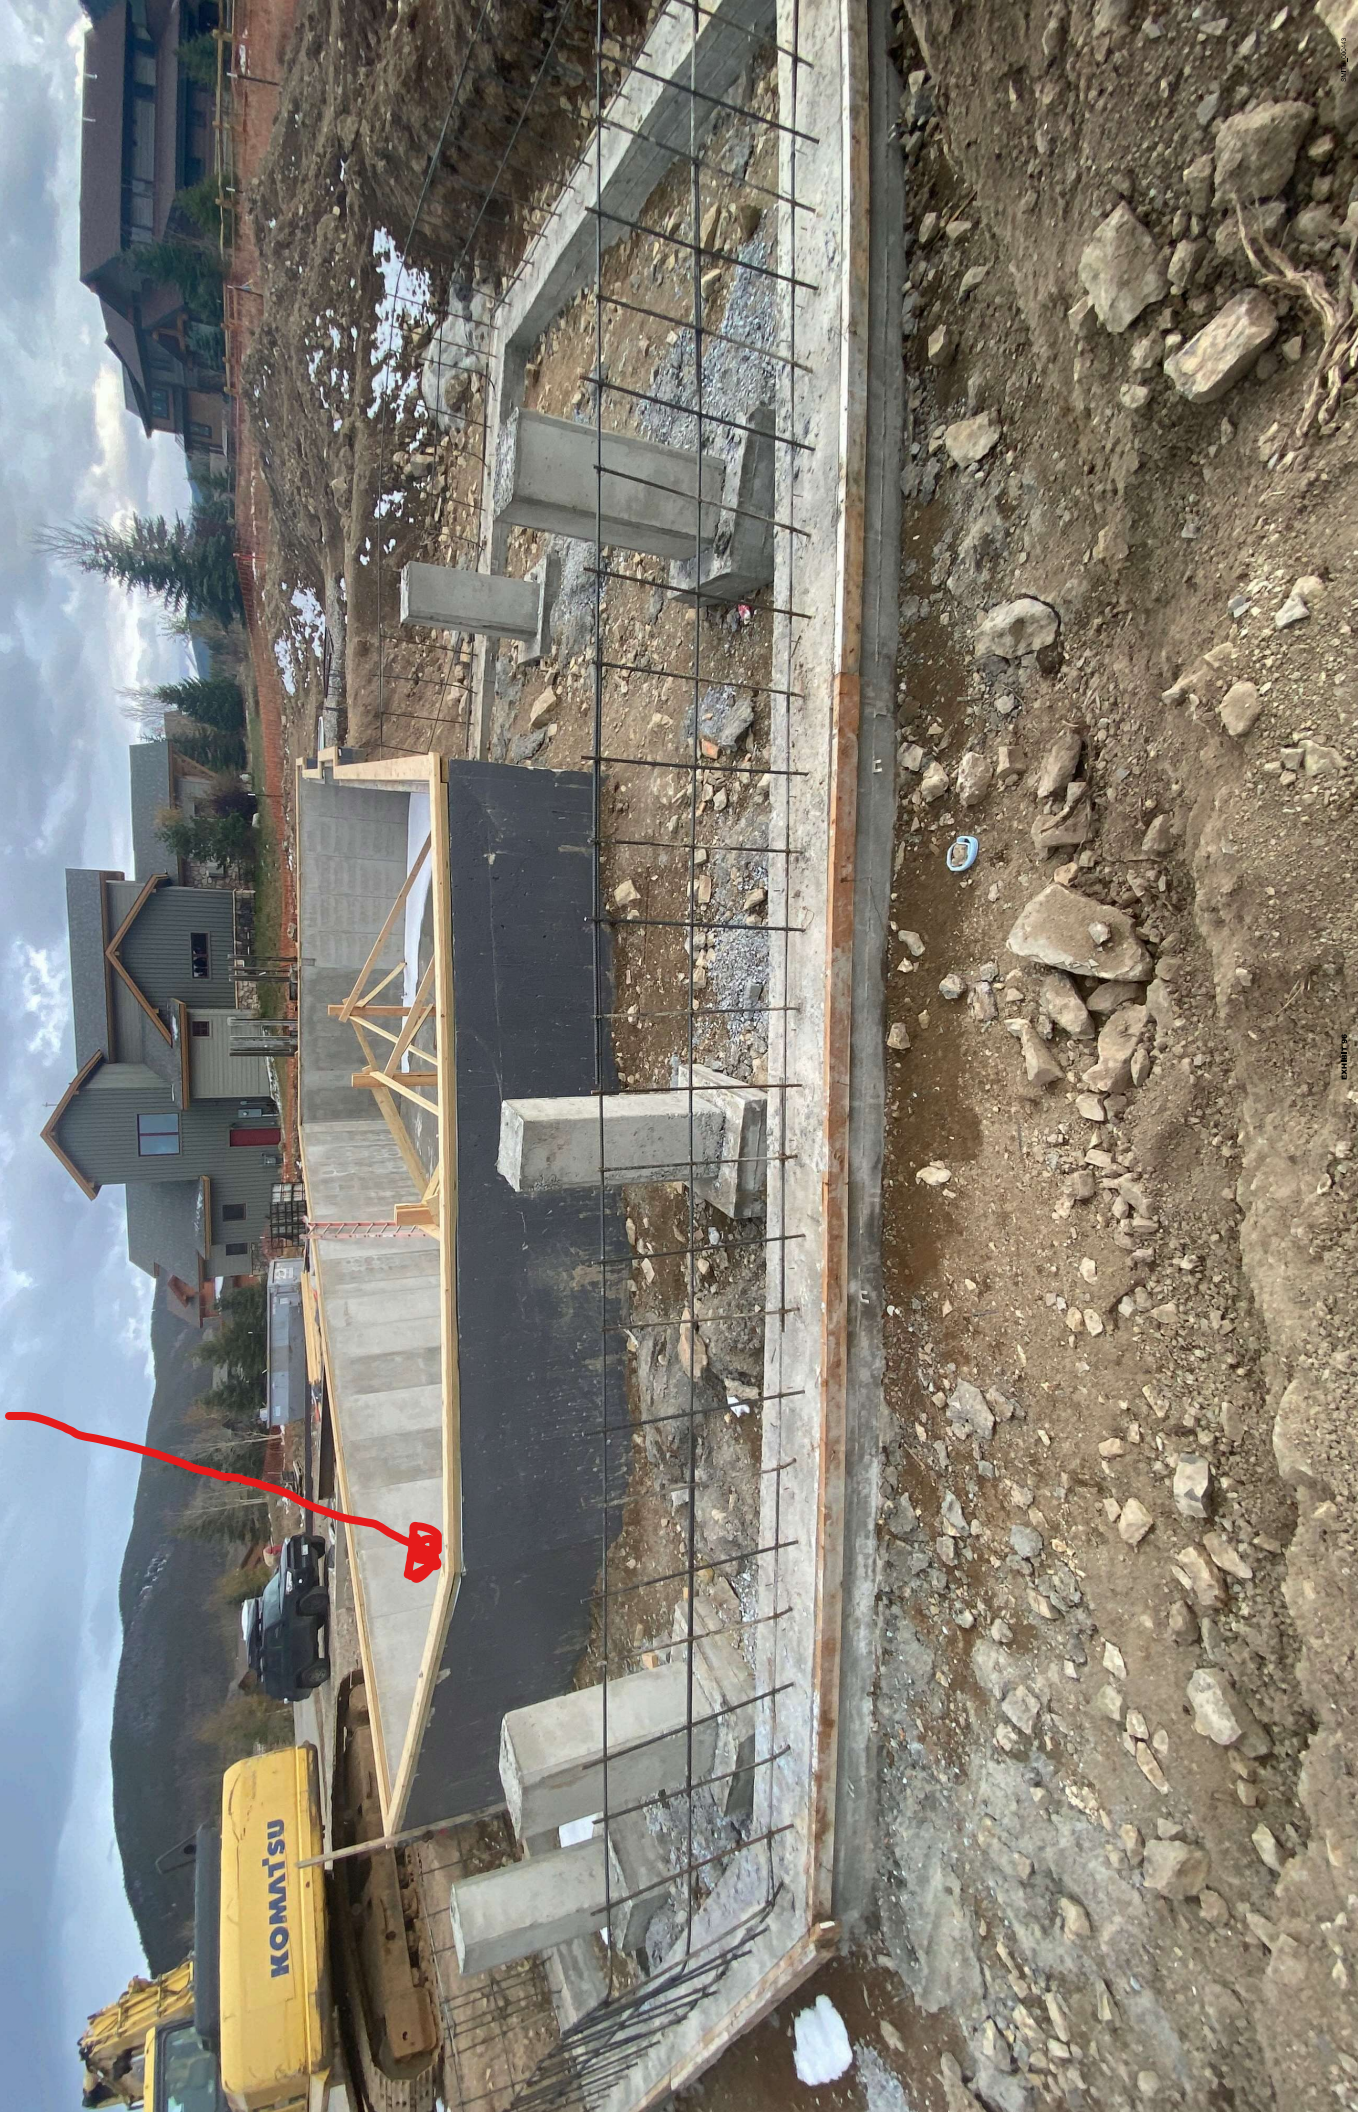
The foundation prior to the modules arriving. Nobody bothered to measure the level or the plumbness of the walls. This portion of the foundation is fully 2" lower than the outside walls. This section of wall is also 4" out of plumb, leaning into the backfill zone.

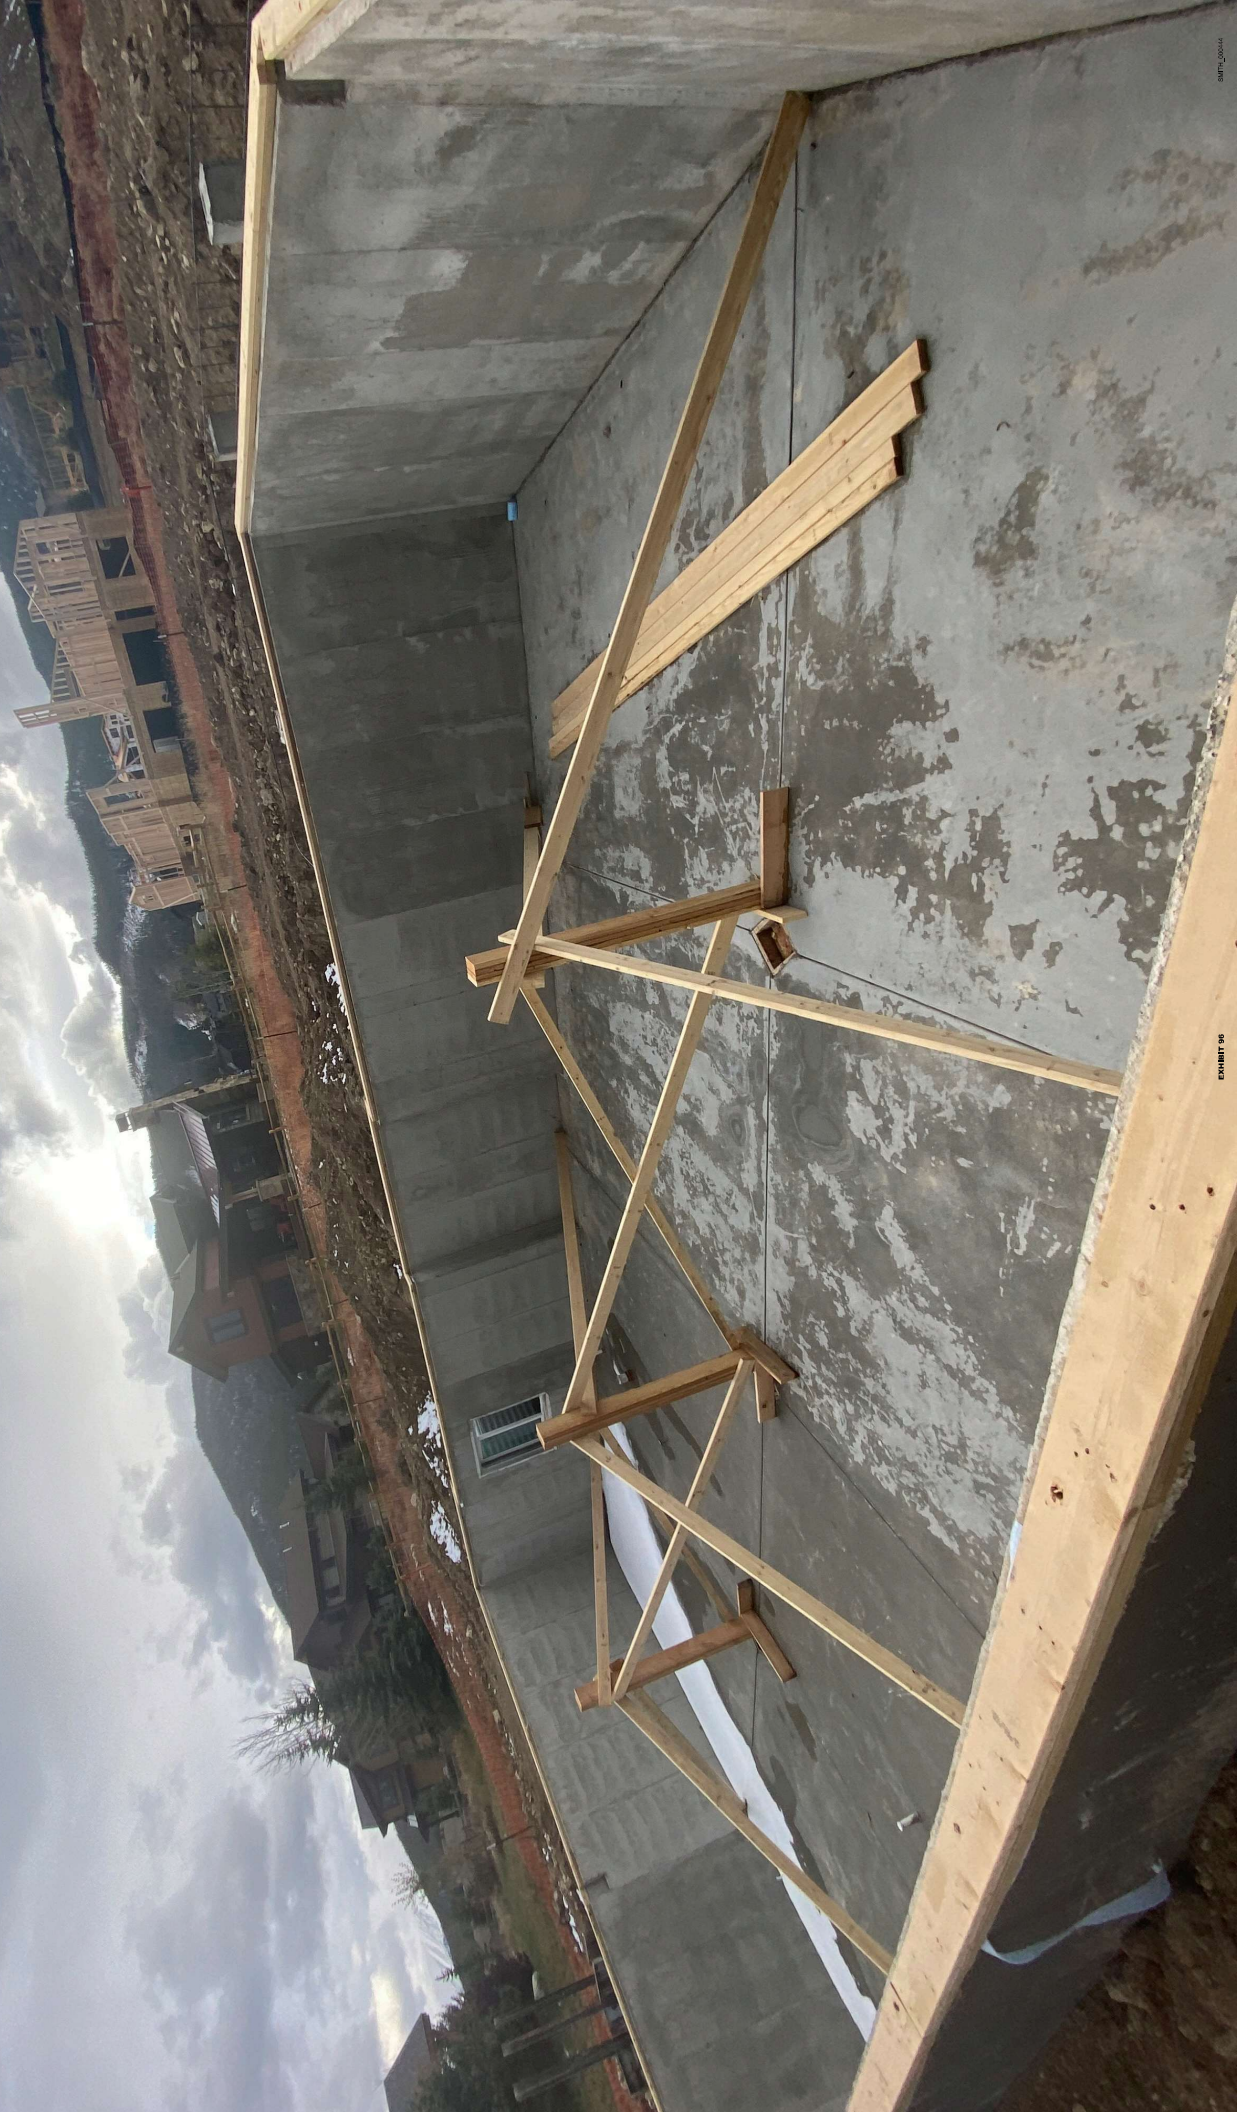
These wooden supports are the only things that held up the structural steel beam while the house was being built on top of it. These supports are not the correct height to hold the steel beam level with the foundation walls. The steel beam wasn't permanently installed until 6 months after the modules arrived. The steel beam should have been permanently leveled and permanently installed prior to the modules even arriving!
