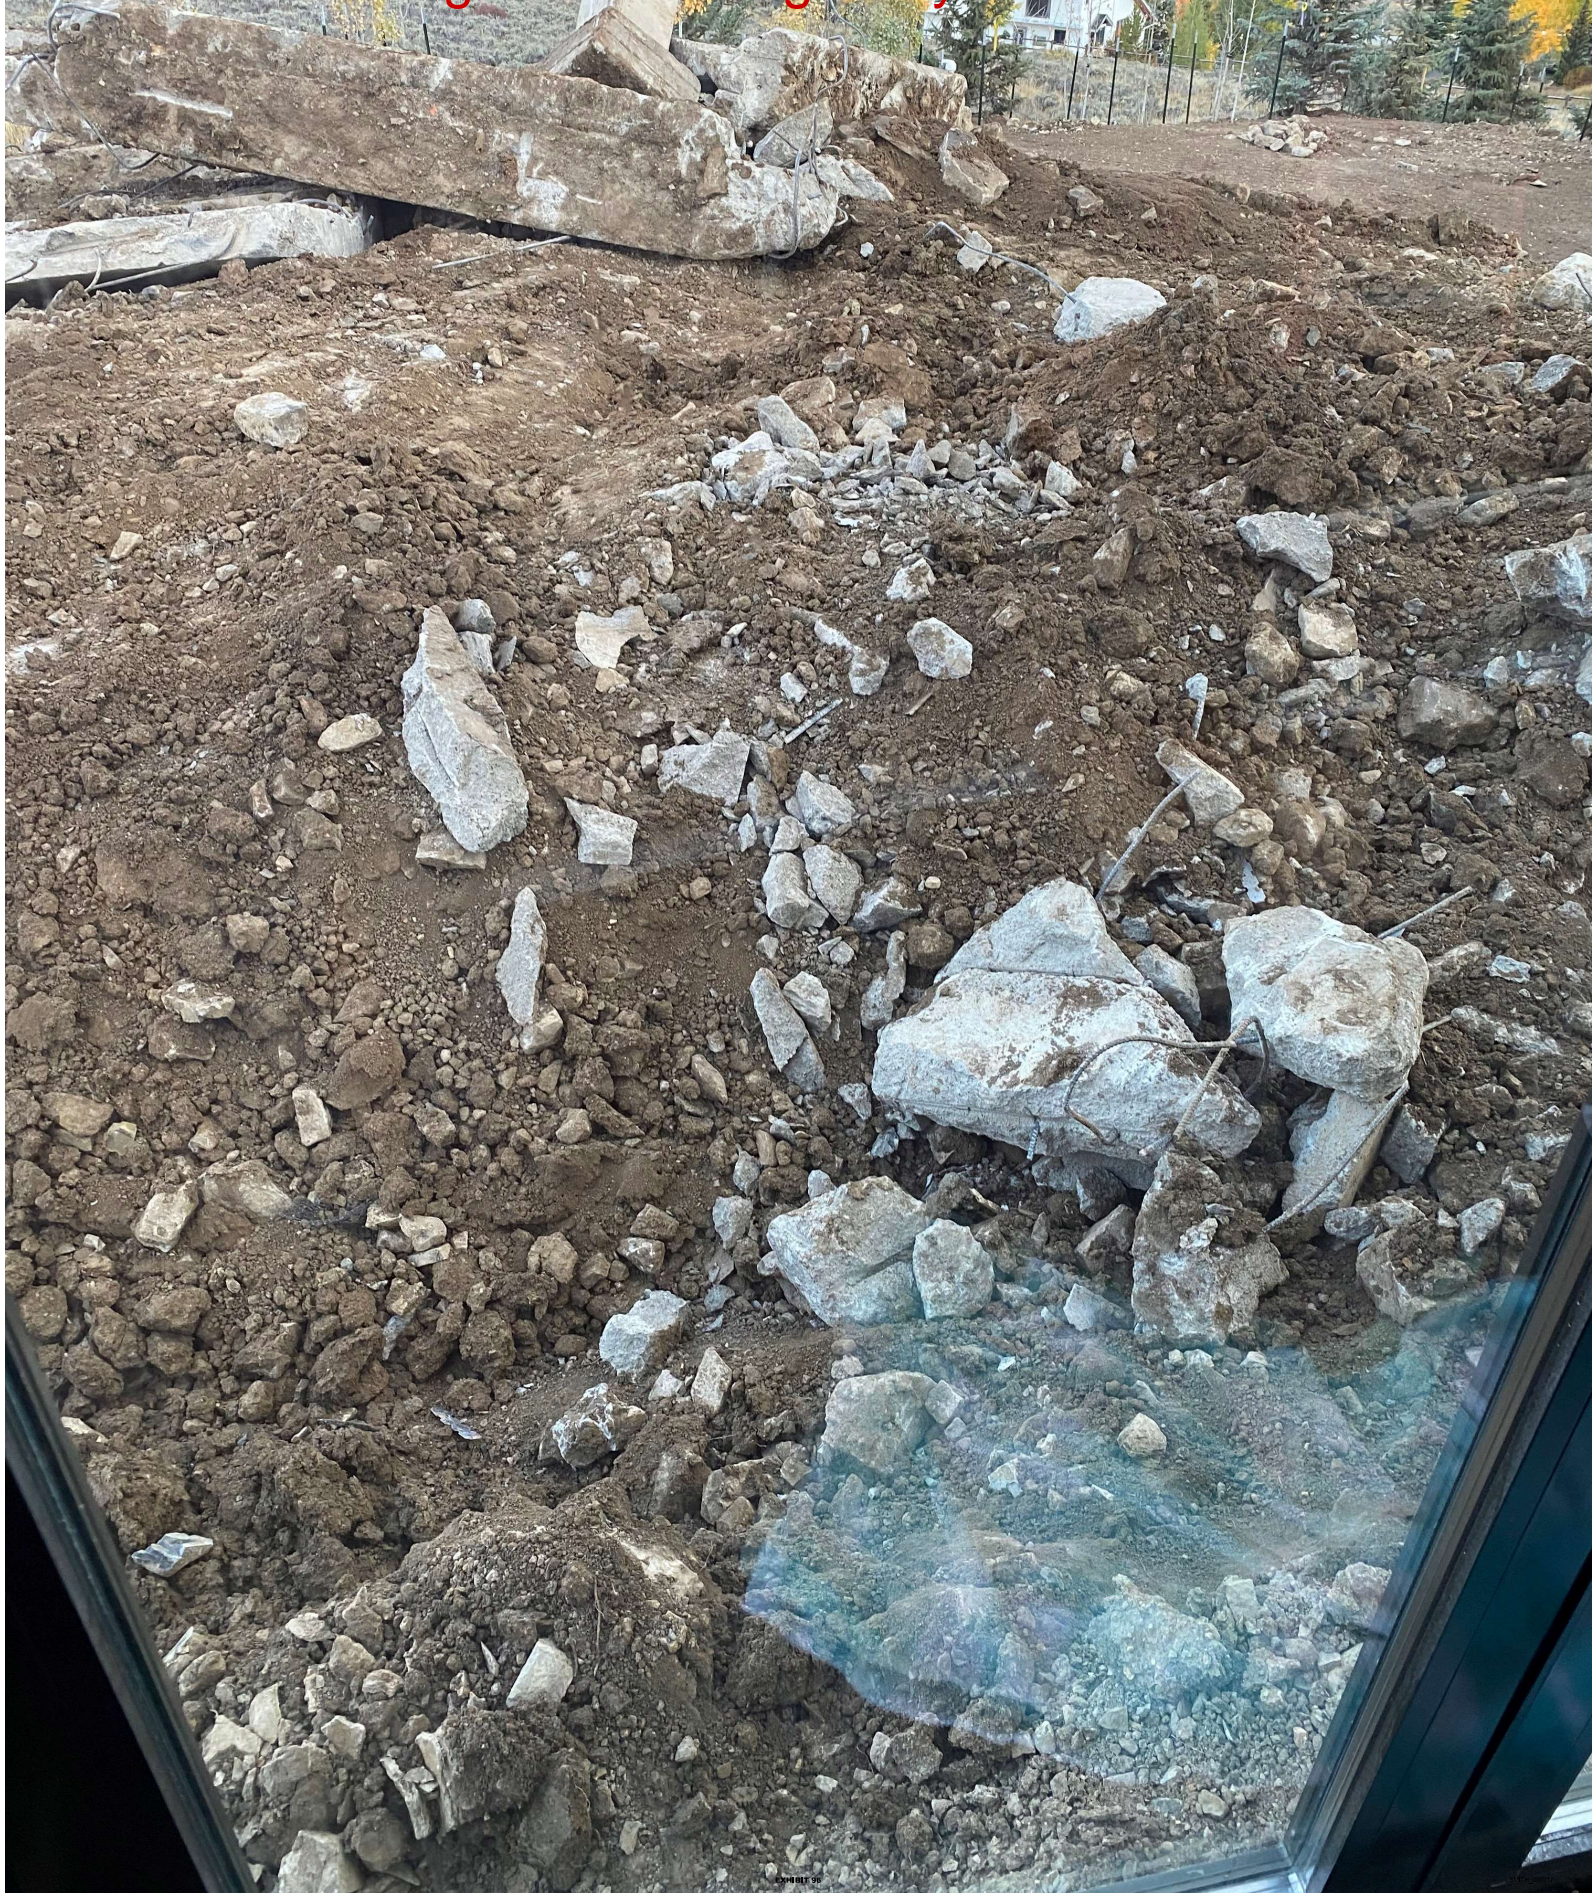
Note the large rocks and native soil in the backfill. This led to poor compaction and every concrete footing for exterior structures sinking and breaking away from the home.

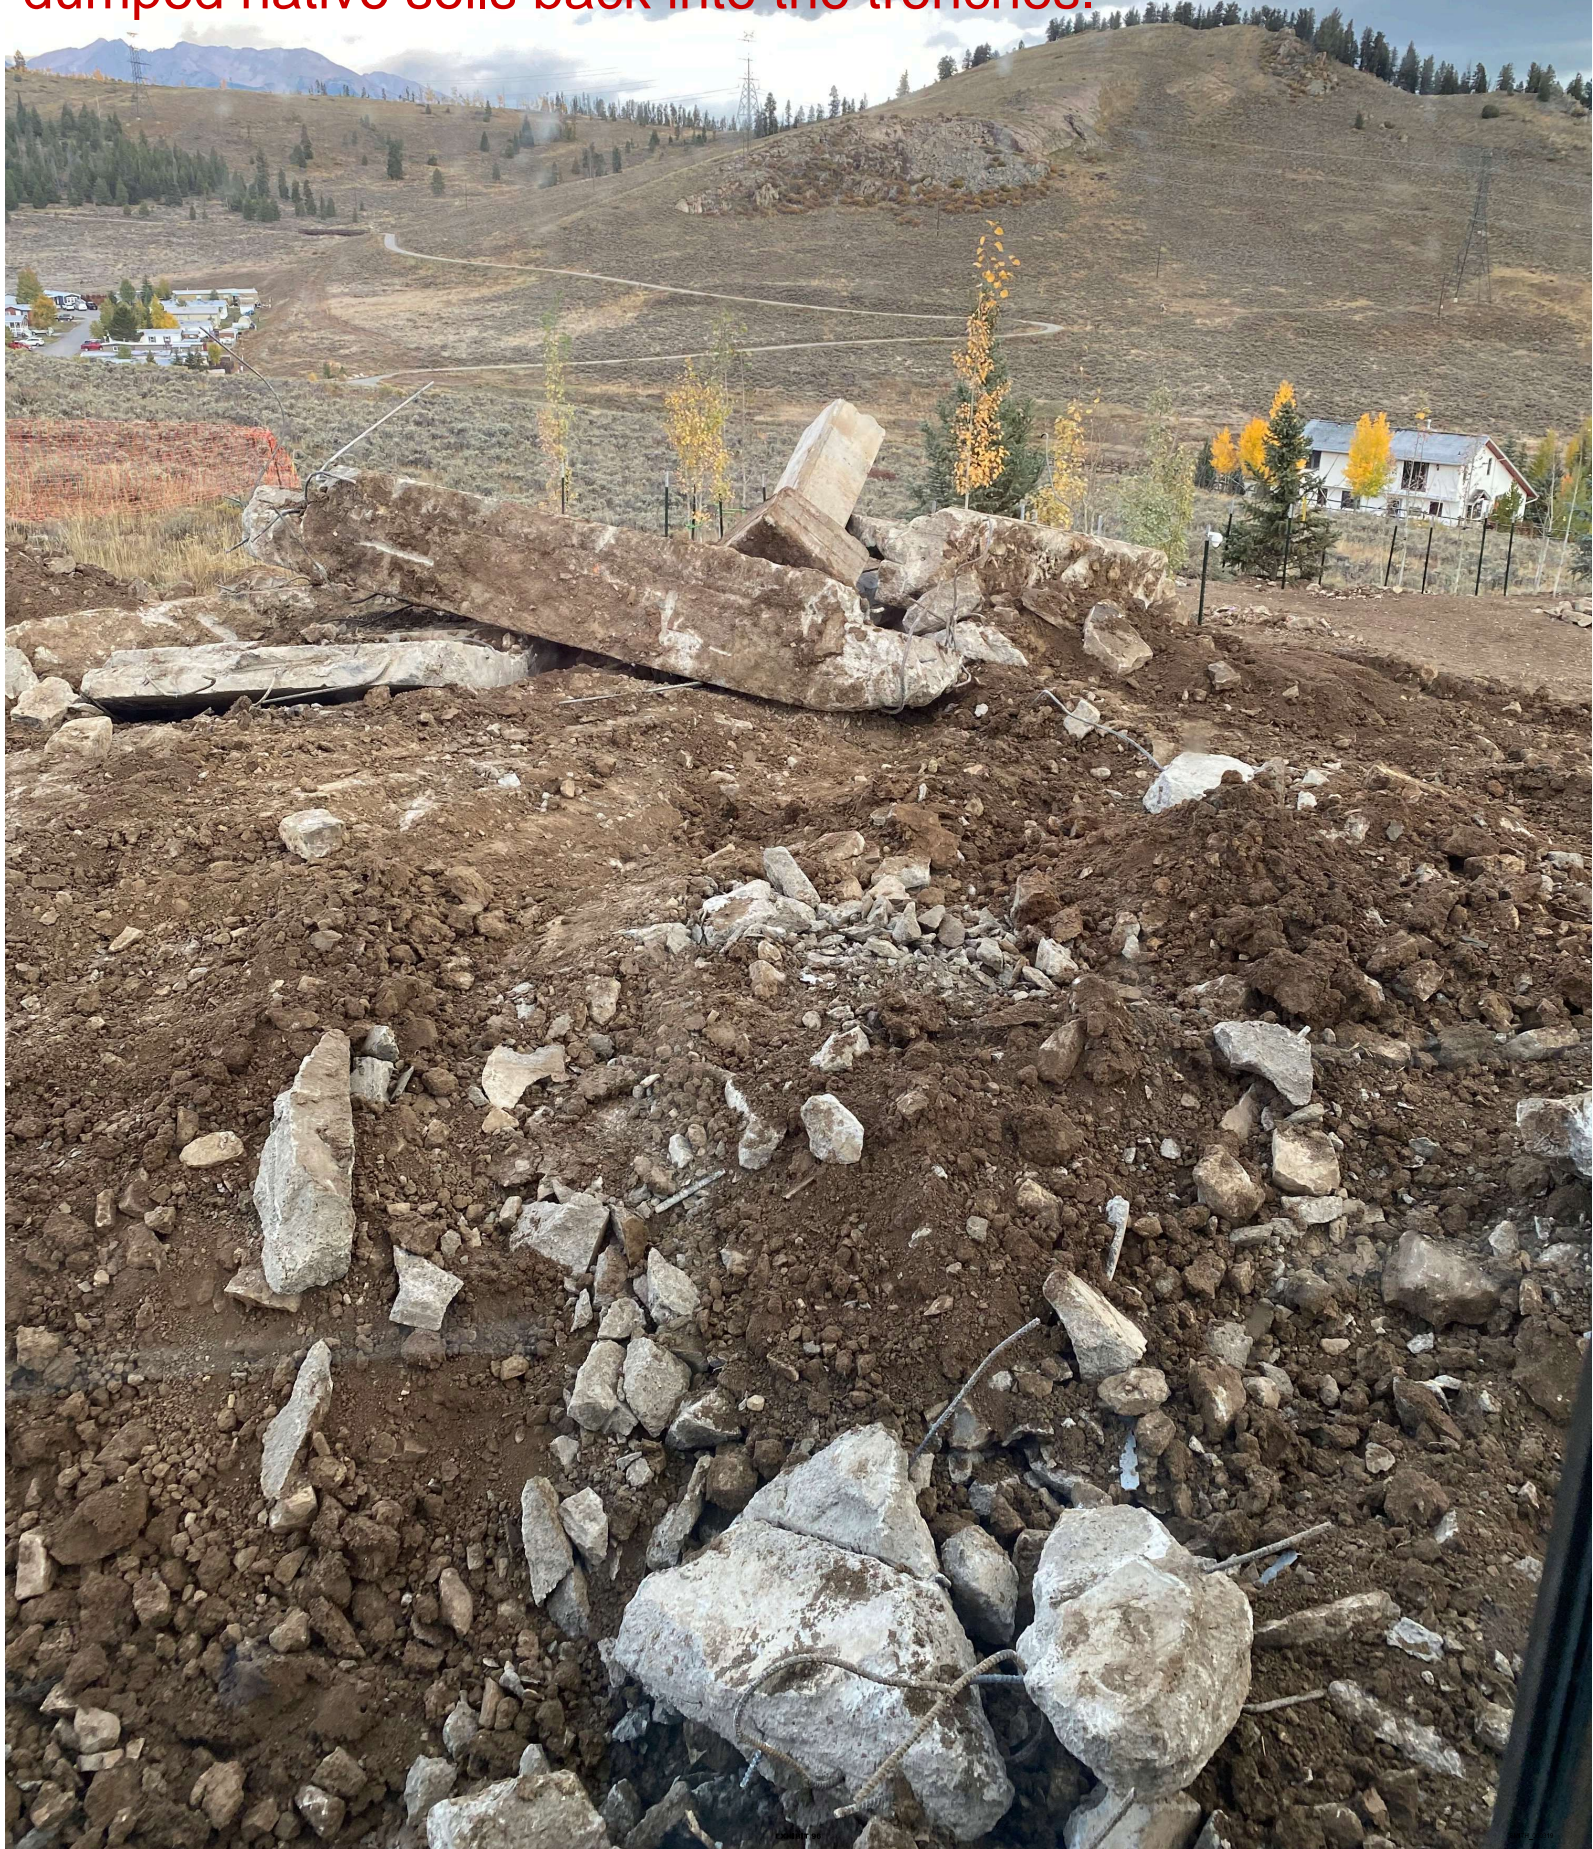
Liscott never had a geotechnical engineer visit the site after the initial soil report was issued. They also didn't follow the guidelines in the report for proper back fill. Liscott simply dumped native soils back into the trenches.
