# Rapid Lesson Sharing

**Event Type:** Missing Rear Stabilizer Engine Link Nut

**Date:** August 2, 2023

**Location:** Prescribed Fire on Private Ranch  
Outside of Clarendon, Texas

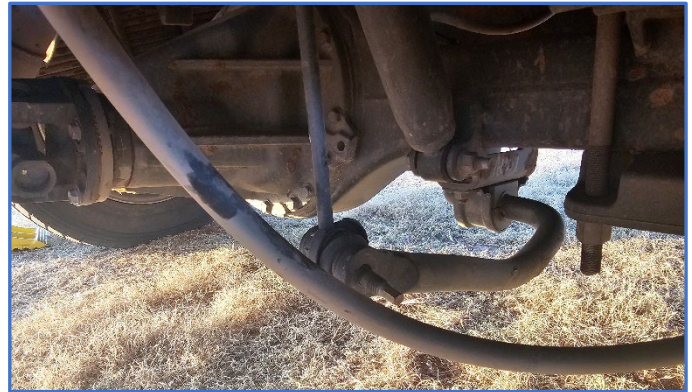
Noah crawled under and found that the nut that normally fastens the stabilizer link to the rear stabilizer bar was missing. Furthermore, the threads on the lower end of the stabilizer link were damaged from the action of the link rubbing on the hole in the stabilizer bar once the nut fell off.

- ❖ A missing nut on the stabilizer link can lead to the stabilizer link and the stabilizer bar separating. This can have a dramatic effect on the way an engine will handle, especially on wash-boarded roads or when tanks are half full of water and water shifts while making sharp or sudden turns.
- ❖ During upfit of a new chassis, upfitters often need to remove and reinstall factory fasteners. One of the affected engines was upfit in 2022 by BFX Fire Apparatus and the other was upfit at the same time in-house. Because we have first-hand knowledge of the upfitting process and know that this fastener *does not* need to be removed in the process (also confirmed by BFX), we concluded that the only time these nuts were torqued was during the original build at the factory.

**Top Photo** – Rear stabilizer link with missing nut and damaged threads.

- ❖ This nut cannot be torqued to proper specifications with a standard torque wrench because the other end of the threaded rod is a ball in a socket, much like a tie rod. Therefore, there is no easy way to check if the nut is properly torqued. One way to check if the nut is beginning to back off is to put a line of RTV silicone sealant from the nut onto the threads. If the nut is loosening, the line of sealant will appear broken. This, however, will not guarantee that it will be noticed in time. It is believed that these two nuts both backed off in a single operational period after driving on wash-boarded roads.

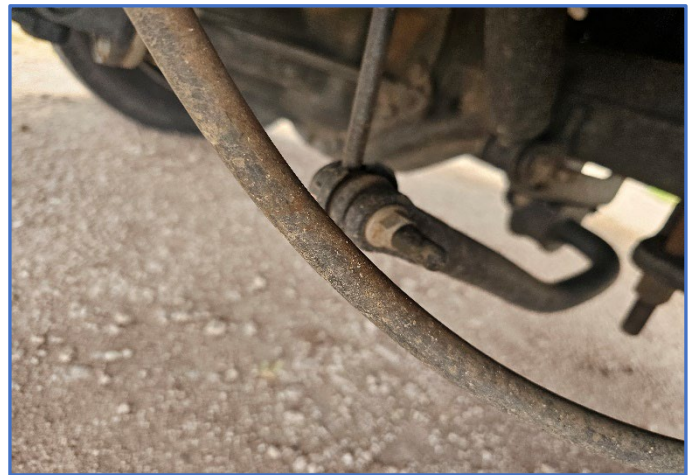
**Middle Photo** – Rear stabilizer link with intact nut.

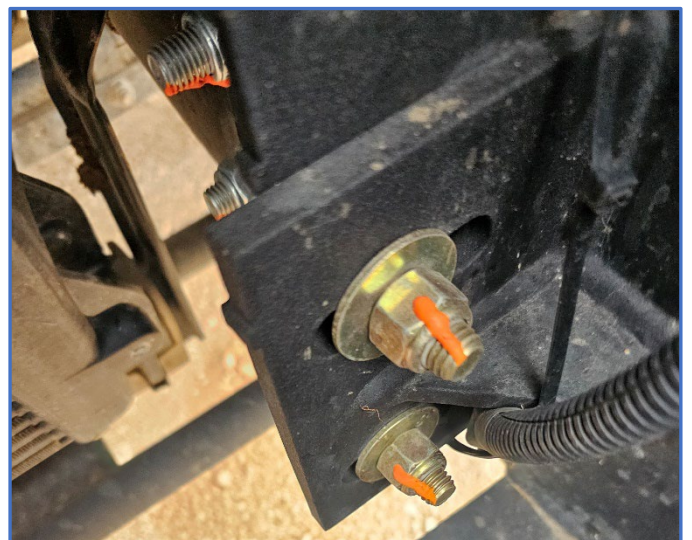
**Bottom Photo** – Beads of RTV silicone sealant that BFX Fire Apparatus places on any nut they install, designed to indicate when a nut is beginning to loosen.
