# PROPERTY INSPECTION REPORT

**Any Street, Any City, 44444**

**Report ID: Example Seller Home Inspection**

**Inspector: John Scaparo**

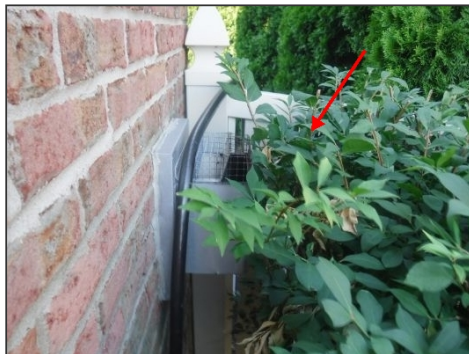
Chimney / Fireplace / Exhaust Venting			
	Page 17 Item: 4	Exhaust Venting (Chimney and Gas Burning Appliances)	4.1. Right side, the landscape vegetation was in contact with the fireplace exhaust vent. Recommend trimming back to help prevent potential of fire.

Trim away bushes from fireplace exhaust vent (Right Side)

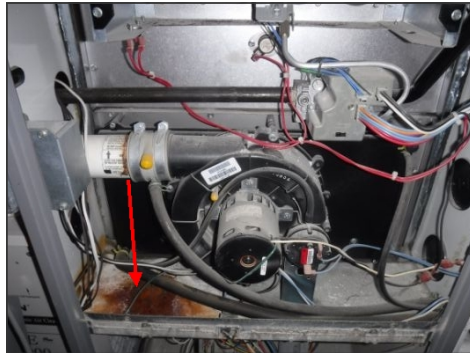
Page 20 Item: 2	Heating System	<p>2.2. Delayed Maintenance, even though the furnace(s) burners responded and provided heat when turned on by the wall thermostat, there was rust in the cabinet directly below the exhaust vent pipe coupler. This is an indication of prior condensation leak at the connection. I do not operate the furnace long enough to confirm if condensation tubes/connectors/clamps leak. Recommend service check-up and cleaning to ensure safe and proper operation. Servicing can also uncover problems not discovered or that are beyond the scope of home inspection standards.</p>
---	-----------------	----------------	---

Example Of Rust In Cabinet / Prior Leak From Exhaust Coupler

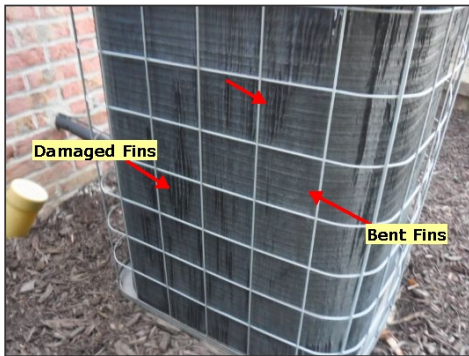
Page 20 Item: 3	Cooling System	<p>3.1. Even though the A/C system responded and provided cooling when turned on by the wall thermostat, the exterior condenser unit fins were damaged and folded over. This will reduce the overall cooling efficiency. Recommend service check-up and cleaning to ensure proper operation. Servicing can also uncover problems not discovered or that are beyond the scope of home inspection standards. Budget for replacement.</p>
---	-----------------	----------------	--

Fins damaged

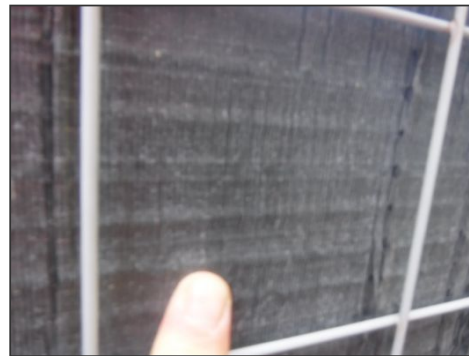
Fins damaged (Close-up)

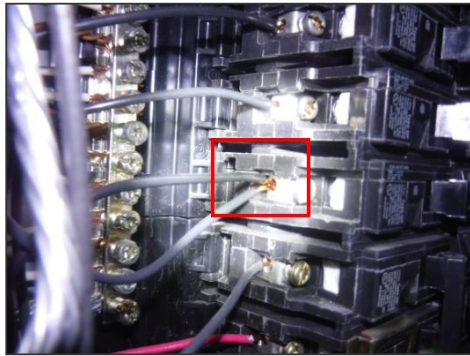
Page 26 Item: 2	Service Panel / Over-Current Protection	<p>2.3. I saw (1) double tapped breaker within the service panel. A double tap is the connection of two wires (circuits) to one circuit breaker. It can add to the load of the circuit causing a possible overload that trips the breakers. Recommend an electrician properly separate the circuits to bring the home up to standards and enhance the safety of the occupants. Service can also uncover problems not discovered or that are beyond the scope of home inspection standards.</p>
---	-----------------	---	--

Example Of Double Tapped Breaker

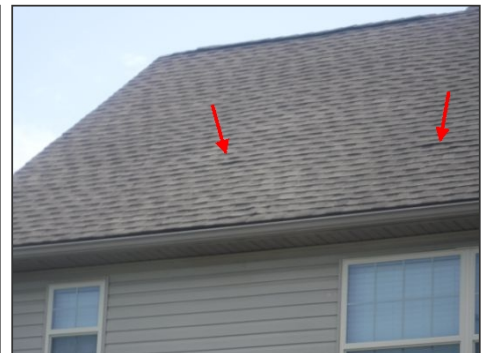
1.1. Age of roof covering estimated at its midpoint of its useful life. I observed a few lifted tabs from nails backing out of the decking (back side). The lifted tabs are potential water entry points and vulnerable to wind damage and wind driven rain. Recommend correction by a qualified and licensed roof contractor evaluate and provide estimate of repair.

Location of lifted singles

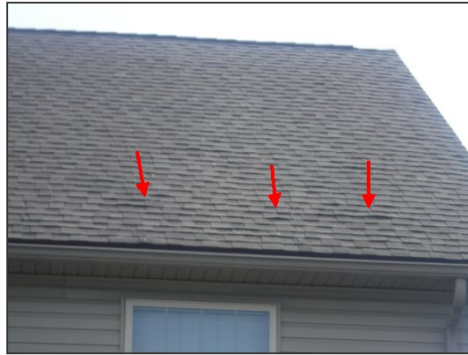
Location of lifted singles

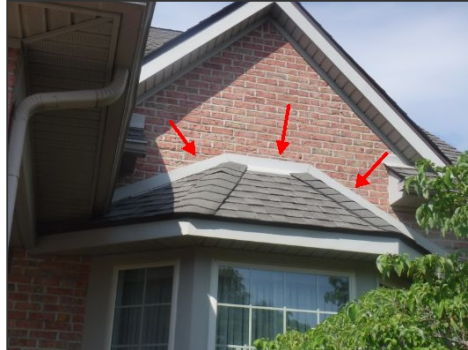
2.1. The exposed roof flashings were in good condition at the time of the inspection. The exterior flashing above the front and back bay/chase window(s) is vulnerable and prone to leak. I did not see any stains or measure any elevated moisture to the interior area above the window today. Recommend annual maintenance of the flashing to help maintain a weather tight seal and to prevent the potential of leak.

Example Of Vulnerable Roof Location

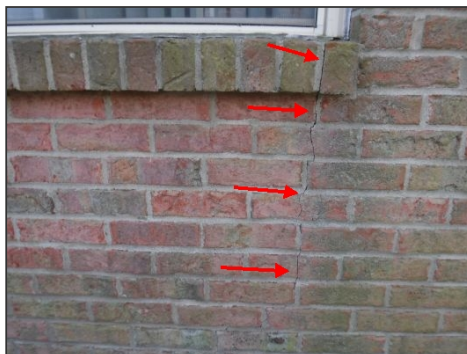
- 4.1. Right side, I observed minor cracks in the mortar joint and bricks under the window. This is an indication of settlement. I did not see any structural concerns but cracks need to be fill/seal to help prevent further damage from freeze thaw cycle and to maintain a weather tight structure.

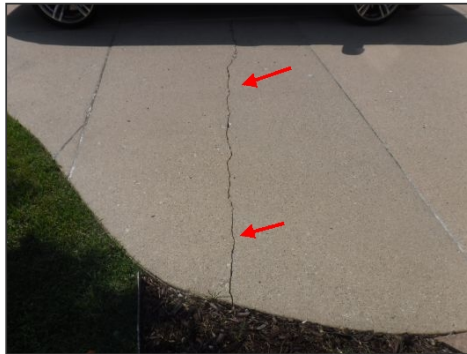
6.1. Delayed Maintenance: the driveway had (2) cracked slabs. There was no heaving/displacement that were a trip hazard today. Fill crack(s) with exterior concrete filler to help prevent further damage from hydraulic separation during freeze/thaw cycle. Budget for slab replacement.

Example Of Driveway Crack, No Trip Hazard

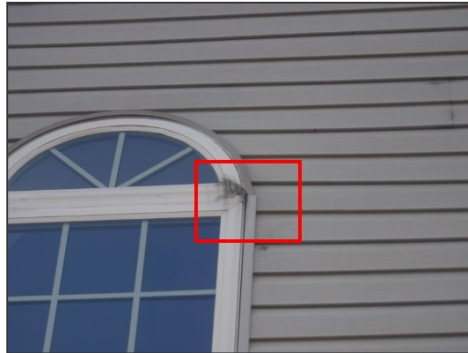
10.1. Delayed Maintenance: there was caulking missing / deteriorated (shrinking, dried, cracked) noted at one or more locations (doors / windows and wall / siding penetrations). The caulk may no longer provides water tight weather seal. Recommend removing deteriorated caulk before application and replacing using a high quality exterior silicone based caulk to create a water tight seal to help prevent water intrusion and insect entry into the interior structure. This includes opening and gaps between the porch platform and structure and the exterior wall around plumbing, A/C Lines, service conductors / receptacles, exterior light fixtures, vents, doors, windows and siding. All exterior caulking should be annually examined and re-caulked as needed. Caution as to NOT seal/caulk the "weep holes" located at the bottom sill of many newer type of windows that allow moisture to escape if condensation does accumulate.

Age caulking

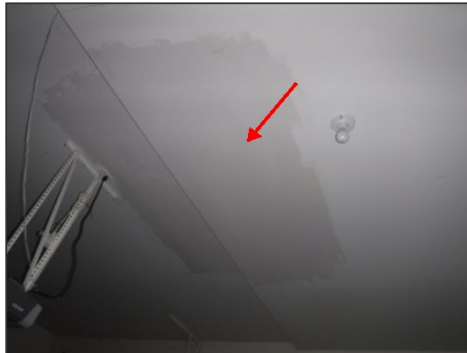
5.1. Ceiling and Walls throughout the garage are in good condition with no significant defects noted. Some cosmetic and typical flaws in finish noted (ceiling patch/repair area). When garages are beneath habitable rooms it is imperative to maintain well sealed walls and ceilings where the attached garage join the interior of a house. This reduces the potential of toxic automobile gases and path for fire to enter the house. Openings should be sealed for your protection.

Patched/repair ceiling area

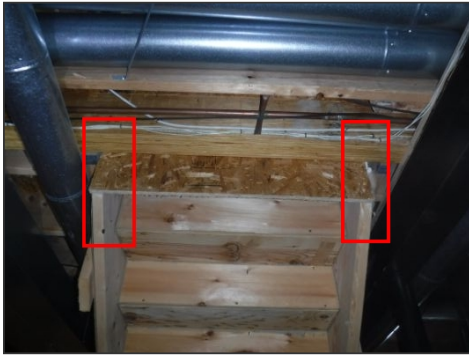
5.1. The stairway/step stringer straps were missing. Straps should be installed when the stringers are not attached directly to the ledge board to properly secure the stairway to the structure. Recommend installing stringer straps to bring the home up to standards and enhance the safety of the occupants.

Example Of Missing Stringer Straps

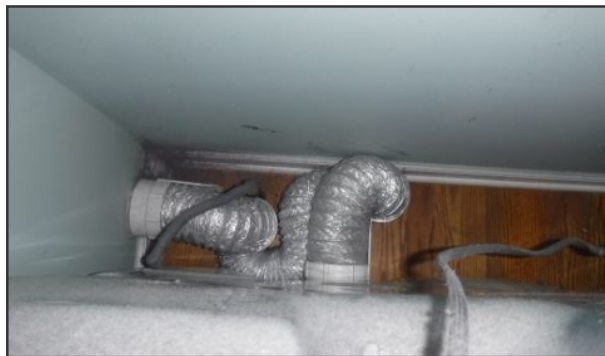
2.1. Gas shut-off valve was present in same room and within 6 feet of the appliance.  
2.2. The dryer vent was a foil type and kinked and/or crushed where it exits the back of the dryer. Recommend installing a ridged compact style exhaust duct or type approved by the manufacture to help prevent accumulation of lint or vent blockage which can cause the dryer to overheat; a potential fire hazard and a condition which will shorten the dryer's lifespan.

Example Of Foil Dryer Duct

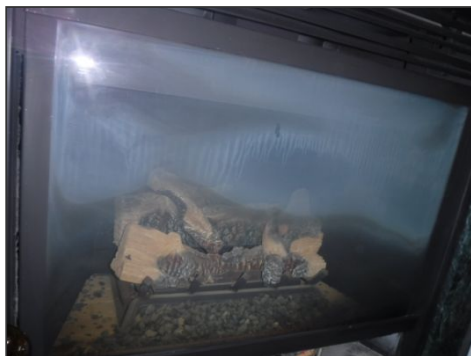
- 3.1. Delayed Maintenance, the direct vent gas fireplace glass front had a hazy film. This is typically a mineral residue left from water vapor as the gas burns and or an indication the gas burners need to be serviced. Recommend service to ensure safe operation. Servicing can also uncover problems not discovered or that are beyond the scope of home inspection standards.

Example Of Soot On Glass

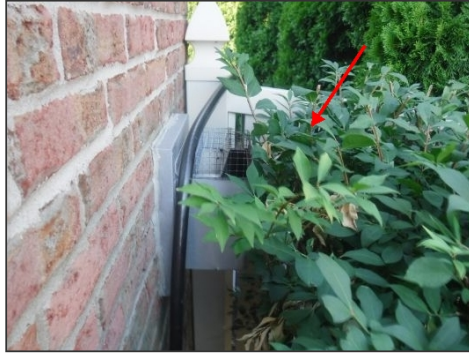
- 4.1. Right side, the landscape vegetation was in contact with the fireplace exhaust vent. Recommend trimming back to help prevent potential of fire.

Trim away bushes from fireplace exhaust vent (Right Side)

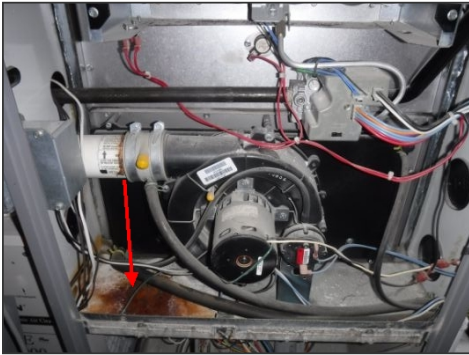
2.2. Delayed Maintenance, even though the furnace(s) burners responded and provided heat when turned on by the wall thermostat, there was rust in the cabinet directly below the exhaust vent pipe coupler. This is an indication of prior condensation leak at the connection. I do not operate the furnace long enough to confirm if condensation tubes/connectors/clamps leak. Recommend service check-up and cleaning to ensure safe and proper operation. Servicing can also uncover problems not discovered or that are beyond the scope of home inspection standards.

Example Of Rust In Cabinet / Prior Leak From Exhaust Coupler

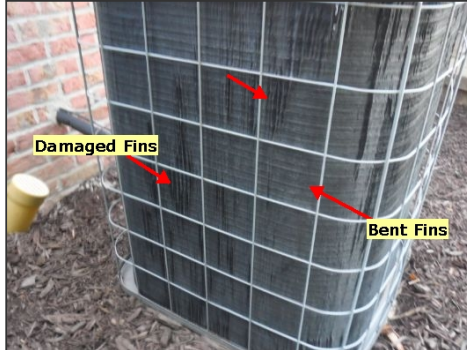
3.1. Even though the A/C system responded and provided cooling when turned on by the wall thermostat, the exterior condenser unit fins were damaged and folded over. This will reduce the overall cooling efficiency. Recommend service check-up and cleaning to ensure proper operation. Servicing can also uncover problems not discovered or that are beyond the scope of home inspection standards. Budget for replacement.

Fins damaged

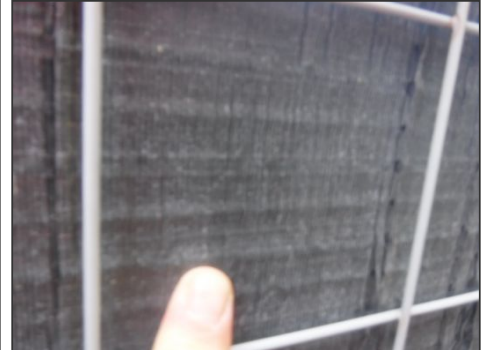
Fins damaged (Close-up)

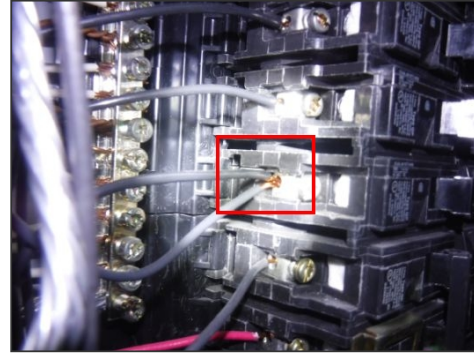
2.3. I saw (1) double tapped breaker within the service panel. A double tap is the connection of two wires (circuits) to one circuit breaker. It can add to the load of the circuit causing a possible overload that trips the breakers. Recommend an electrician properly separate the circuits to bring the home up to standards and enhance the safety of the occupants. Service can also uncover problems not discovered or that are beyond the scope of home inspection standards.

Example Of Double Tapped Breaker

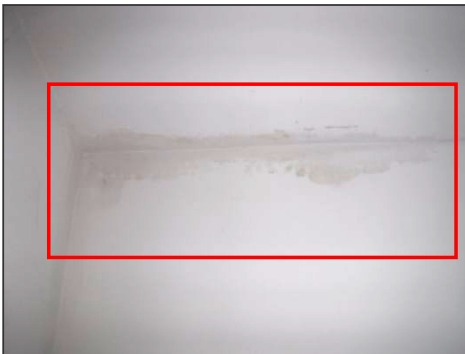
2.1. Main floor, I did not observe any ceiling/wall moisture stains or ceiling patching directly below the second floor bath room areas.  
2.2. Dried ceiling stains were observed in the den and master bathroom ceiling above shower. There was no elevated levels of moisture measured at the stained locations. The stain(s) may be due to past roof leaks. Recommend asking the seller about the stains and monitoring the stained area(s) in the future, especially after heavy or prolonged rain. If elevated moisture is found in the future, a qualified contractor should evaluate and repair as necessary.

Den Ceiling Stain (Dried stain)

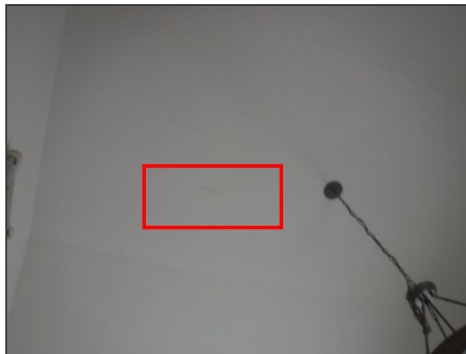
Den Location of Ceiling Stain (Dried stain)

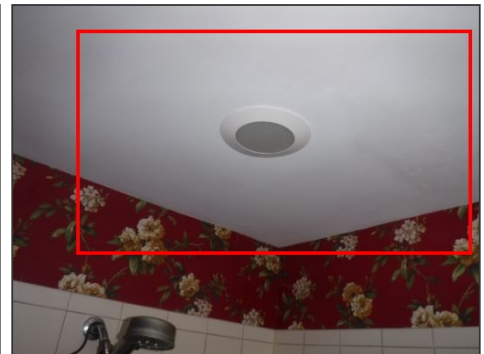
Master bathroom show ceiling (Patched area)

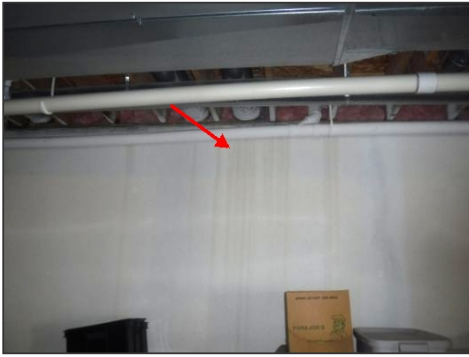
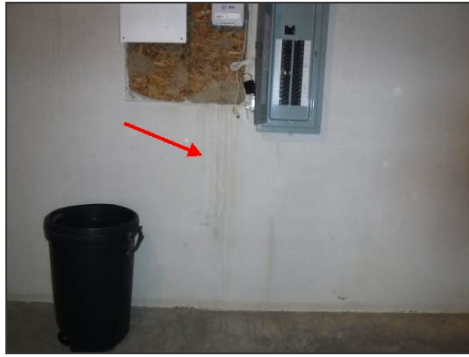
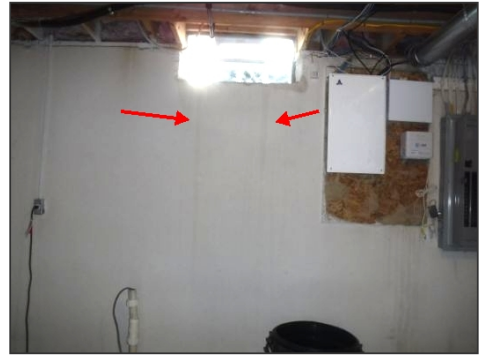
4.1. Dried moisture stains were observed on the foundation wall in (3) locations. There was no active leaks or elevated moisture levels measured today. Recommend asking seller history of water stains and prior leaks. Monitor areas for leaks, if leaks should occur I recommend correction by a qualified basement waterproof contractor.

Dried moisture stains
