- #49 - Leaks along head of CW and Steel - Holes / Gaps Between the Steel, Cladding and CW - missing Insulations . Weatherproof Details Issues - ( ) . Remedial Works required Along Grid B and Curve Area. to Check if 1hr Marine Ply installed and all weatherproof as per own details

Leaks | Peter Mazur | Leaks  
Plan: Plan Ground | Location: Lev 1  
Tags: #lev\_1\_cw\_canopy, #site\_inspection\_16.03.23, #zefyr  
Created 03-17-2023

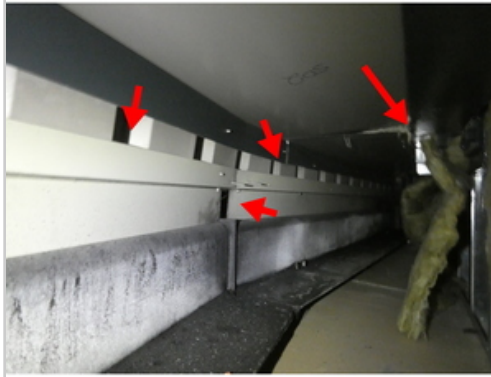
6

Daylight between Steel and Zefyr Flashings

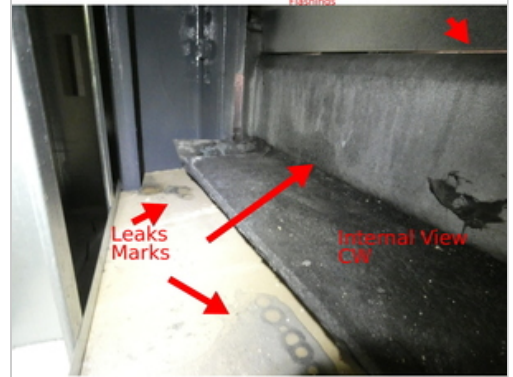
7

Water Marks

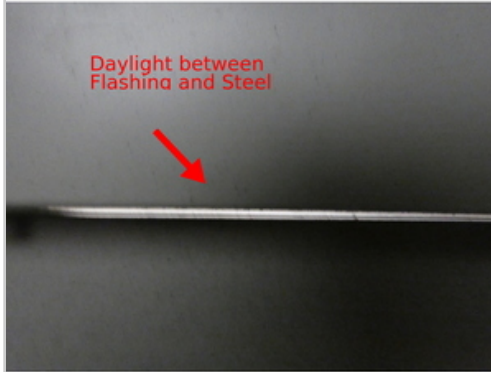
9

External View

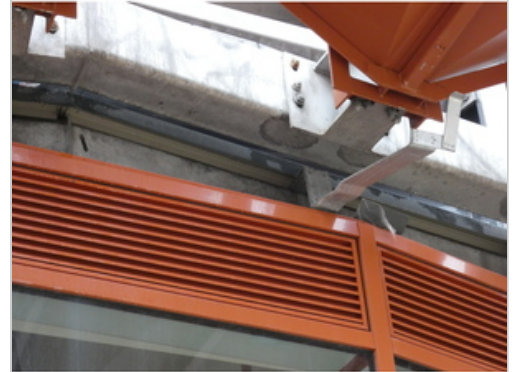
10

Externall View

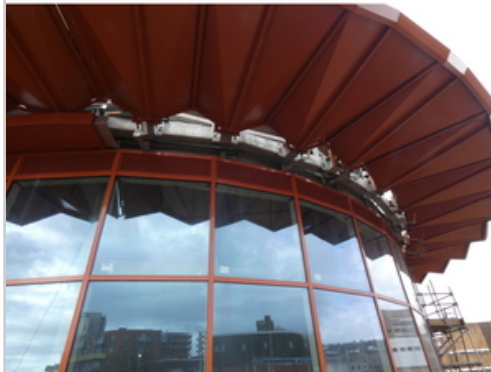
12

External View
