## Leaks Report -Level 0 and 1 East

Site Inspection 16.03.23  
Rainy Condition  
Prepare by P. Mazur

### Leaks Observation Report

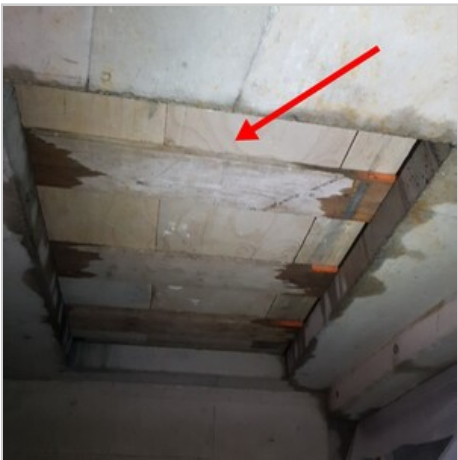
MISSING HATCH/PANEL

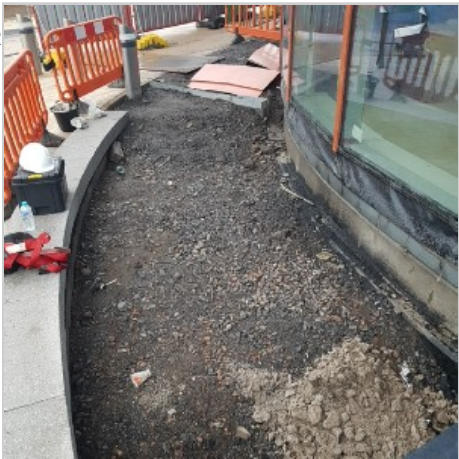
TOP VIEW - UPSTAND TO  
BE INSPECT AND UNCOVER

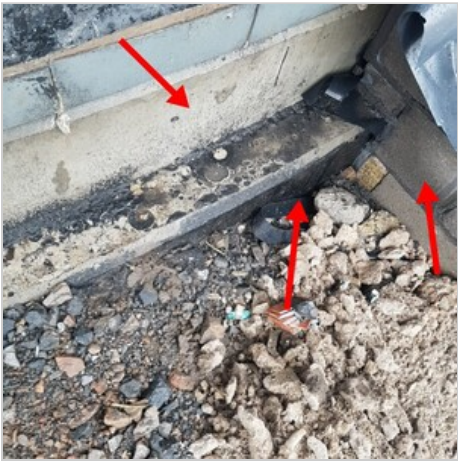
MISSING WEATHERPROOF  
MEMBRANE AND BOARDS

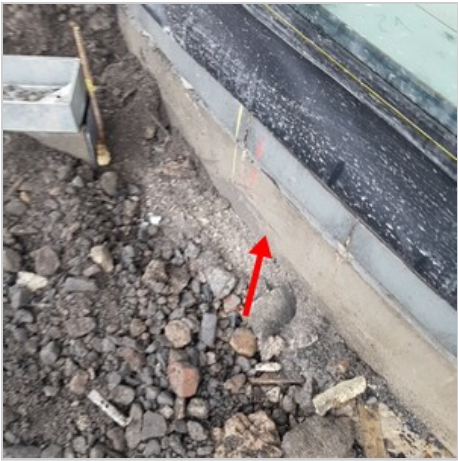
MISSING WEATHERPROOF  
MEMBRANE AND THE  
BOARDS

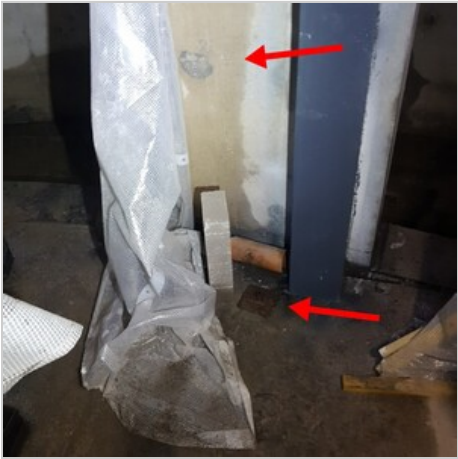
WET CONCRETE

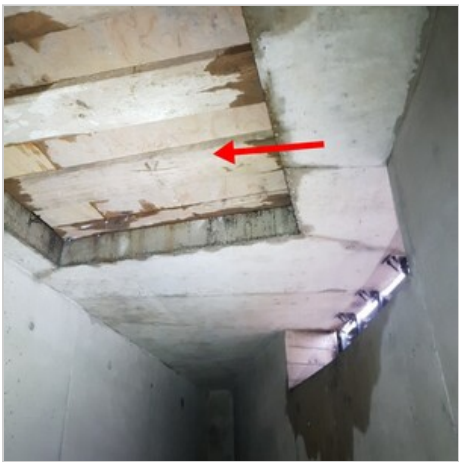
MISSING HATCH/PANEL

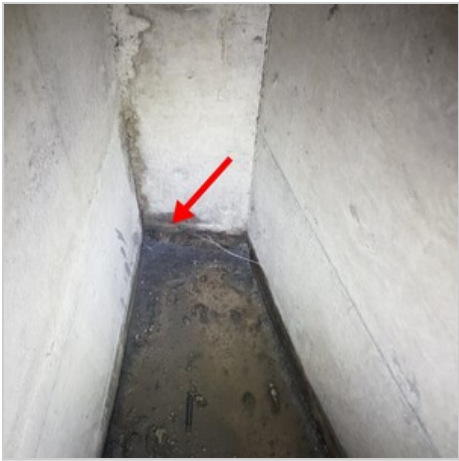
WET CONCRETE

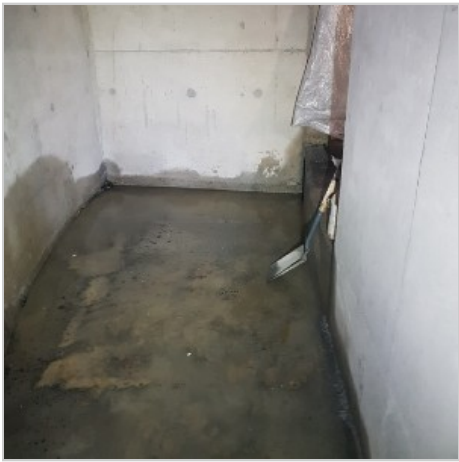
WET CONCRETE

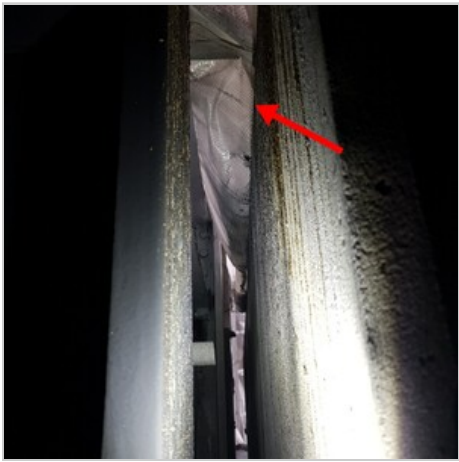
OUTSTANDING WORKS

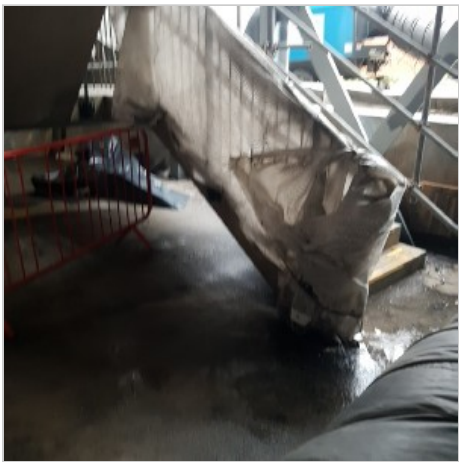
OUTSTANDING WORKS

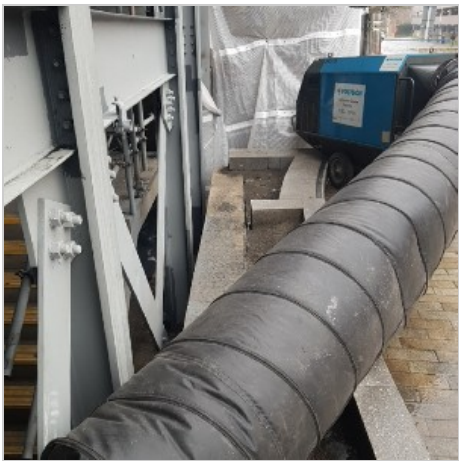
CLADDING TO INSTALL

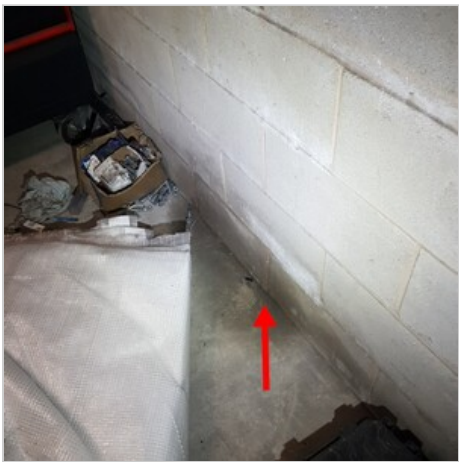
WET BLOCKWORK

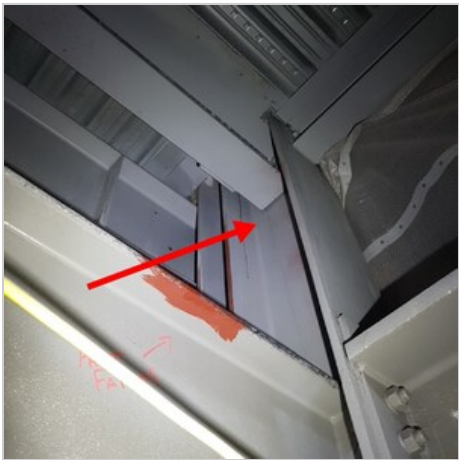
WET STEEL

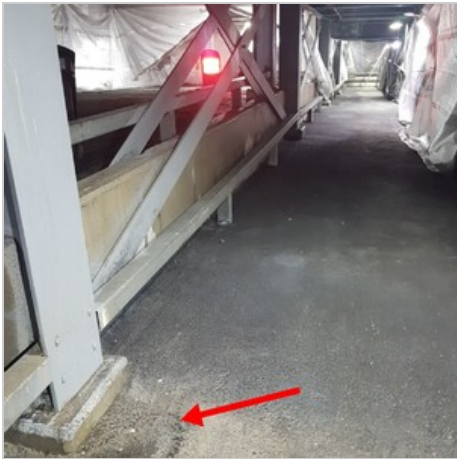
WET CONCRETE

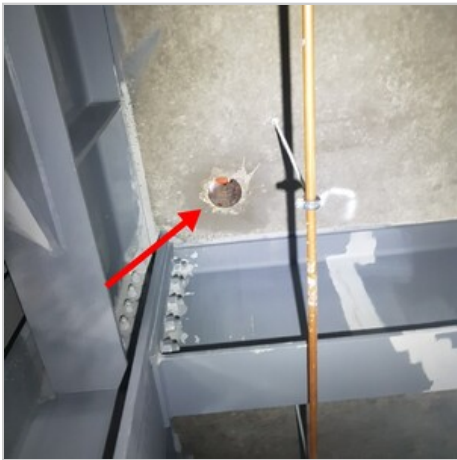
MISSING OUTLET

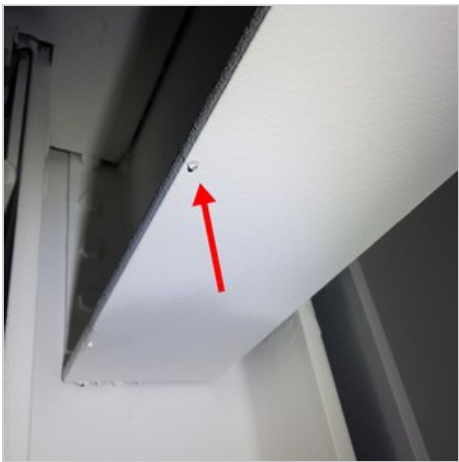
WATER ON THE STEEL

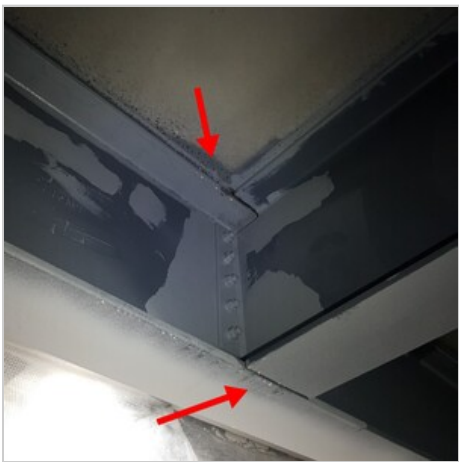
WET STEEL

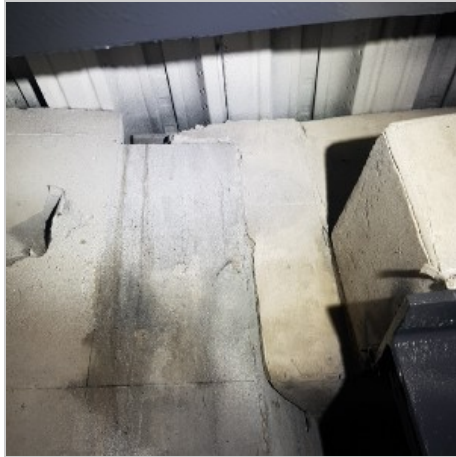
WET CONCRETE

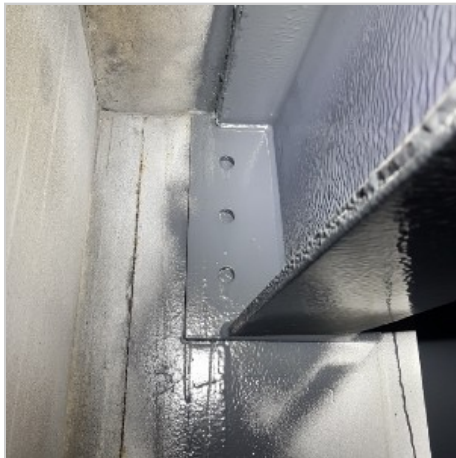
MISSING BOLTS

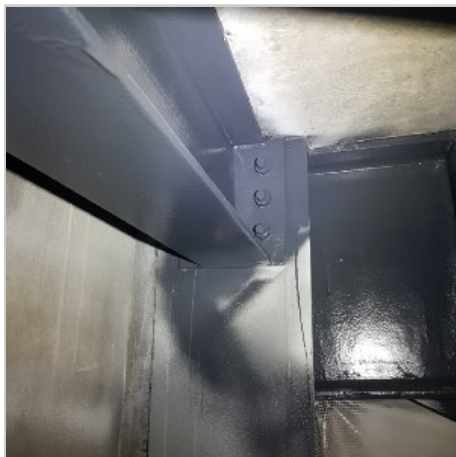
BOLTS INSTALLED

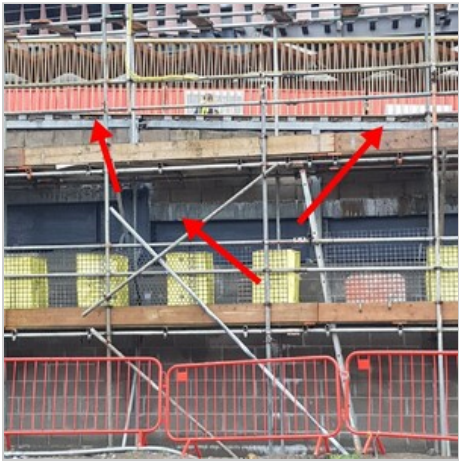
TO BE COMPLETE AS PER  
DETAILS

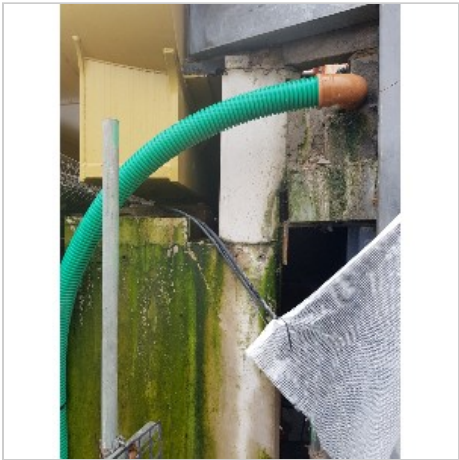
● **#43 - Corner Closures not completed and Water/Air penetrate along cavity. Not as per details. Missing Membrane/Weatherproof, EPDM, Flashings. Need to be remediate ASAP.**

CORNER NOT COMPLETE  
OUTLETS NOT COMPLETE

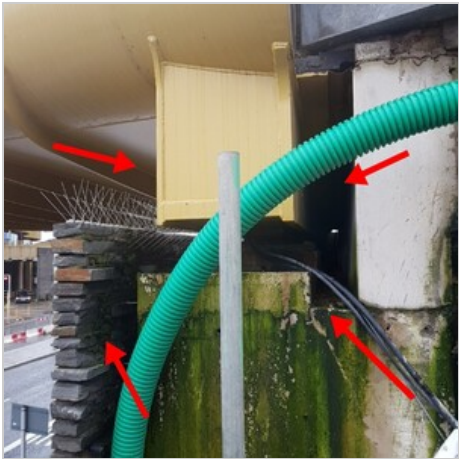
MISSING FLASHING'S  
WEATHERPROOF NOT AS  
PER DETAILS , EPDM NOT  
INSTALLED

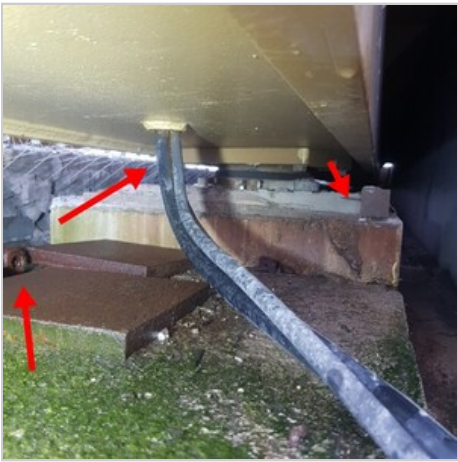
POWER CABLE EXPOSED  
MATERIALS LOOSE FREE  
TO REMOVE

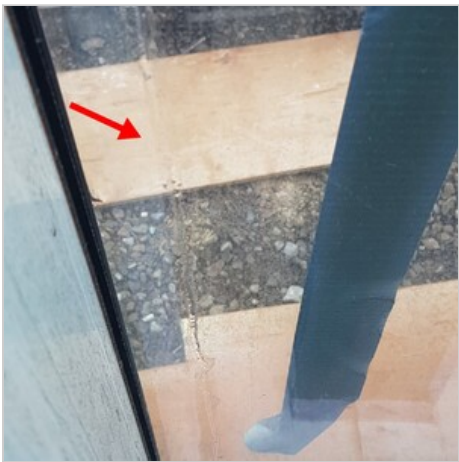
WATER ON THE GLASS

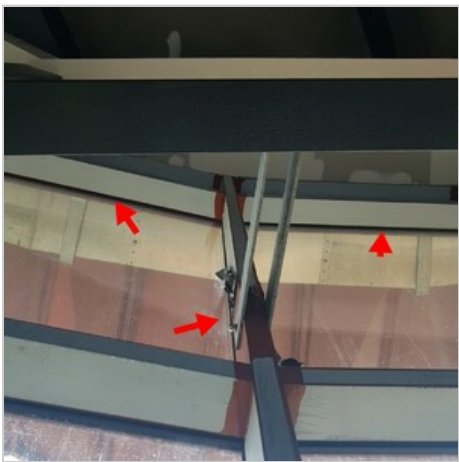
WATER DRIP THROUGH THE TRANSOM PLATES AND GASKET

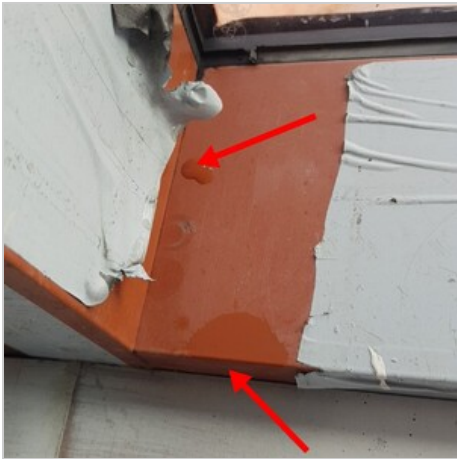
CW WET

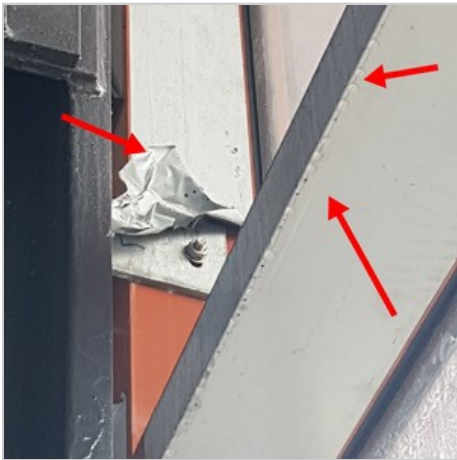
WATER STAINED ON CW

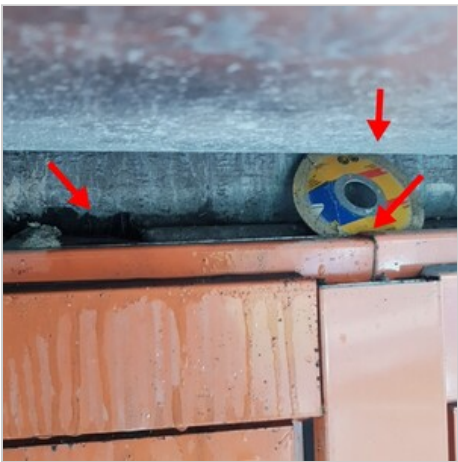
EPDM VISSIBLE ADHESIVE  
OTHERS LEFT CUTTING DIS  
EPDM RIOSK OF DAMAGE

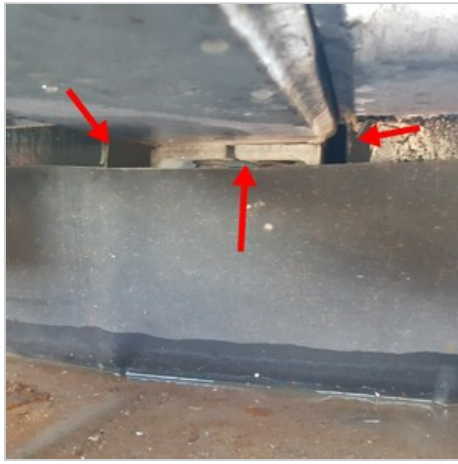
NO WEATHERPROOFING  
AND DRIP FLASHINGS

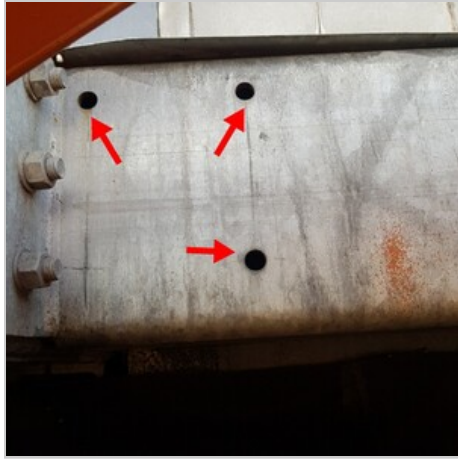
PWATER / AIR PENETRATE  
THROUGH THE  
UNWANTED HOLES

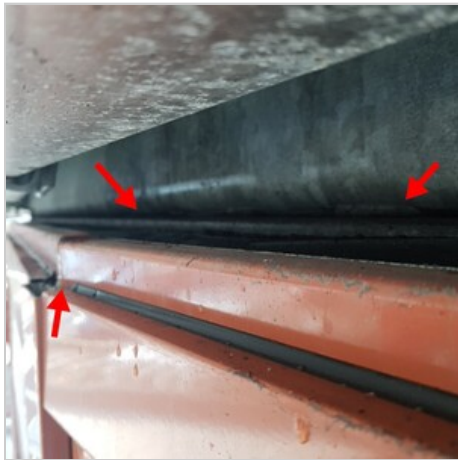
MISSING GASKET - EPDM  
SHOULD BE STICK IN TO  
FACE STEEL  
NOT UNDER  
POOR DETAILS

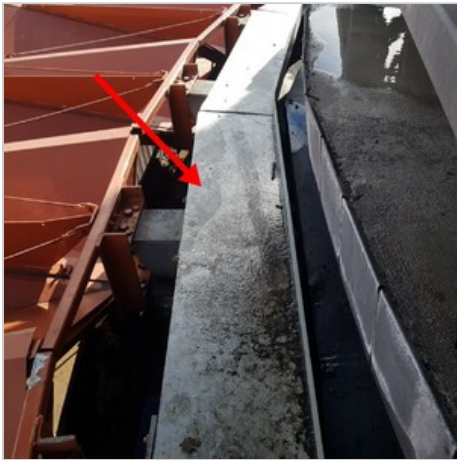
SAME AS PICT ABOVE  
WRONG MATERIALS  
NO JOINT SLEEVES

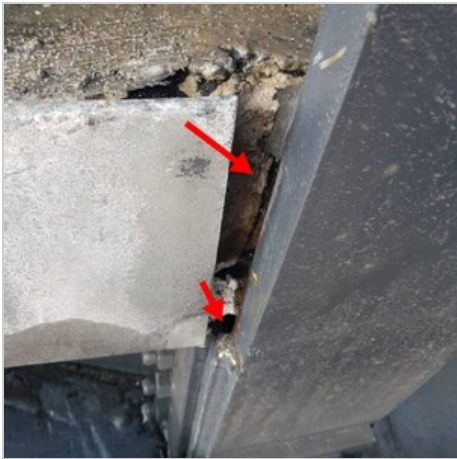
WATER LEAK IN TO THE  
COLUMNS

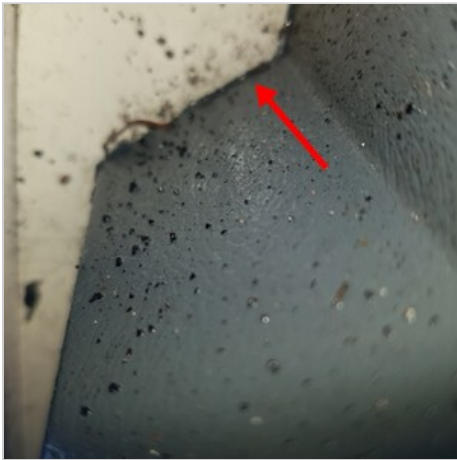
WEAK SPOT UNDER THE  
CLADDING

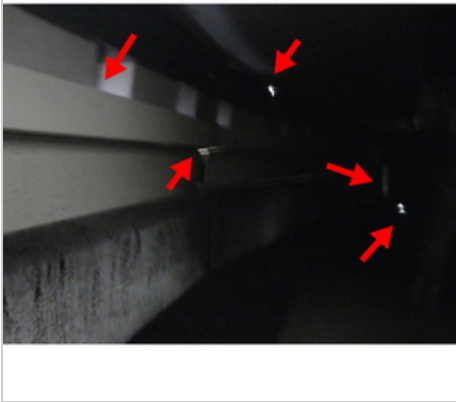
VISIBLE DAYLIGHTS  
NO WATERPROOFING

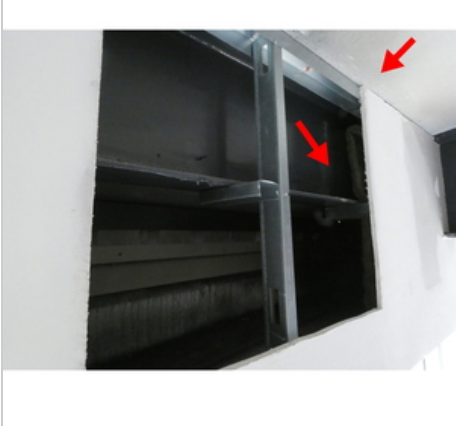
MISSING INSULATION
