Swansea MSCP

Drain Inspection – Link Bridge West End

Prepared by P.Mazur – BGCL

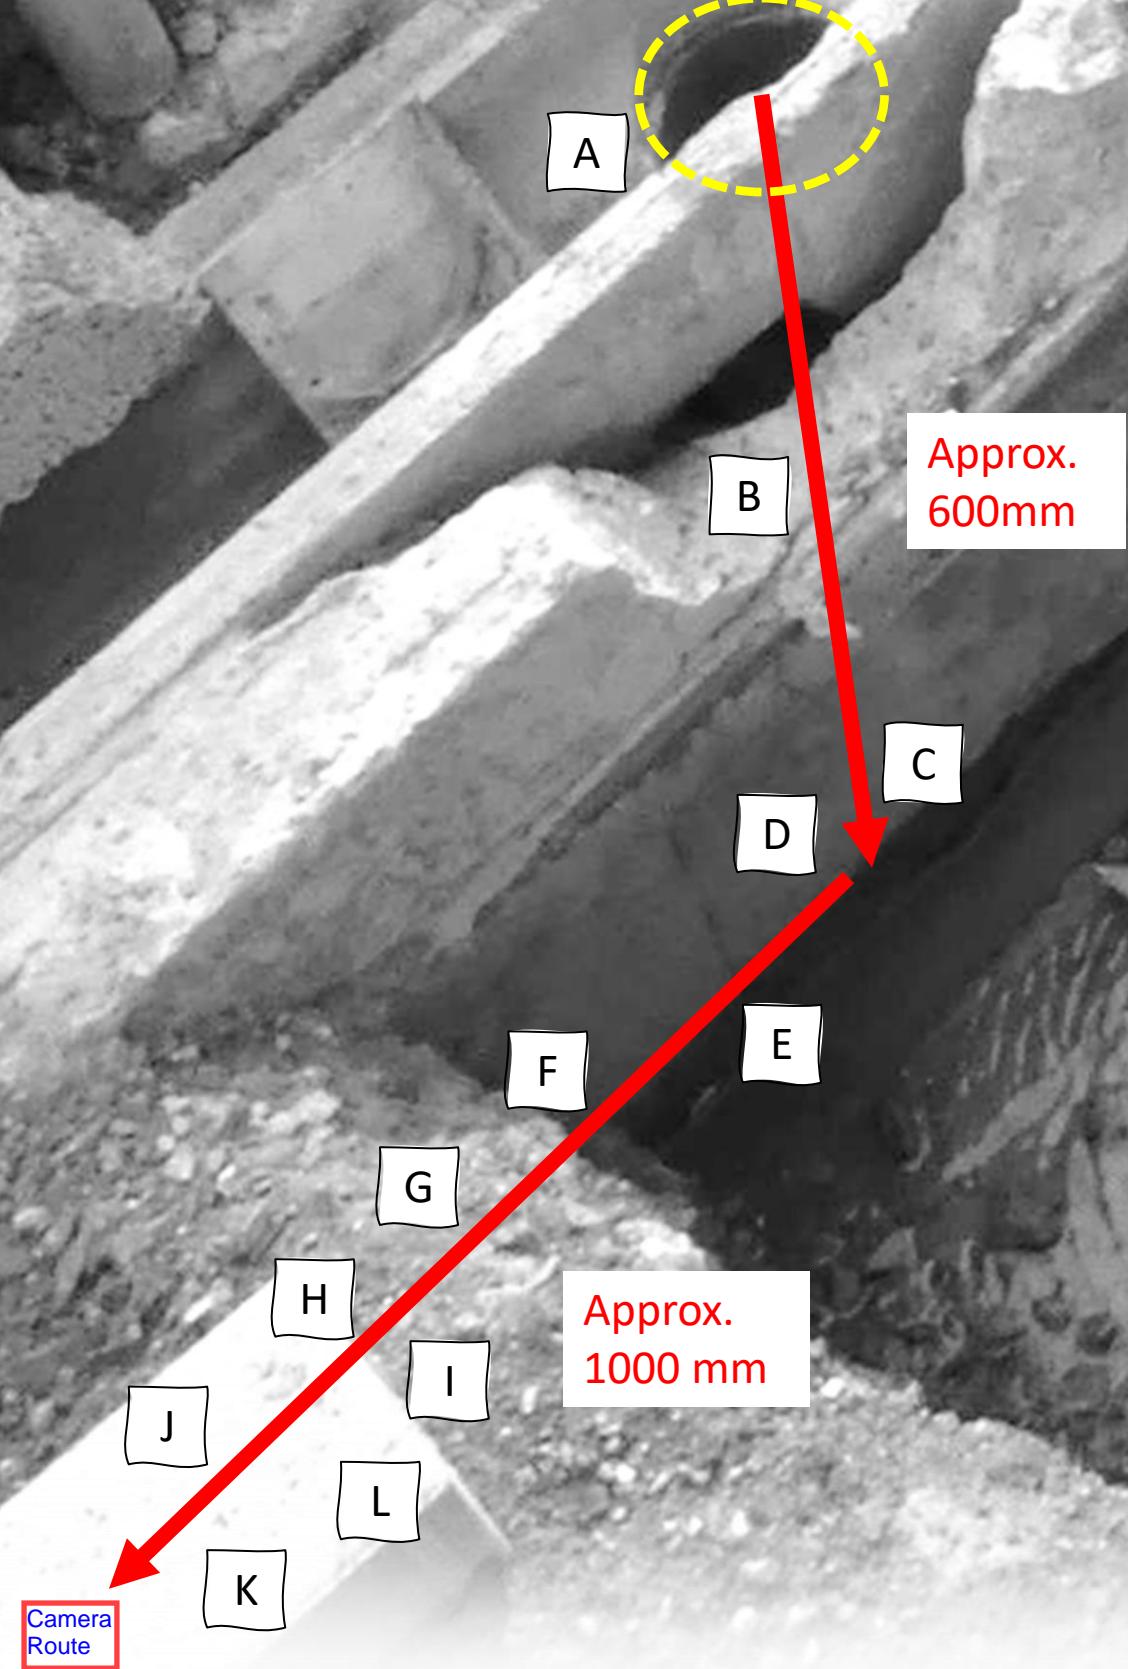
B 110 mm PVC Drain Pipe

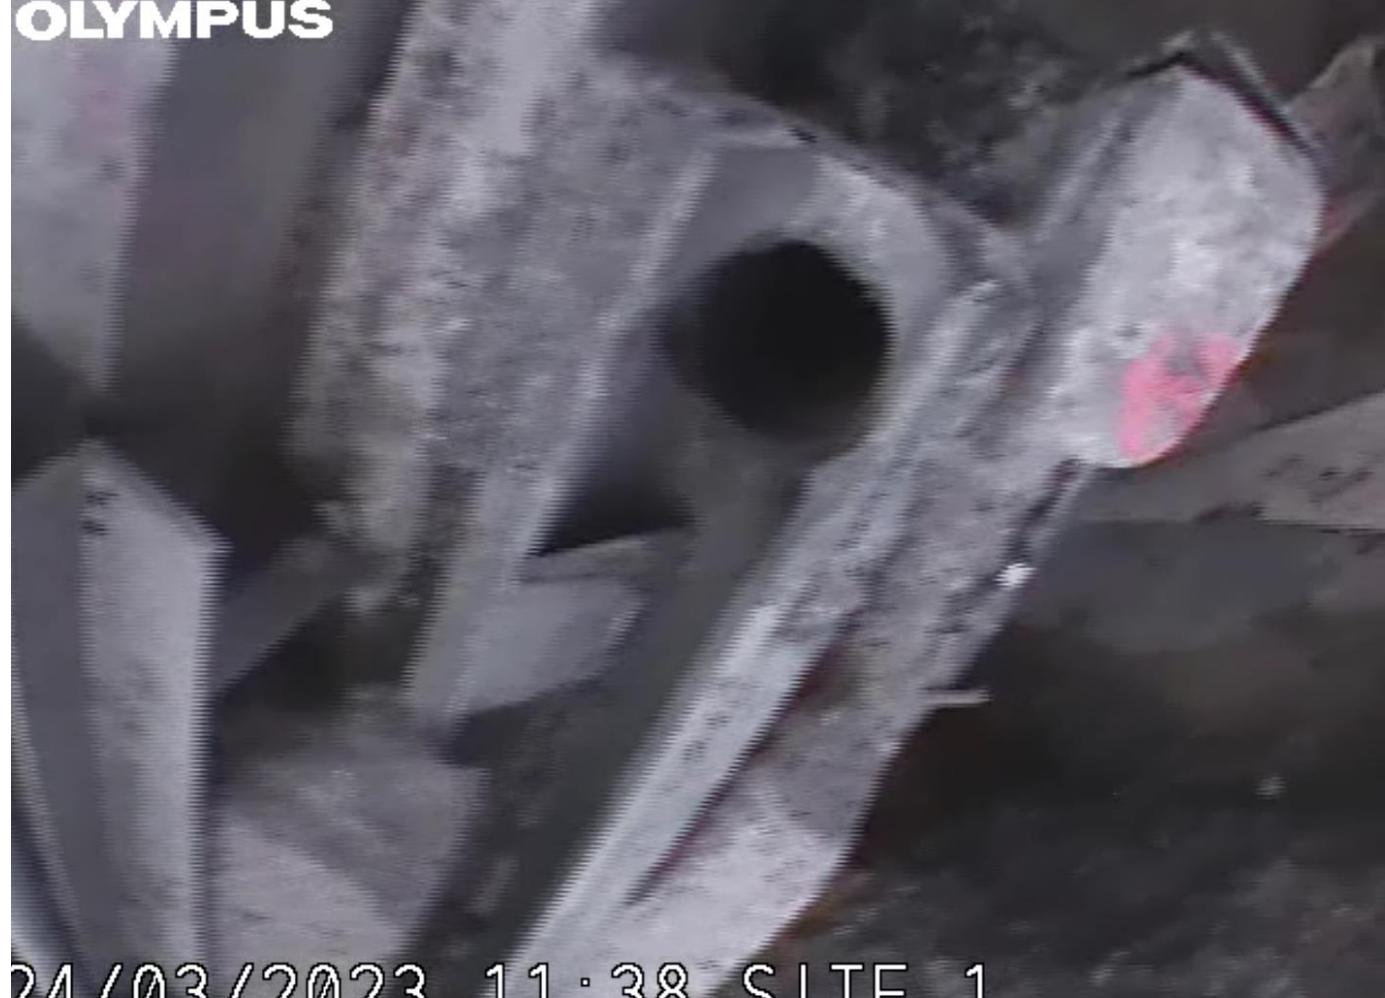
C Gaps- possibility of water ingress

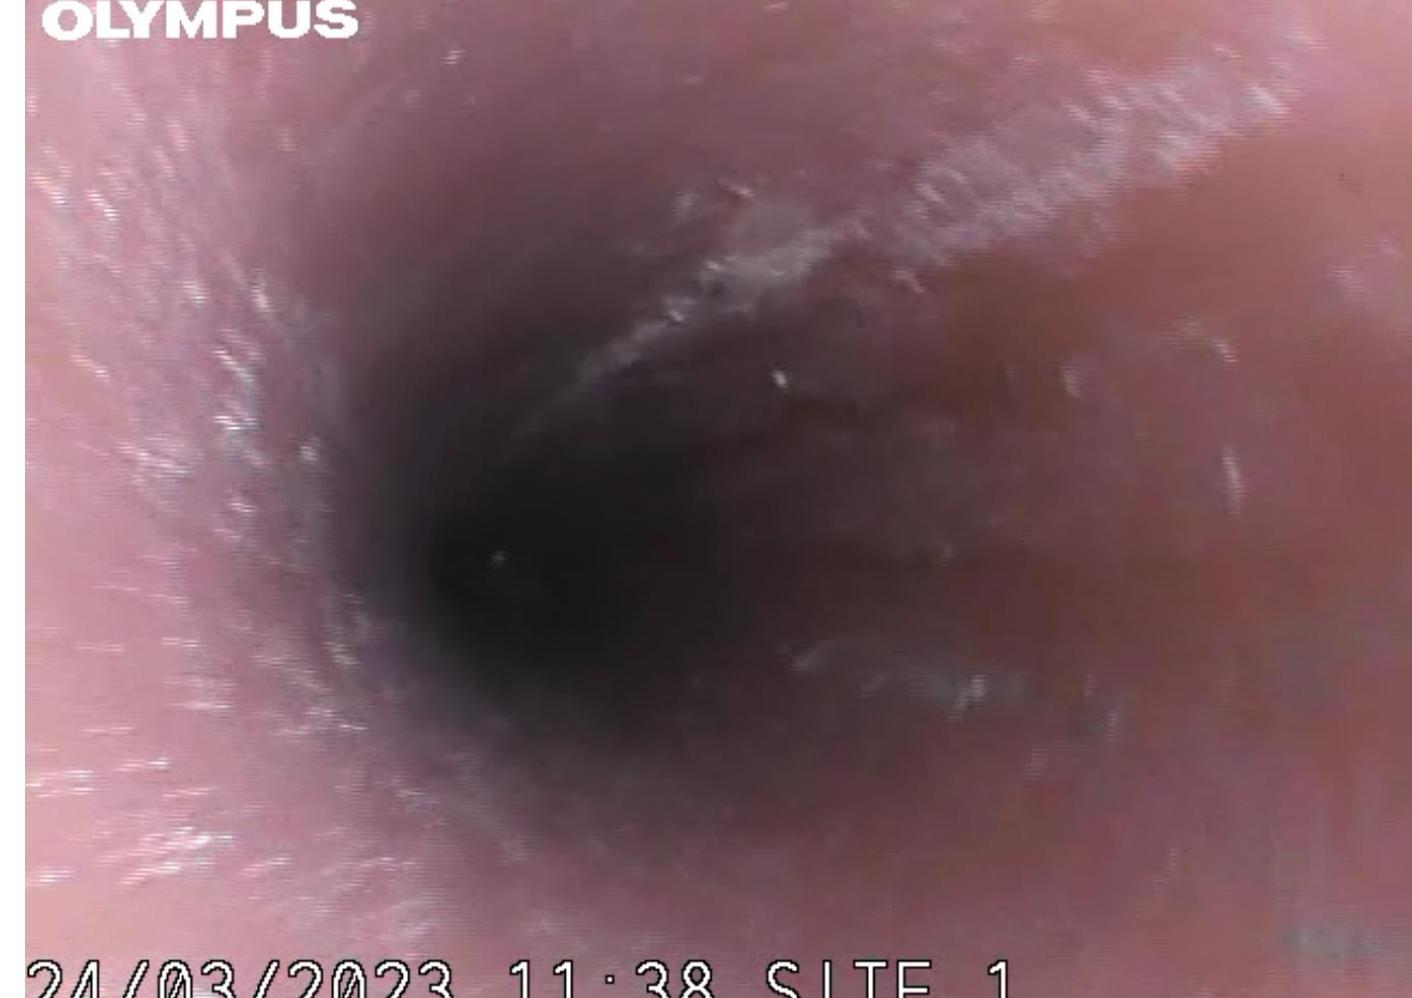
D Unknown type of materials and dirt's/concrete

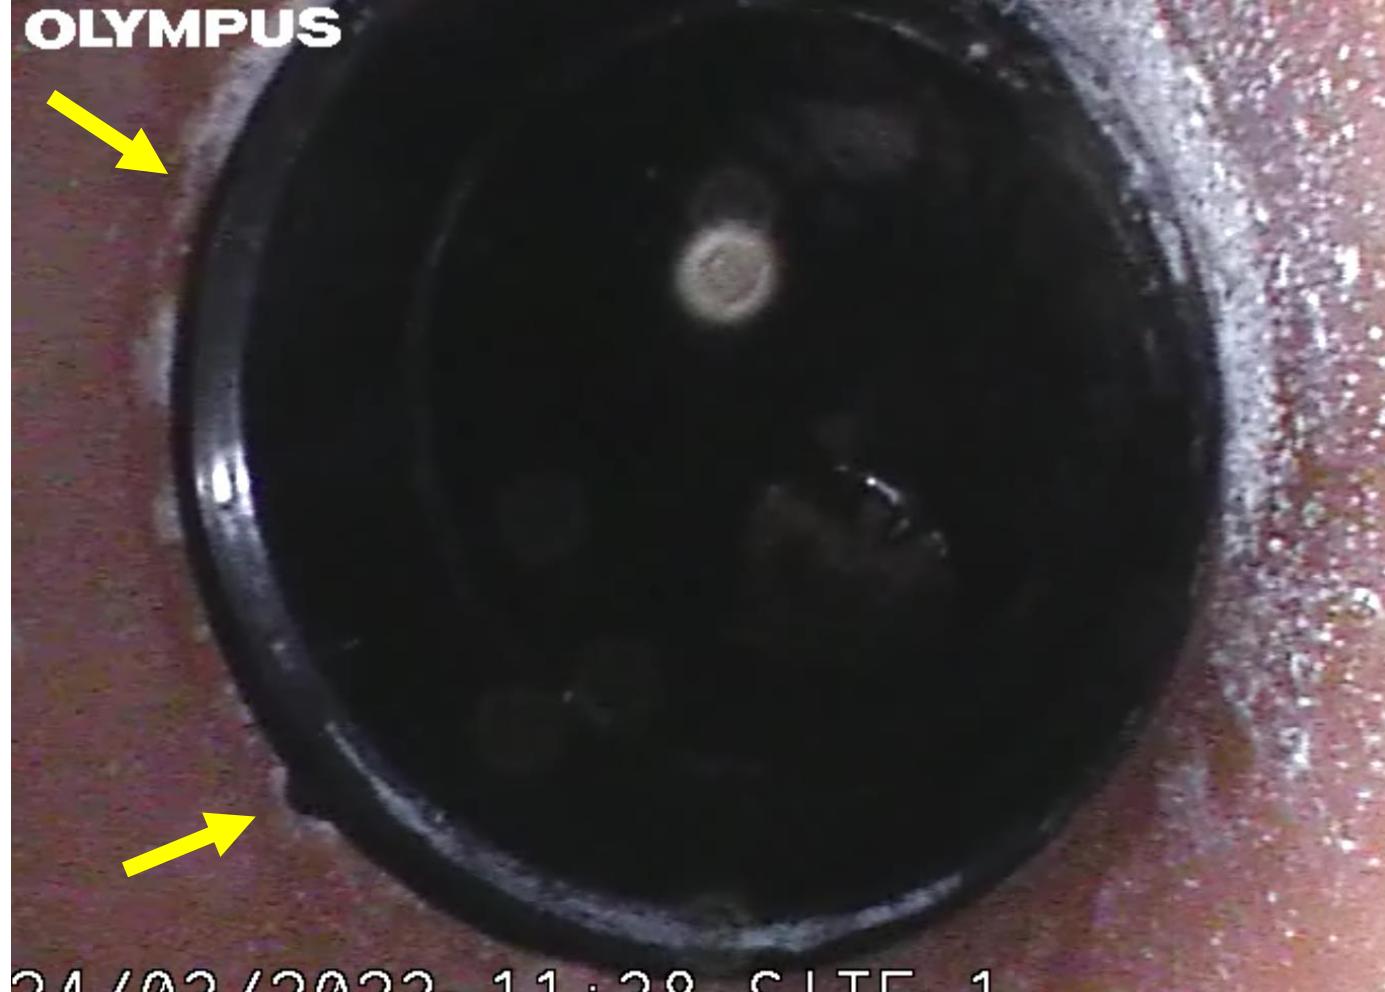
E Poor connection and Felt/pipe

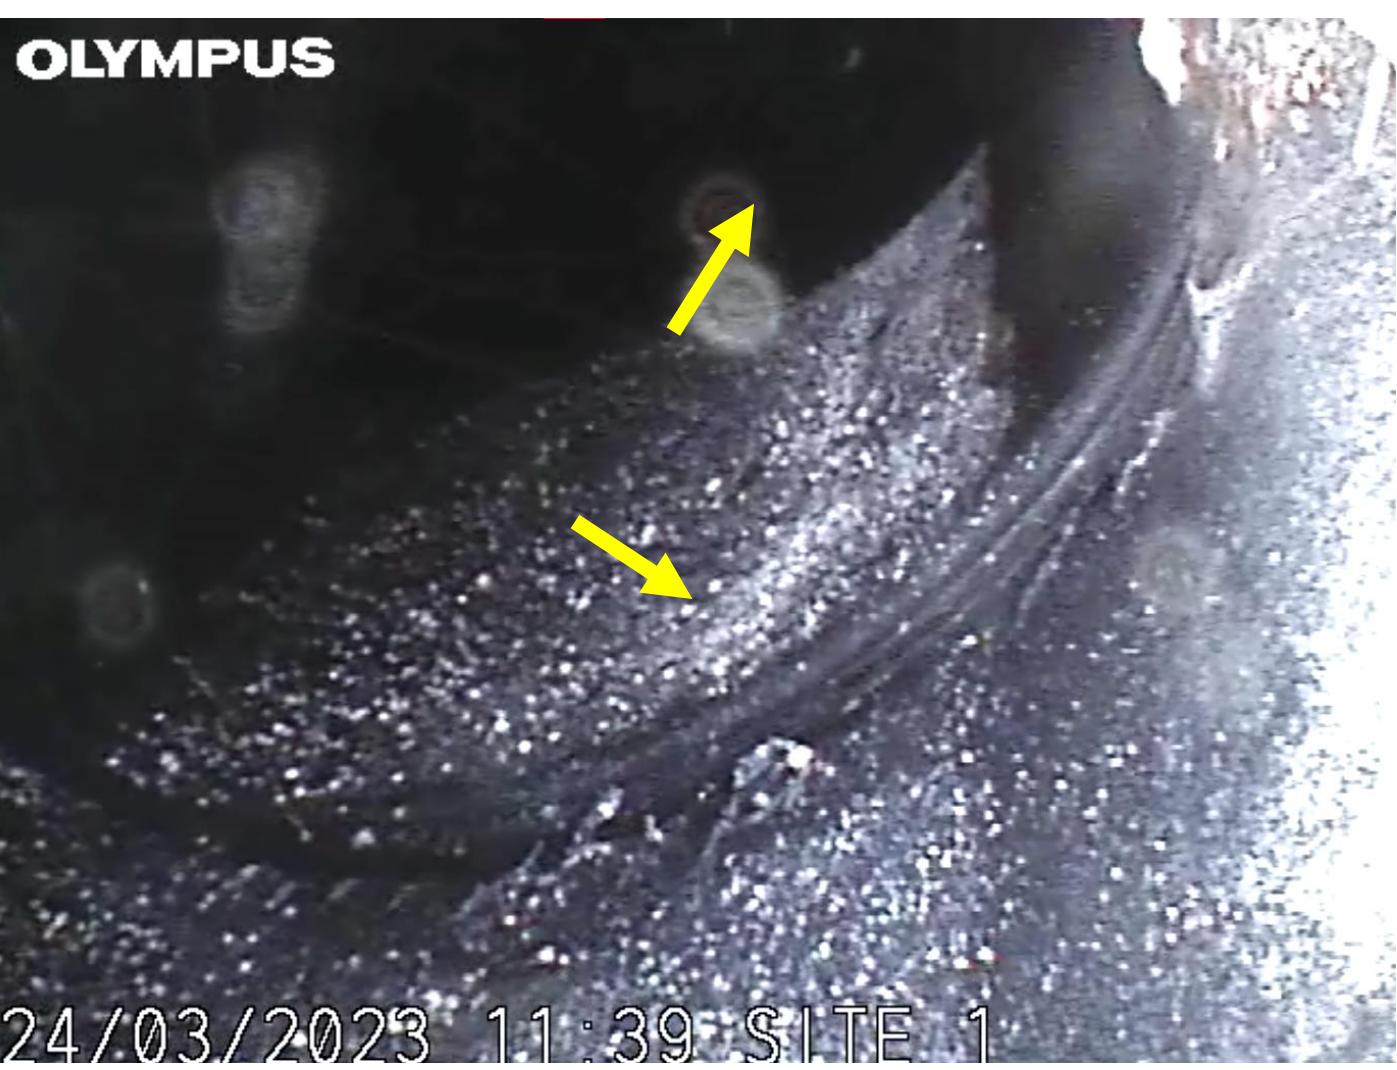
F Poor connection and Felt/pipe

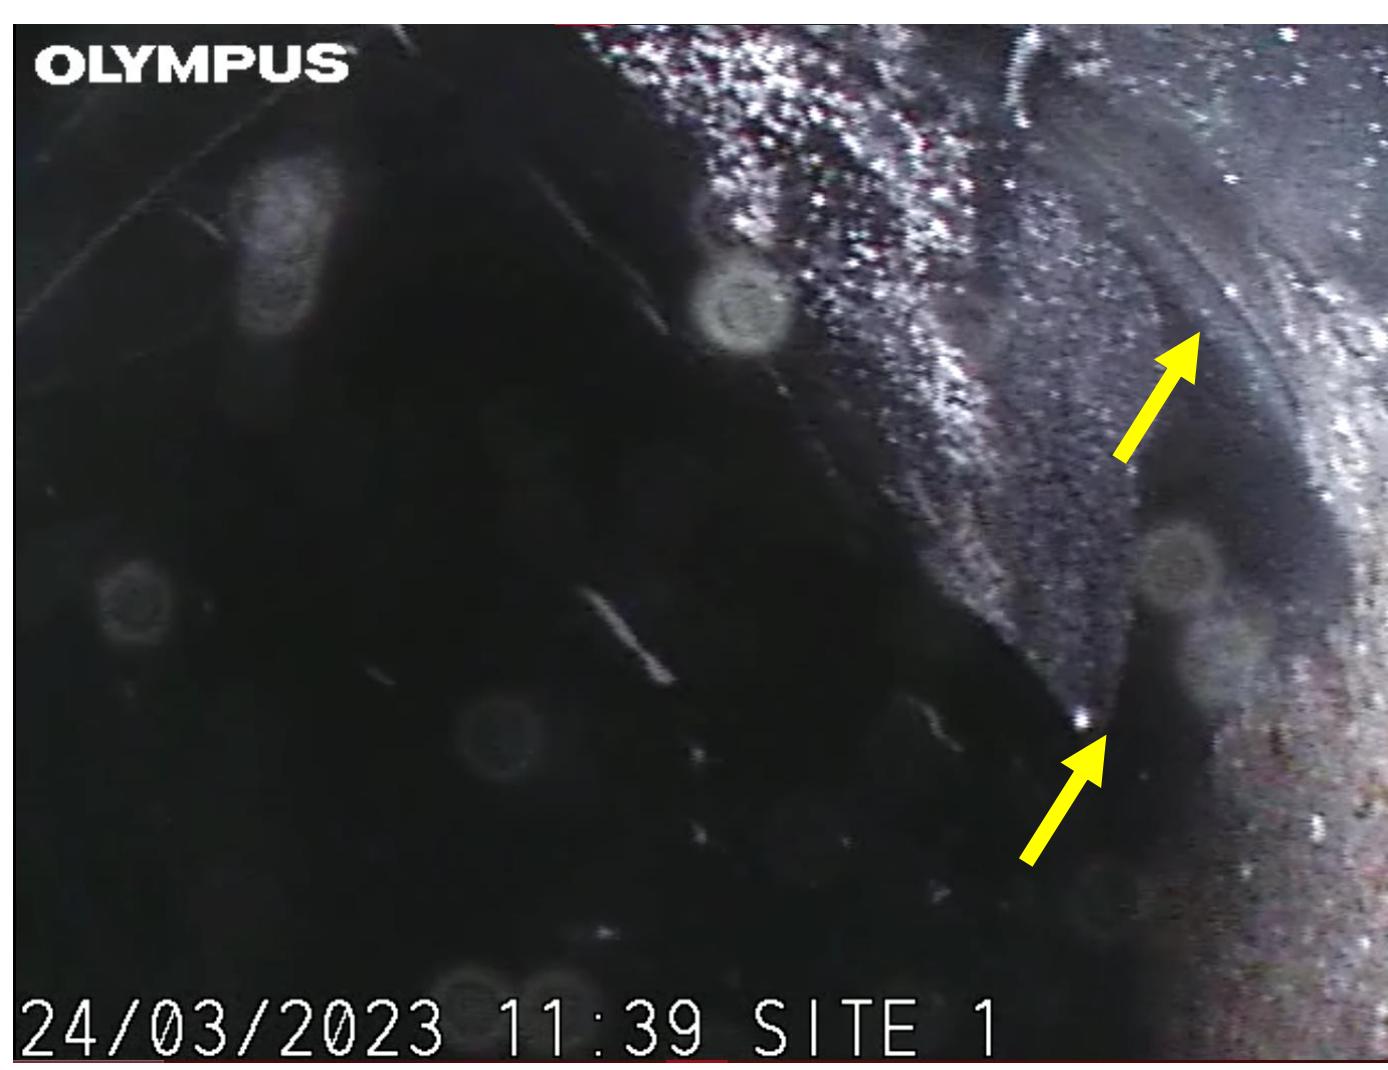
G Concrete

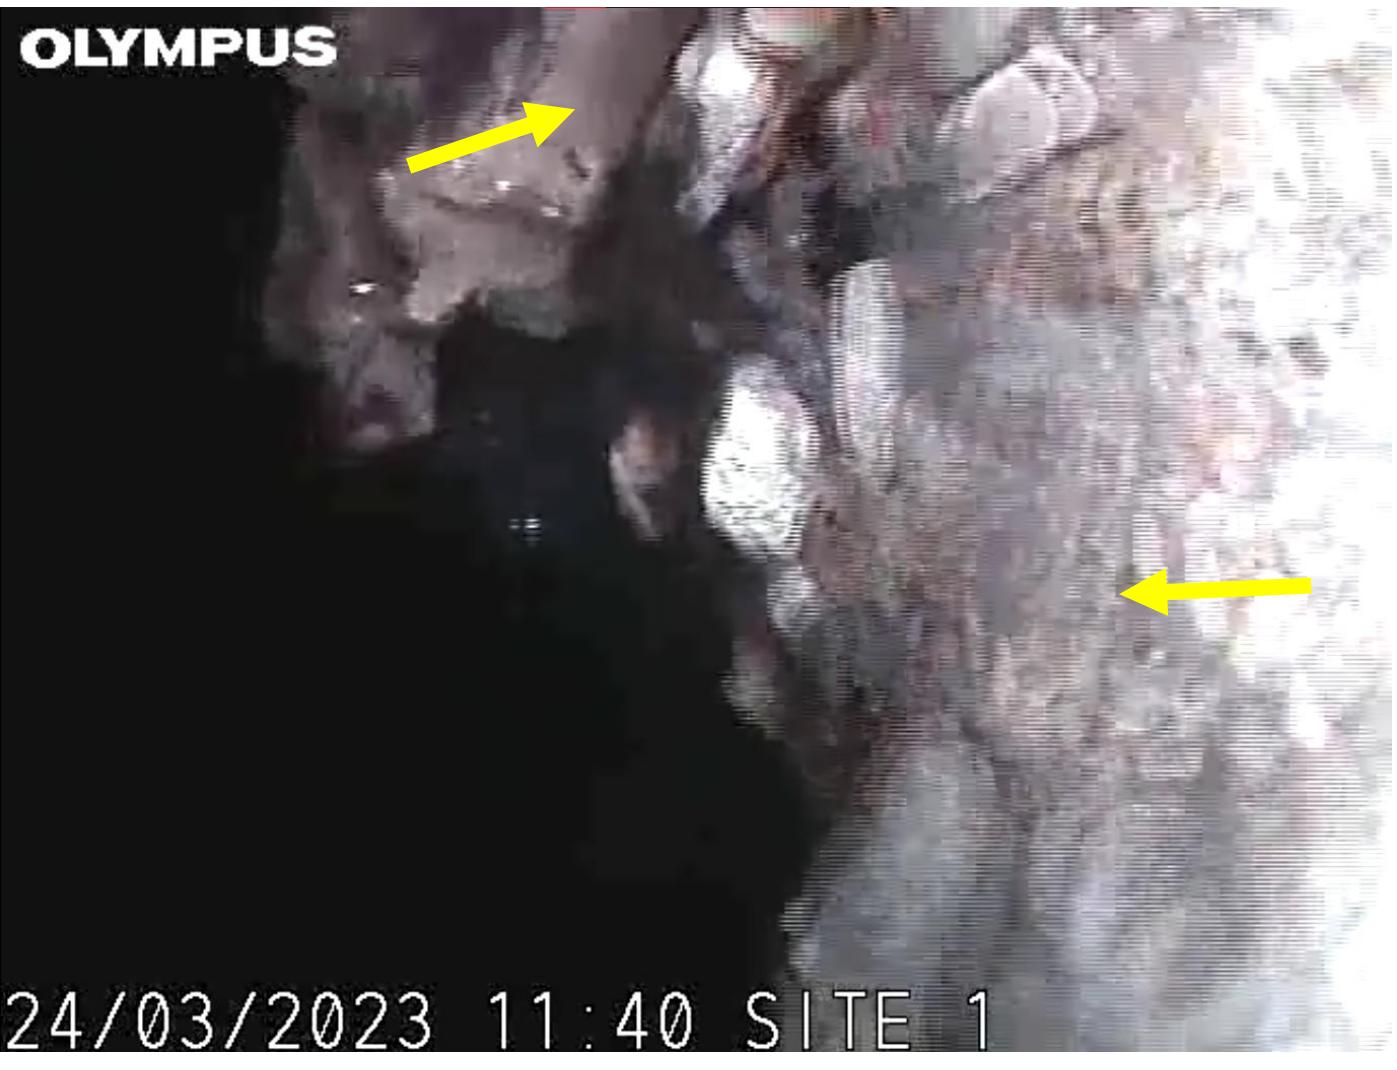
H Unknown materials bits and the Felt, concrete on background

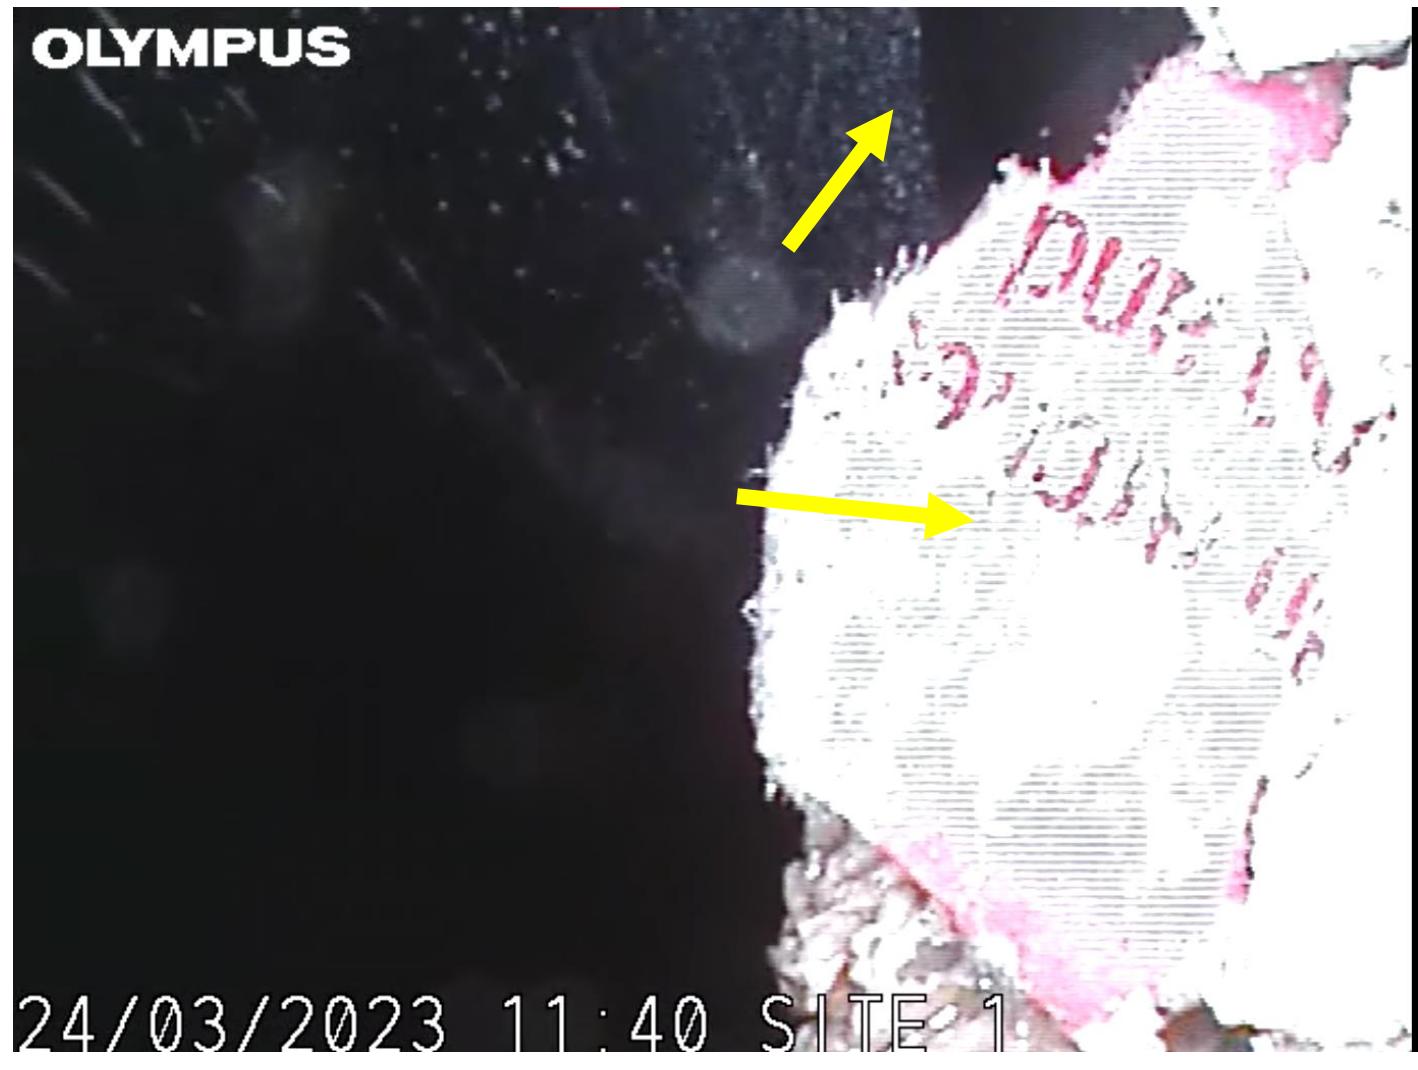
I Concrete and stones wash out

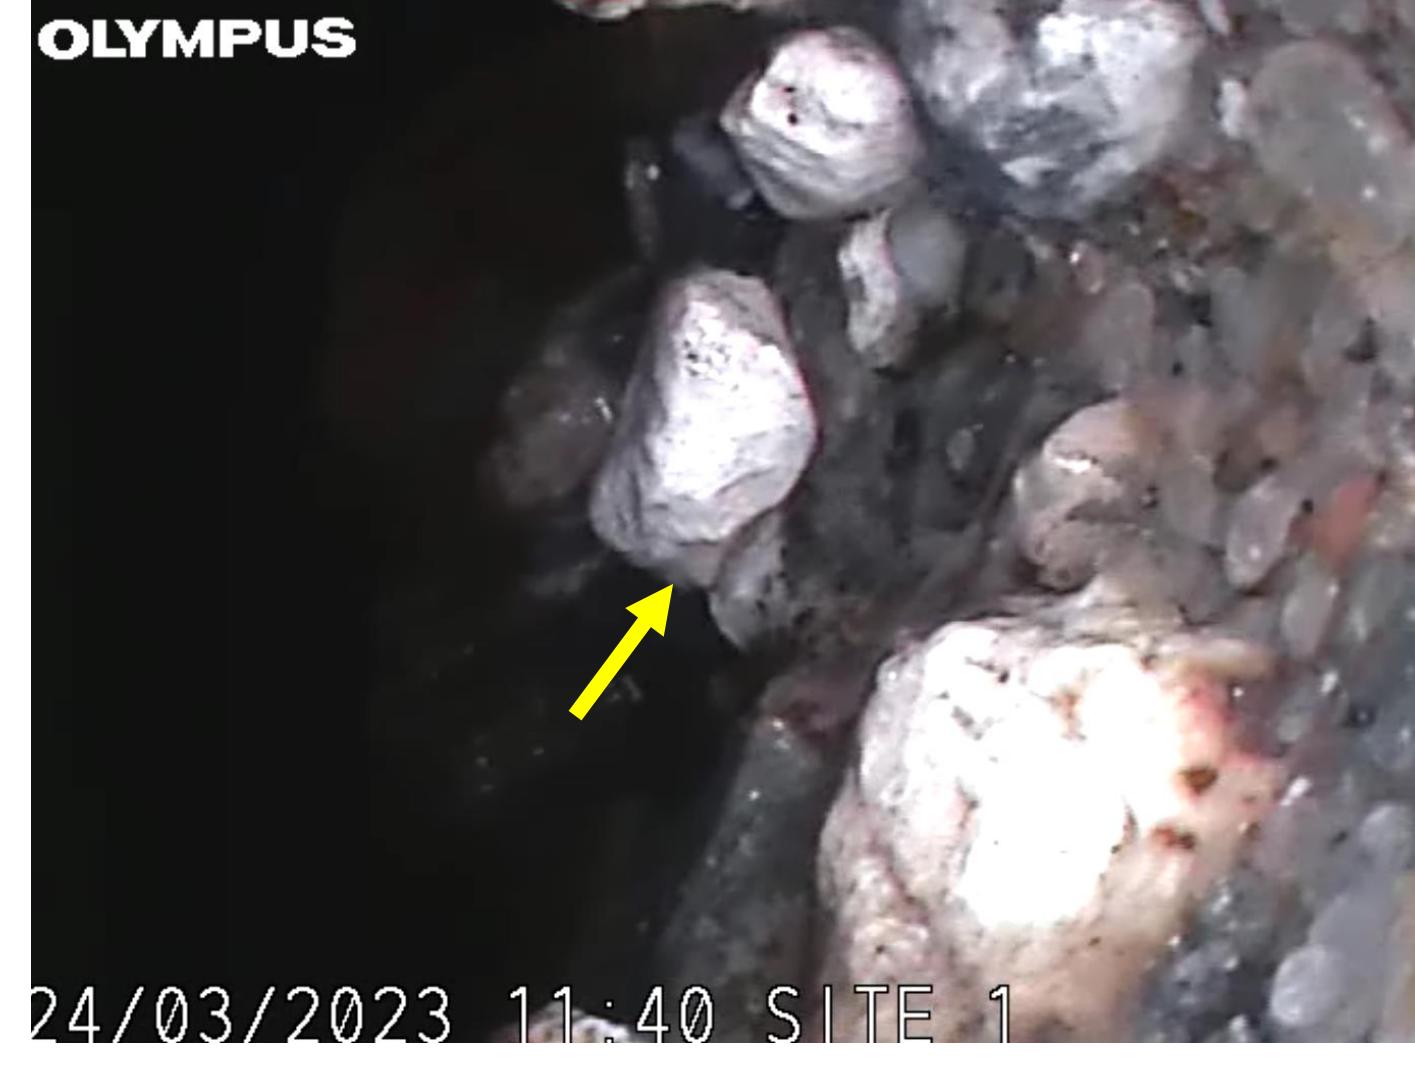
J Felt and concrete

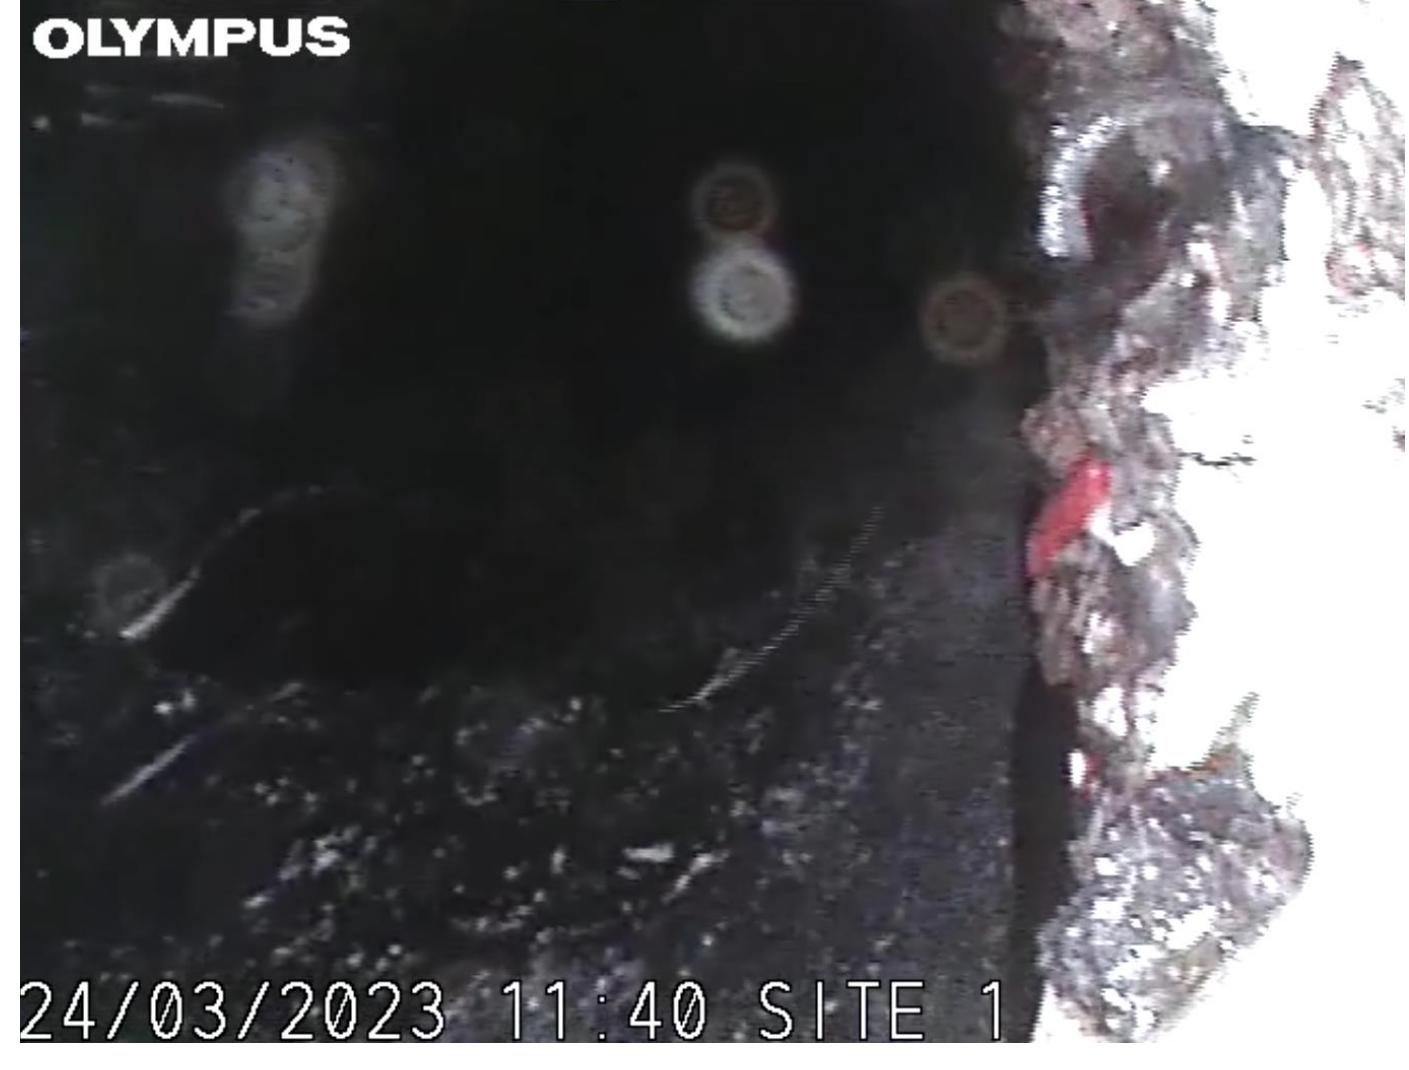
K Sharp objects and concrete – aluminium visible

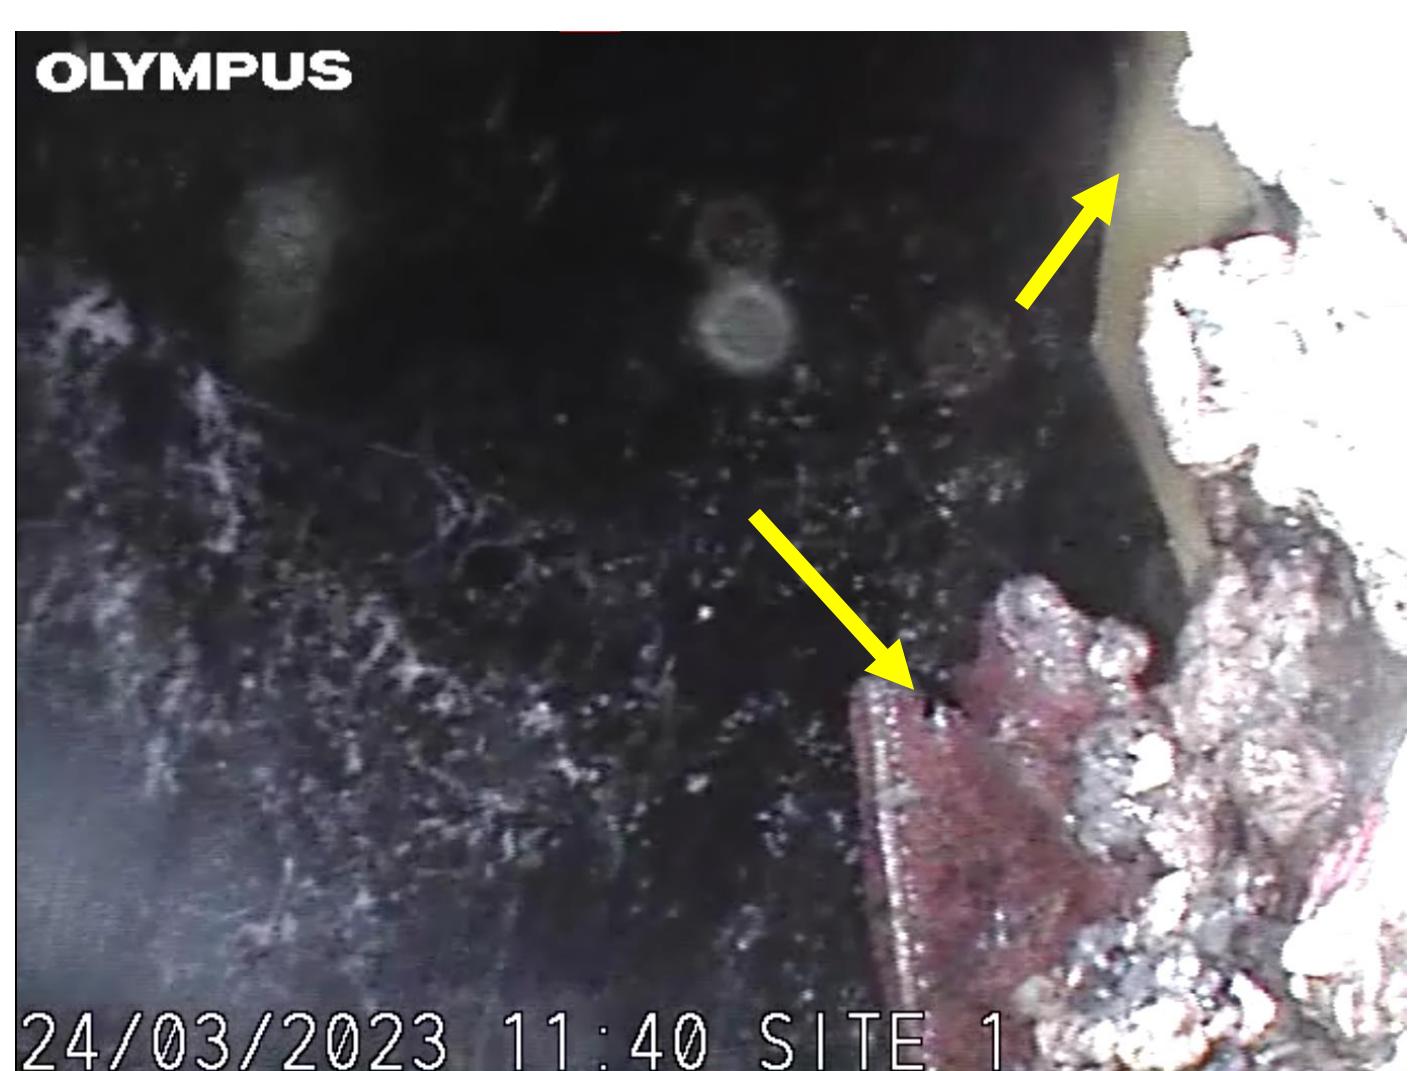
L Felt/membrane visible
