Project Name Removed - All Remedials works has been completed and no leaks observed by date - copyright to FTC

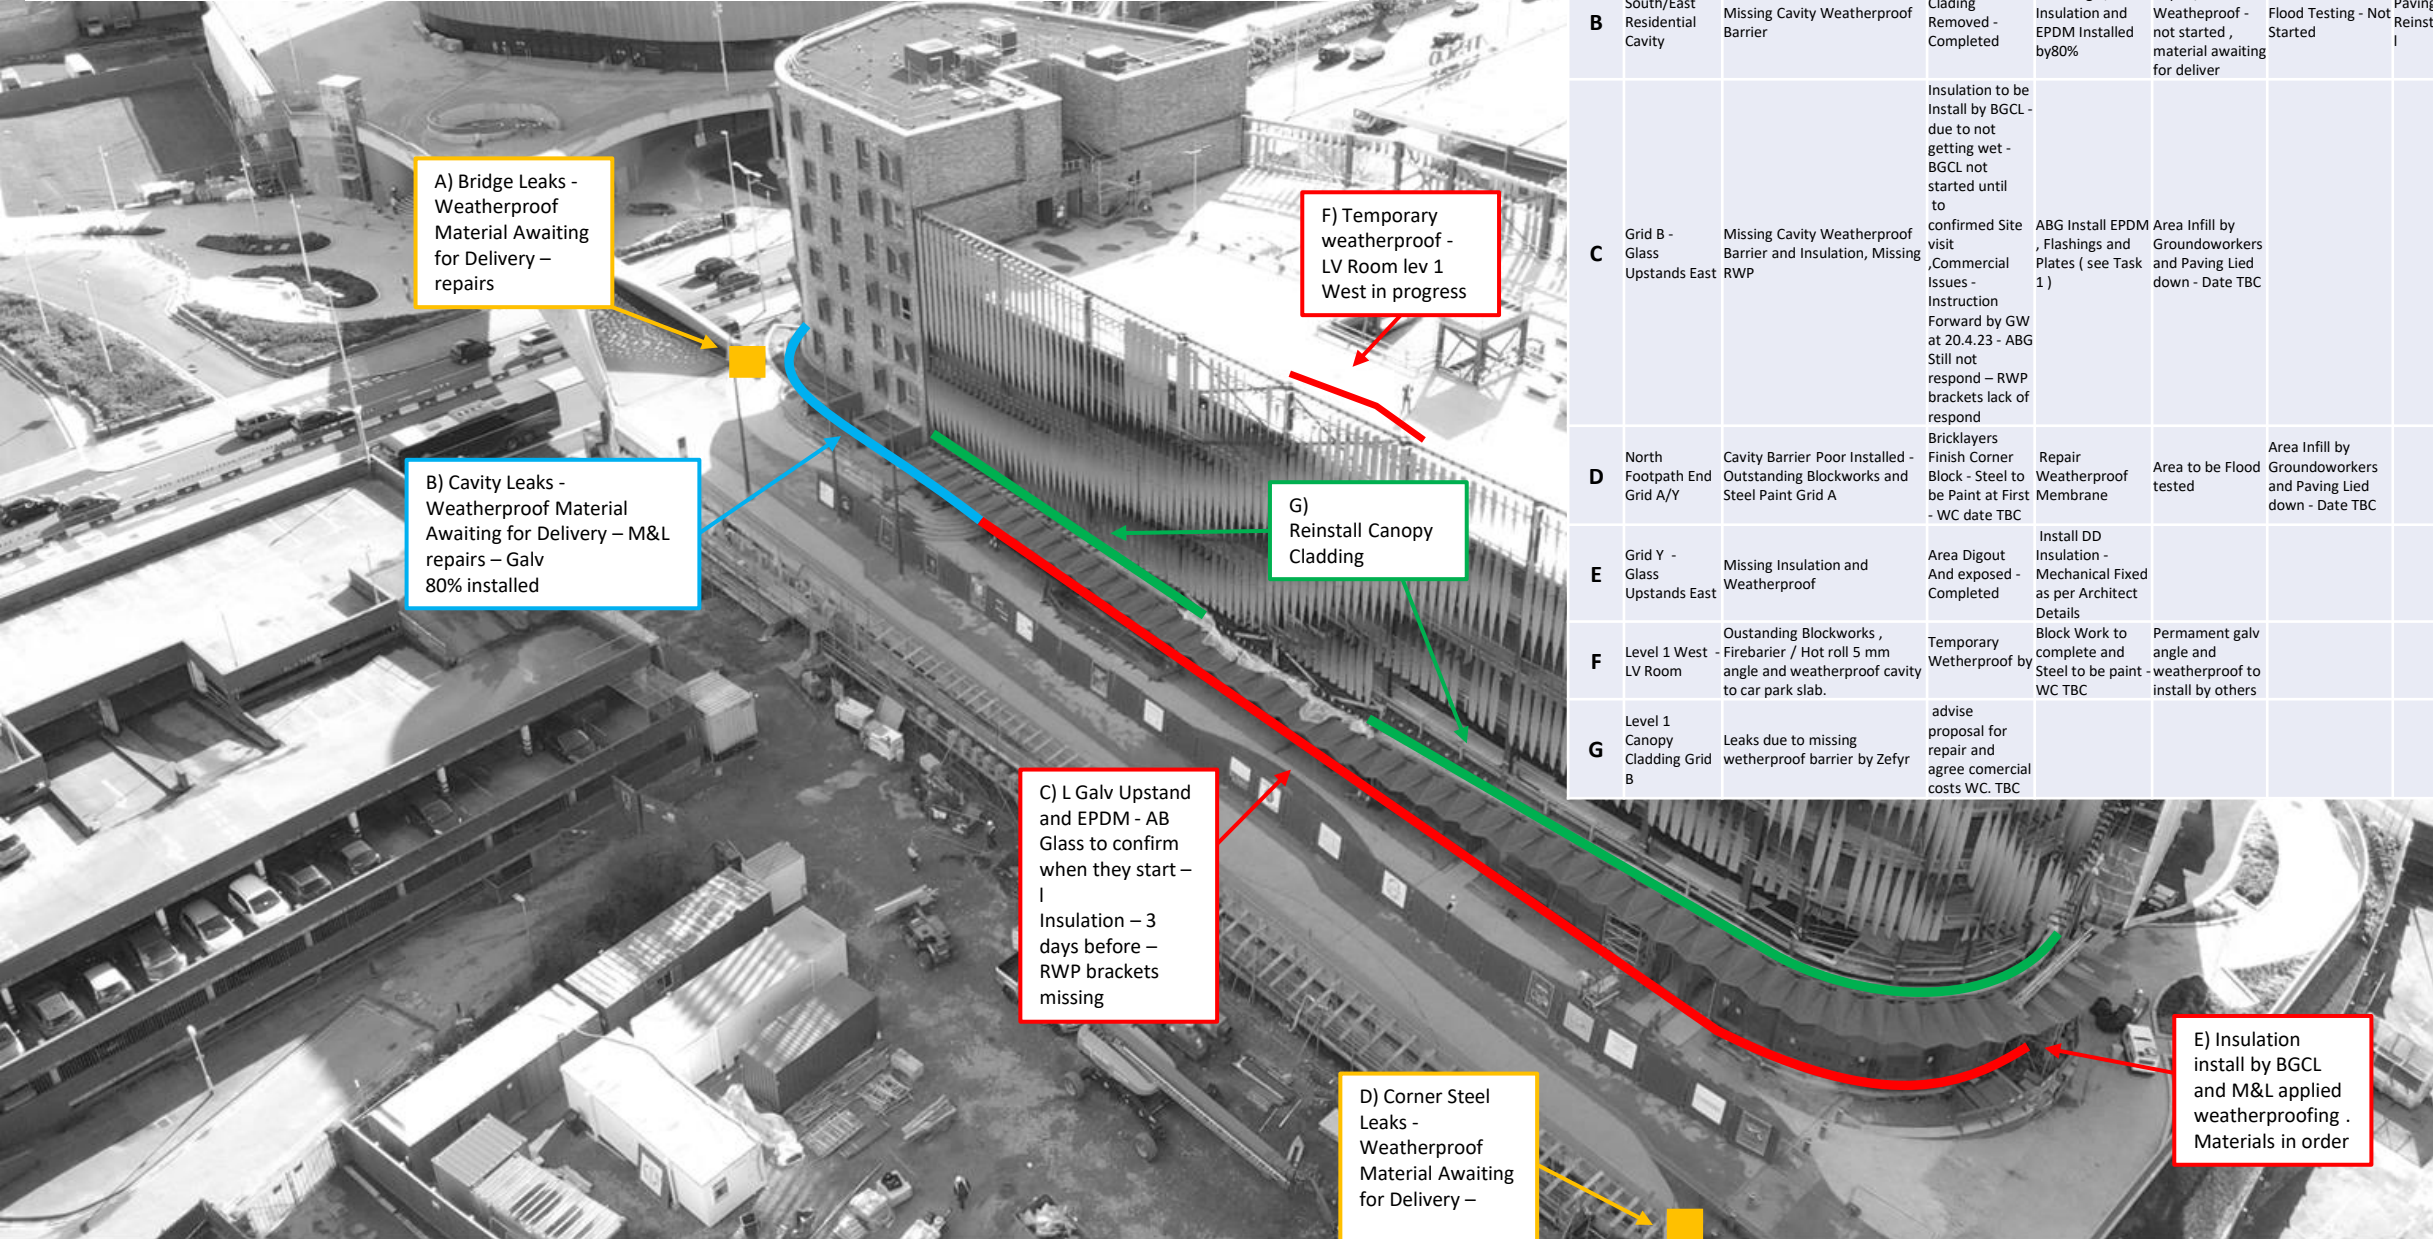
A) Bridge Leaks - Weatherproof Material Awaiting for Delivery – repairs

B) Cavity Leaks - Weatherproof Material Awaiting for Delivery – M&L repairs – Galv 80% installed

F) Temporary weatherproof - LV Room lev 1 West in progress

G) Reinstall Canopy Cladding

C) L Galv Uprand and EPDM - AB Glass to confirm when they start – Insulation – 3 days before – RWP brackets missing

D) Corner Steel Leaks - Weatherproof Material Awaiting for Delivery –

E) Insulation install by BGCL and M&L applied weatherproofing . Materials in order

Code	Leak Location	Description	Step 1	Step 2	Step 3	Step 4	Step 5	Step 6
A	South Bridge	RWP Poor Connection and Missing/Damage Weatherproof	Repair Gutters - In Progress	Repair Weatherproof - not started , material awaiting for deliver	Flood Testing - Not Started	Build Upstands Wall and Paving Reinstall		
B	South/East Residential Cavity	Missing Cavity Weatherproof Barrier	Cladding Removed - Completed	Galv Angle, Insulation and EPDM Installed by 80%	M&L Repair/Install Weatherproof - not started , material awaiting for deliver	Flood Testing - Not Started	Paving Reinstall	Cladding Install Back
C	Grid B - Glass Upstands East	Missing Cavity Weatherproof Barrier and Insulation, Missing RWP	Insulation to be Install by BGCL - due to not getting wet - BGCL not started until to confirmed Site visit ,Commercial Issues - Instruction Forward by GW at 20.4.23 - ABG Still not respond – RWP brackets lack of respond Bricklayers	ABG Install EPDM , Flashings and Plates (see Task 1)	Area Infill by Groundworkers and Paving Lied down - Date TBC

D	North Footpath End Grid A/Y	Cavity Barrier Poor Installed - Outstanding Blockworks and Steel Paint Grid A	Finish Corner Block - Steel to be Paint at First - WC date TBC	Repair Weatherproof Membrane	Area to be Flood tested	Area Infill by Groundworkers and Paving Lied down - Date TBC		
E	Grid Y - Glass Upstands East	Missing Insulation and Weatherproof	Area Digout And exposed - Completed	Install DD Insulation - Mechanical Fixed as per Architect Details				
F	Level 1 West LV Room	Outstanding Blockworks , - Firebarier / Hot roll 5 mm angle and weatherproof cavity to car park slab.	Temporary Wetherproof by	Block Work to complete and Steel to be paint - WC TBC	Permanent galv angle and weatherproof to install by others			
G	Level 1 Canopy Cladding Grid B	Leaks due to missing wetherproof barrier by Zefyr	advise proposal for repair and agree comercial costs WC. TBC
