Project Name Removed - All Remedials works has been completed and no leaks observed by date - copyright to FTC

MSCP - Swansea - Leaks - Water Test Link Bridge and Weatherproof preparation for Ramp Cornerp

Created: 04-04-2023  
Creator: Peter Mazur (@PMA)  
Status:  
Dates: 02-20-2023 - 04-04-2023

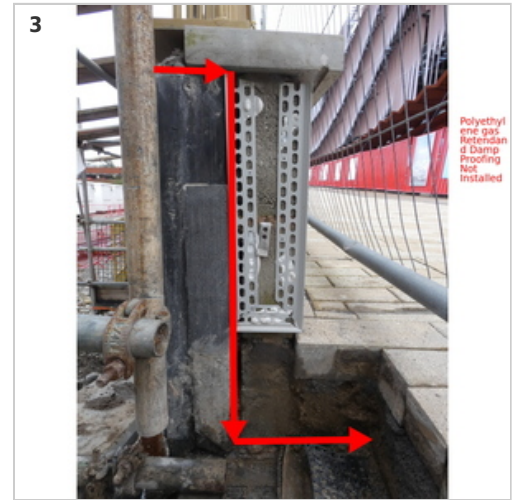
4 Missing Weatherproof Membrane and Concrete Seal

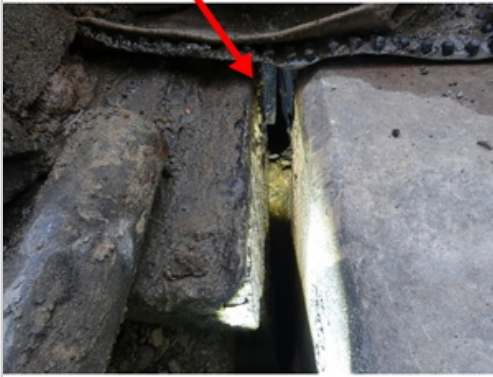
5

Top View Area Exposed

Missing Weatherproofing

Membrane Finish up to line - not stick to concrete - water ingress under

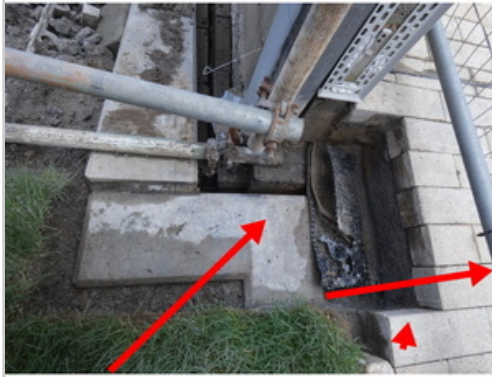
6

Site View

Not completed weatherproof

Membrane not completed

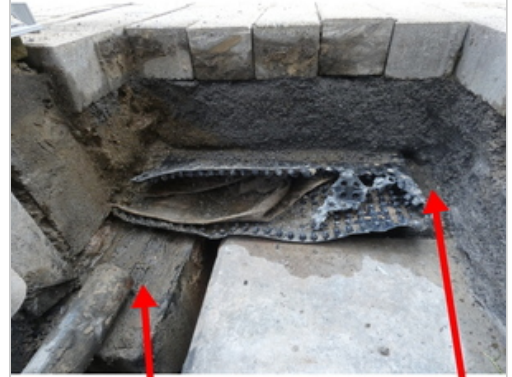
7

Cavity not complete. To be weatherproofed

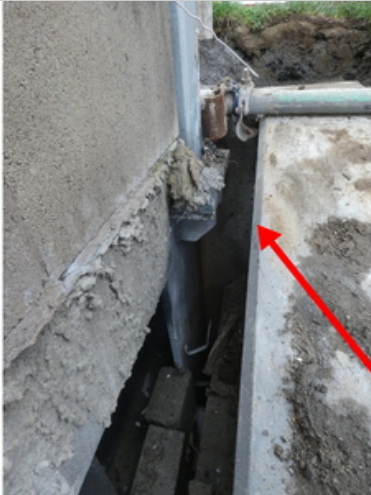
8

Membrane not stick to concrete

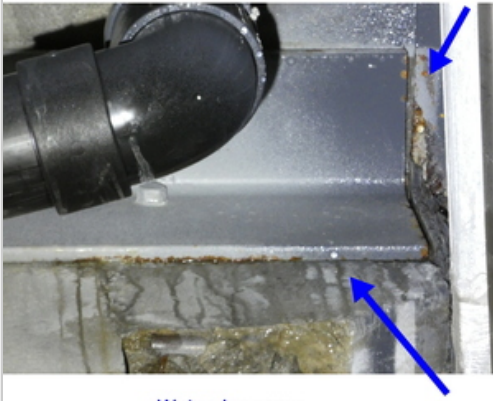
4

Water Ingress

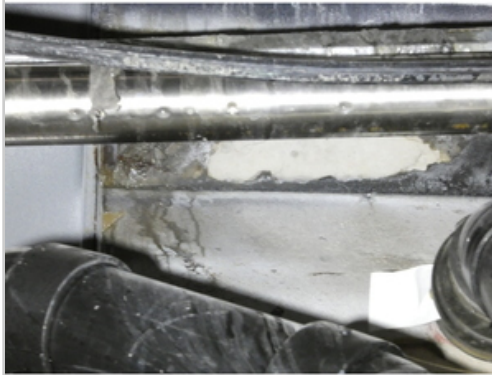
5

Water Ingress

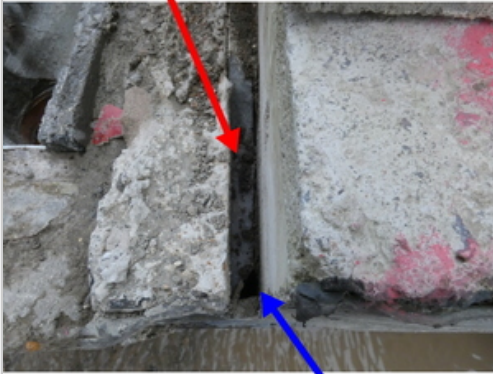
7

Gap - no seal and weatherproof

Water test aprox 6 liter - 04.04.23

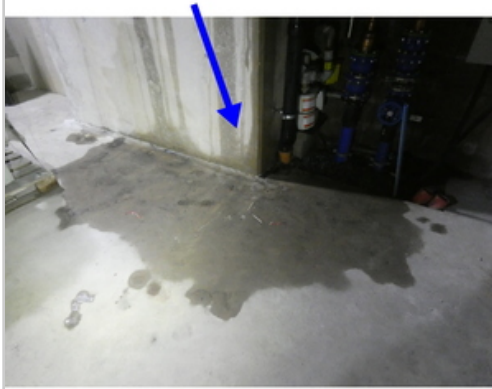
8

Water inress

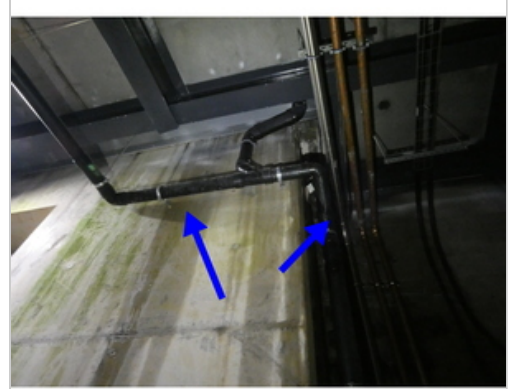
9

Leaks

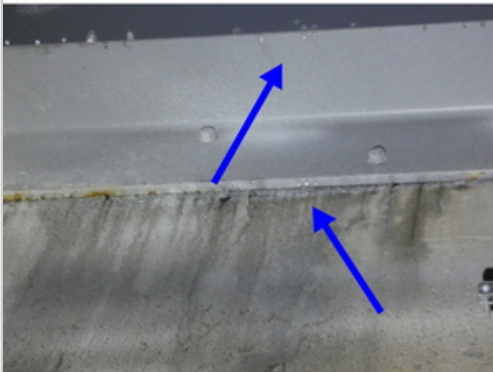
10

Leaks

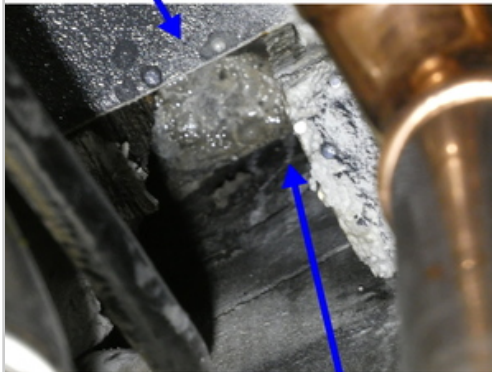
11

Leak

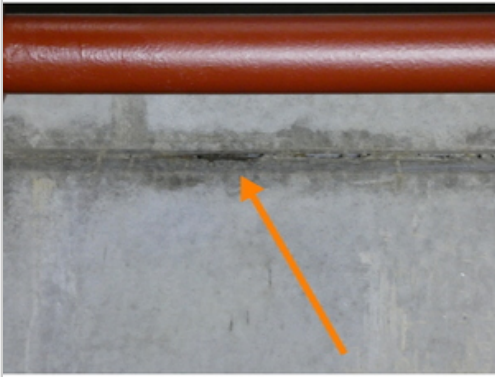
7

Wet Gaps , water  
flush out grout
