External - Observation Report

- Roof Issues, Gutters
- Unitise Panels
- Fullflow
- Curtain Wall Doors and Glass
- SFS and Firestop
- Rimex and Metal Soffit

August 2021

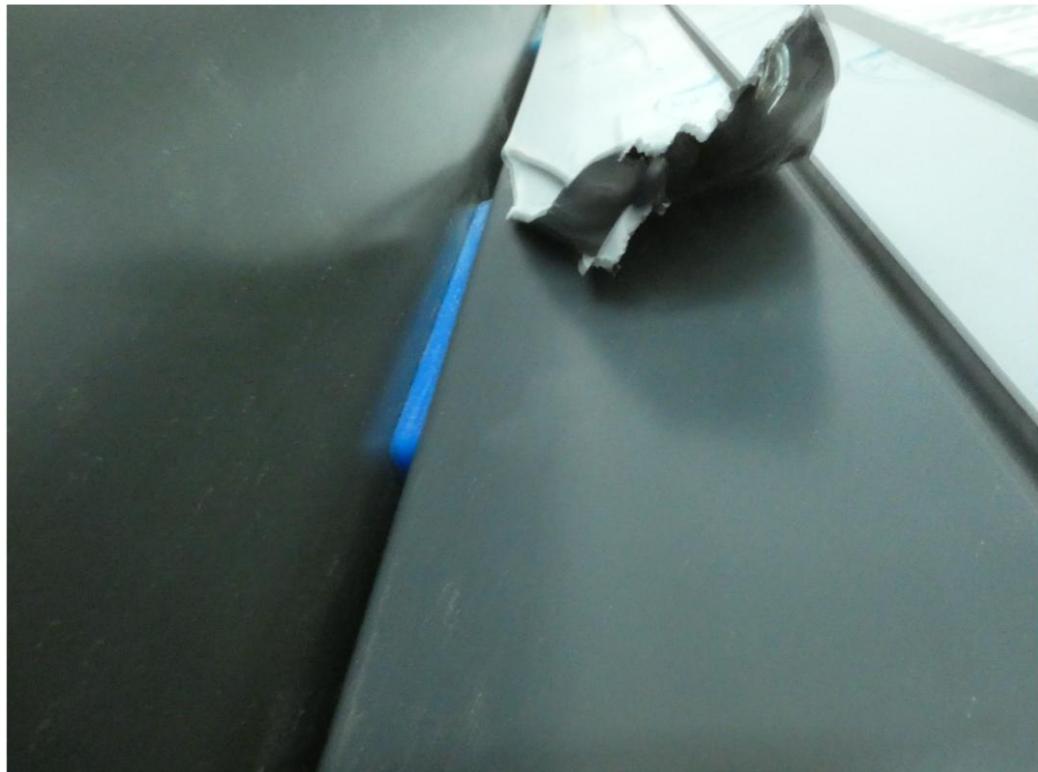
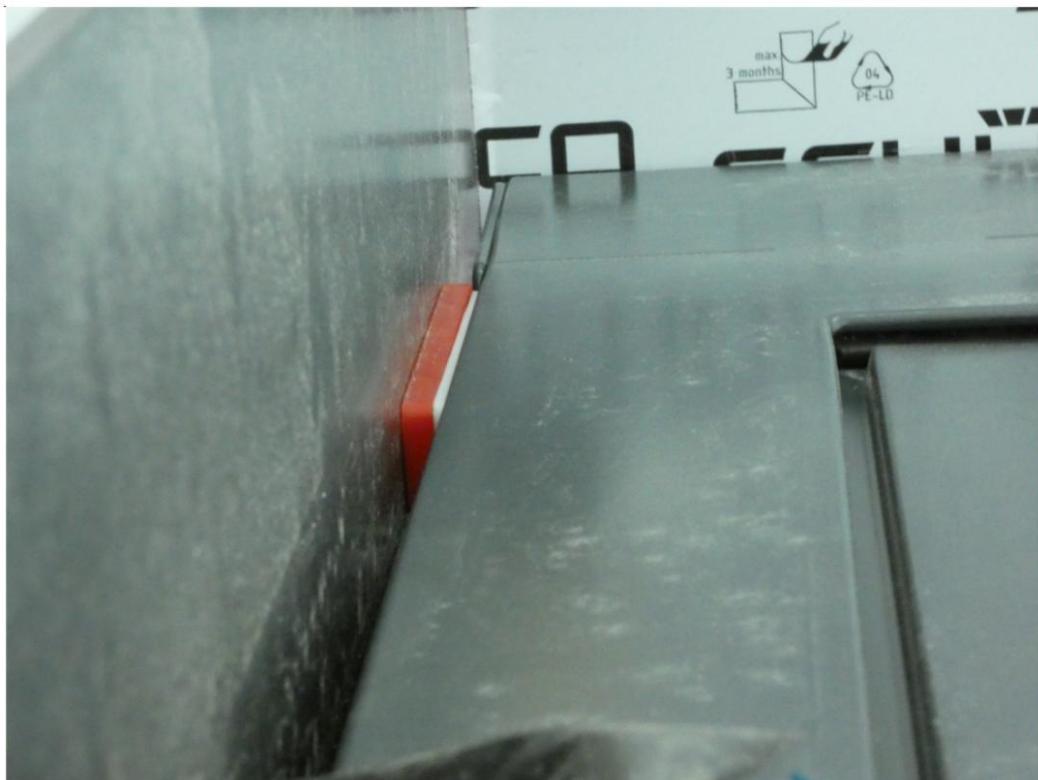
Lev 0 - Doors

Doors Packers installed not deep enough for Mastic Seal (ratio 2:1)
What will hold packers in position and prevent for falling down - shall we add a bit of mastic/glue?

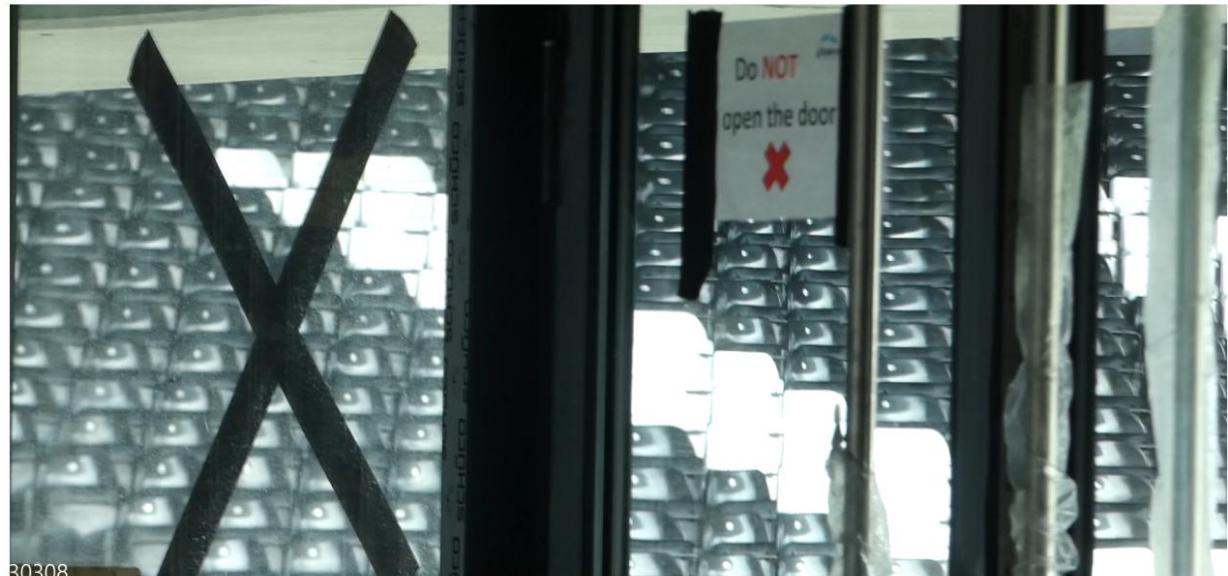
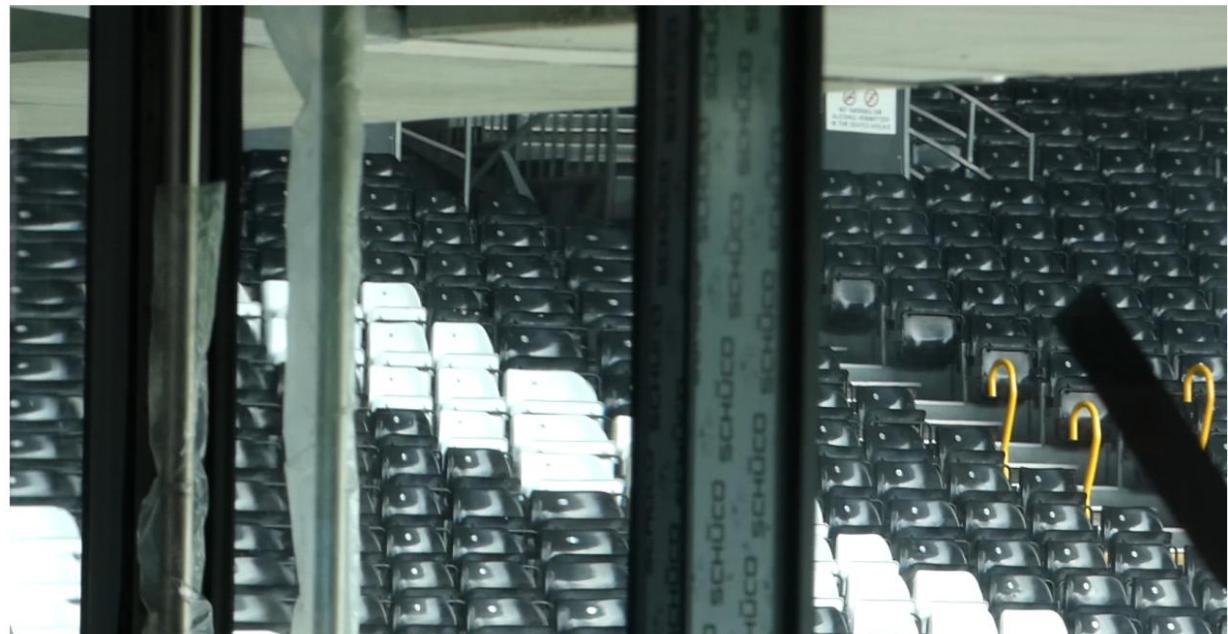
Lev 0 Doors

Blured and Widened View through the Door Glass

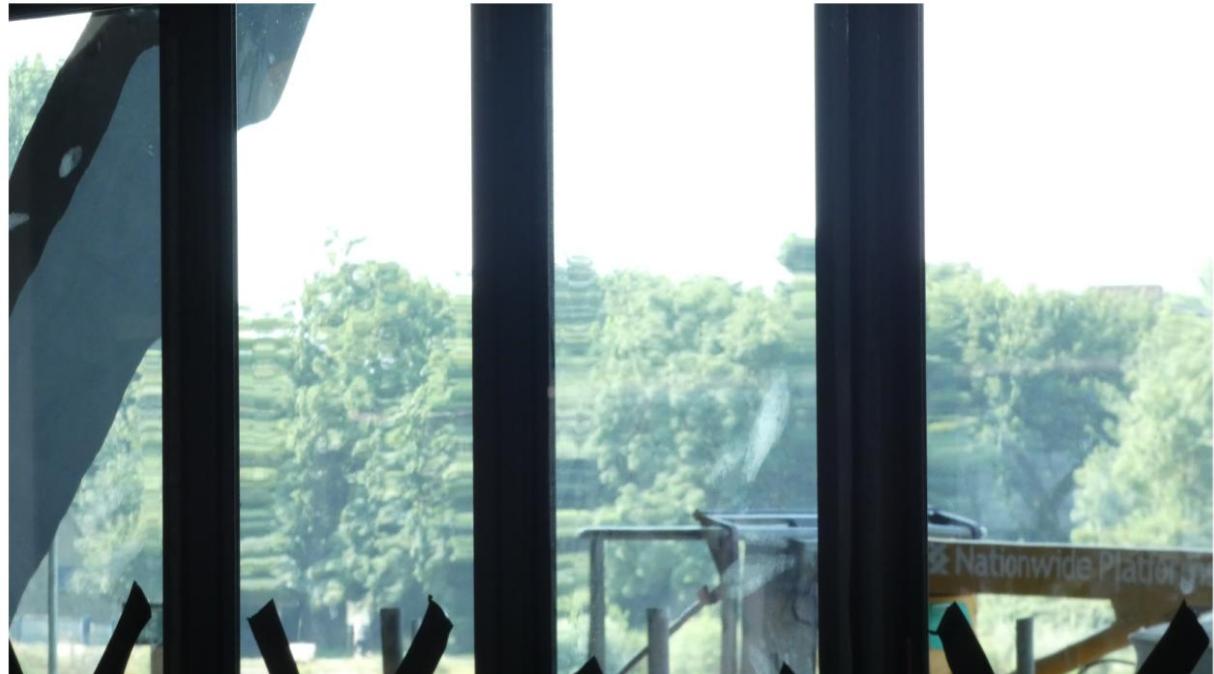
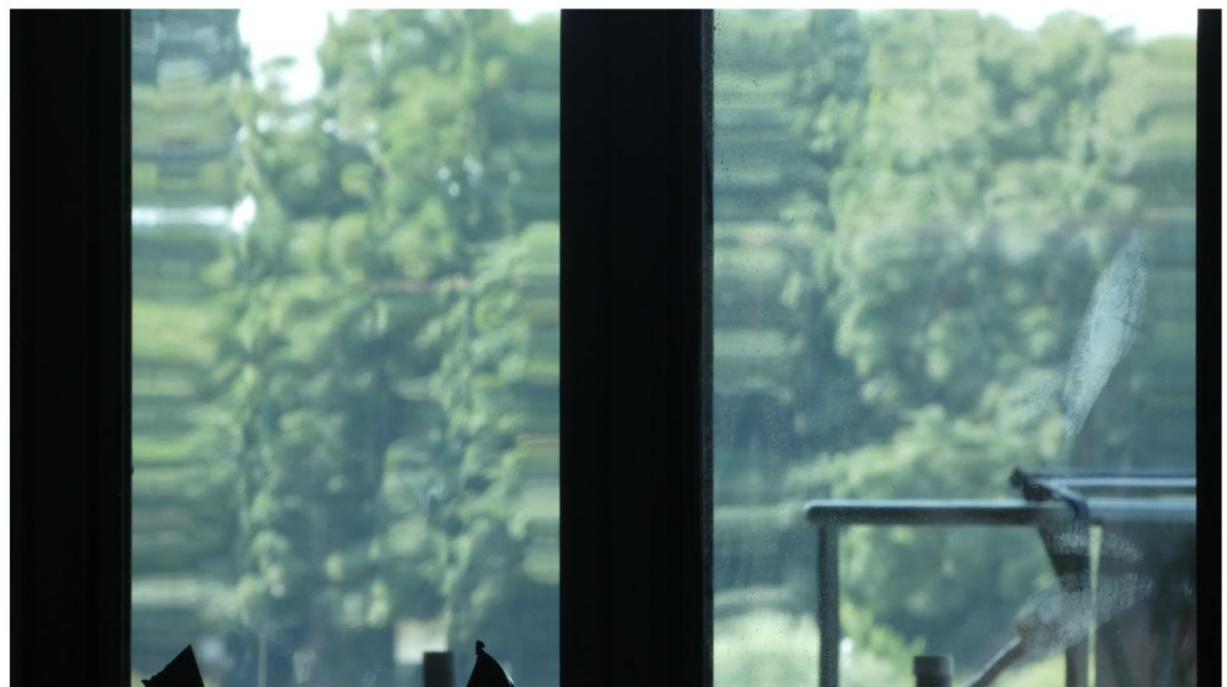
Lev 0 The Doors

Blured and Widened View through the Door Glass

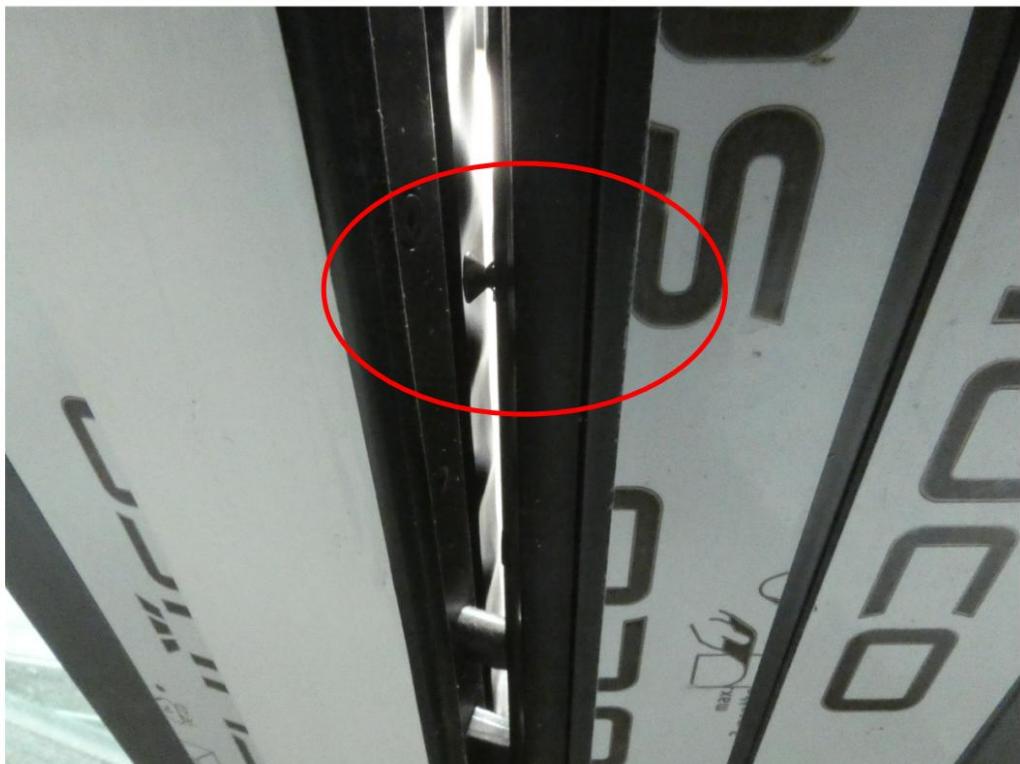
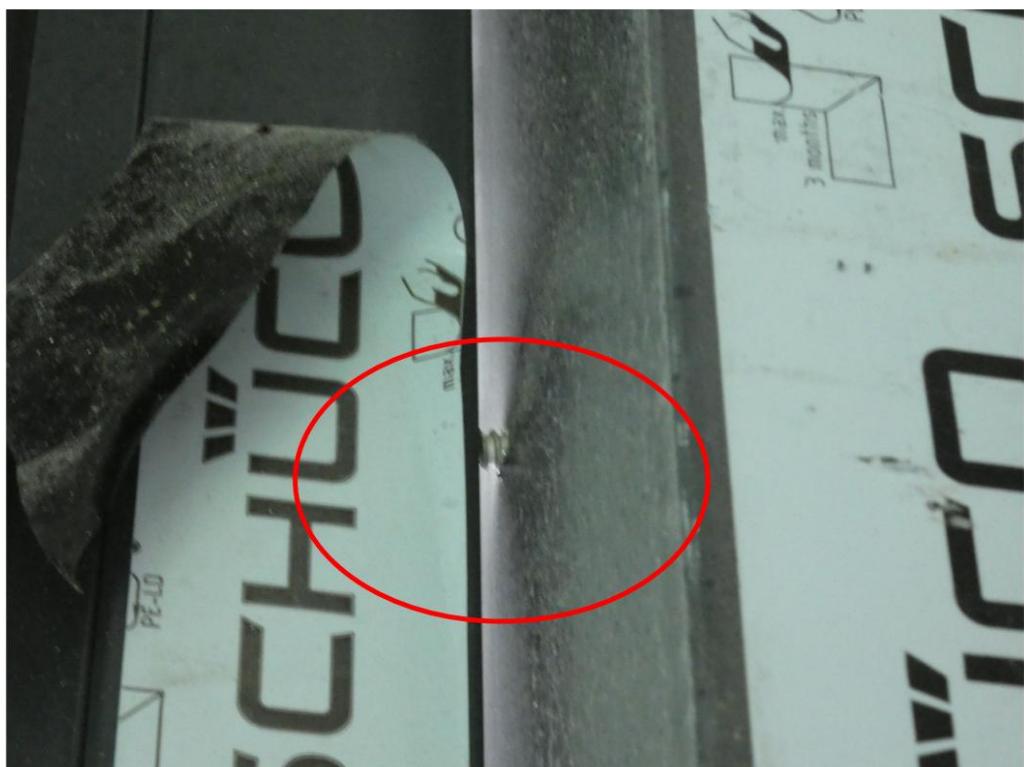
Lev 0 - Doors

Screws Loose and Frame Fixing Missing Packers .

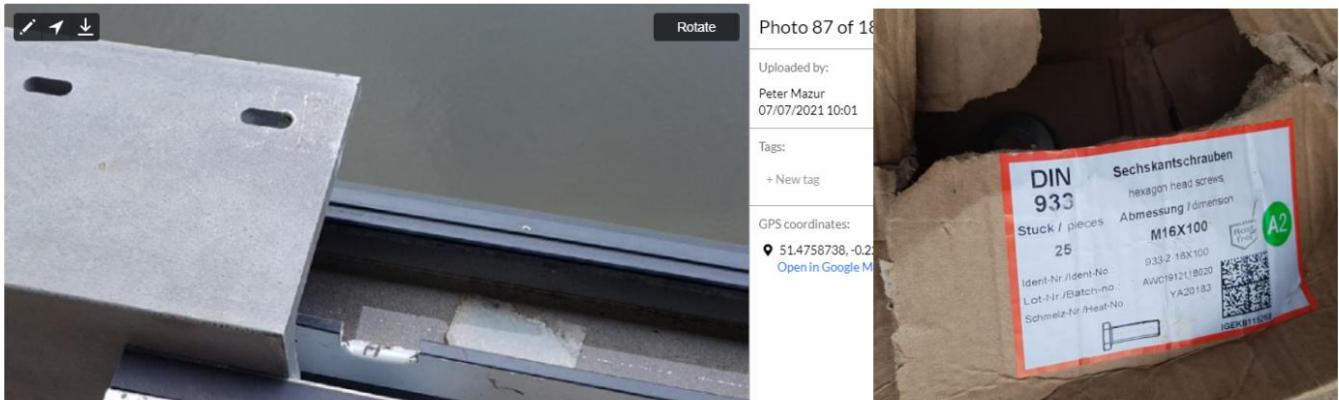
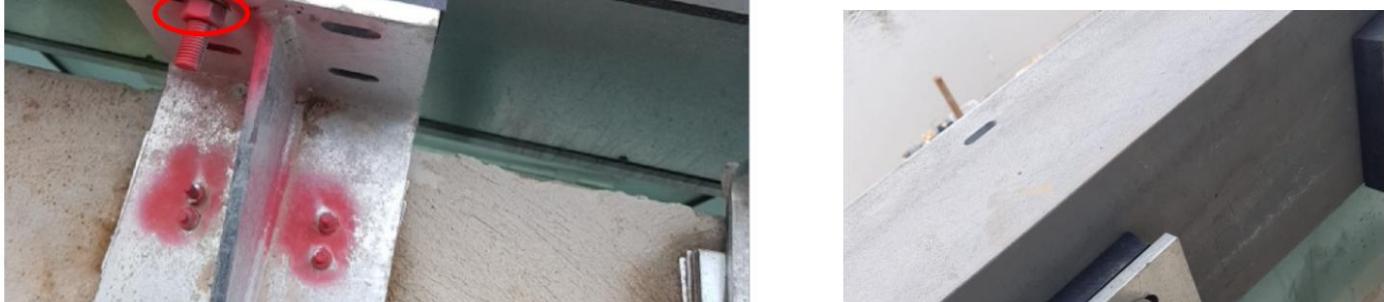
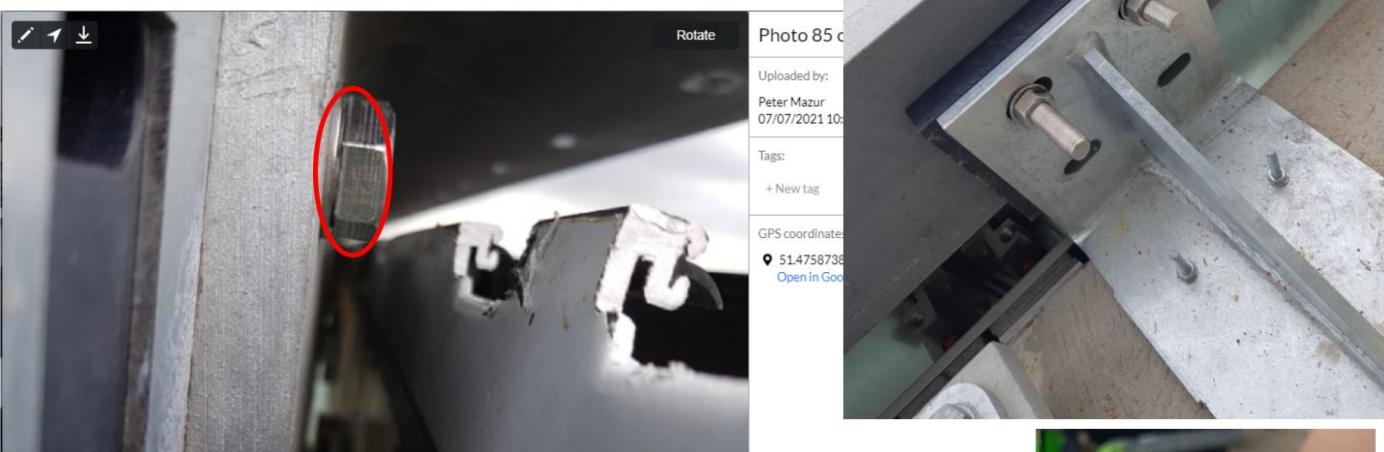
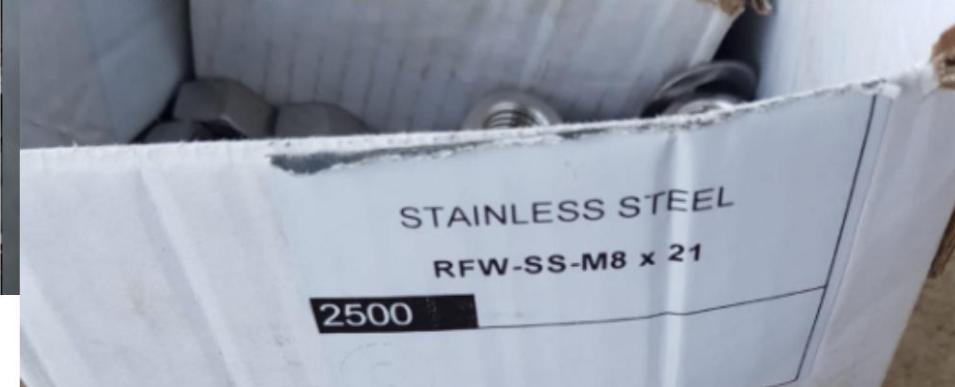
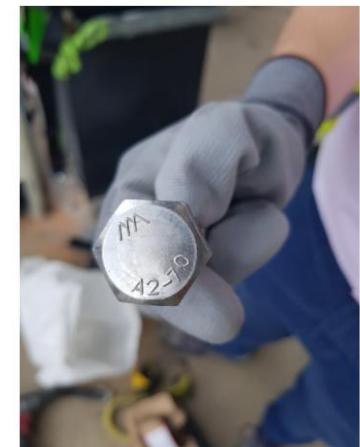
Lev 5 Unitise and Balustrades

Stainless Bolts/ nuts /washes and Galv brackets - no separators between different type of metals

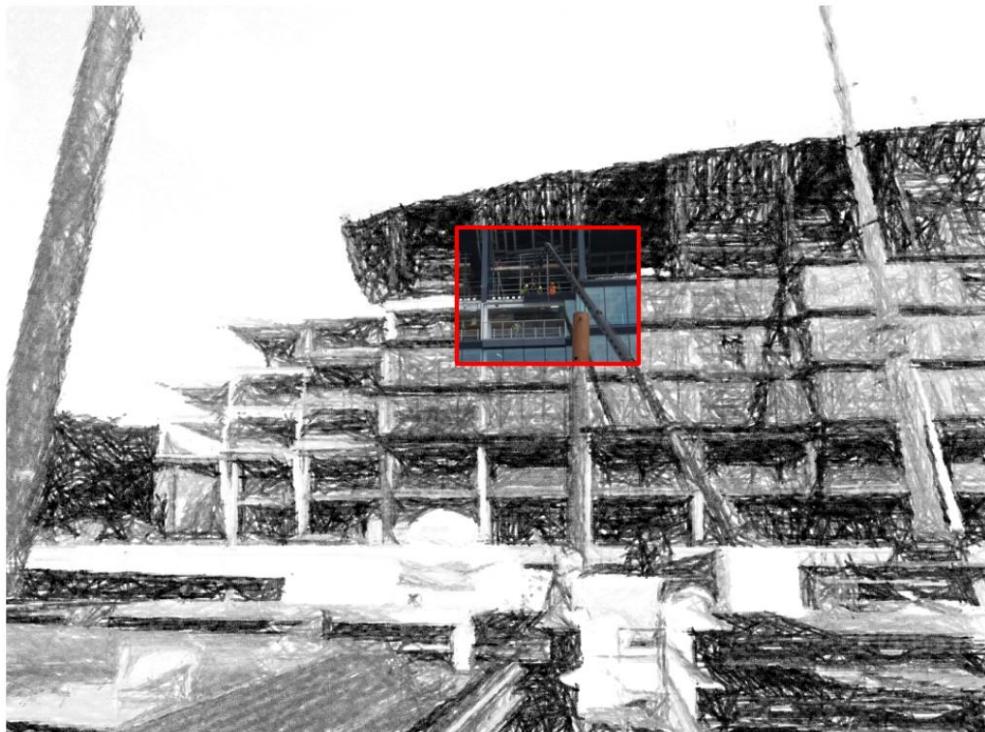
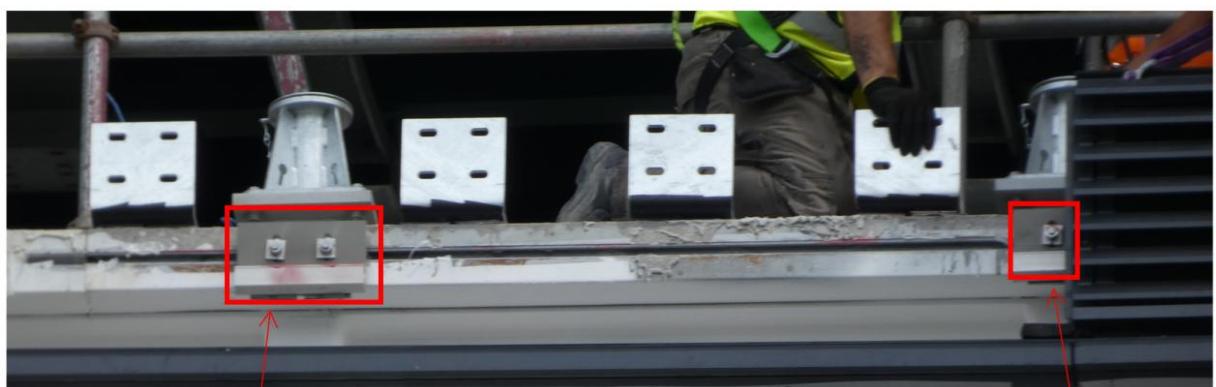
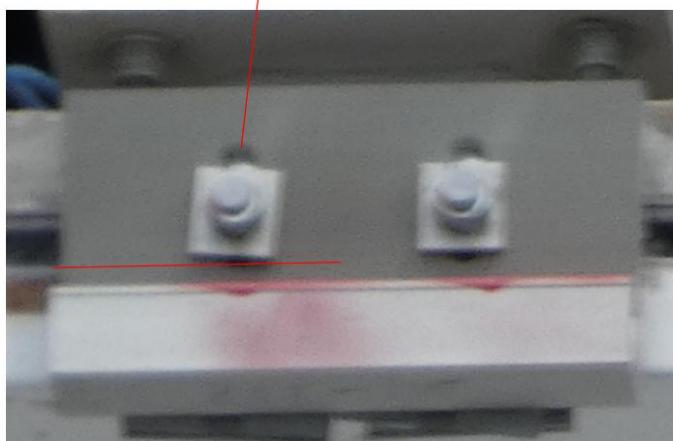
External - Observation Report Unitise Panels

Brackets Must to be Check and Torque Prior Unitise panels to be installed - Issues has been reported to Kaicer/DNA
Immediately. On photos below square washers not correct installed/twist to the grove triangle chanells. ITP, Brackets and
Panels not to offer to BGCL for Inspection and Sign Off.

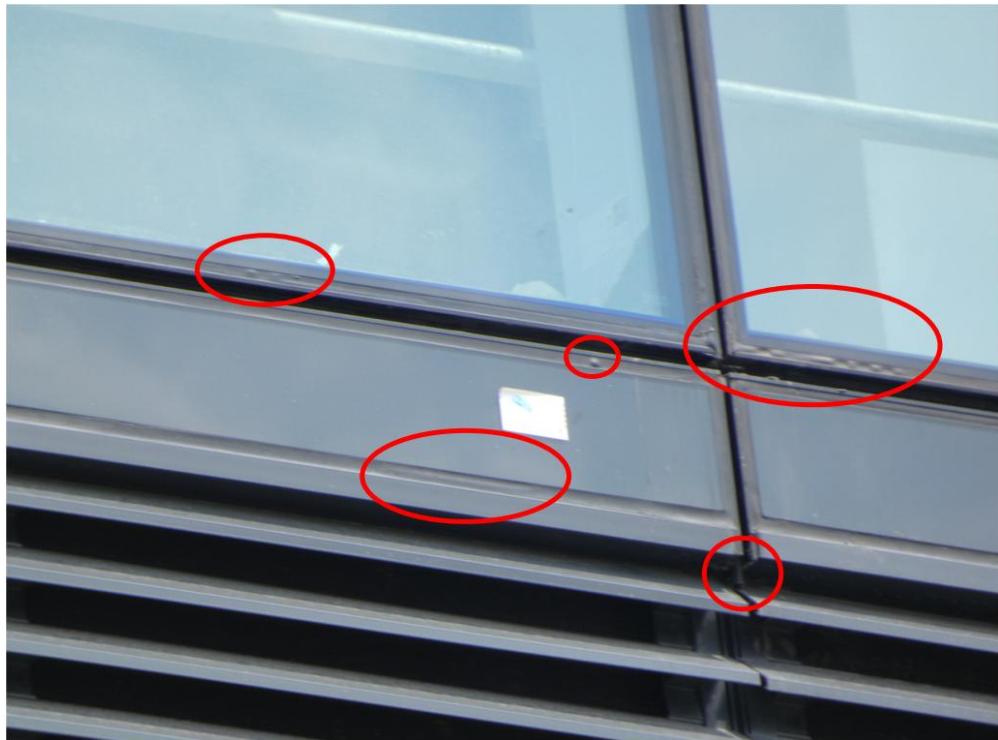
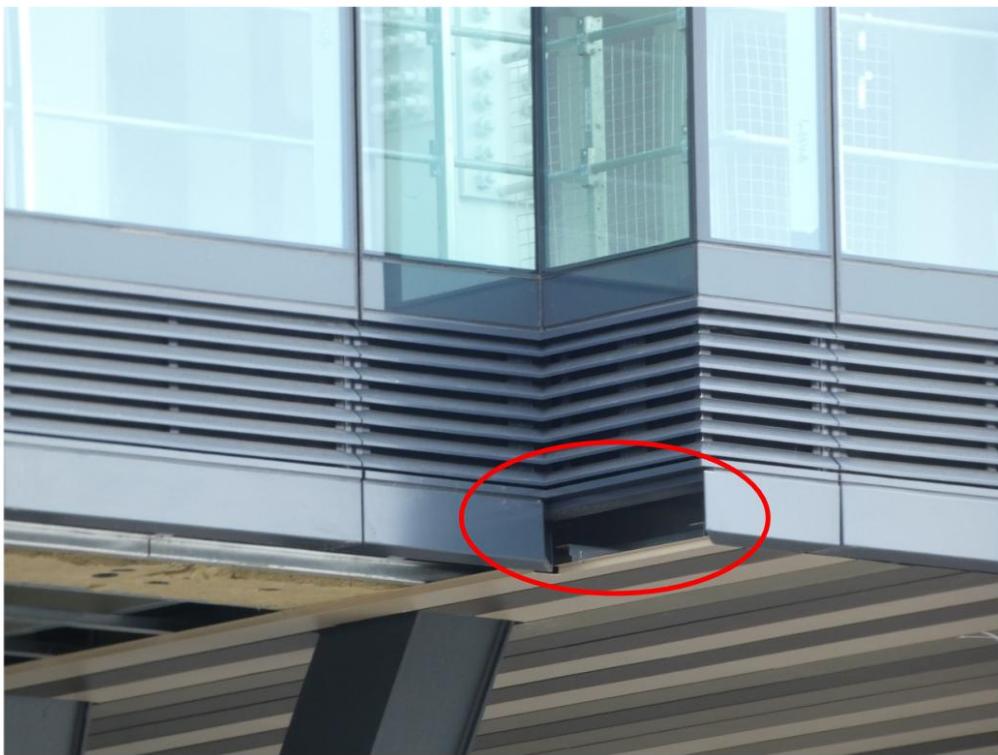
Unitise CW

Typical Mastic Poor Applied by Sunvast and Missing Panel.
Gasket to long and sick out

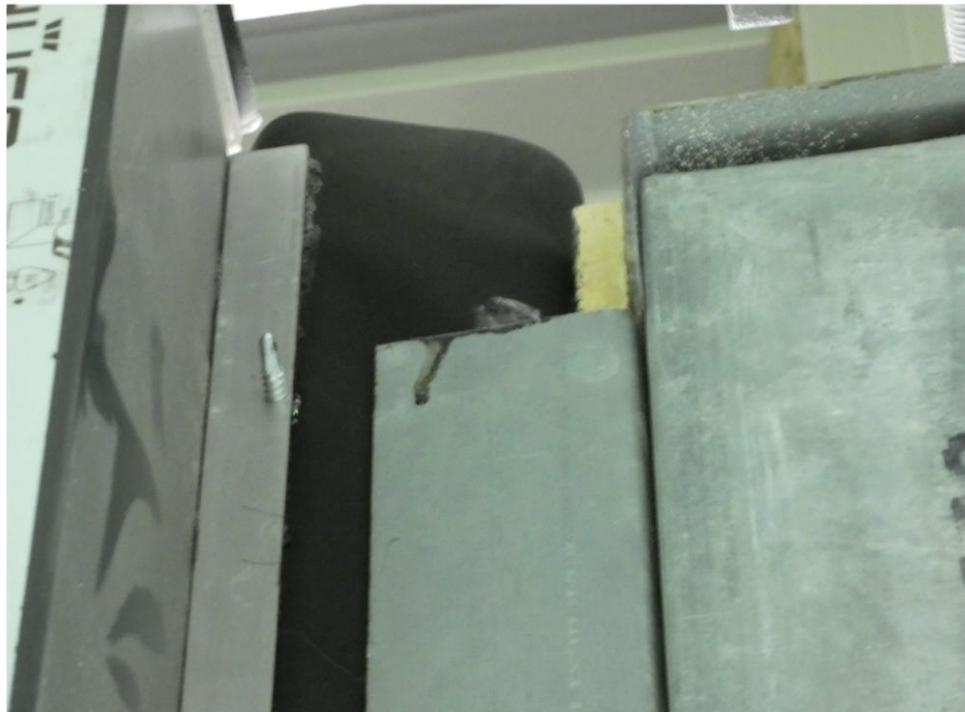
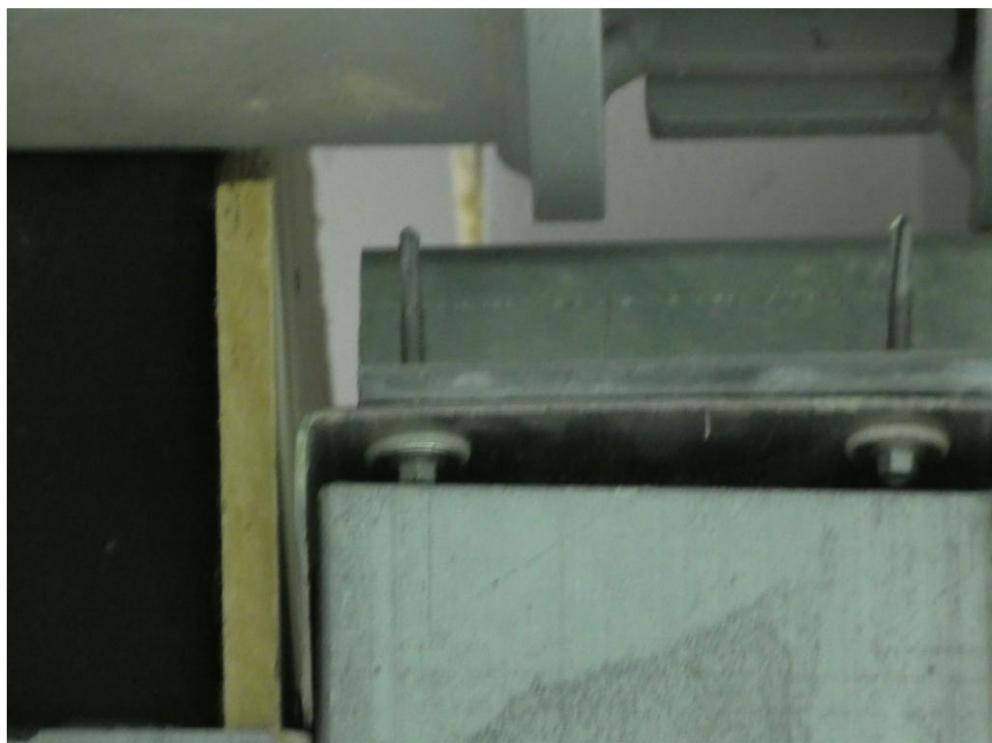
SFS between Doors Riverside - lev 0

Sharp Edge of galv may damage weatherproof membrane. On Another photo there is insulation missing

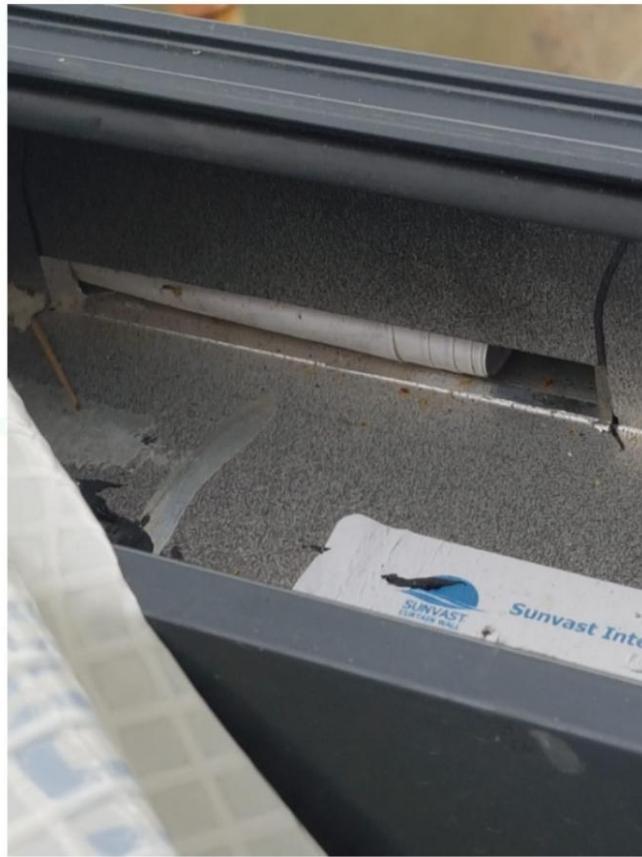
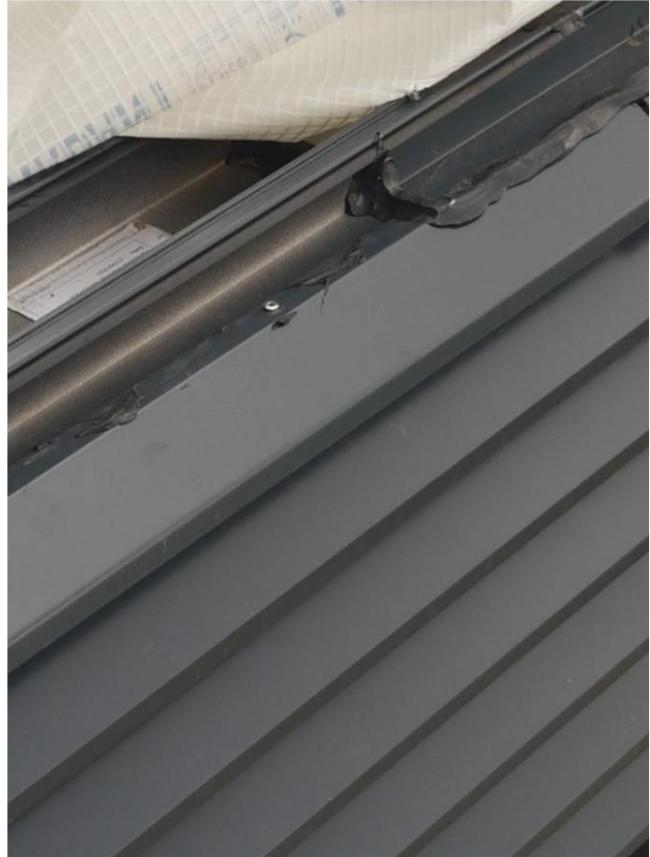
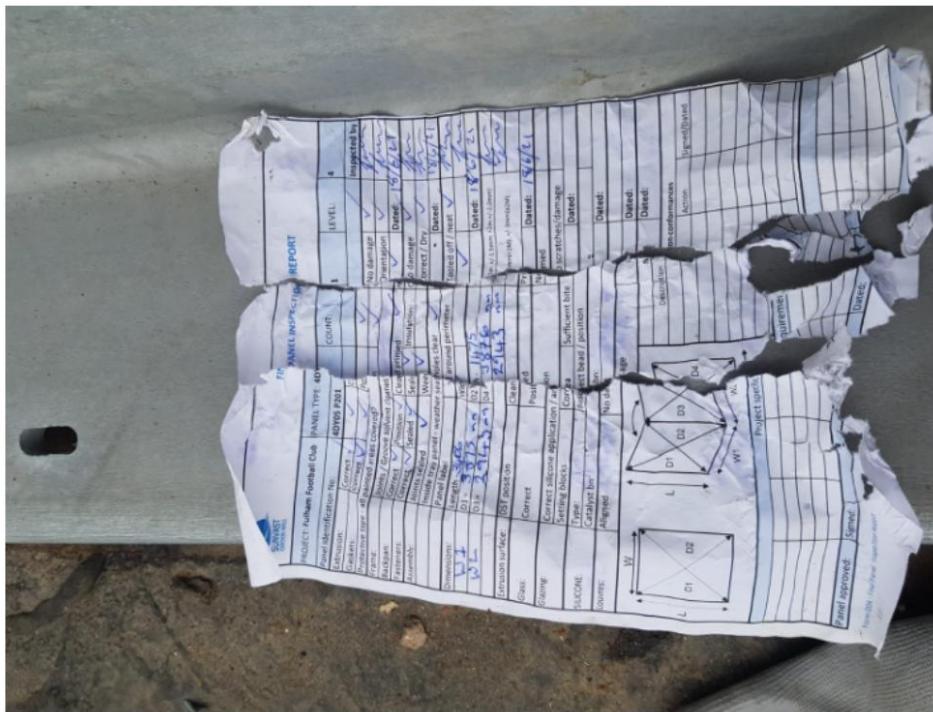
Unitise Panels lev 5

Sunvast blocking drainage channels with Fabrication Qaulity Control Check Sheets. All drainage to be check by Kaicer

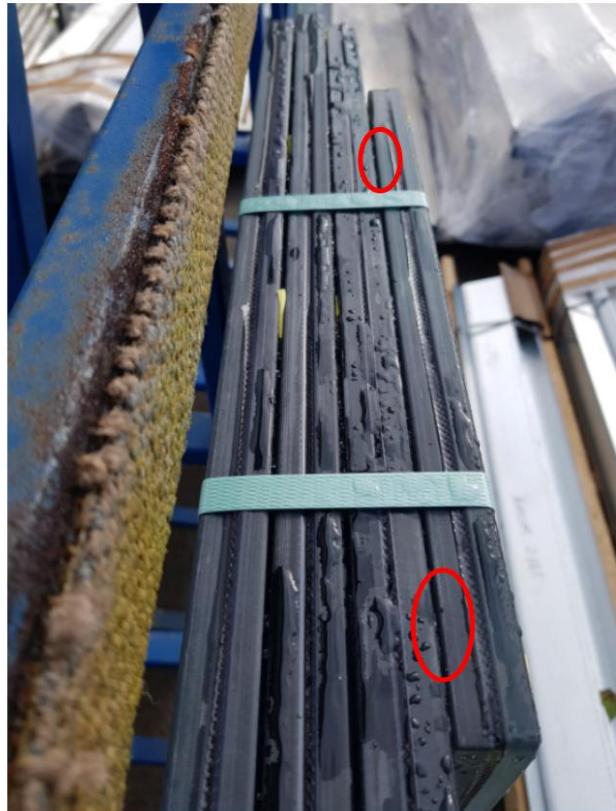
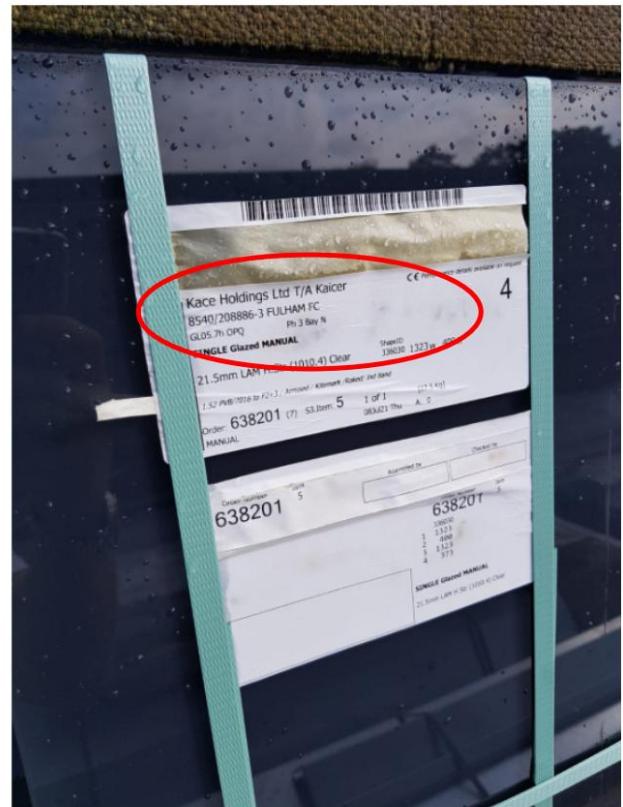
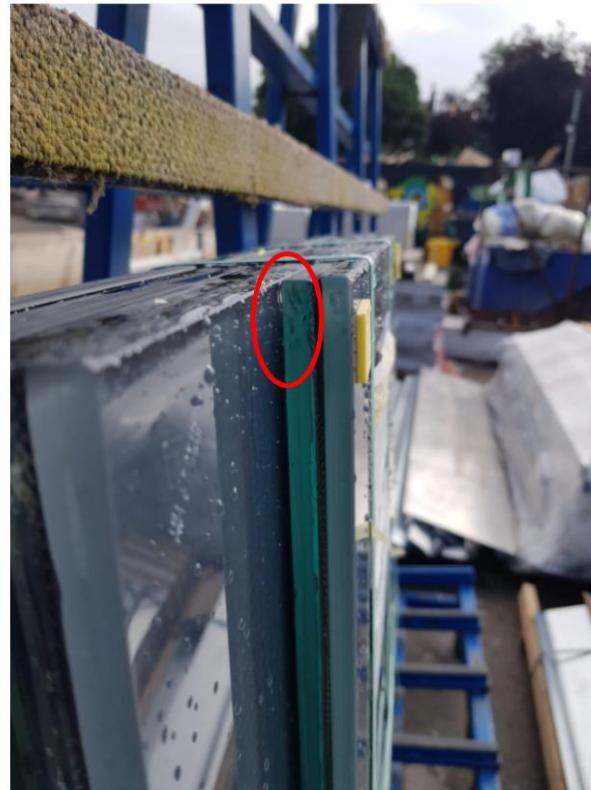
Yard - Glass Panels

Glass Panels delivered to site poor protected - missing spacers and cover sheet, glass shall be individual protected.

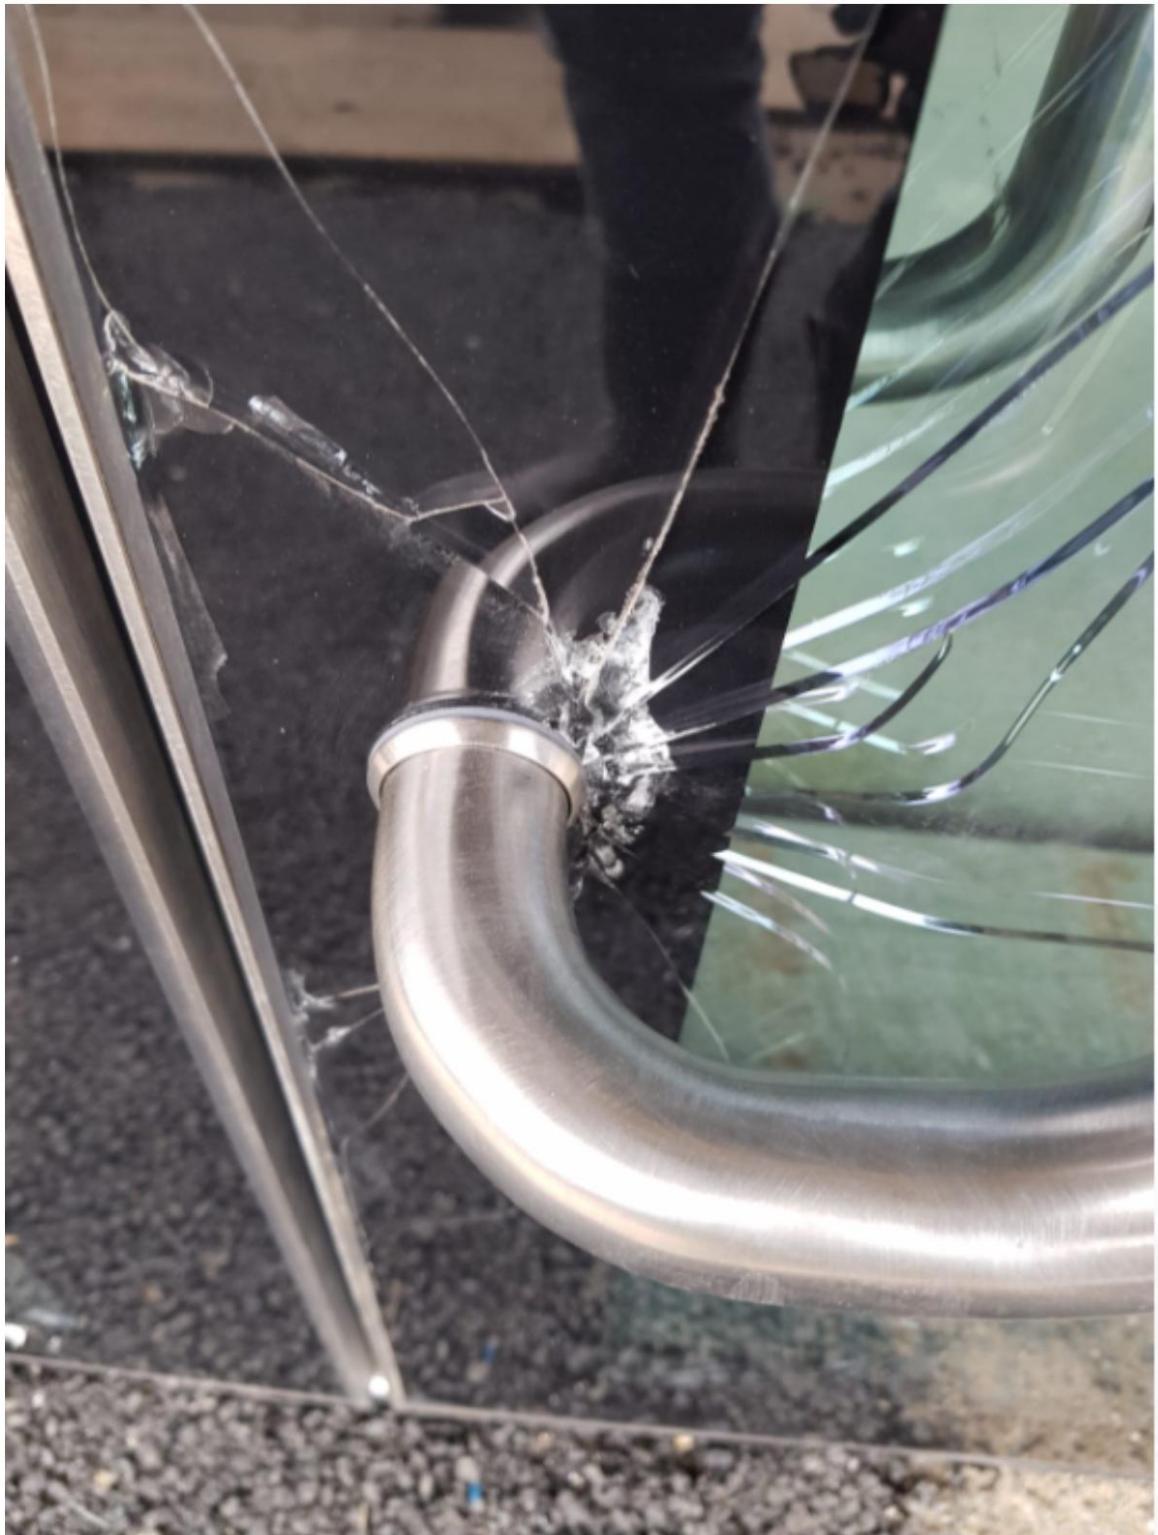
External - Observation Report Main Entrance Door

Kaicer do not interest to protect broken glass - there is sharp edge surface . BGCL recomend attached adhesive tape and protection.

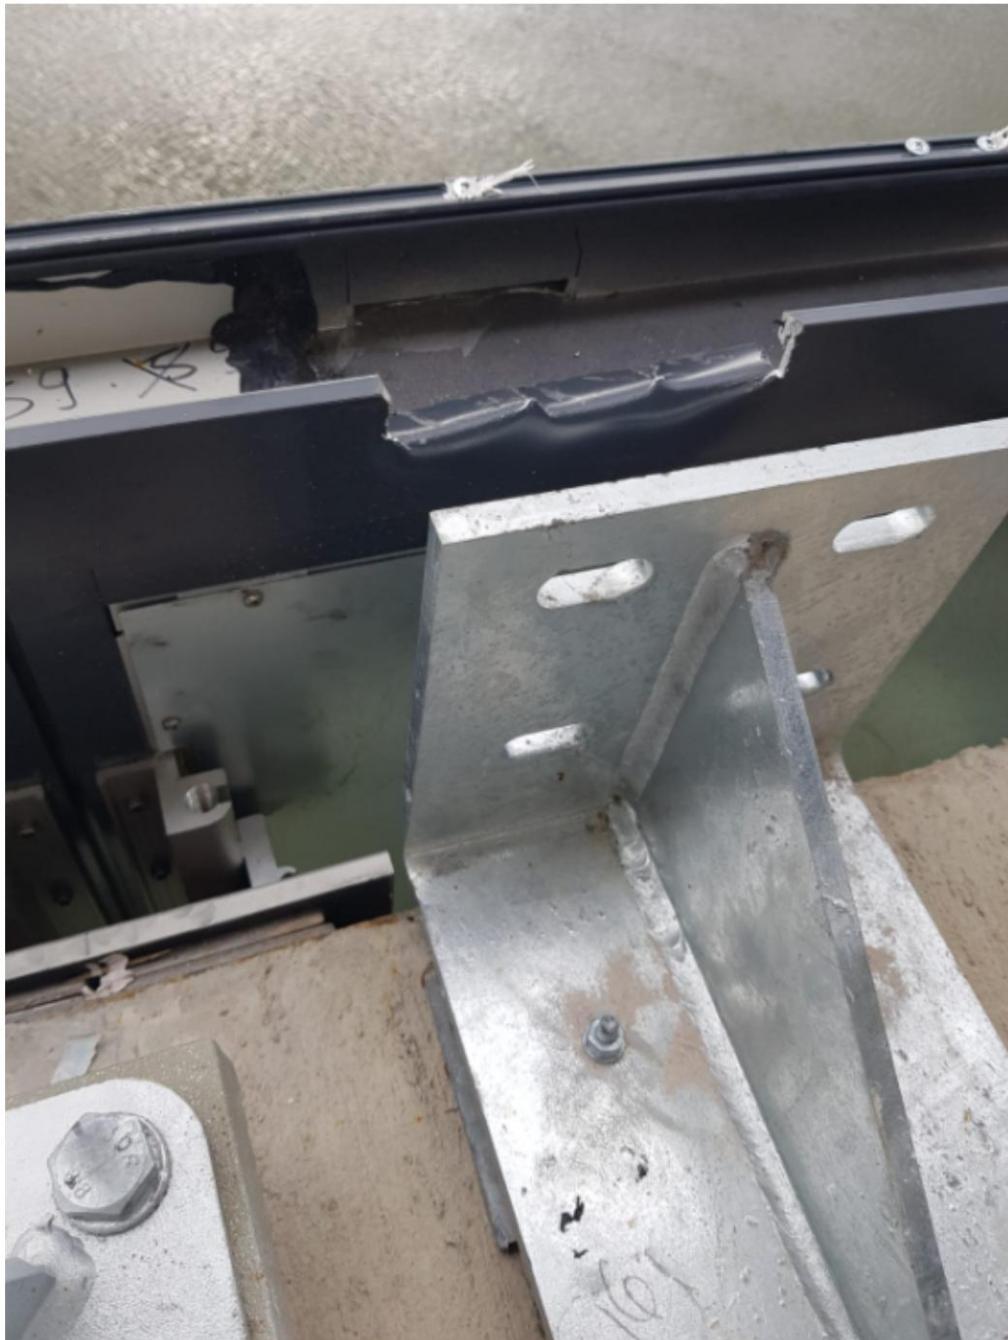
External - Observation Report Unitise Panels lev 5

Unitise had damage / notch off top of Panels due to installing Balustrade top of Brackets . Kaicer / Sunvast to advise if Panels to loose performance.

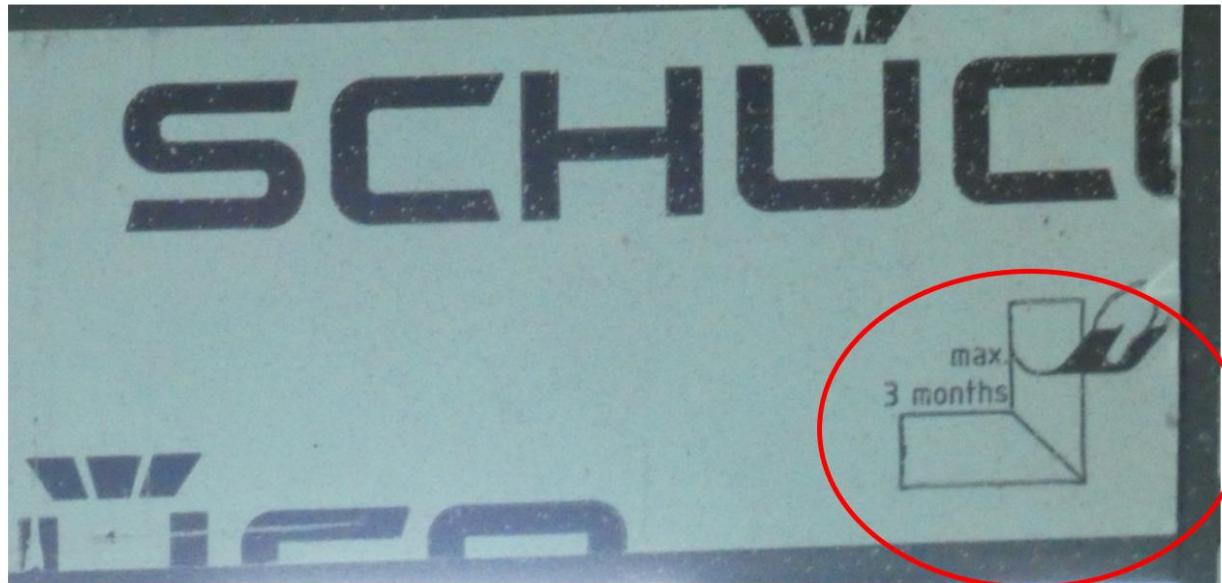
External - Observation Report Schucco - Doors and CW

On the Schucco Protection Film there is max 3 months information signs. Some of Curtain Wall/Doors due to not completed on time have tape left over 6 months. Please contact to the schucco and advise if is any problem with the coating if Protection film is left / extend over 3 months.

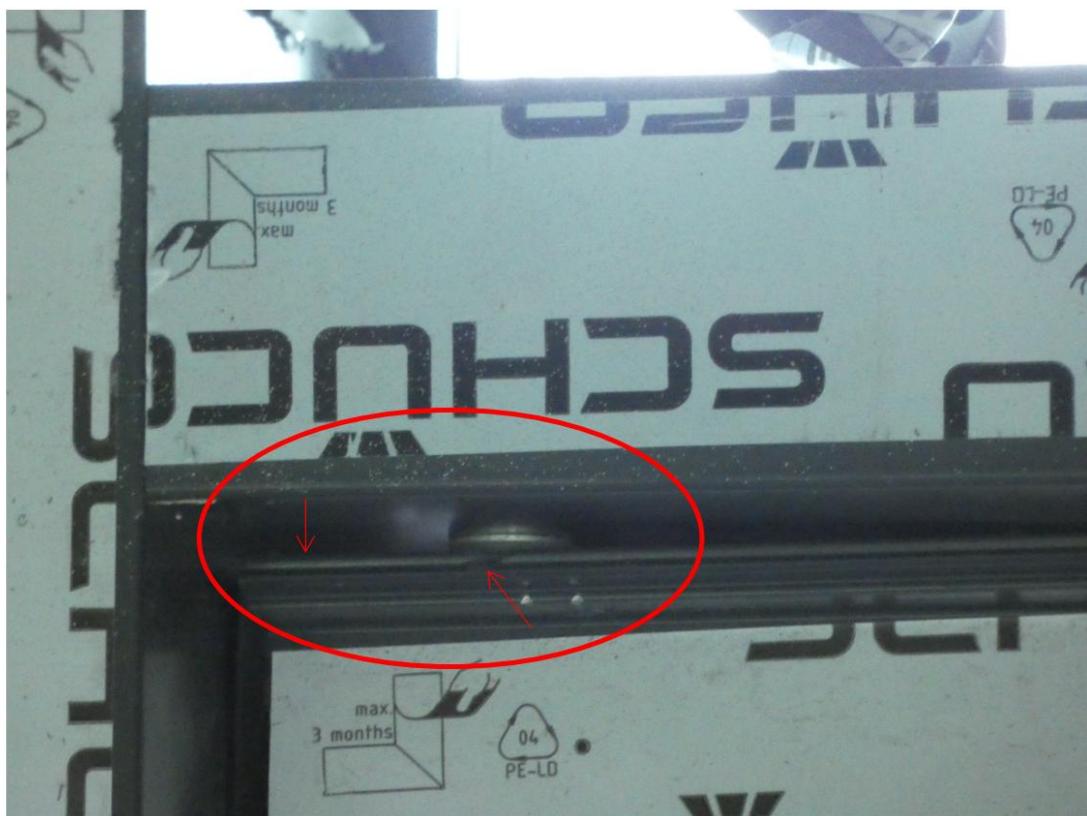
Due to changed Details for Fixings Doors - top trim clashed against transom bolt - Kaicer to advise if these Doors Installed to the Frame as per Schucco Manual .

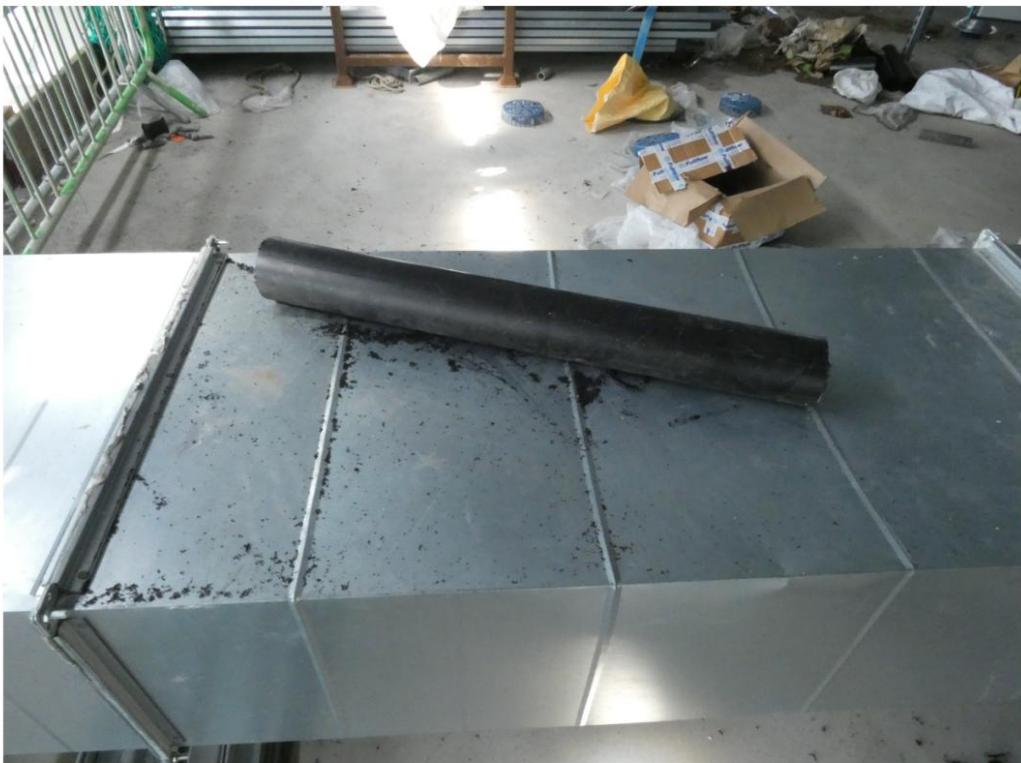
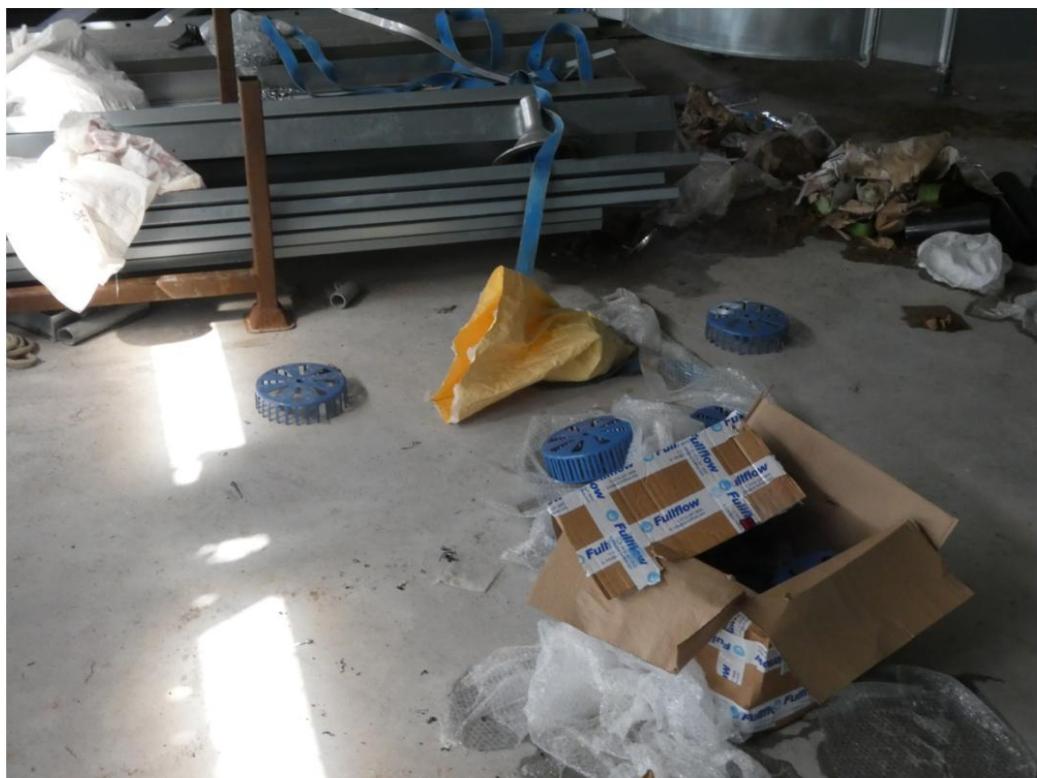
External - Observation Report Fullflow Syphonic lev 6 and the Roof

Kaicers Subcontractor left rubbish on Level 6 and when they have cut pipes and damage - dent ventilation duct
