External - Observation Report

- Roof Issues, Gutters
- Unitise Panels
- Fullflow
- Curtain Wall Doors and Glass
- SFS and Firestop
- Rimex and Metal Soffit

August 2021

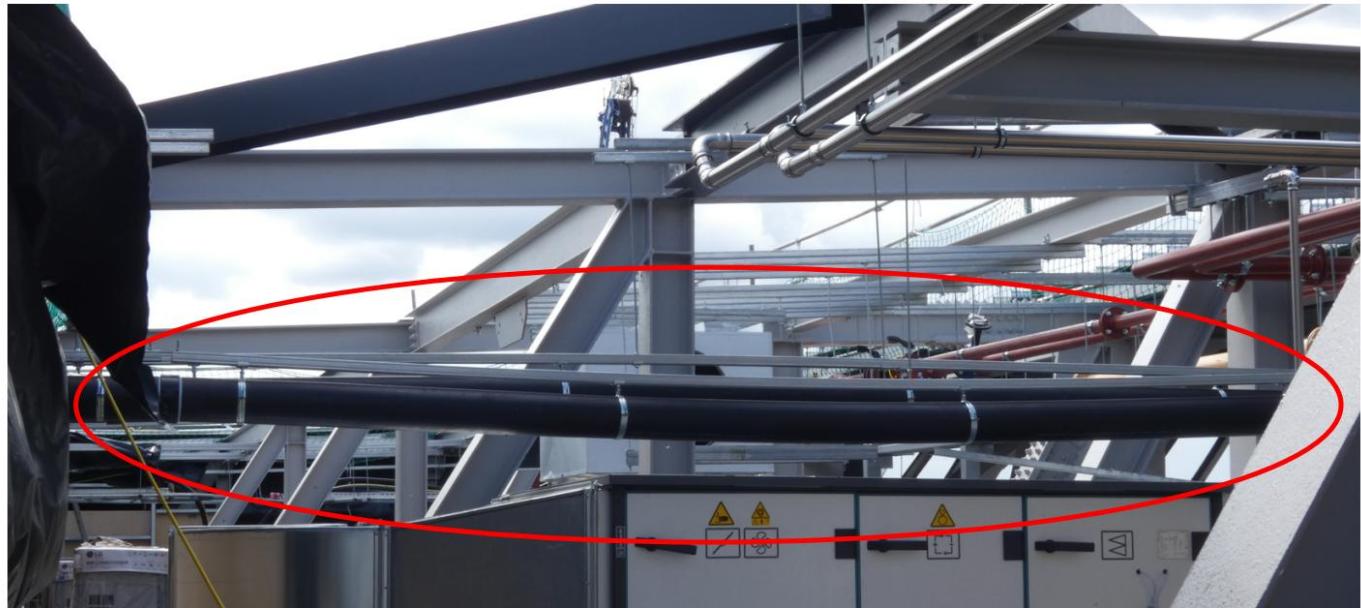
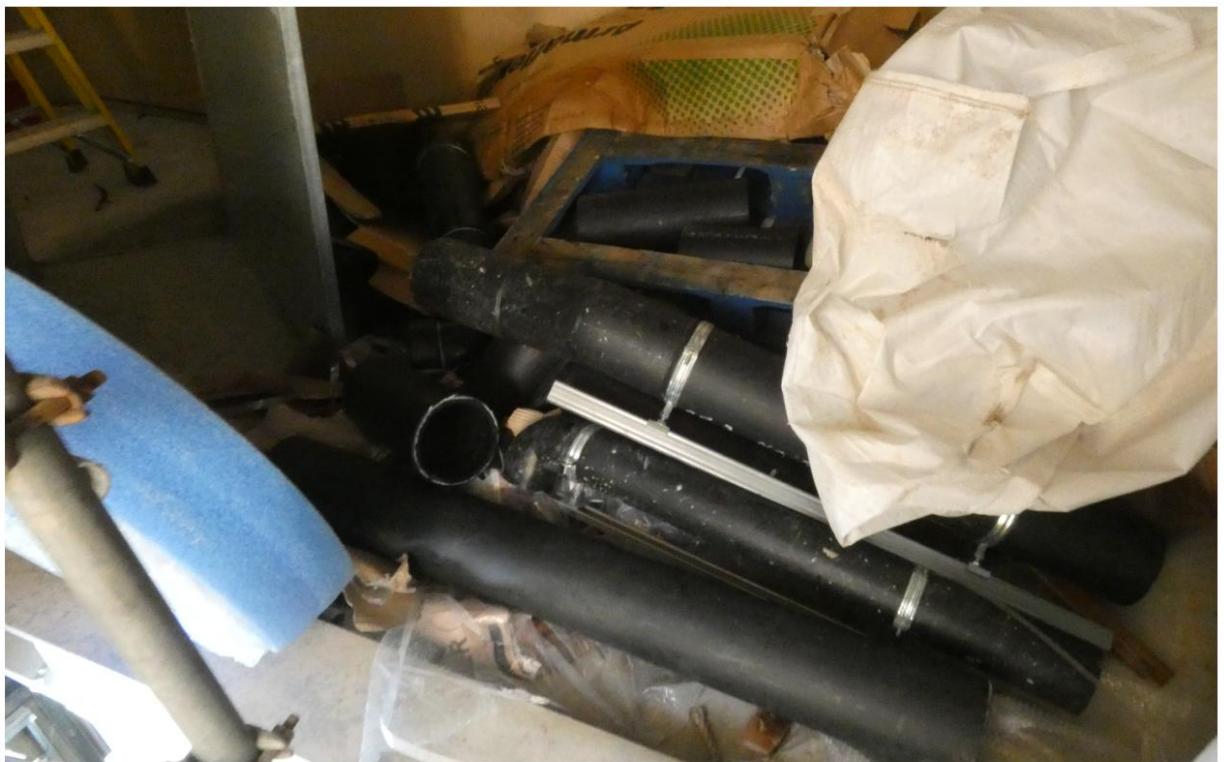
Fulflow - Lev 6

Drainage Pipe no in the level as per Drawings, Pipe Cut Out was left on the roof

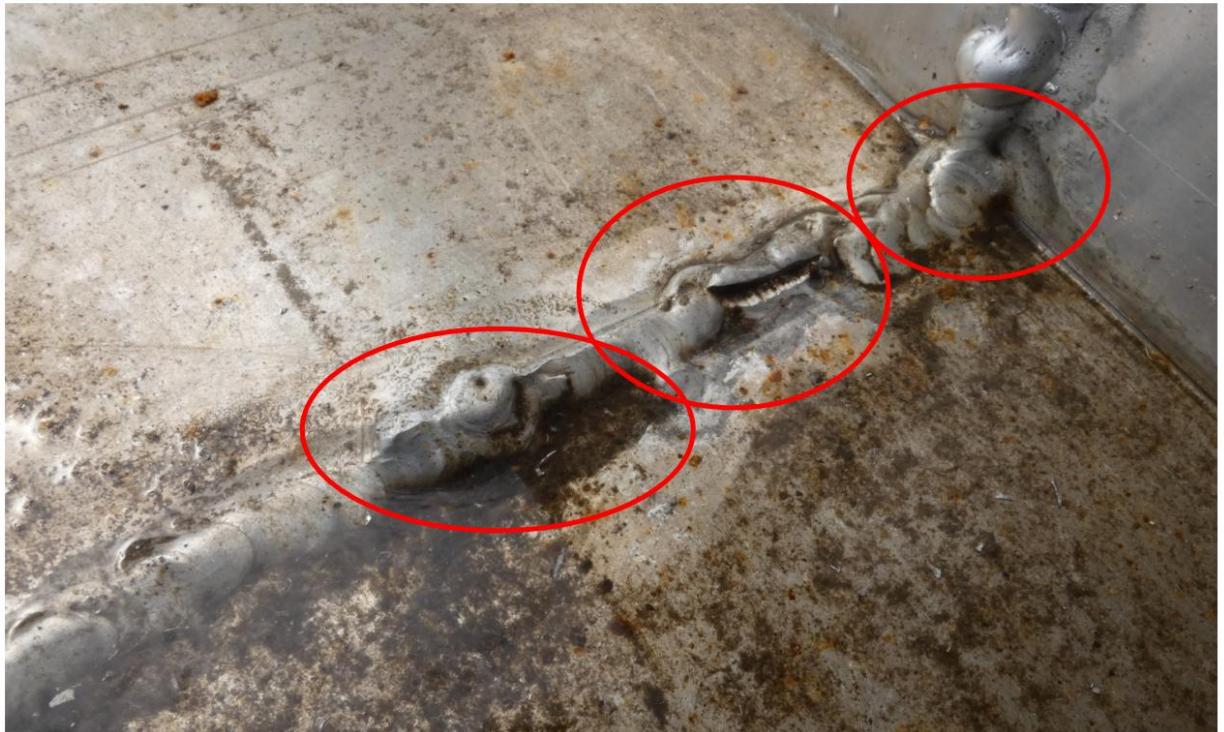
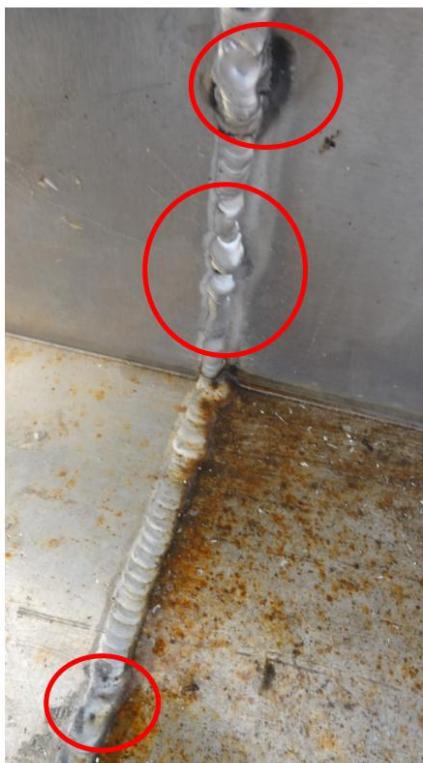
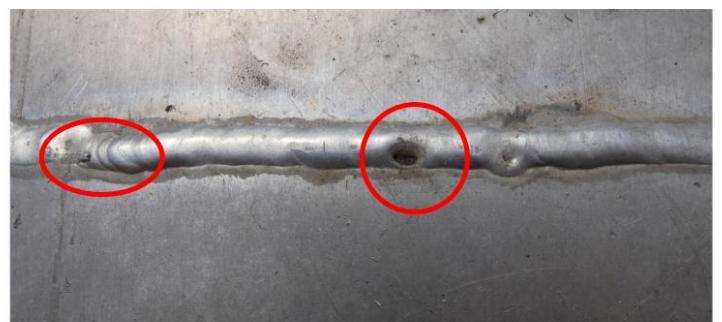
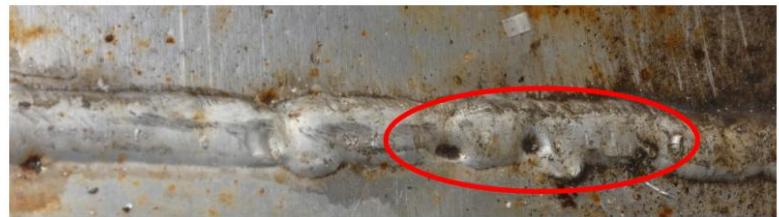
Roof - Gutter

Poor Qaulity of Welding Joints
Rust to be clean off from the Gutters

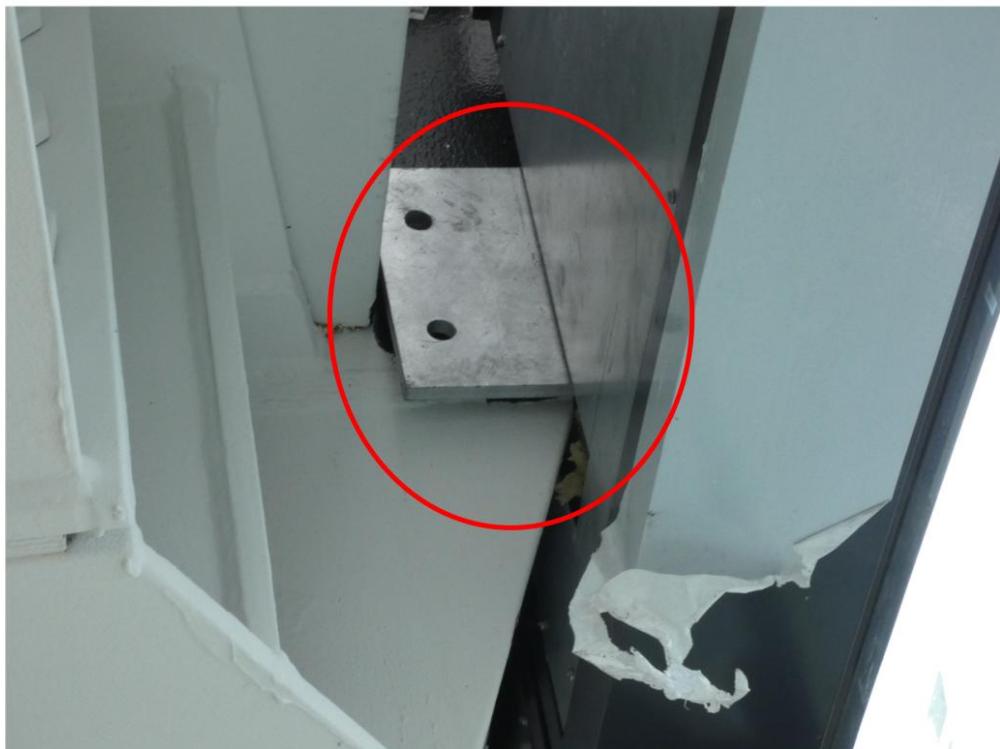
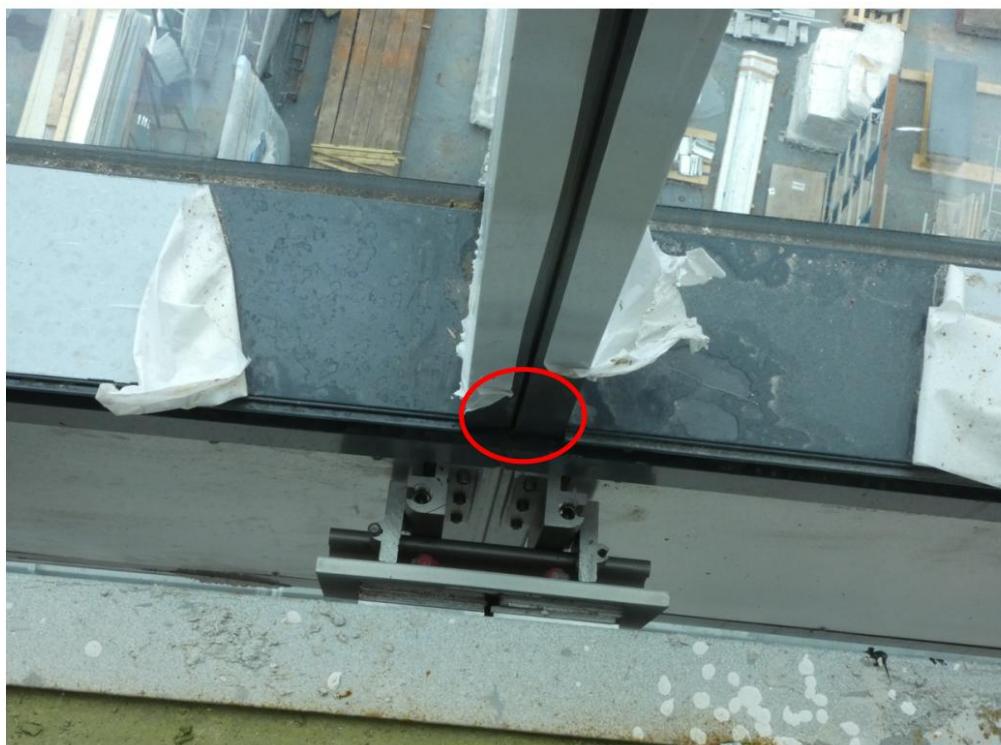
Unitise CW - Lev 4

Unitise Panels Not Installed and Out Off Tollerance

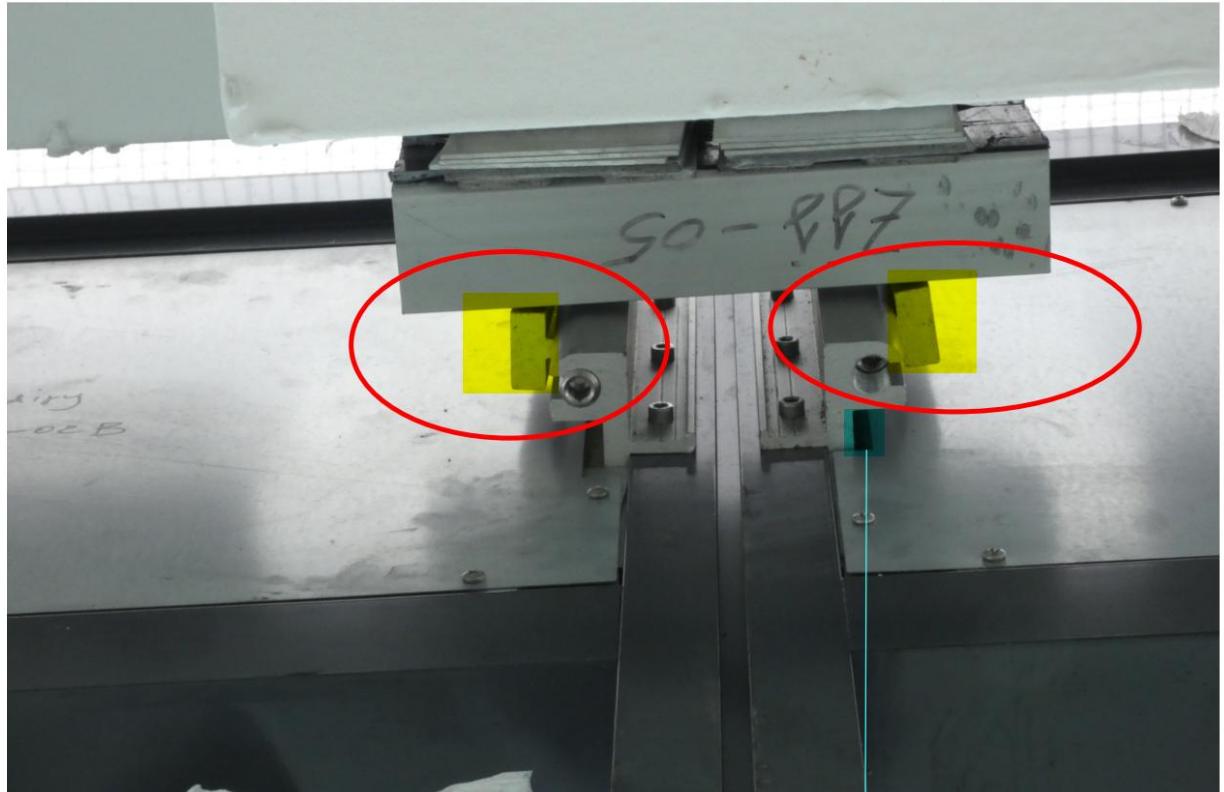
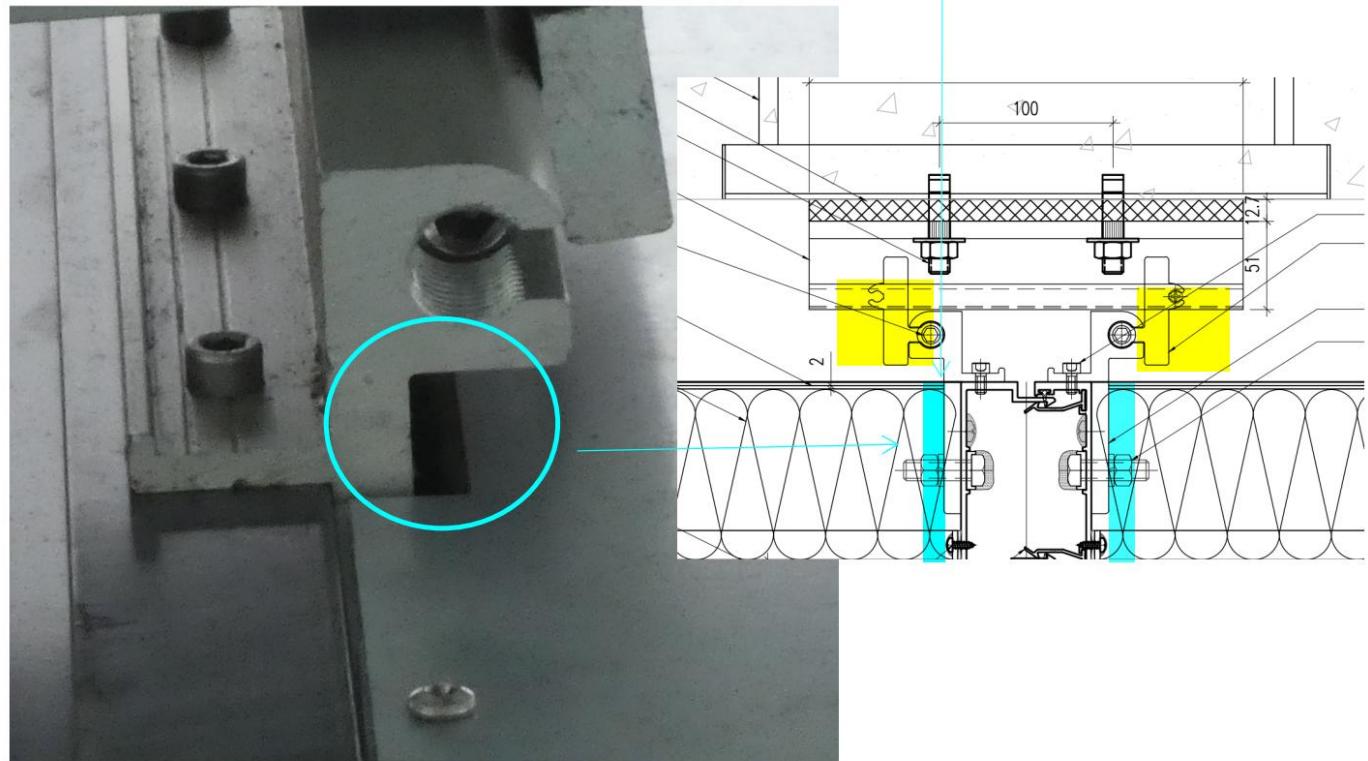
External - Observation Report Unitise CW - Lev 4

Brackets unnatural twist/ forced see mark yellow and drawing below.

Missing insulation and thermal gaps for insulation marked by blue.

No silicon between closure galv pale and panels - and risk of condensation ingress to the building.

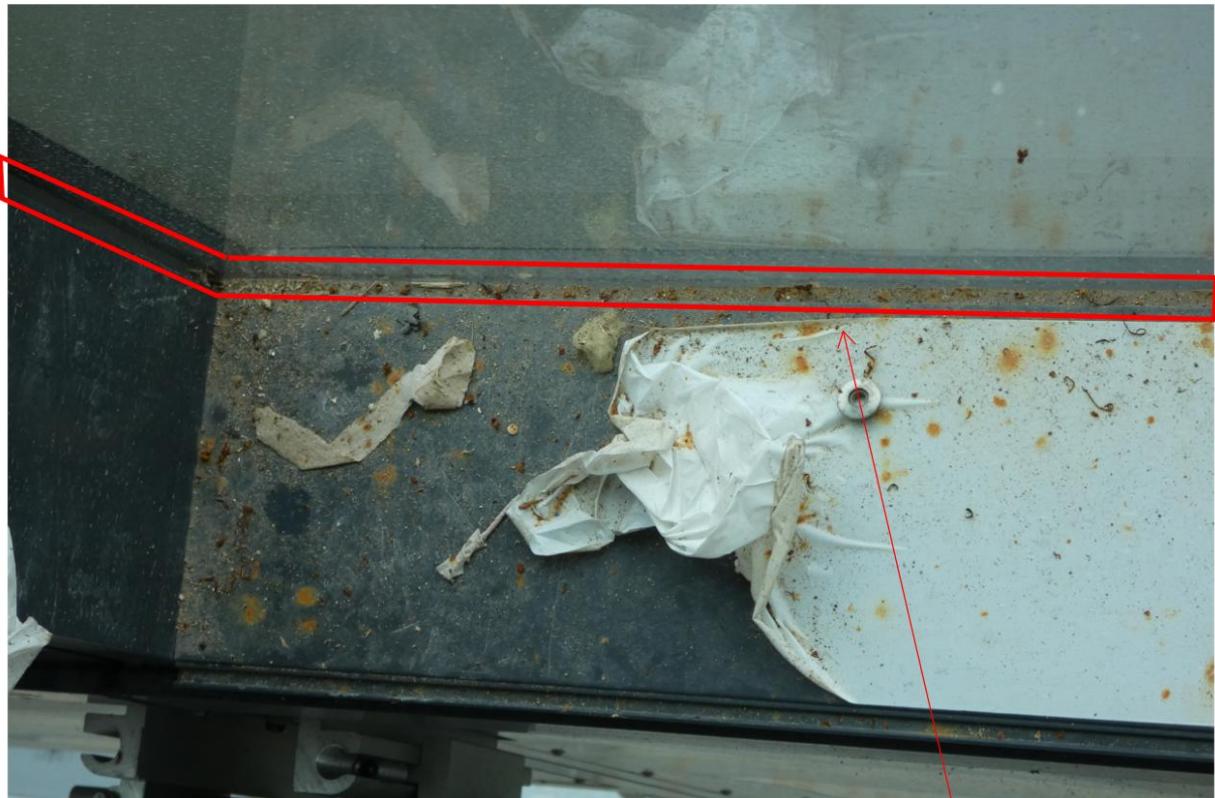
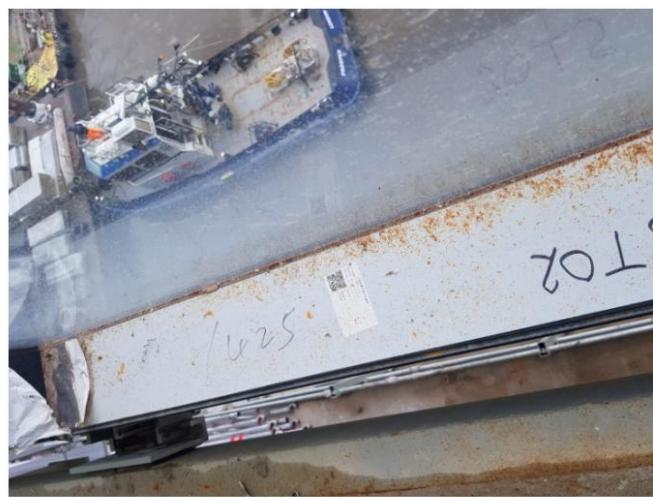
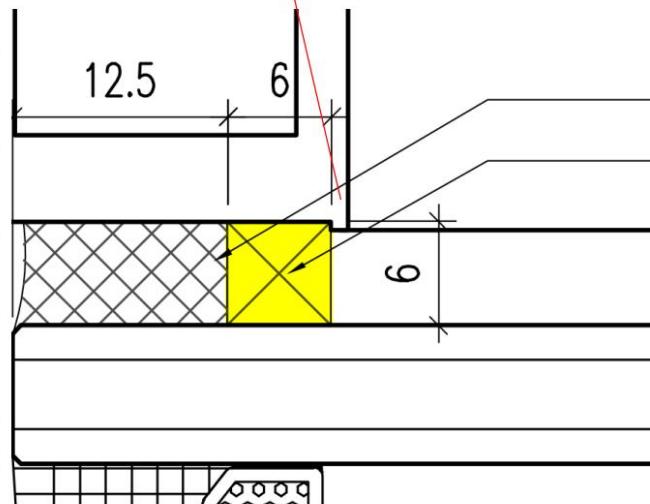
Unitise CW - Lev 4

Unitise Panels poor protected , debris and bits left from from Drilling and rust marks left on the surface

Foam Highlighte in Yellow shall be flush with transom/mulion surface no more +/- 1mm
Sunvast Fabricate unitise where this foam its a lot deeper then shoul be - now is perfect environment to creat dust and will be difficult for a cleaning and mainatinining.

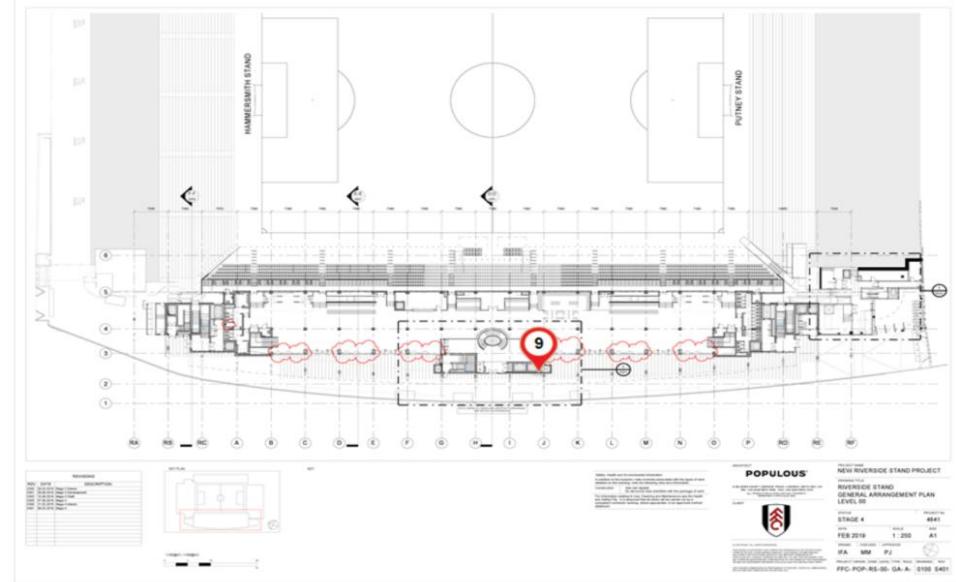
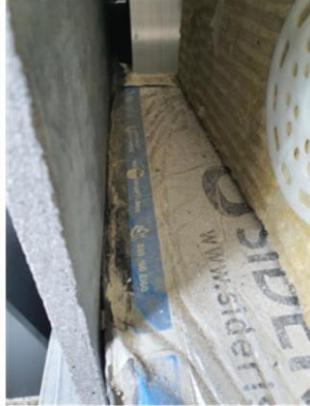
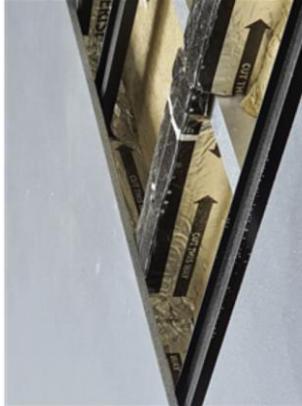
SFS/GRC Firestop Lev 5 / 5-4 and 0-1

IFCO Record			
IFCO PIN NUMBER	9	IFCO Title	No air gaps on horizontal cavity barriers
Description of the Issue	No air gaps have been observed between the horizontal cavity barriers and the cladding panels. Siderise recommend an air gap of maximum 50mm for this product to ventilate the facade.		
Associated Work Package	GRC cladding systems

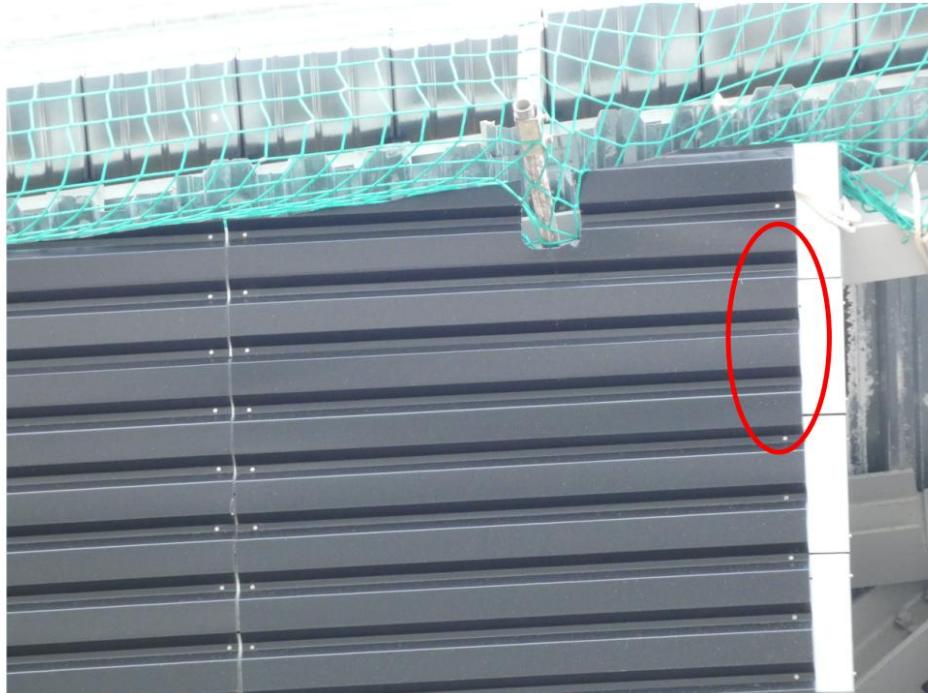
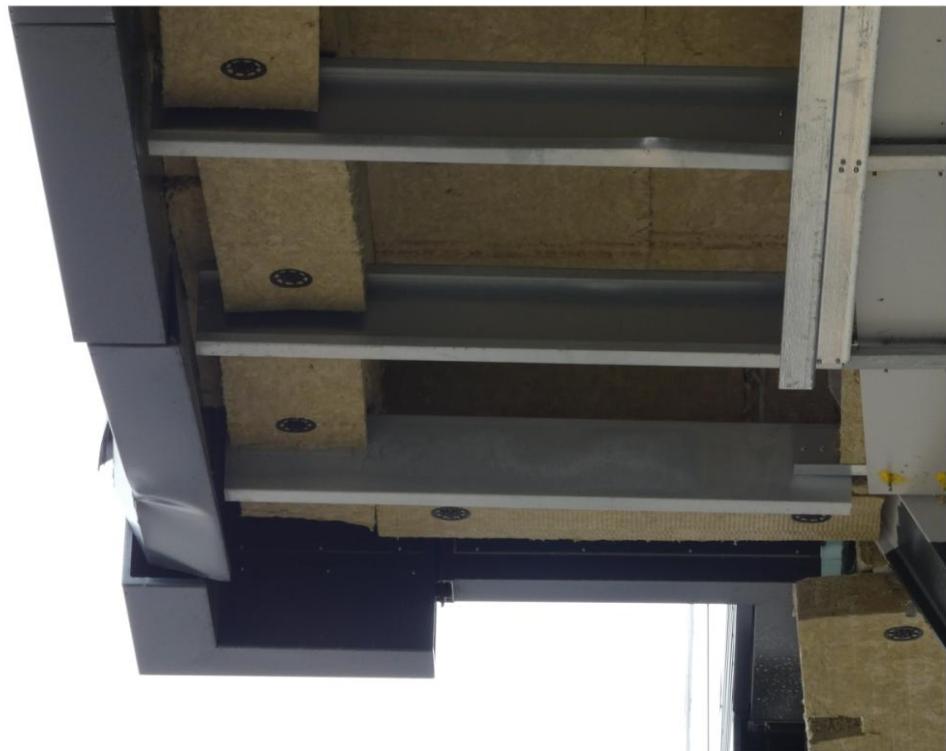
Rimex Soffit - lev 6 and Lev 1 top

Each trapezonal Sheets to be re-check and sign off by BGCL. Photos Below shown Missing Fixings lev 6

Unitise Bottom Panels had no replaced and is damaged lev 1

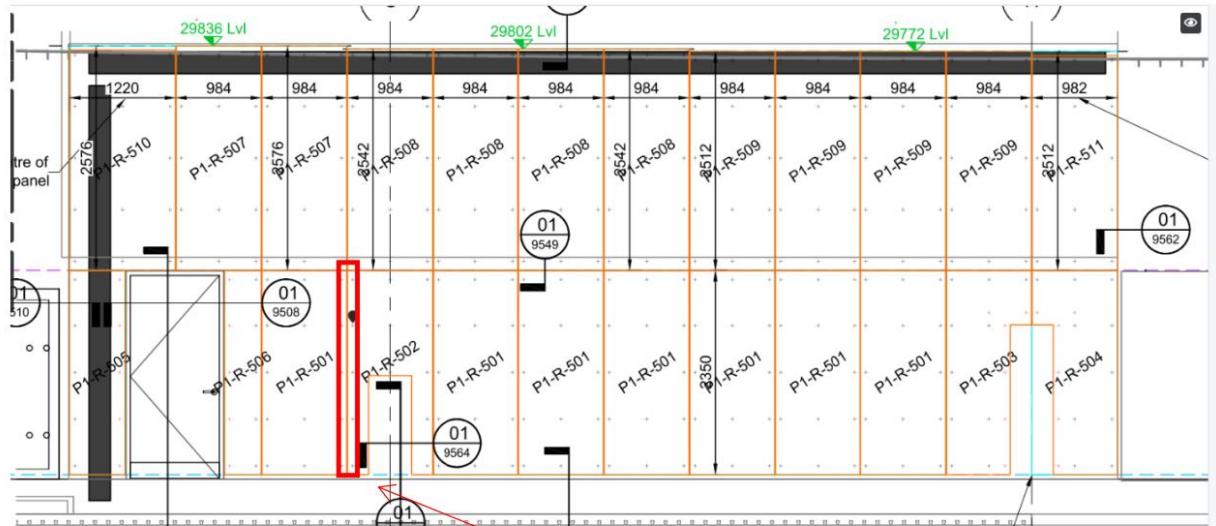
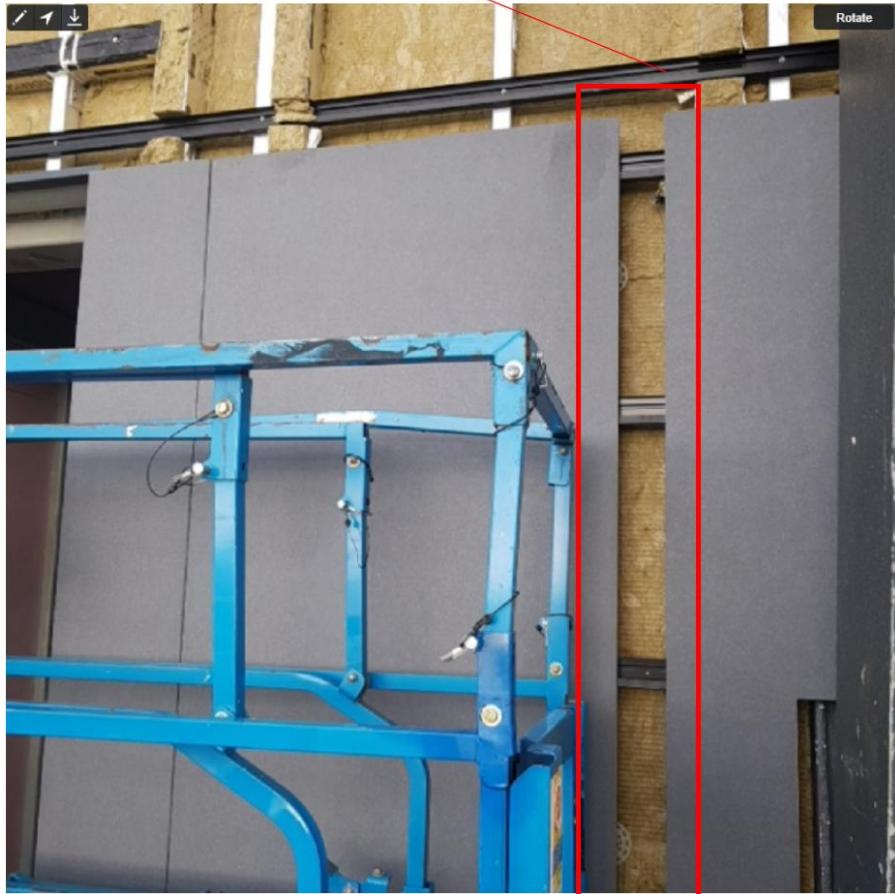
External - Observation Report GRC Firestop Lev 5

GRC Panels not layout as per plan
