Observation Report 04.02 – 11.02.2021

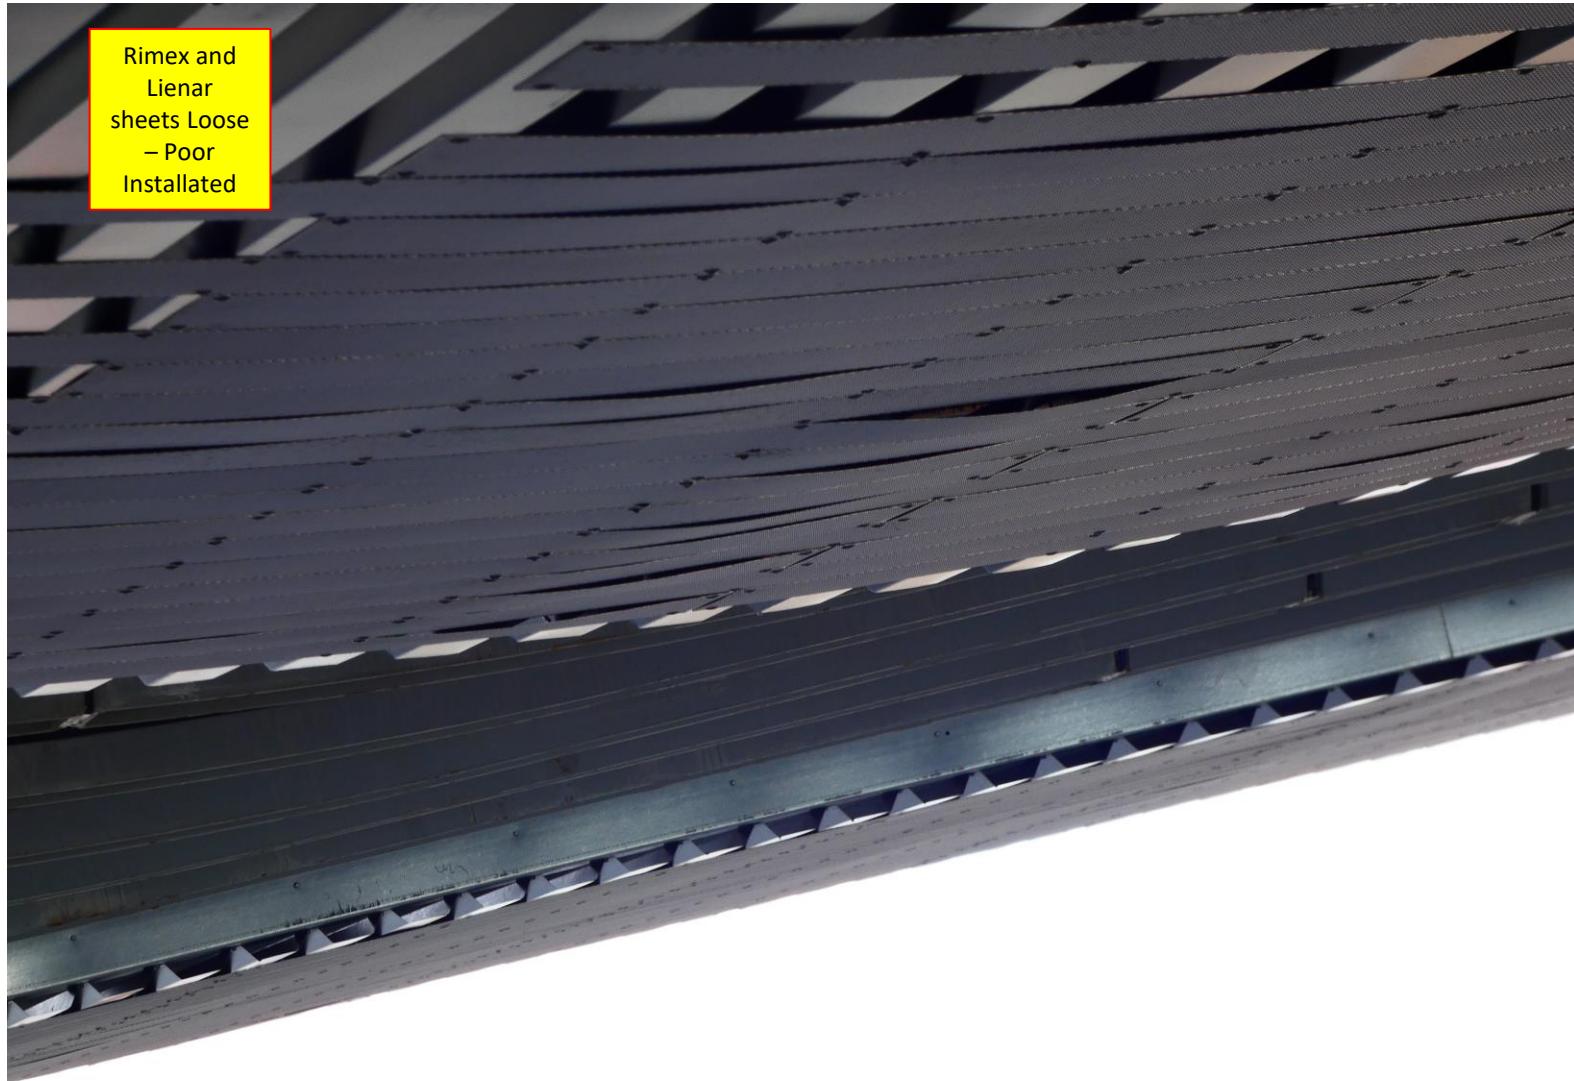
P2A/RF/RIM_TR3 – Rimex Panels installed out of tolerance Truss nr 5

Backing Structure poor installed , rimex bowed and bailinear sheets loosed – please refer to video attached.

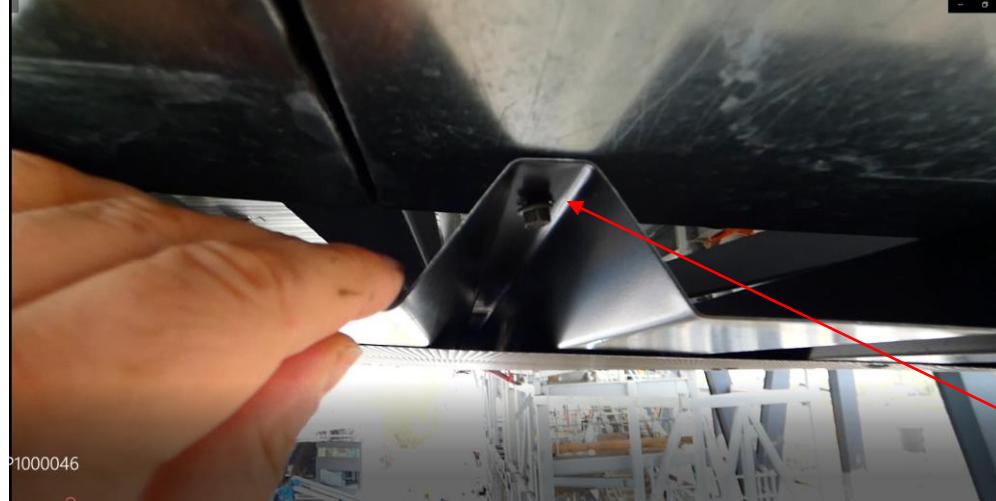
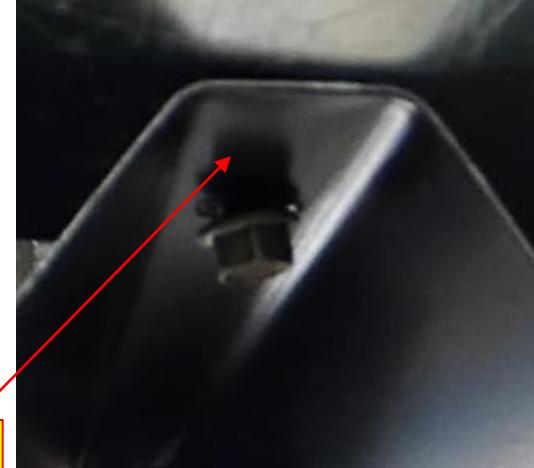
P2A/RF/RIM_TR3 – Galv backing structure and fixings not installed in line as per drawings

There is side wide issues where Kaicer do not follow drawings , in affect loose tolerance over 5mm on Rimex panels – Ref to Video.

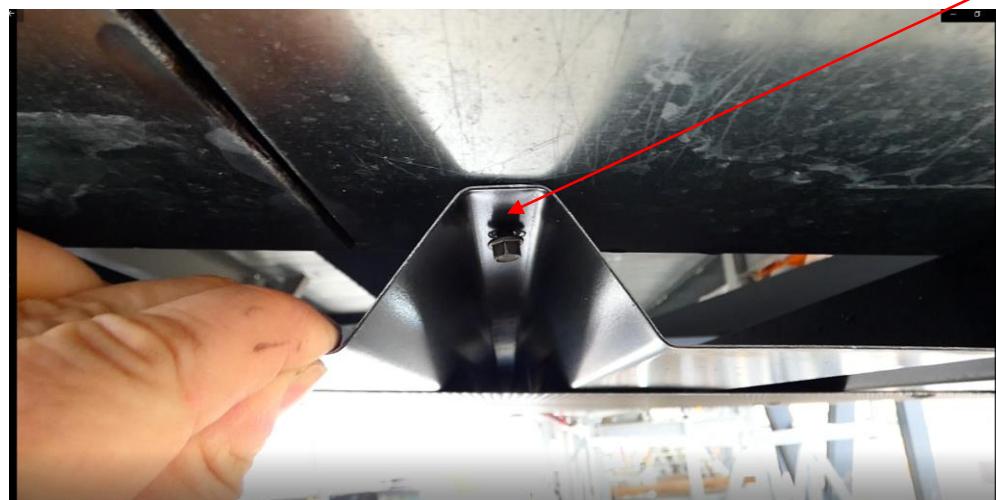
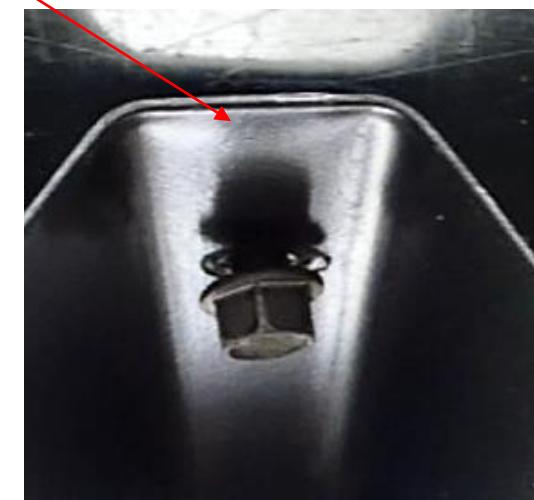
Fixing not
installed
correct

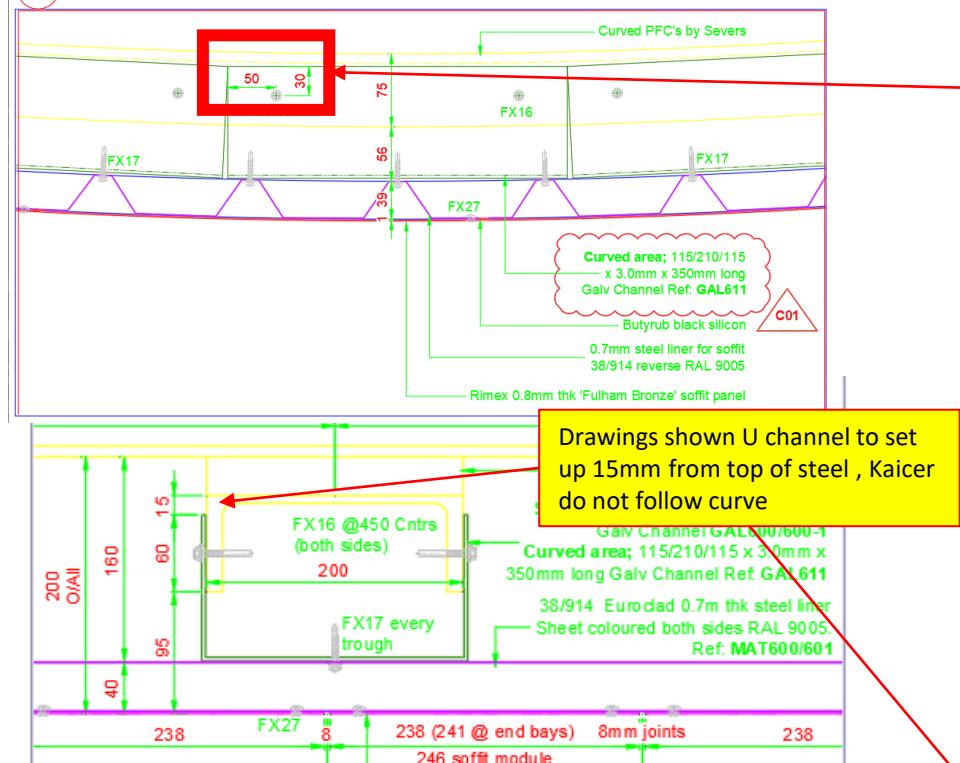
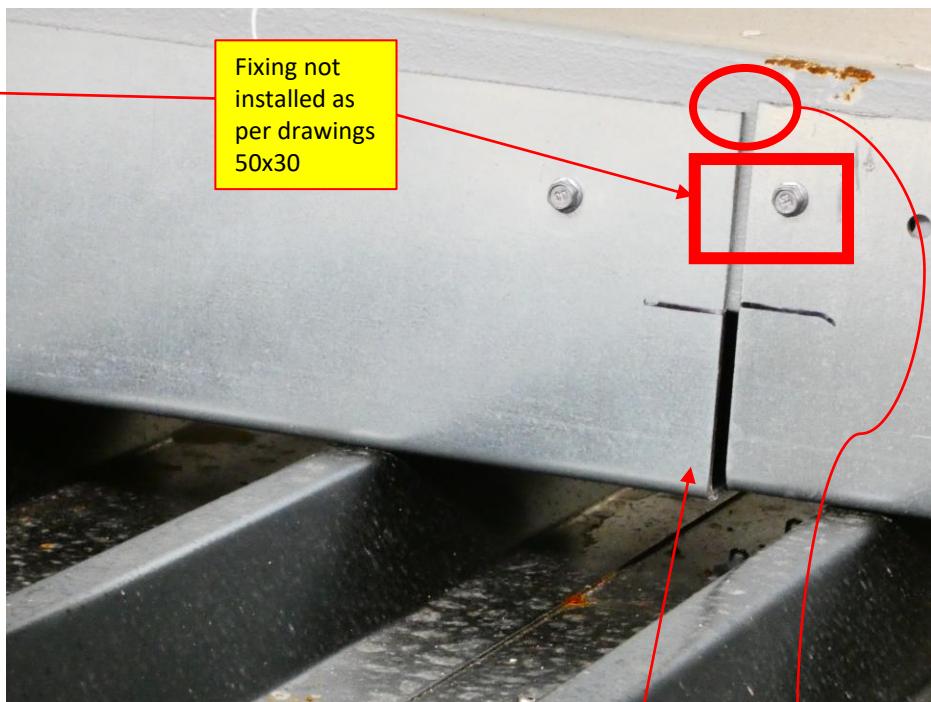
AA Section A-A

P2A/RF/RIM_TR5 – Galv backing structure and fixings not installed in line as per drawings

There is side wide issues where Kaicer do not follow drawings , in affect loose tolerance over 5mm on Rimex panels

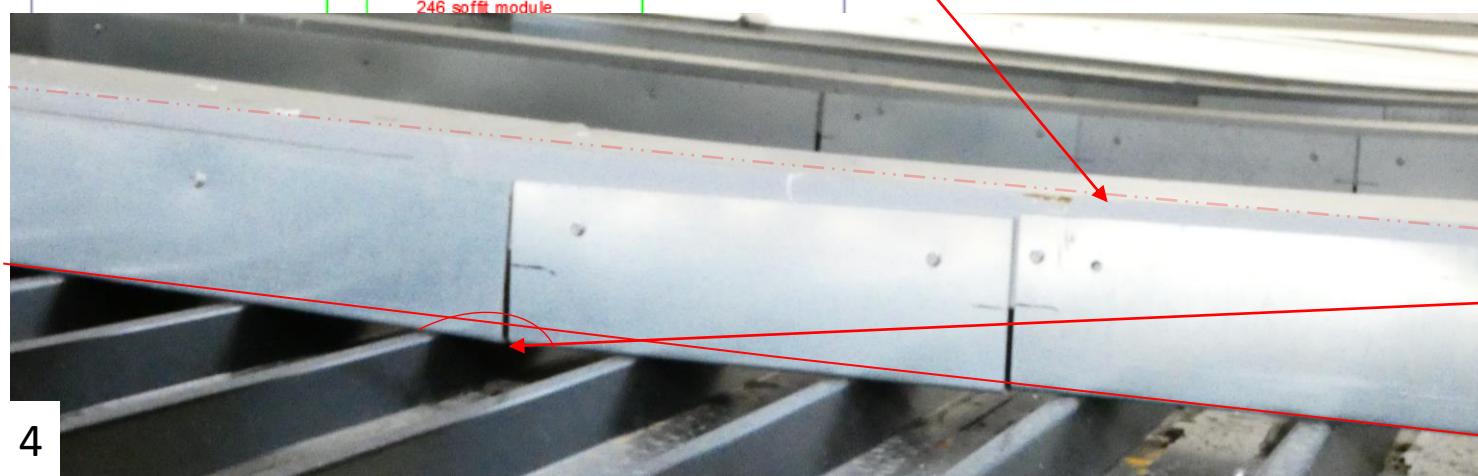
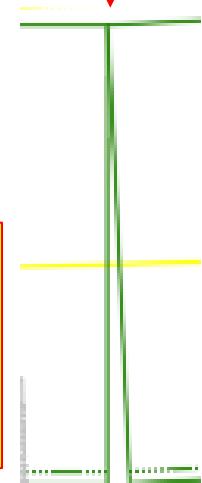
Step on Galv
Channels/not
installed as
per drawings
will affect
Linear and
Rimex Level

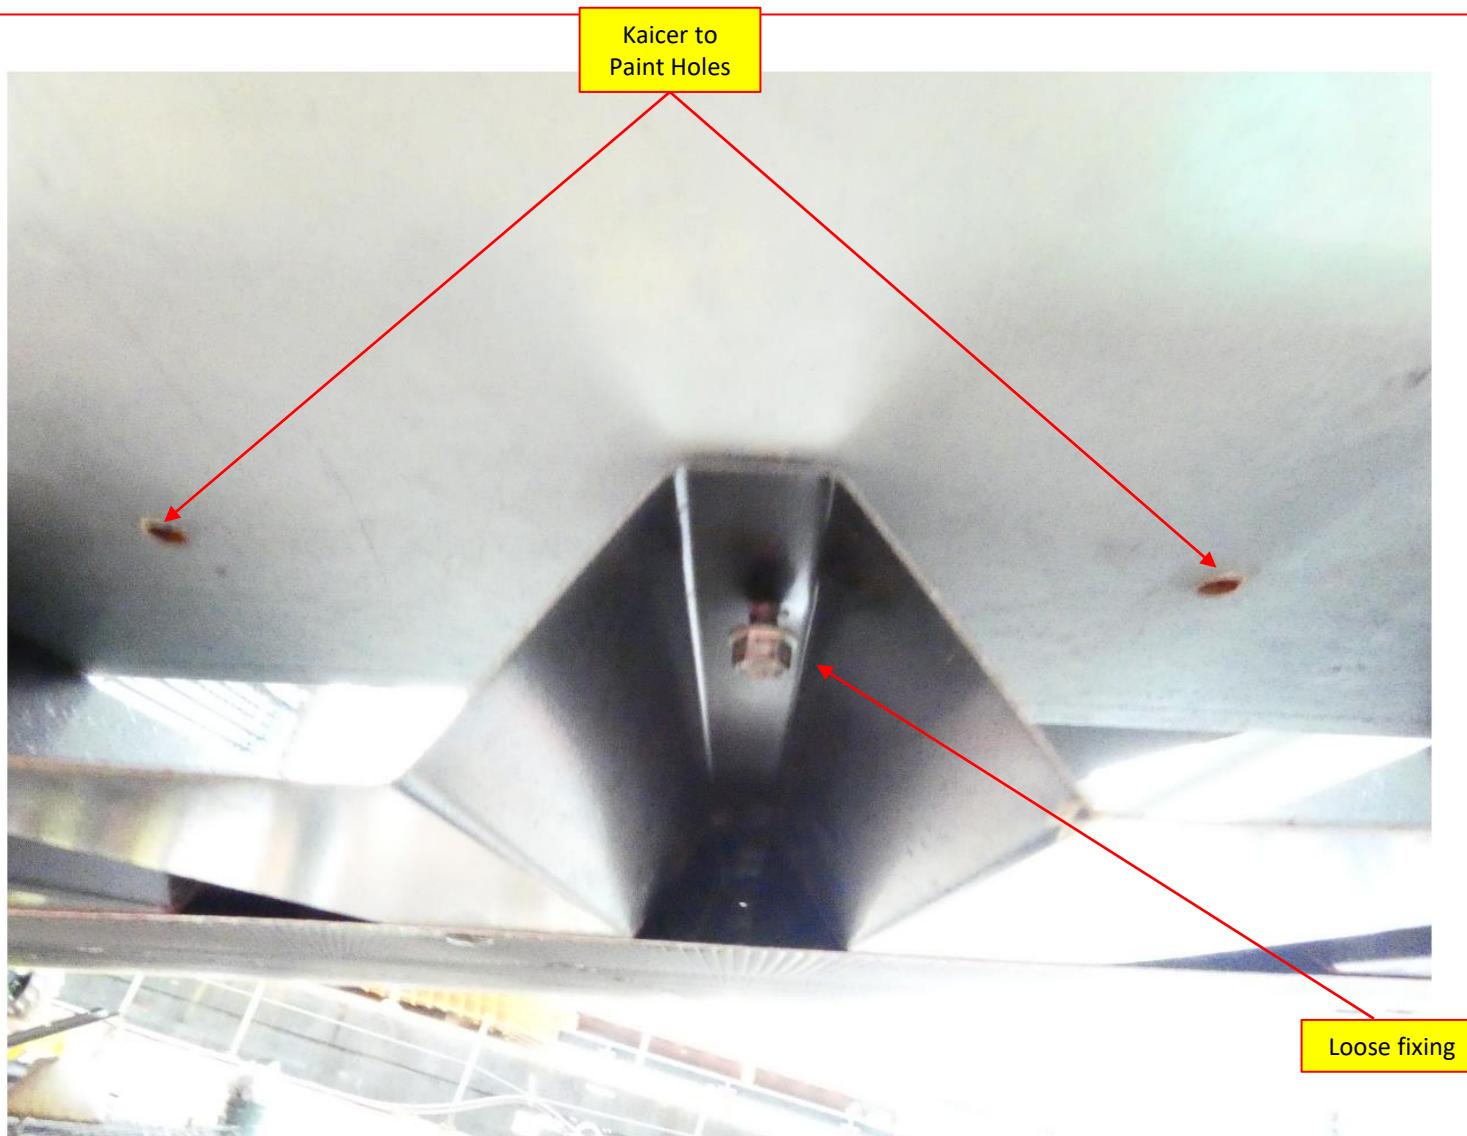
P3/RF/RIM_TR6 – Loose Fixings not Installed Correct

As per photo below, Kaicer to advise why this is site wide problem that fixings not installed correct

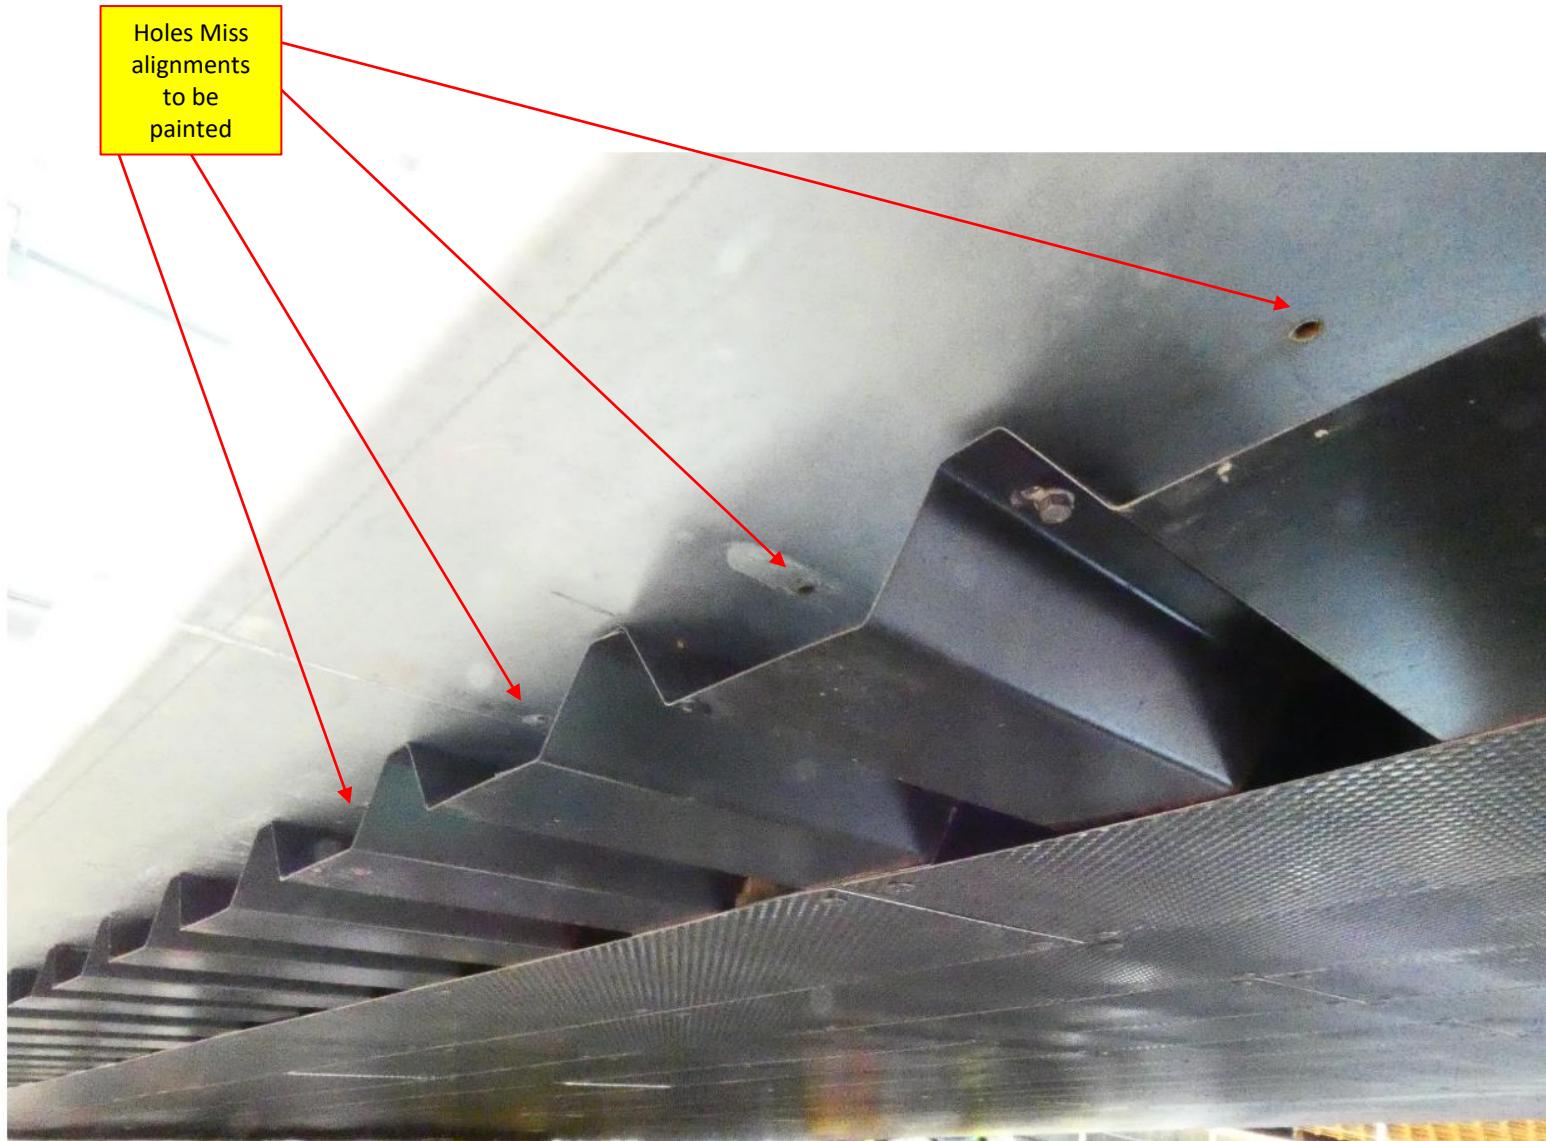
P3/RF/RIM_TR6 – Kaicer Miss Alignment and unwanted holes exposed

Holes on Galv channels to touch up against corrosion.

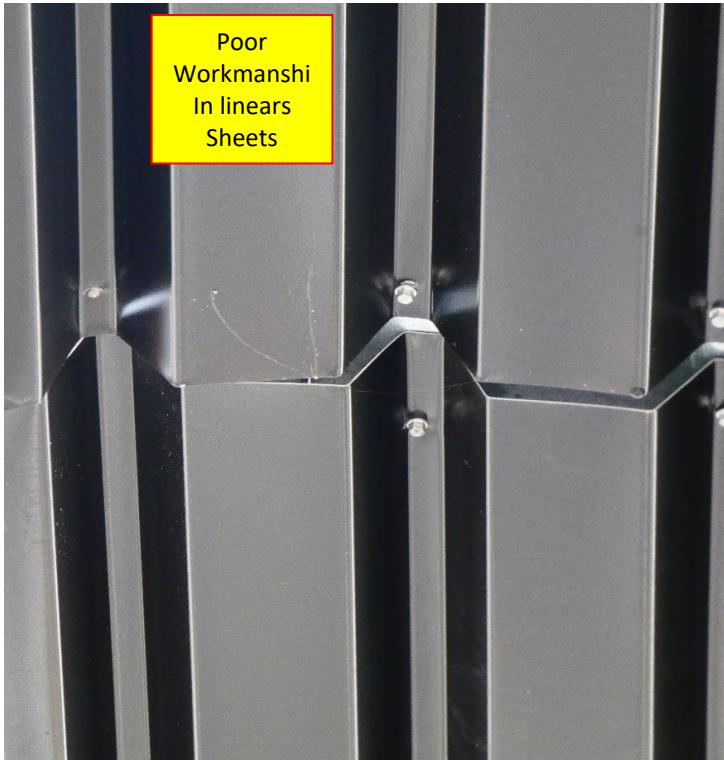
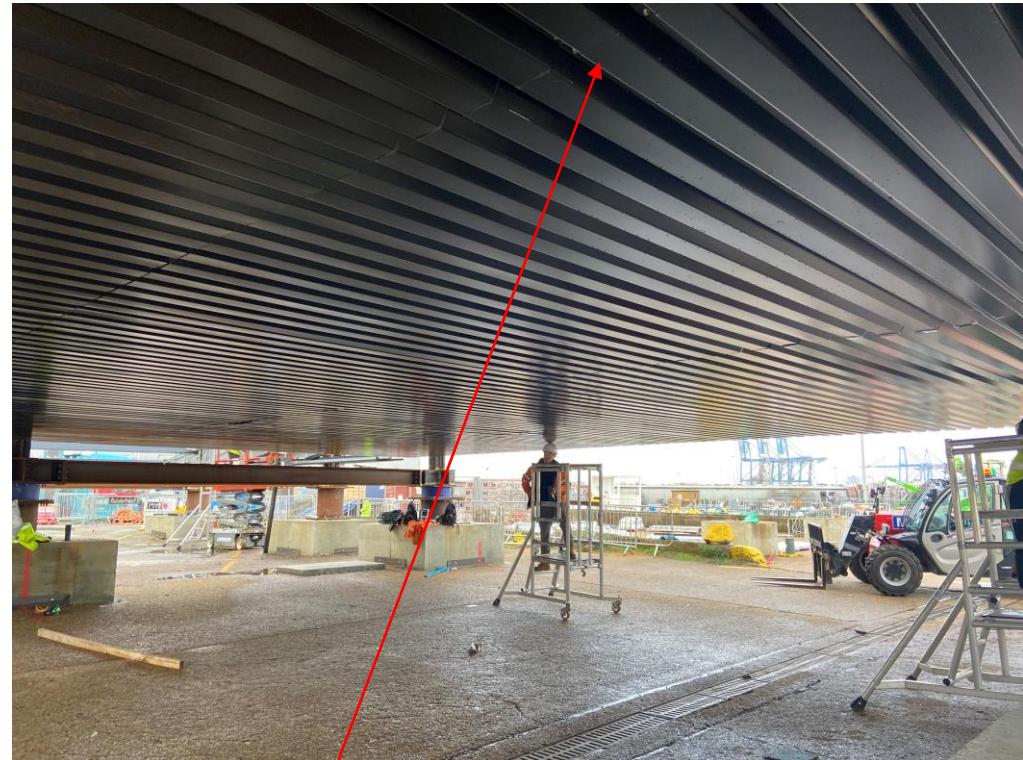
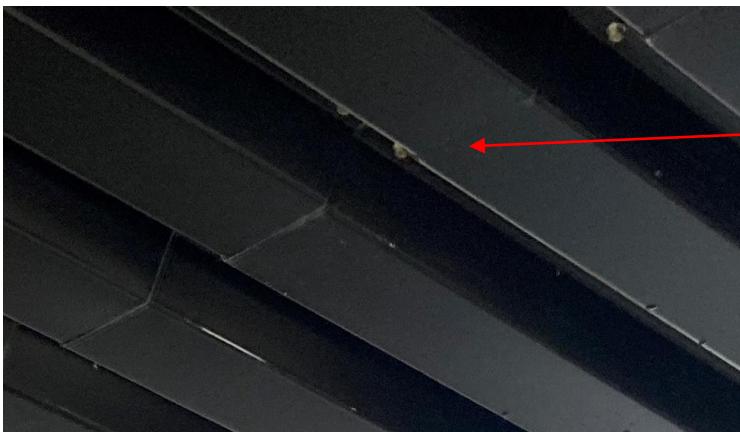
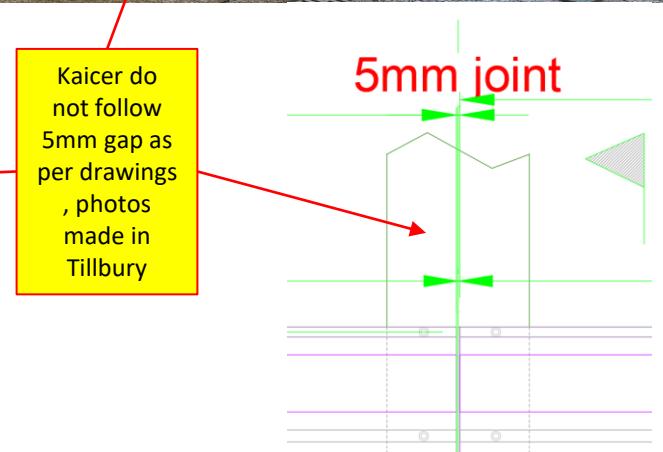
P1/RF/RIM_TR2 – Rimex Backing Structure Sheets poor Installed

There is side wide issues where Kaicer do not follow drawings or fixings not installed correct.

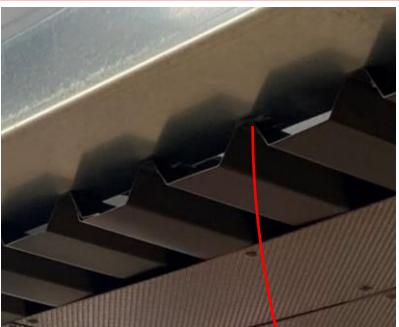
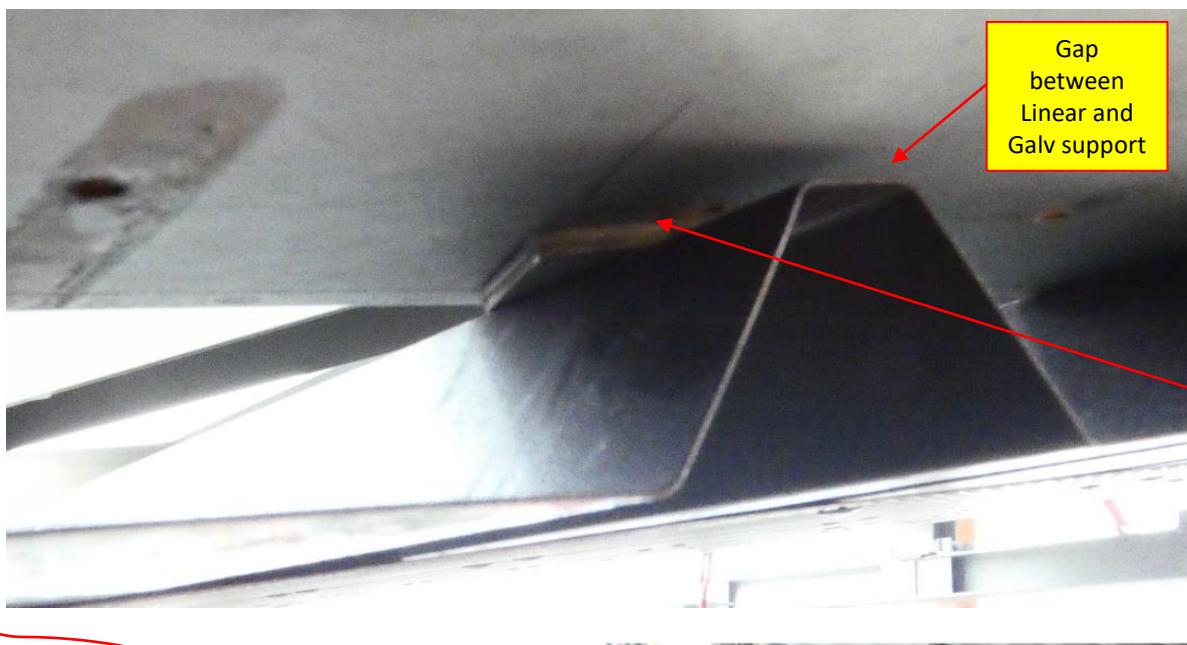
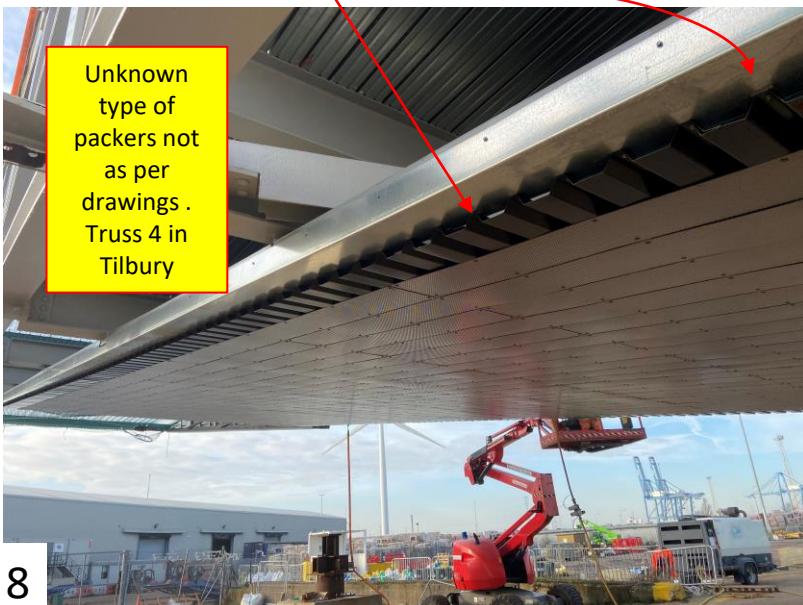
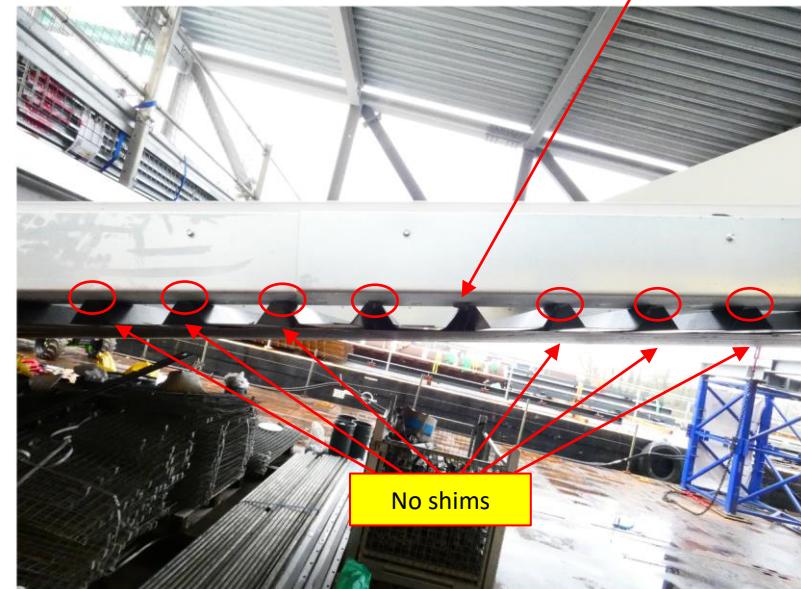
P3/RF/RIM_TR6 – Packers Installed between Galv and Linear

Not as per drawings – unknown type of materials TBC.

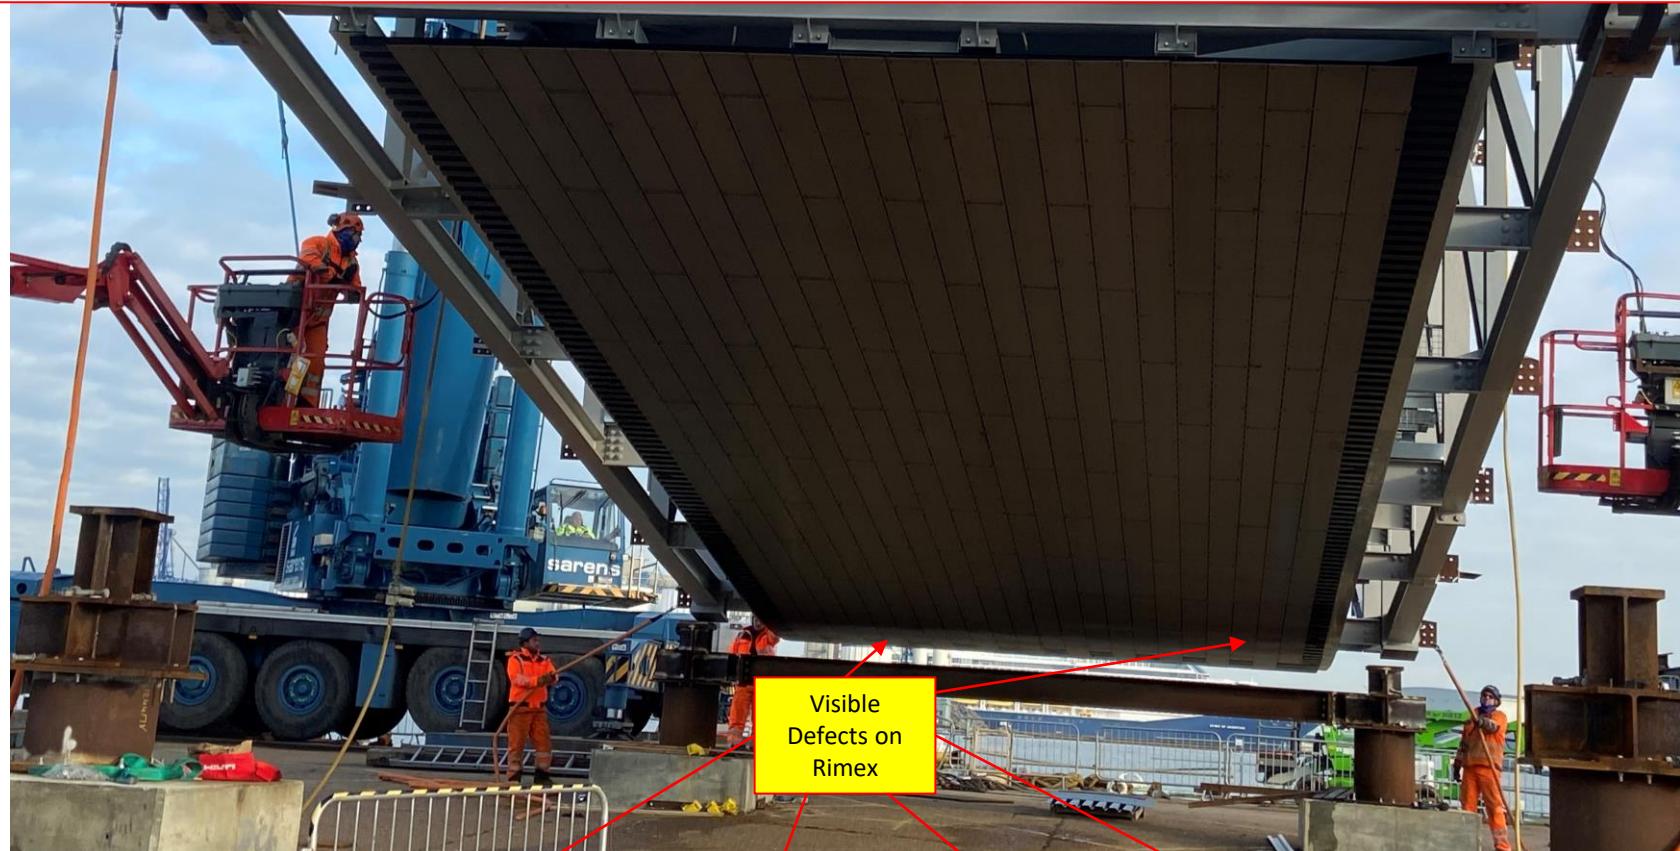
Tillbury Truss – Defects on Rimex ,Visible from low angle view

Photo made at Tillbury . Kaicer to advise why there rimex bows.

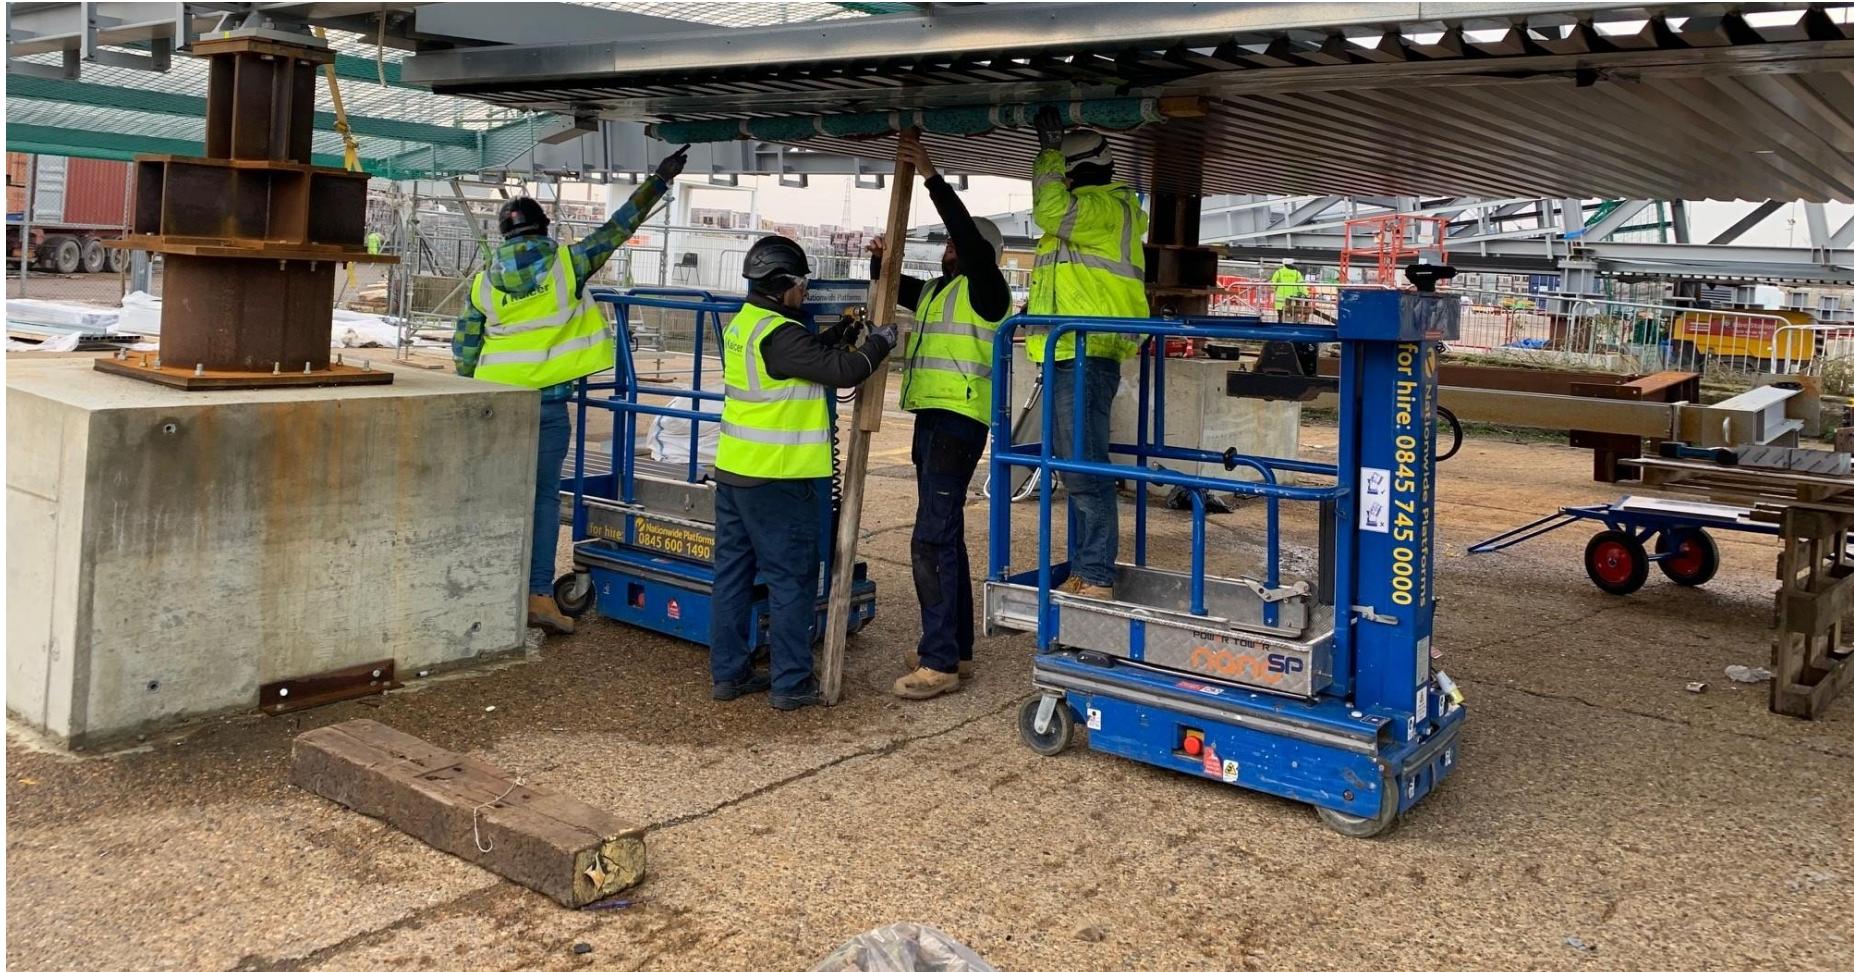
Tillbury Truss – Rimex Installation - Bad practice

Photo below shown poor way of installation Rimex panels and need to be improved.

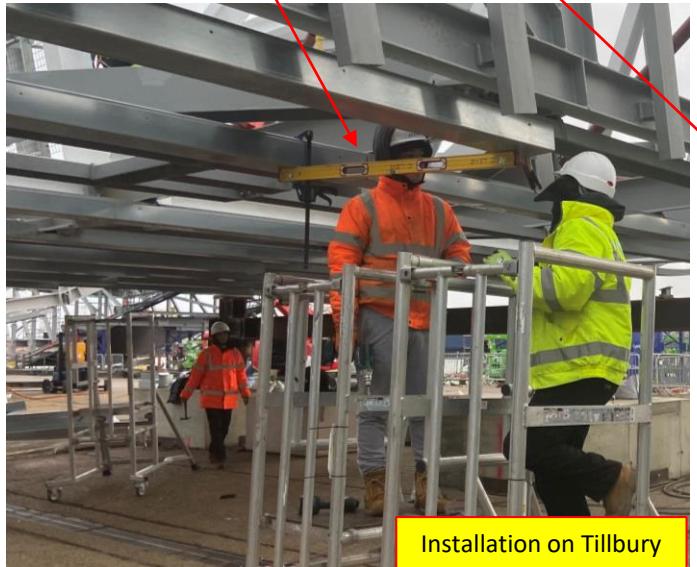
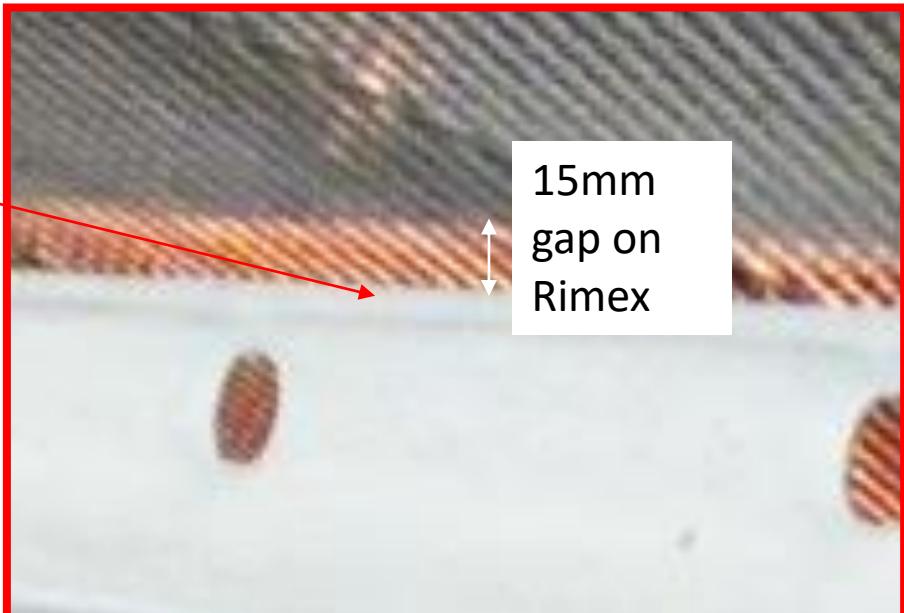
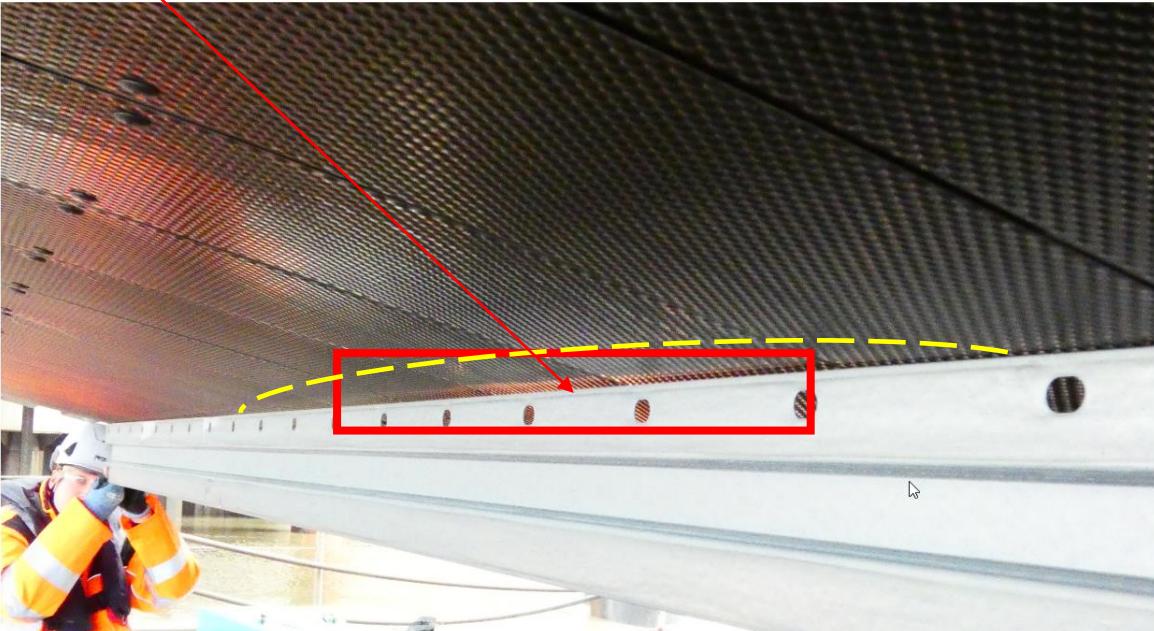
P3/RF/RIM_TR5 – Gap across Rimex panels

There is side wide issues where Kaicer do not follow drawings , in affect loose tolerance over 5mm on Rimex panels

- Short Bubble , allowed to transfer level from Galv to galv 1.47m only- there is possibility that level loose across truss

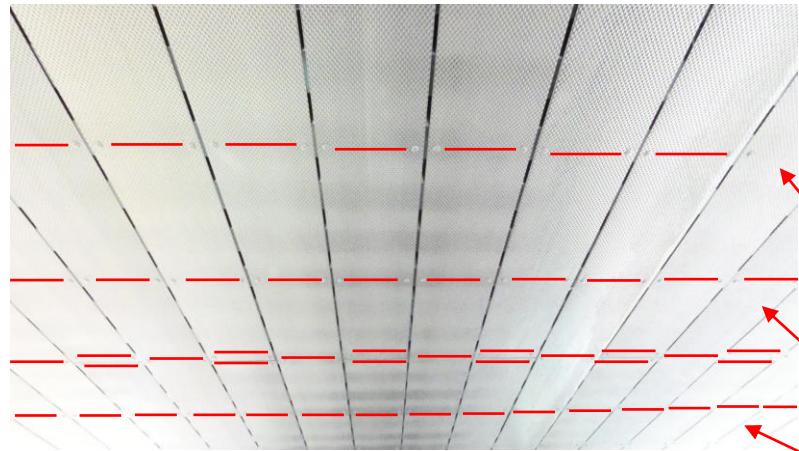
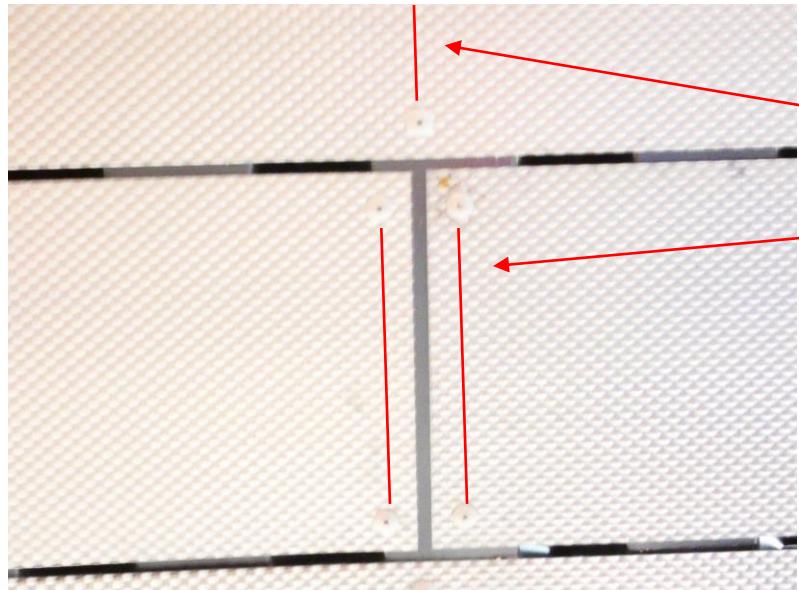
P123/RF/PS_Rimex – Butyl Rub Silicone/Tape Installed/missing

There is possibility that Kaicer not Installed or Poor installed uknow type of product. Rimex panels will be randomly check.

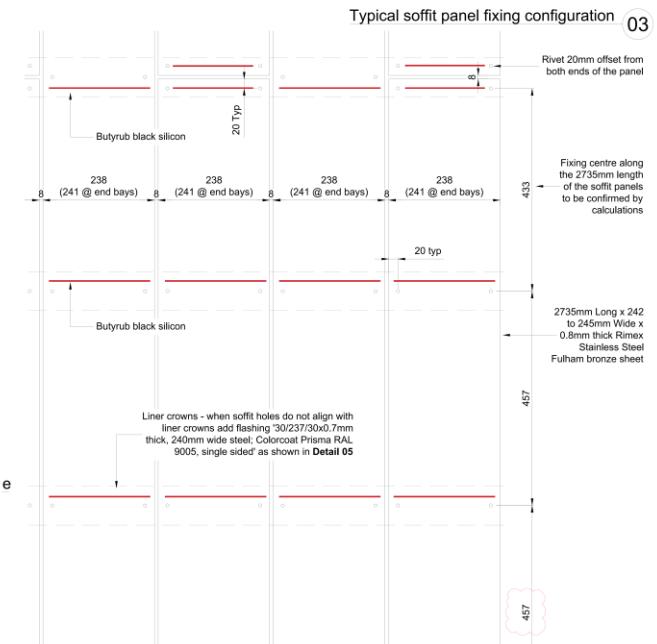
Butyl Rub
Silicone
missing or
poor applied
– Kaicer to
advise what
type of
silicone/tape
it is.
Techndata
to review

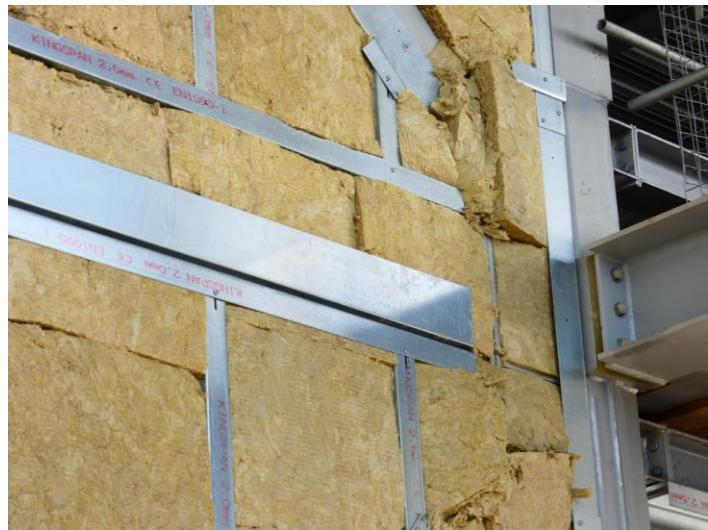
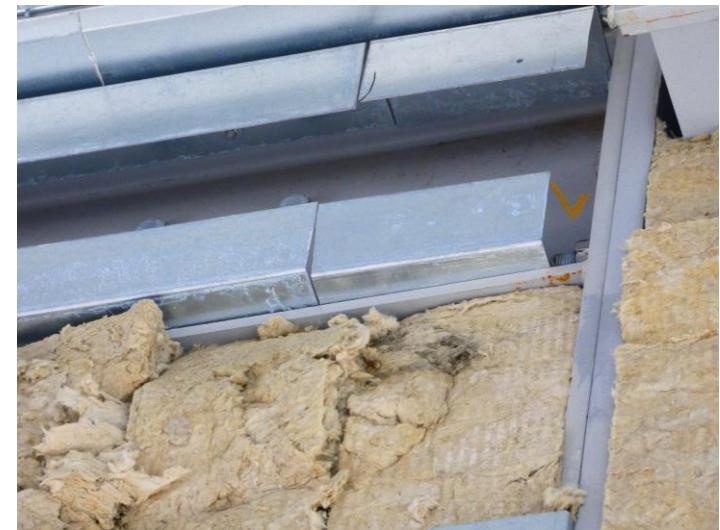
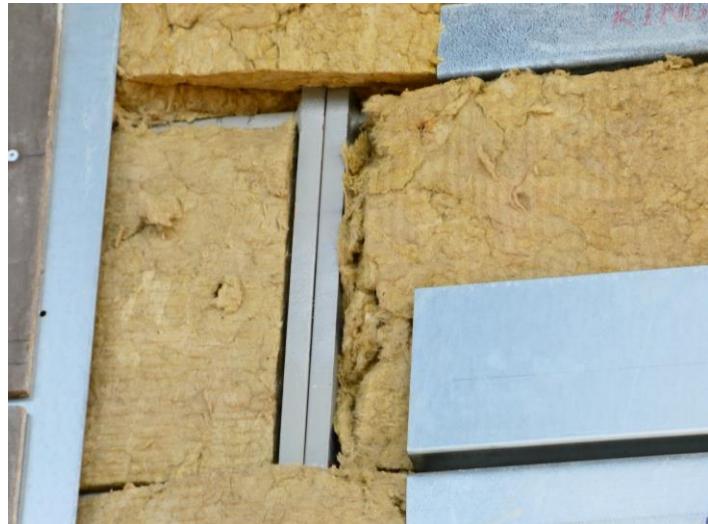
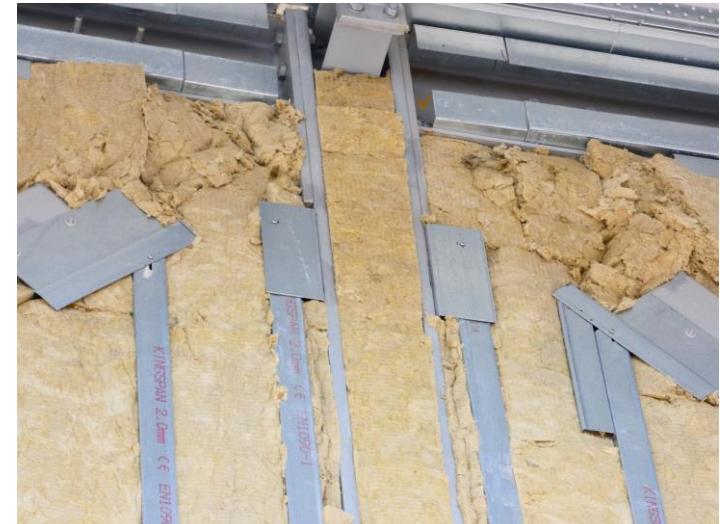
P1/00_01/RS_SFS – Insulation type not as per drawings and poor Installed

Kaicer to Continue poor workmanship, install not correct type of insulations , missing or not compressed as per manufacturer guidance. SFS structure rejected by BGCL caused by Kaicer site modifications - not as per drawings and manufacturer manual.

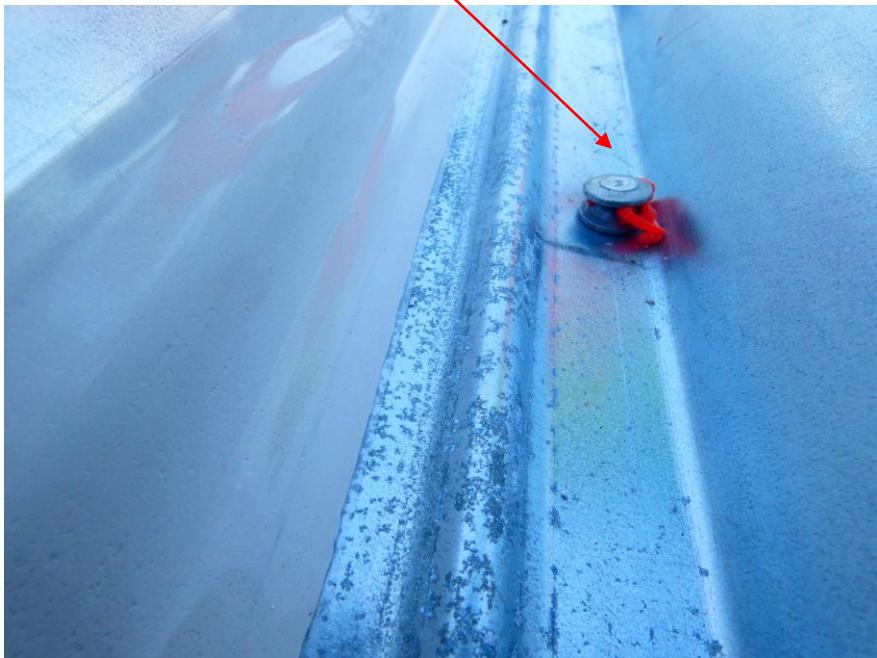
P123/RF/PS_KAL – Different Type of Decking Nails

Kaicer to Advise why 2 different type of nails in use, data sheets missing.

Fixing A –
Missing data
sheet TBC

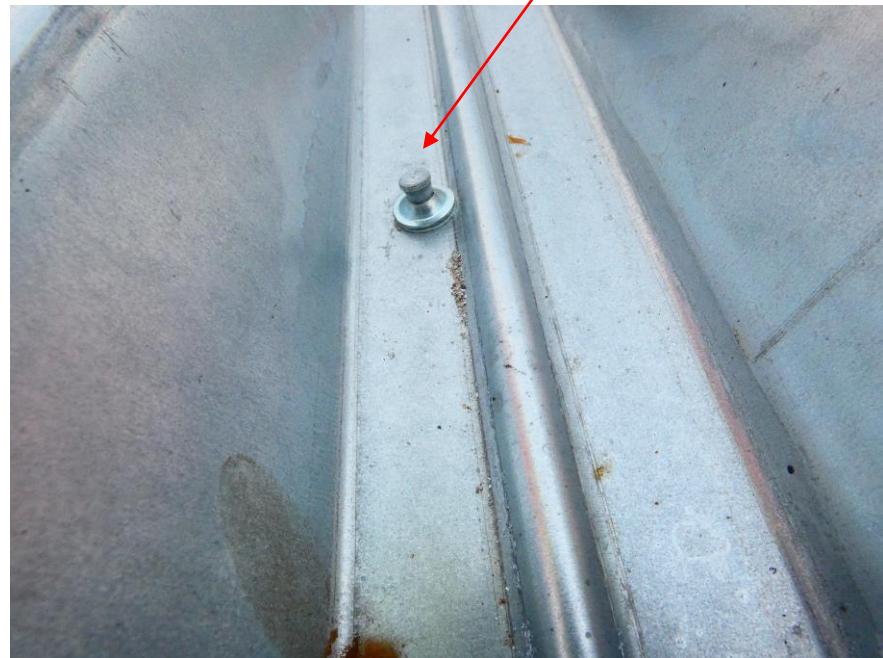
Fixing B –
Missing data
sheet TBC
