Observation Report 04.02 – 11.02.2021

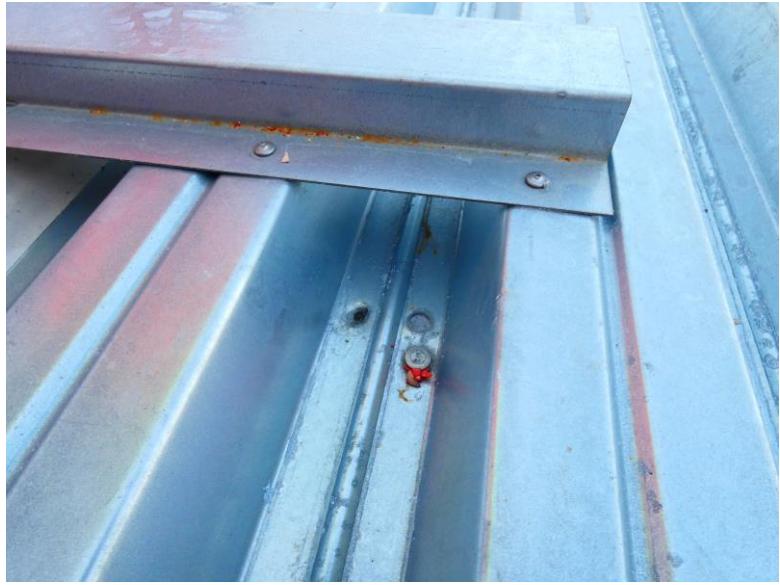
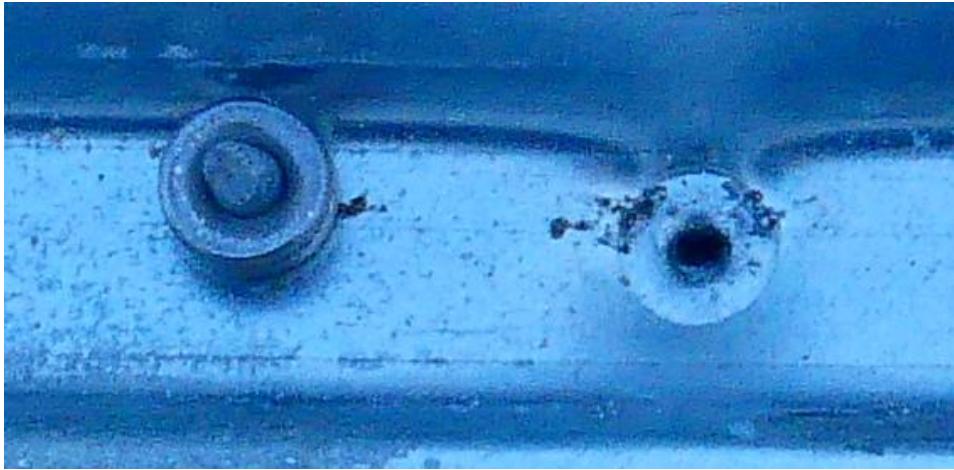
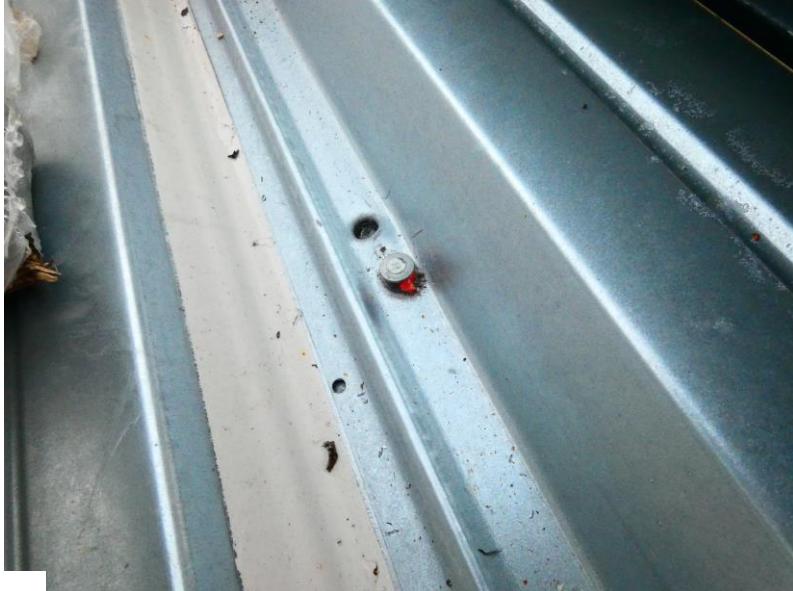
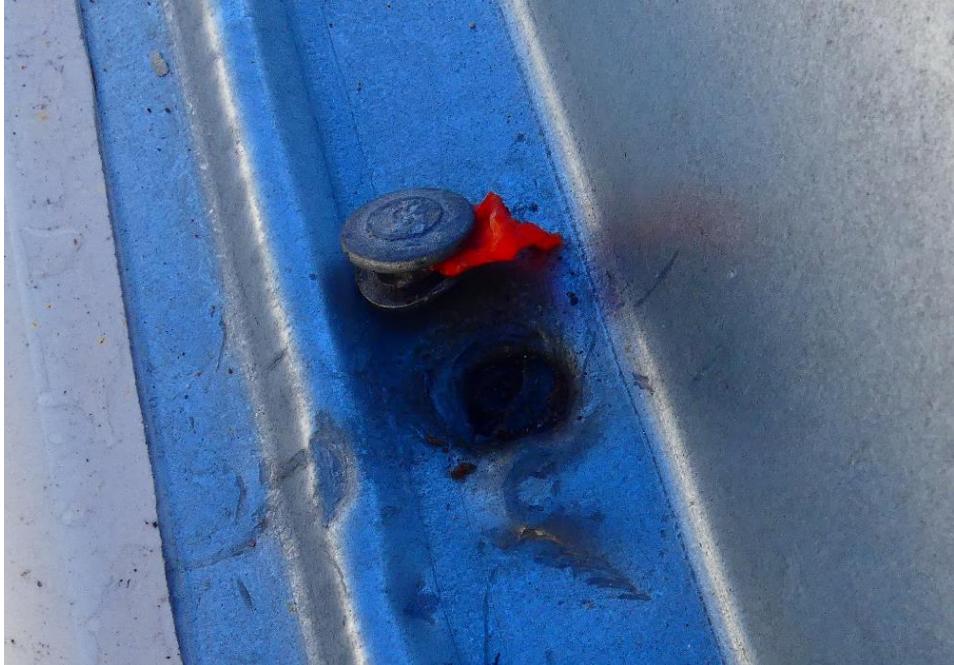
P123/RF/PS_KAL – Decking Nails coming off

Kaicer to advise why nails coming off, what type of nails in use.

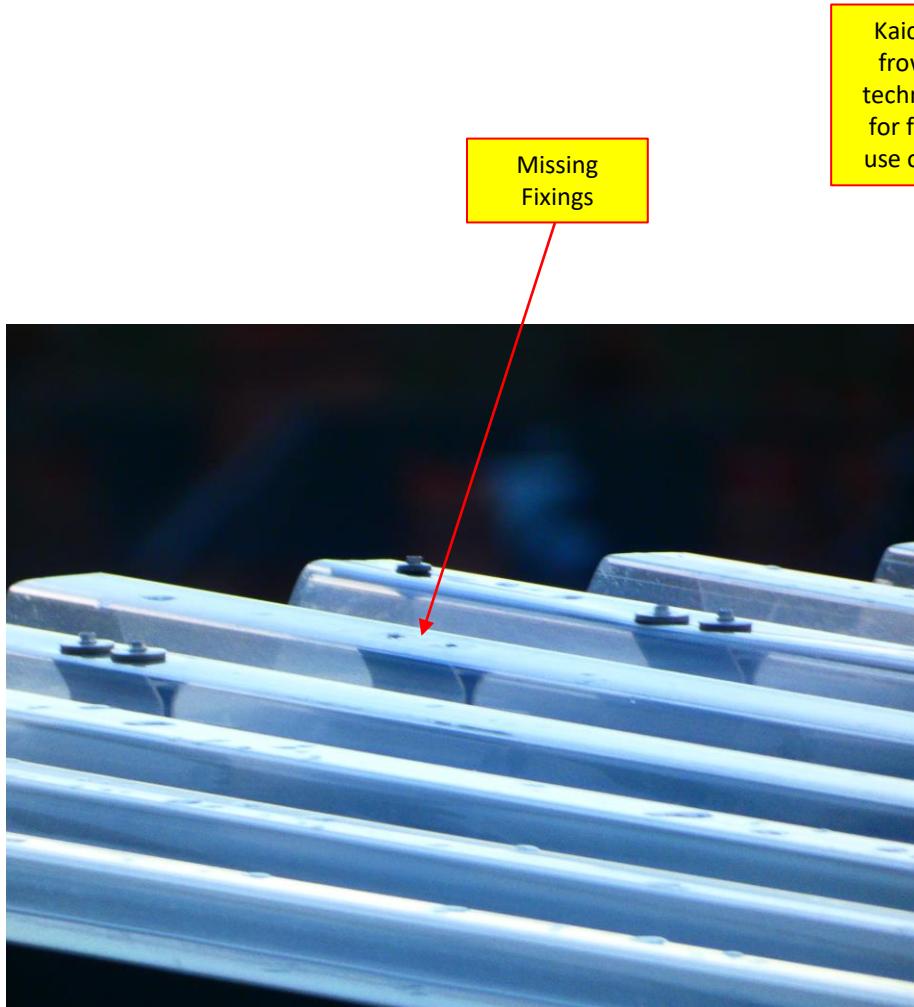
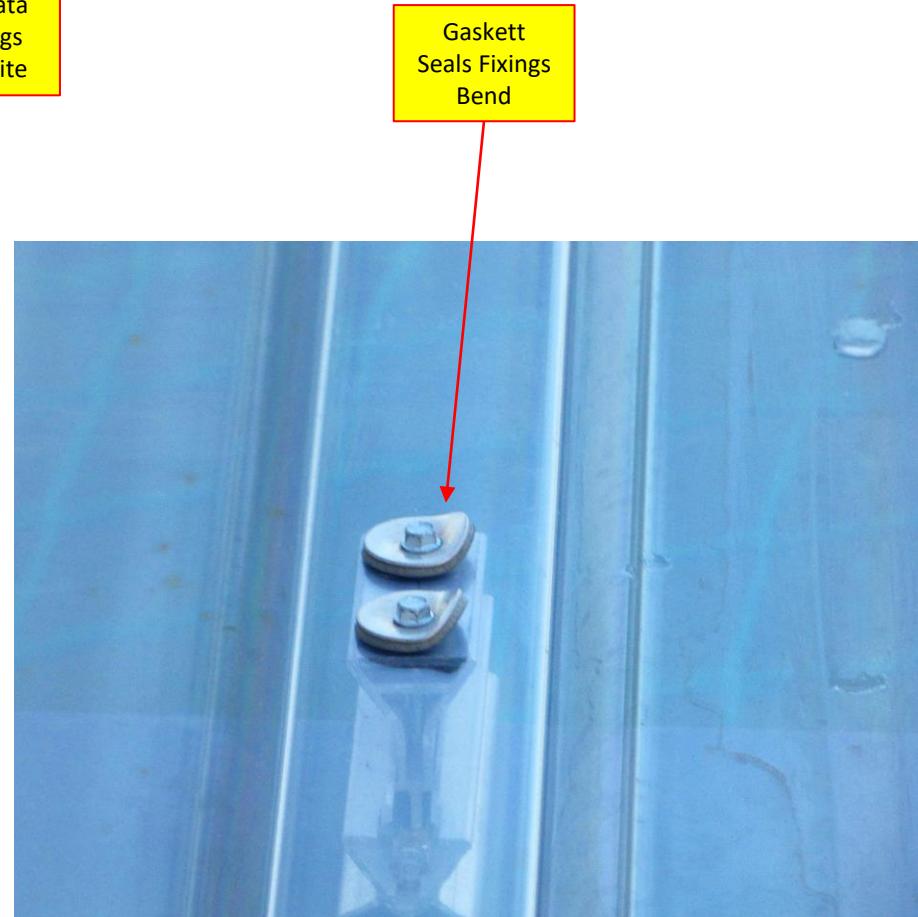
P1/RF/RIM_TR1 – Polycarbonate Fixings poor Installed or missing

Photo bellow show fixings missing or poorly installed

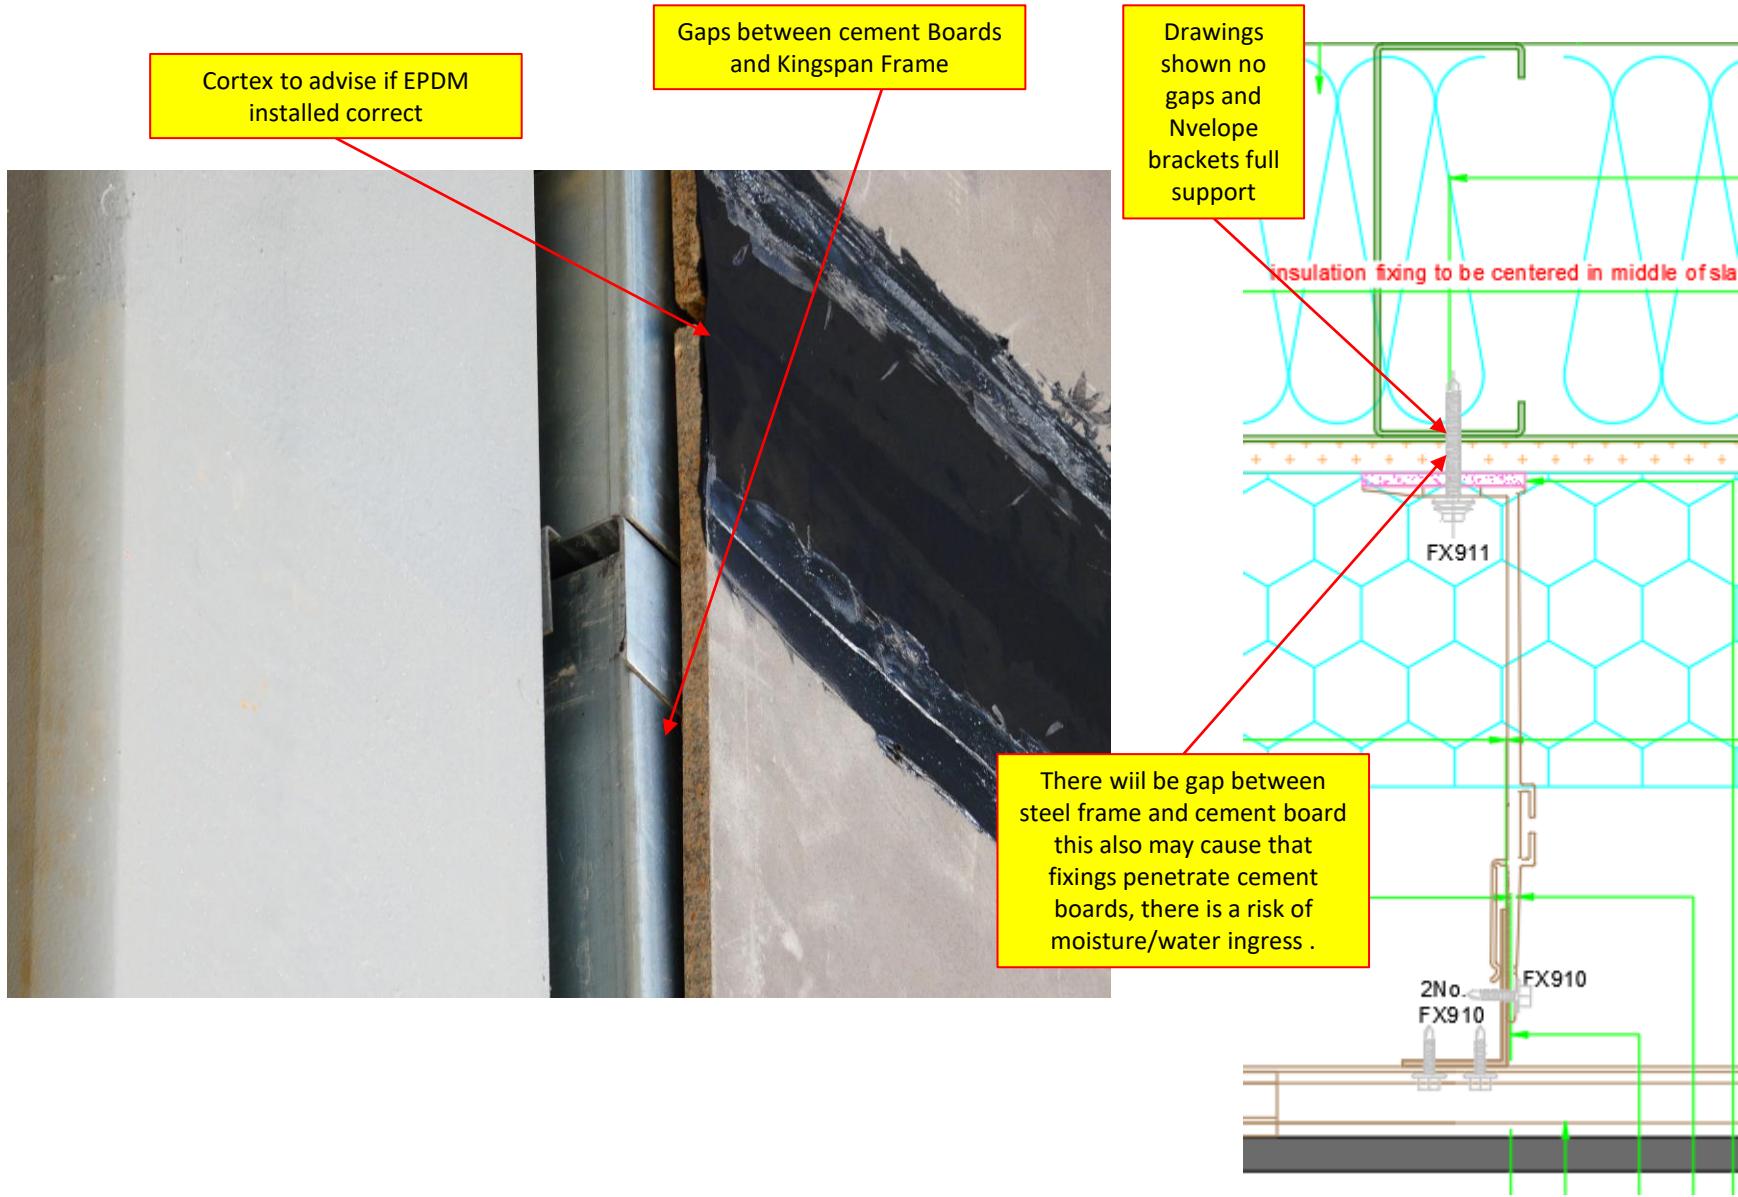
P1/00_01/RS_SFS – Gap between cement Boards and Kingspan Frame + EPDM to tight for movement joint?

If Kaicer Install Nvelope Brackets with optimal torque on screw - There is a risk that Cement boards will be damaged/crack .
Inspection from Cortex technician recommended.
