## Indian Lake Dam Inspection Report

Dam Identification No.: 687

Date of Inspection: November 18, 2013

Date of Final Report: December 31, 2013

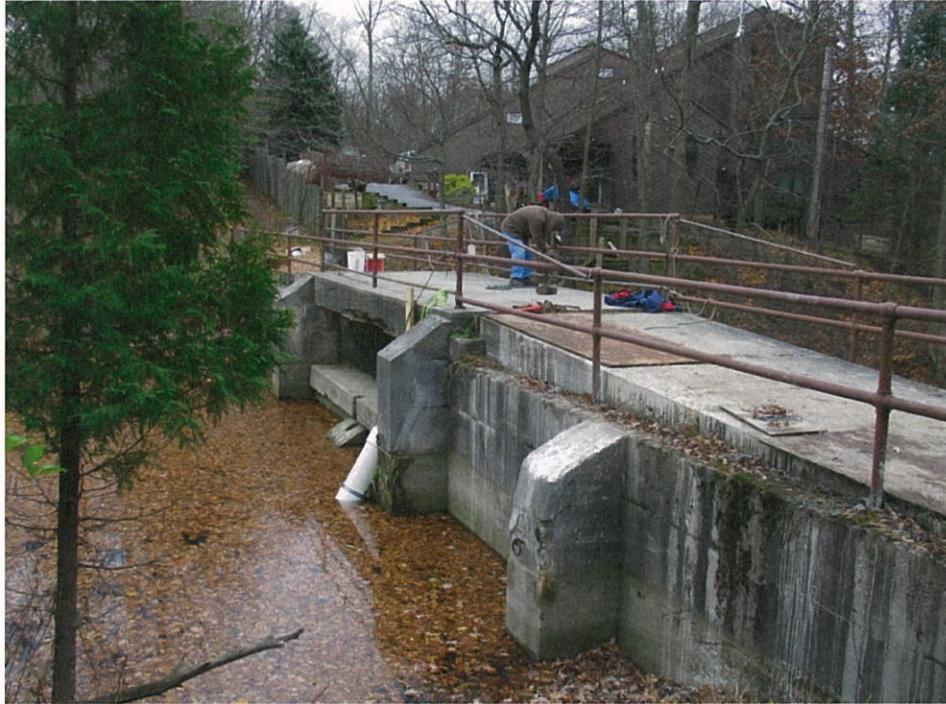
- e. The upstream face of the dam has deterioration, cracks, and efflorescence especially at locations of prior temporary patching.

Upstream Face – Looking south-easterly during drawdown

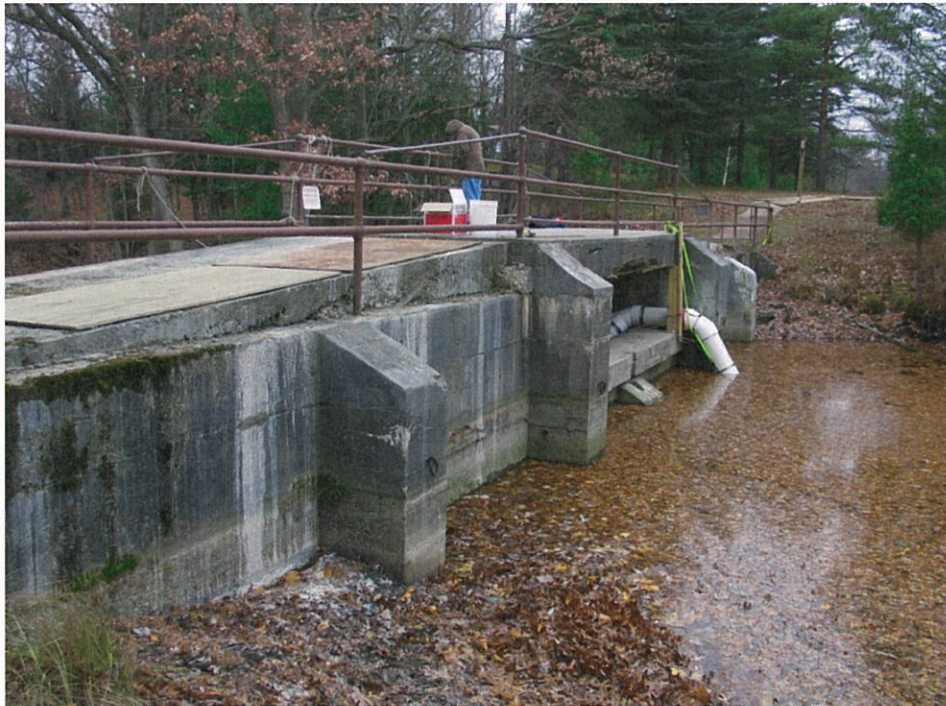
Upstream Face – Looking south-westerly

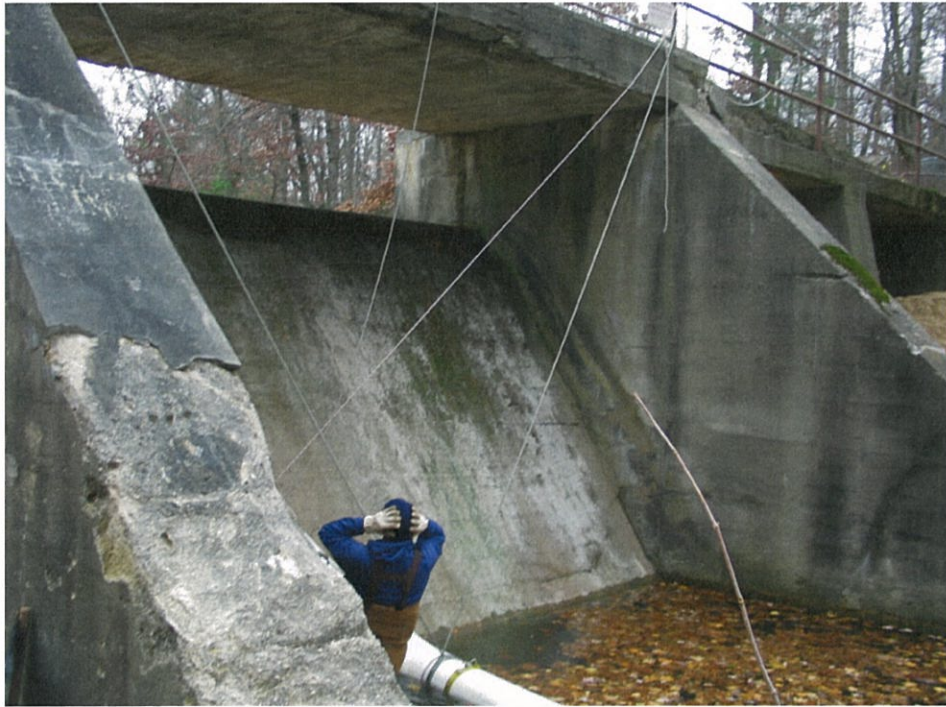
- D. The approach channel is open and free of debris.
- E. The spillway appears to be generally fair to good condition, maintenance patching and sealing were yet to be done.

Downstream Spillway – Looking NE prior to spillway patching and sealing

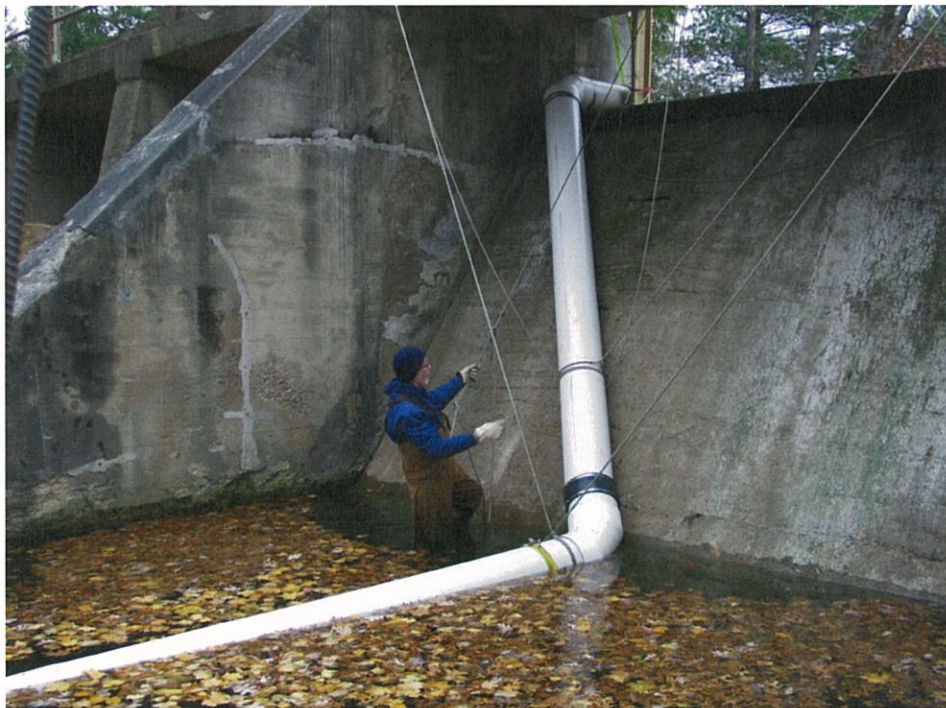
- A. The rehabilitation of the walls at Bay 2, 3, 4, and 5 were just being completed during the inspection and were in new-like condition.
- B. The temporary siphon tube was being removed during the inspection. As seen in the photos the water depth was about 18" below the spillway at the time of inspection.

Downstream Spillway – Looking NW prior to spillway patching and removal of temporary siphon tube.

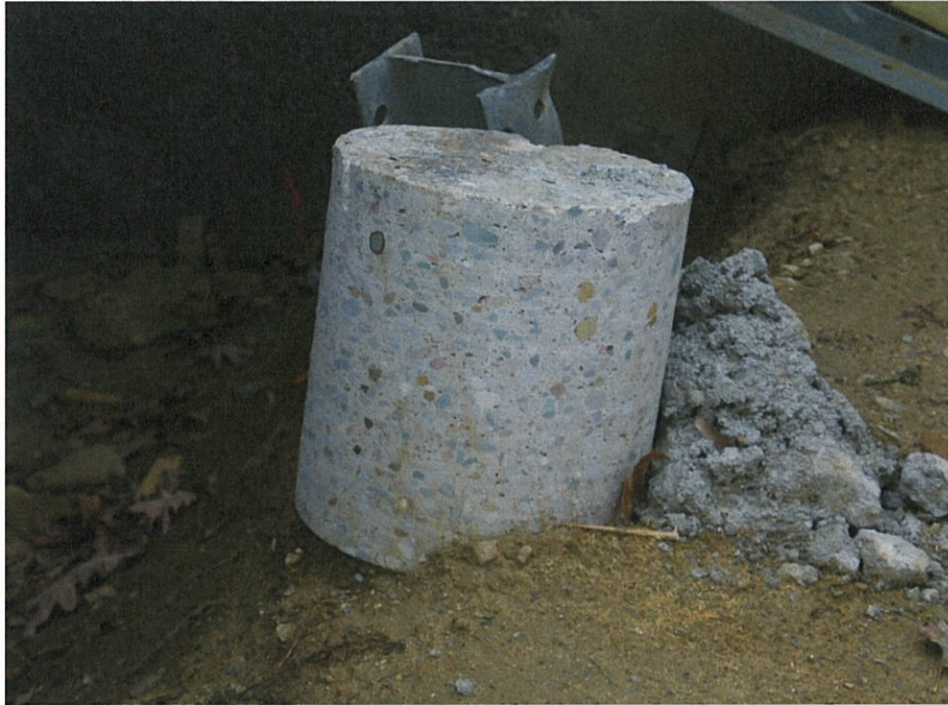
- C. 12-inch diameter concrete cores through the upper deck were taken to facilitate concrete placement. The concrete from the cores was considered to be in good condition within the deck even though there is significant deterioration along the fascias.

Deck Core – Typical of 8 cores taken

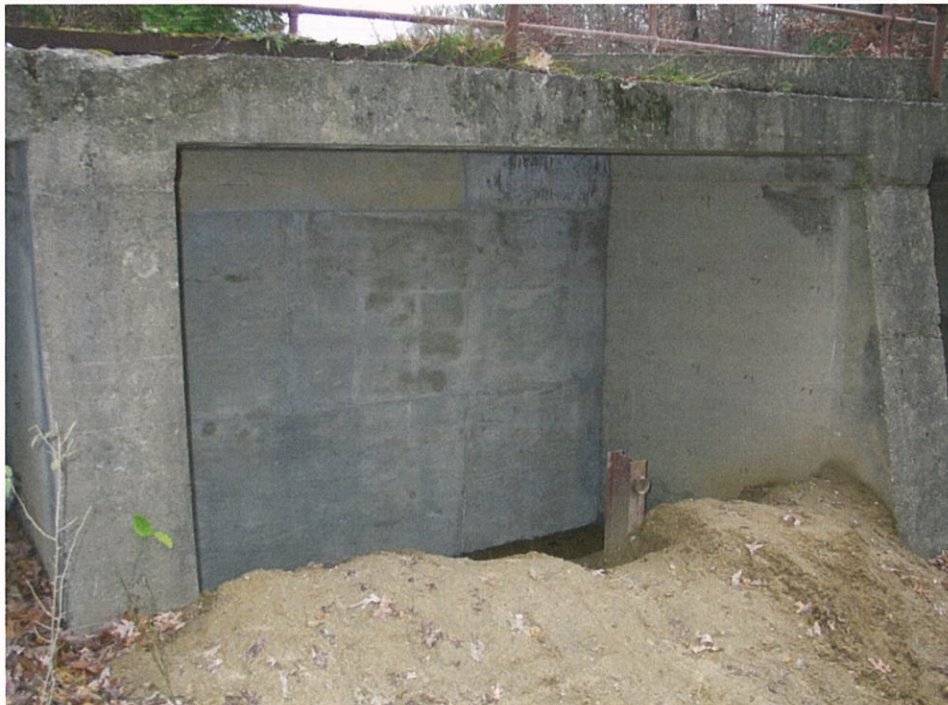
Typical Newly Constructed Wall – Looking at Bay 2

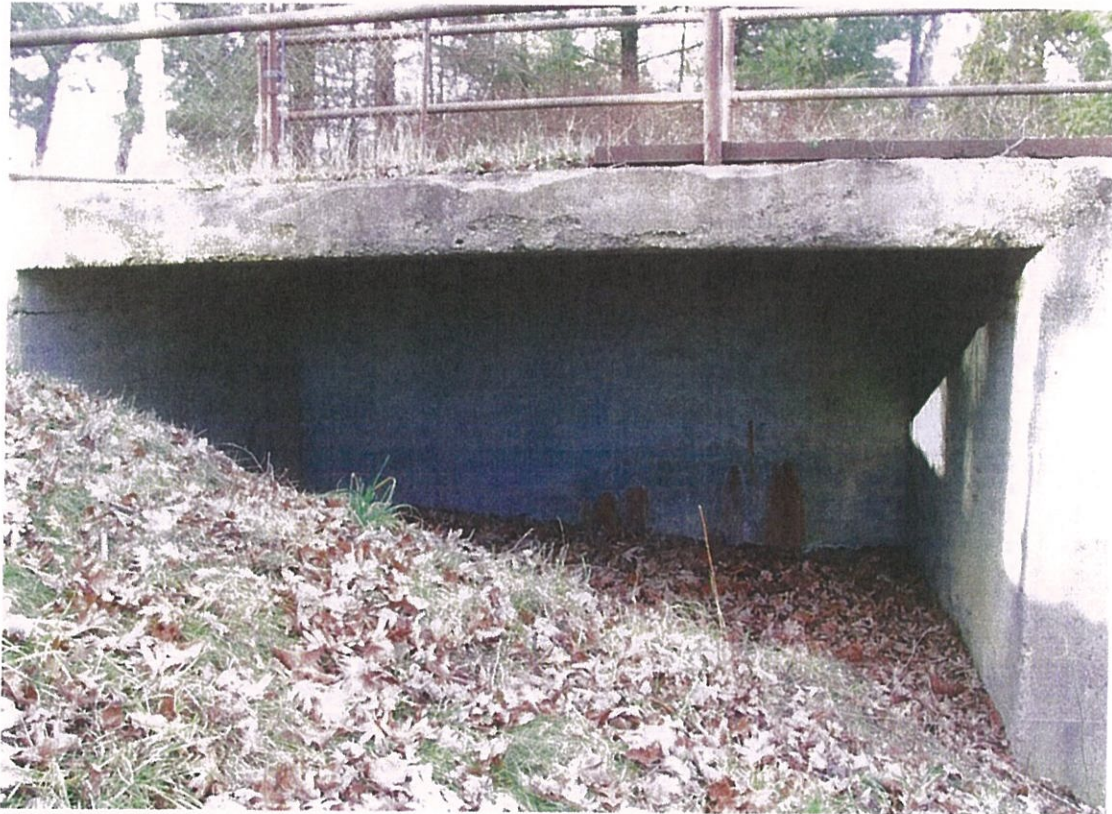
**BAY 1**

1. Poor Cone with Consolidation Issues at Lower Portion
2. Rust stains, however no spalling concrete, therefore likely from form ties.
3. No freeze thaw spalling which suggests minimal if any water leaking.
4. Buttress walls in good condition
5. Deck fascia has minor spalling and deterioration
6. Concrete Strength Uniform with an average reading of 0.40

1. Low to Medium Priority for wall replacement
2. If not replaced insulate to reduce future freeze thaw

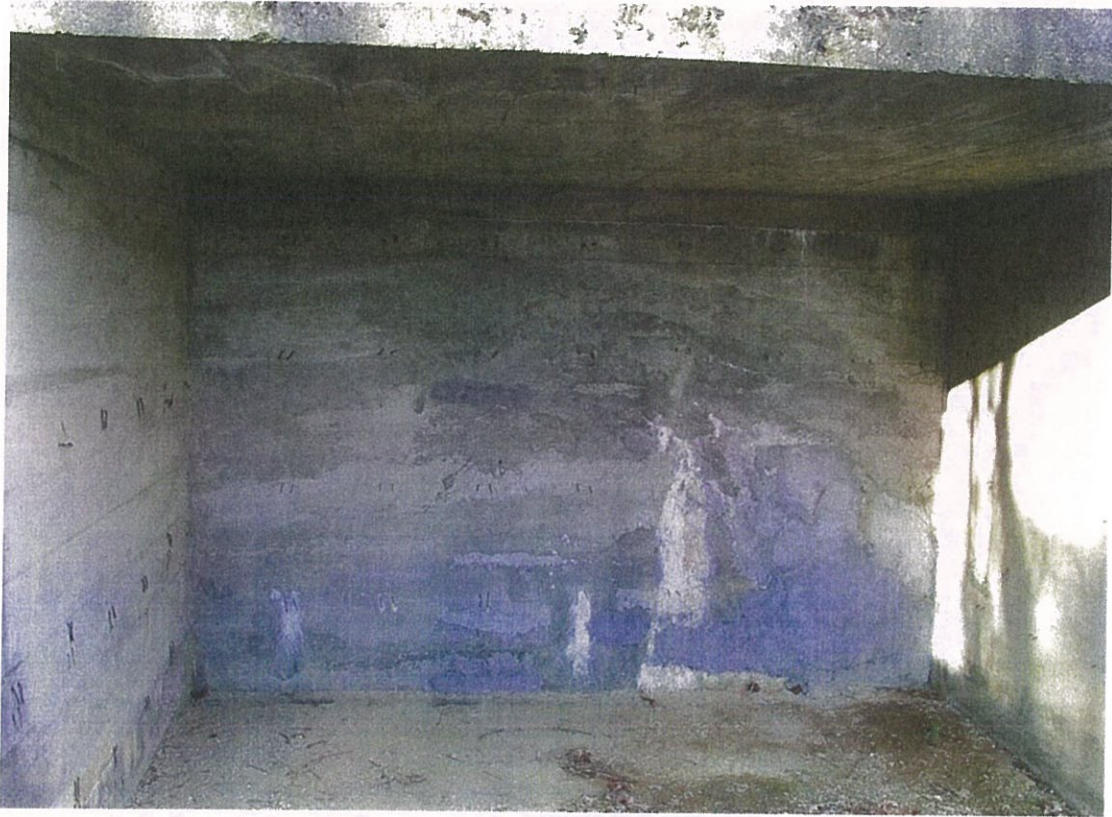
## BAY 2

1. Discoloration is a combination of prior patching and pour lines suggesting poor consolidation
2. Existing Patch is in Fair Condition.
3. Buttress Walls are in good condition.
4. Deck fascia has minor spalling and deterioration
5. Three 1'-2' long hairline cracks noted with some efflorescence.
6. Concrete Strength Left Half = 0.50, Right Half=0.40.

1. Medium Priority for wall replacement
2. If not replaced insulate to reduce future freeze thaw

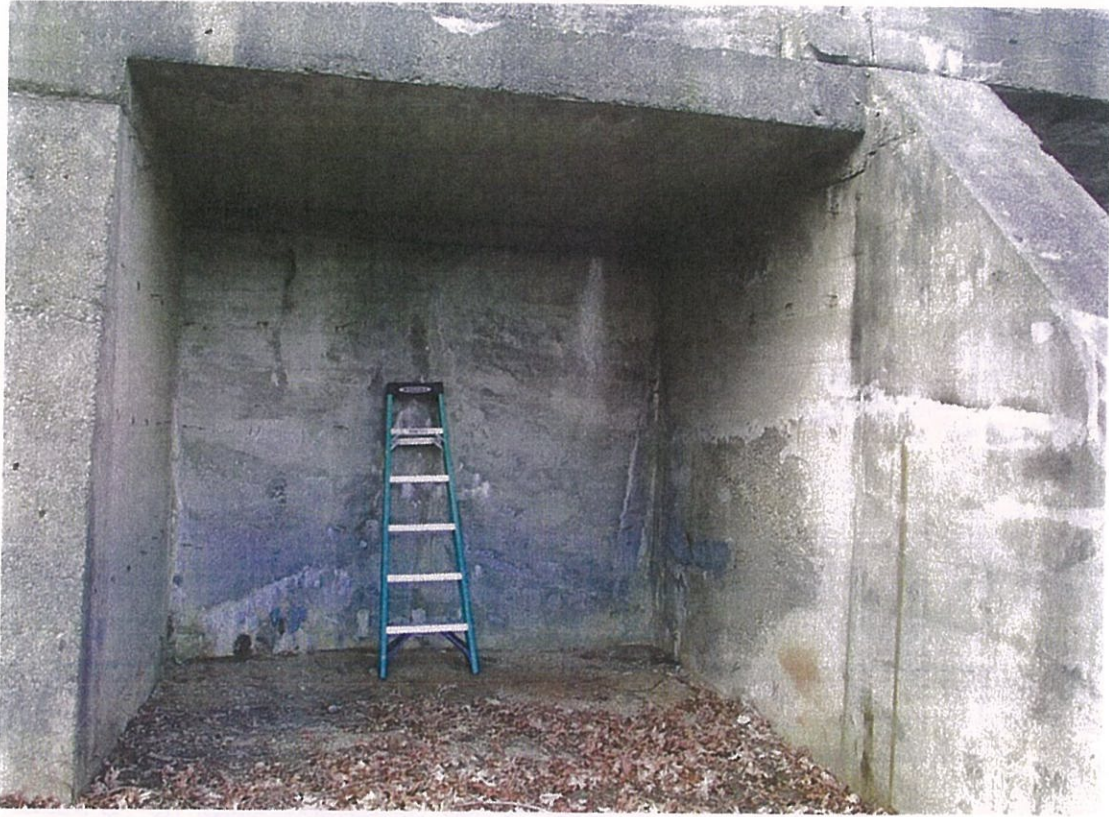
### BAY 3

1. Discoloration is a combination of prior patching and pour lines suggesting poor consolidation
2. Spalling area 4'x 4' at lower left corner..
3. Left buttress wall in good condition
4. Right buttress/slope wall of spillway has an area 4'x4' with imminent spall. Previously grouted cracks in generally good condition.
5. Deck fascia has minor spalling and deterioration
6. Concrete Strength Left Half = 0.40, Right Half=0.30. Suggesting lower strength

1. **High Priority** for wall replacement
2. Repair Wingwall – Sawcut around spall 1" deep, remove unsound concrete, patch spall, repair cracks, and add sealer using Sika Brand Materials as recommended by Sika Corporation

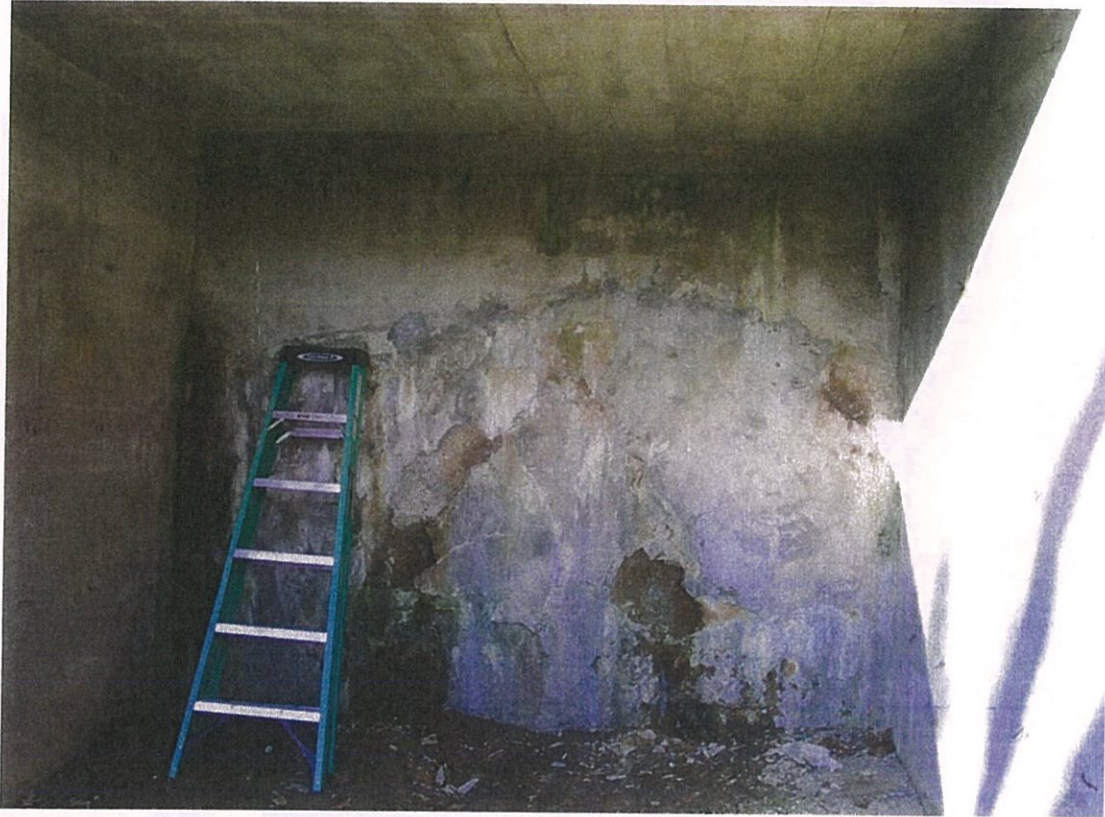
## BAY 4

1. Severe Freeze Thaw spalling and moisture leaking.
2. Prior recent patching accelerated the freeze thaw by trapping moisture.
3. Concrete 12" down below soil grade is in good condition.
4. Buttress walls in generally good condition, small horizontal crack with efflorescence on west buttress wall
5. Deck fascia has minor spalling and deterioration
6. Concrete Strength Upper 2' = 0.50, Lower = 0.00. Buttress Ave=0.45

1. **High Priority** for wall replacement
2. Low to Medium Repair Wingwall – Sawcut around any spalls 1" deep, remove unsound concrete, patch spall, repair cracks, and add sealer using Sika Brand Materials as recommended by Sika Corporation

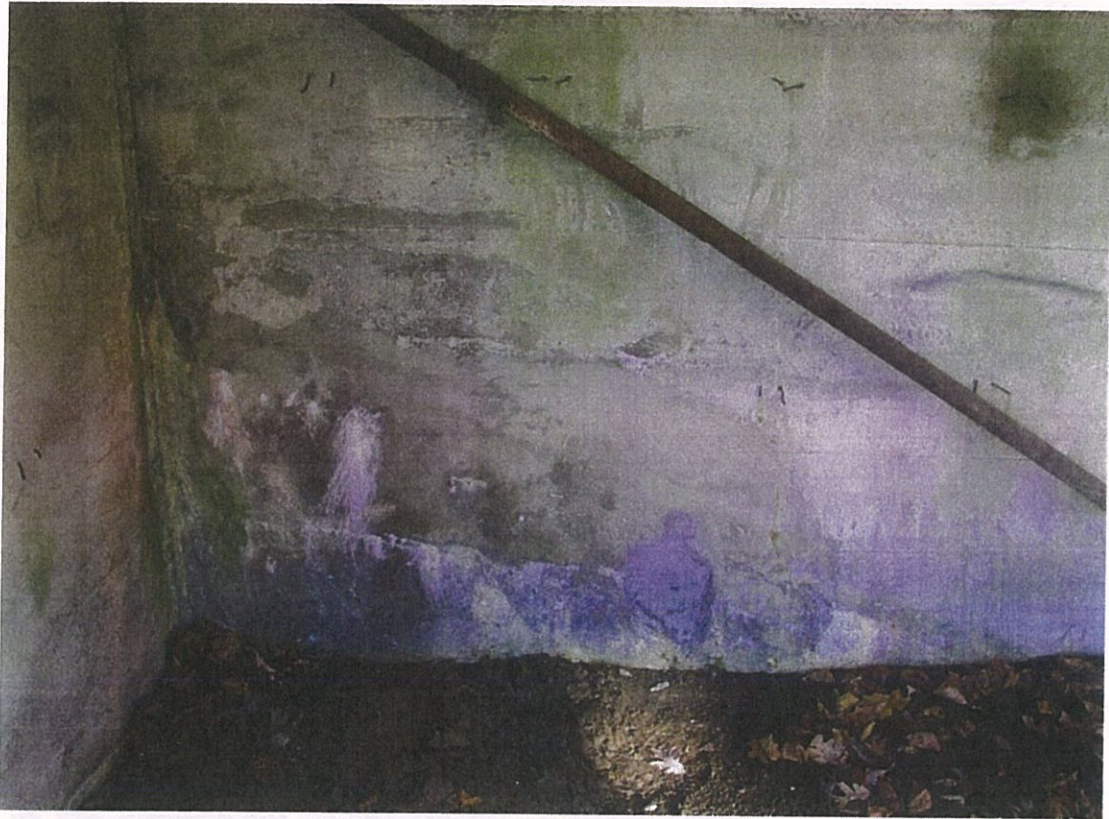
## BAY 5

1. Discoloration is a combination of prior patching and pour lines
2. Concrete is in generally good condition except the lower left portion has a couple diagonal cracks with some efflorescence staining.
3. Concrete is in good condition 12" below grade at the lower left location
4. Buttress walls are in good condition
5. Concrete Strength Average = 0.48.

1. Low to Medium Priority for wall replacement
2. If not replaced insulate to reduce future freeze thaw

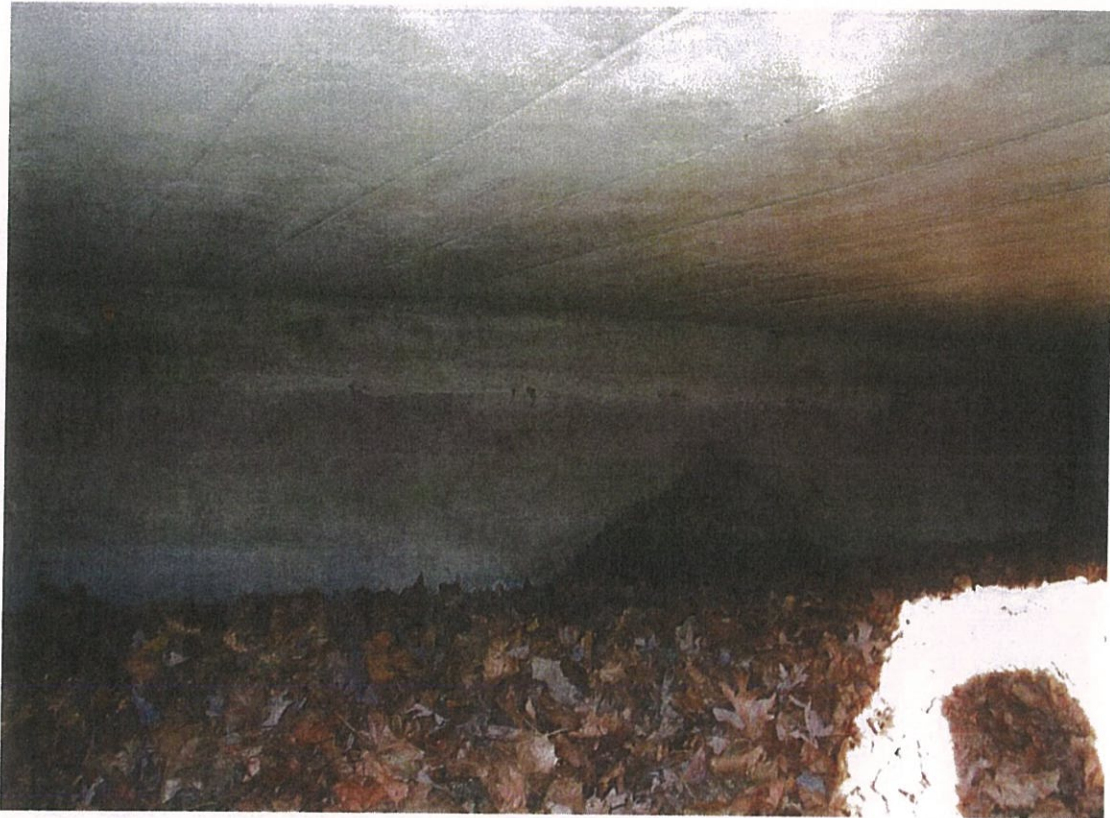
## BAY 6

1. Concrete in generally good condition.
2. There is a spall that is 2' high x 5' long. And is relatively shallow with little accelerated freeze thaw spalling around it.
3. The spall follows a pour cone discoloration area with noticeable unconsolidated concrete.
4. Buttress walls are in good condition .
5. Deck fascia has minor spalling and deterioration
6. Concrete Strength Average = 0.46

1. Low Priority for wall replacement
2. If not replaced insulate to reduce future freeze thaw

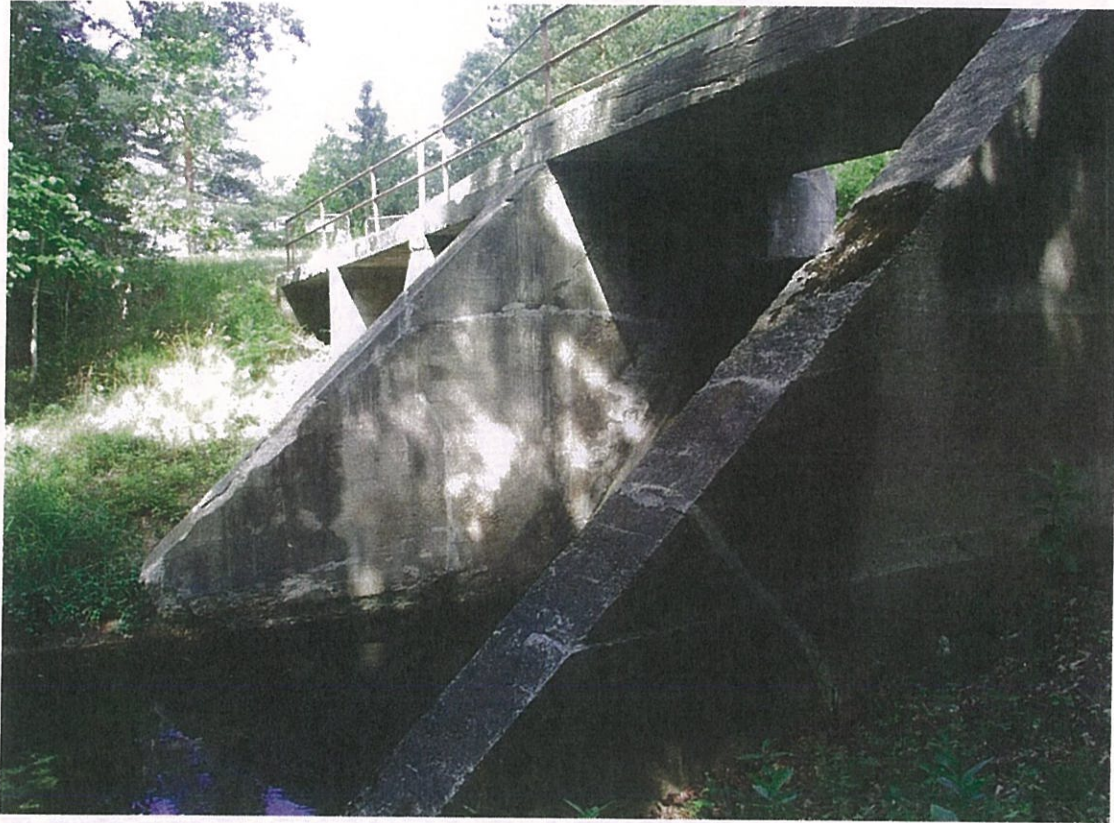
## SPILLWAY WINGWALLS

1. The wingalls are in generally fair condition. Previous crack repairs are in generally good condition.
2. There are some areas of continual deterioration and spalling especially near the low water line.
3. Deck facia is deteriorating and spalling.
4. Concrete Strength Average = 0.45

1. Low to Medium Priority for wall replacement
2. Medium Priority for wall and deck repairs
3. Repairs: Sawcut around any spalls 1" deep, remove unsound concrete, patch spall, repair cracks, and add sealer using Sika Brand Materials as recommended by Sika Corporation

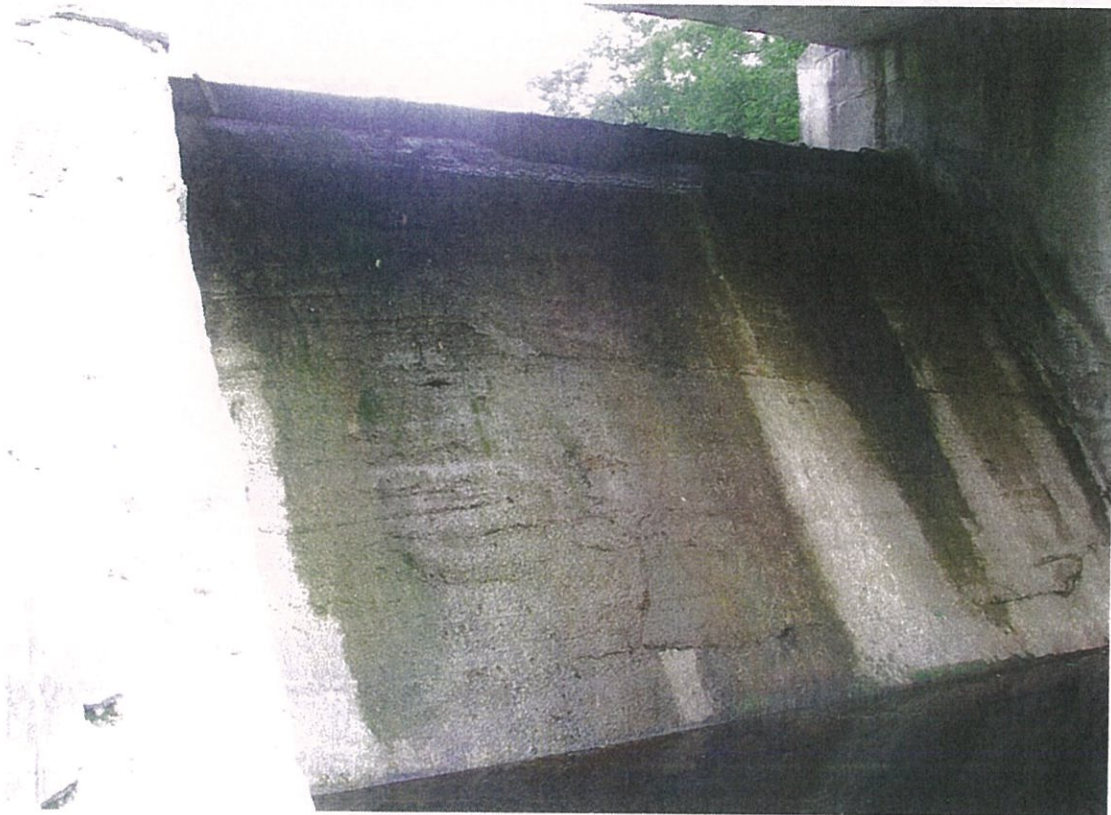
## SPILLWAY

1. The spillway appears to have a vertical structural wall with the sloped spillway mainly to redirect water and not as a structural element.
2. The concrete of the sloped spillway is in generally good sound condition especially for its age. Only a few small areas of localized deterioration, which are along the pour lines and along the upper portion adjacent to the spillway crest.
3. The spillway vertical structural wall could not be observed, however the visible portions appeared to be in good condition.

1. Very Low Priority for wall replacement
2. Low Priority for sloped wall repairs, however the upper spillway crest portion needs to be monitored and inspected without water flowing over it. Some minor patching repairs at that time may be warranted.

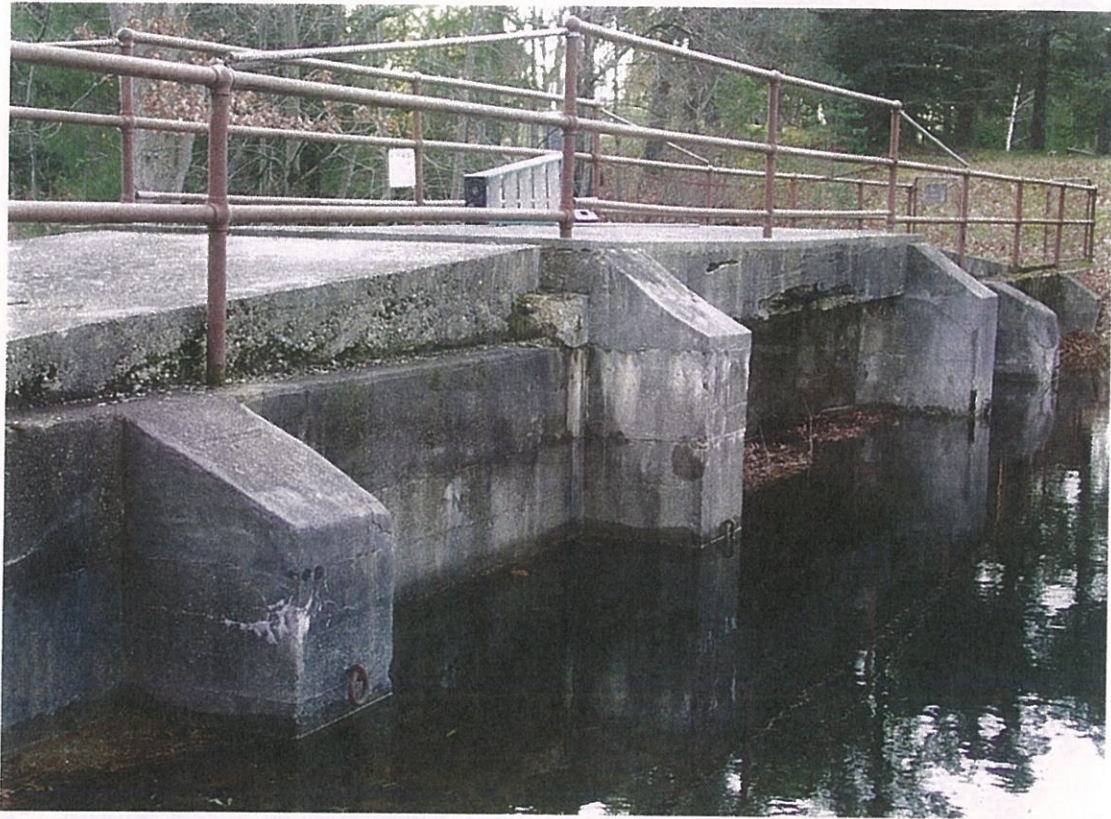
## UPSTREAM FACE

1. The wall and short front buttresses appear to have been poured monolithic (at the same time). It then makes sense that the downstream buttresses were poured against the dam face wall which is what the cold joints suggest.
2. The walls are in generally fair condition at and above the waterline. The buttress walls are in fair condition except the cap portions are in poor condition. It was noted by local resident that the front wall of Bay 4 had a horizontal section of deteriorated concrete. This is consistent with the poor condition and water/moisture migration through that bay.
3. There are some areas of continual deterioration and spalling especially near the low water line.
4. Deck fascia is deteriorating and spalling.

1. Low Priority for wall replacement as new walls will be placed behind
2. Medium to High Priority for wall, buttress and deck repairs.
3. Repairs: Sawcut around any spalls 1" deep, remove unsound concrete, patch spill, repair cracks, and add sealer using Sika Brand Materials as recommended by Sika Corporation

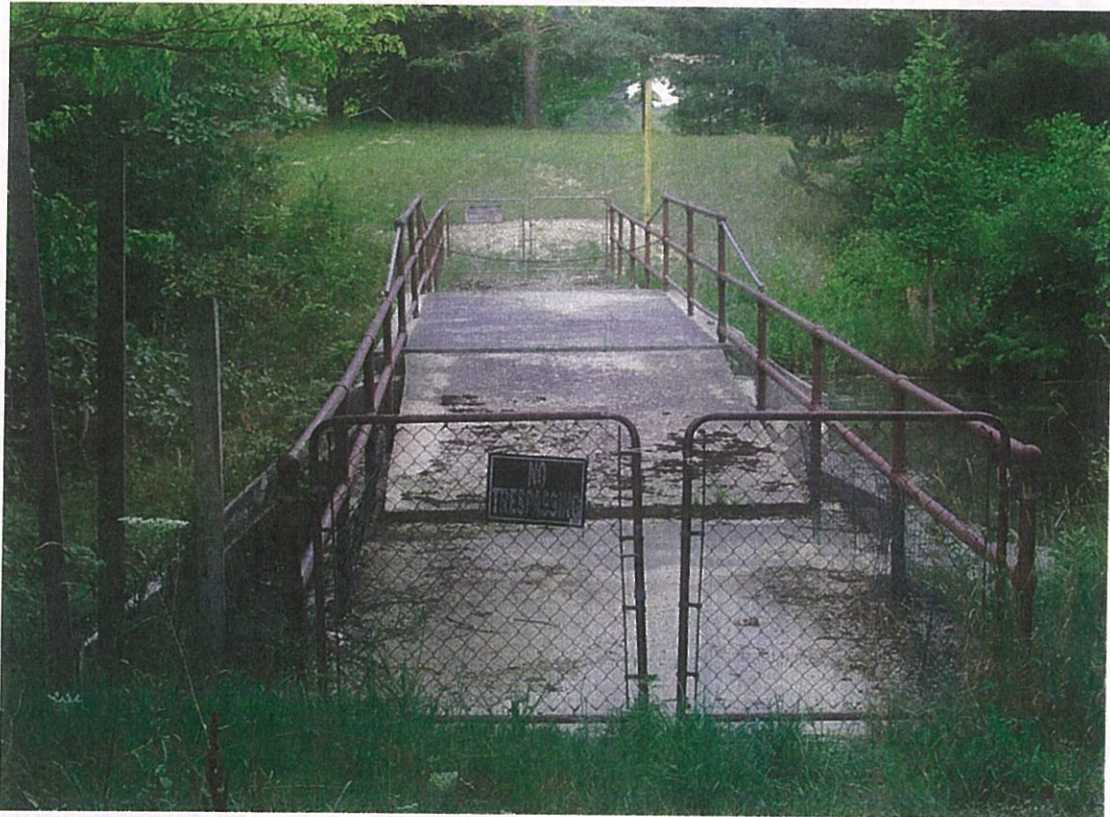
## DECK AND RAILINGS

1. Top concrete surfaces are in generally fair condition with some pitting.
2. Top bituminous surface at west approach should be removed (if not already done)
3. The railings are deteriorating at the concrete interface. The railings are still able to support significant loading noting that deck is closed to pedestrian traffic.
4. Deck fascia is deteriorating and spalling.

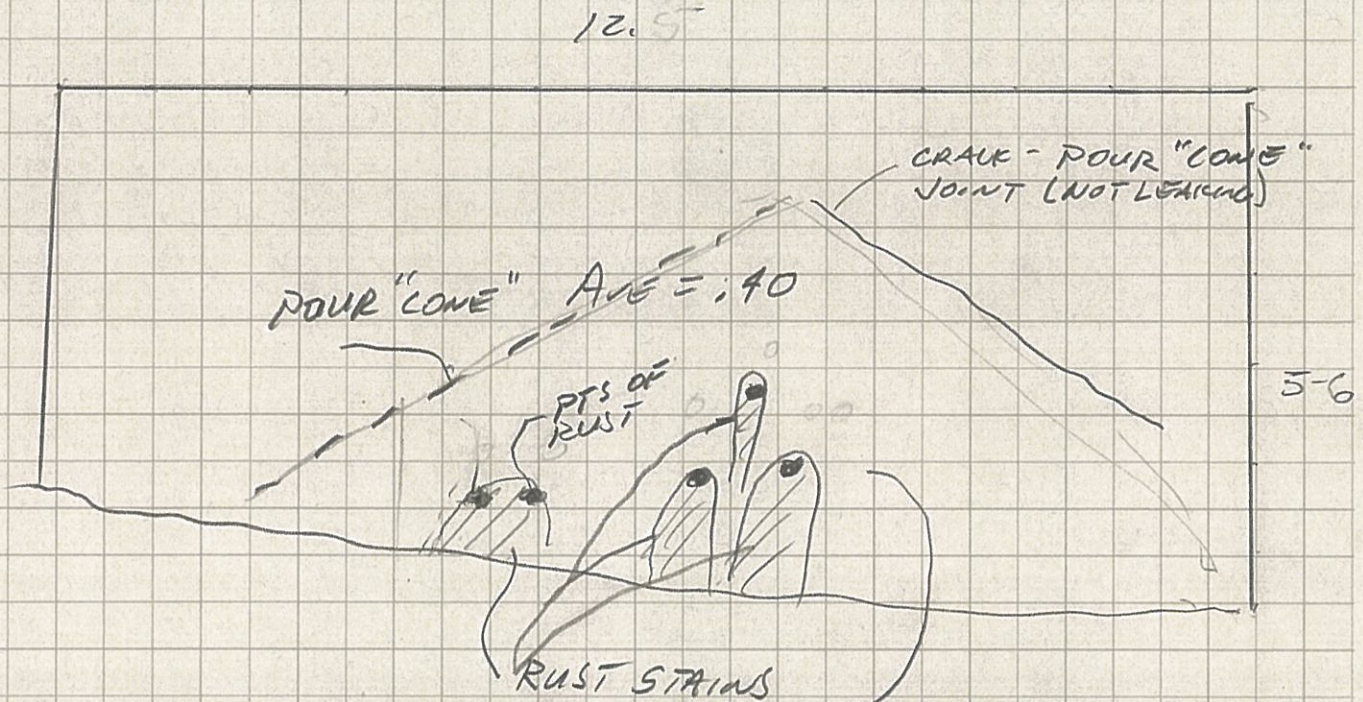
BAY 1

IN GENERAL THIS  
AREA IS DEFINED BY UPPER POUR COLOR PYRAMID  
RUST AREA DUE TO ISSUES WITH CONSOLIDATION.  
NO SPALLING SUGGESTS MINIMAL IF ANY  
WATER LEAKING.
