## Indian Lake Dam Inspection Report

Dam Identification No.: 687  
Hazard Potential: Low  
Section 31; T.5N. – R.11E.  
Addison Township, Oakland County, Michigan  
Located on a tributary of West Branch of Stony Creek  
Per Part 315, Act 451 of 1994

Date of Inspection: December 16, 2022  
Date of Final Report: December 23, 2022

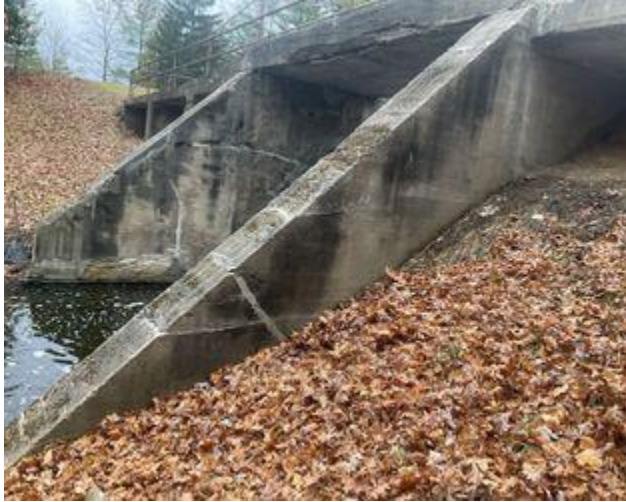
DESCRIPTION: Cracks filled on  
left main spillway abutment  
SEVERITY: Low

Recommend: Monitor cracks for increased separation, loss of material, or delamination of the patches. Fill cracks and repair concrete section loss as necessary.

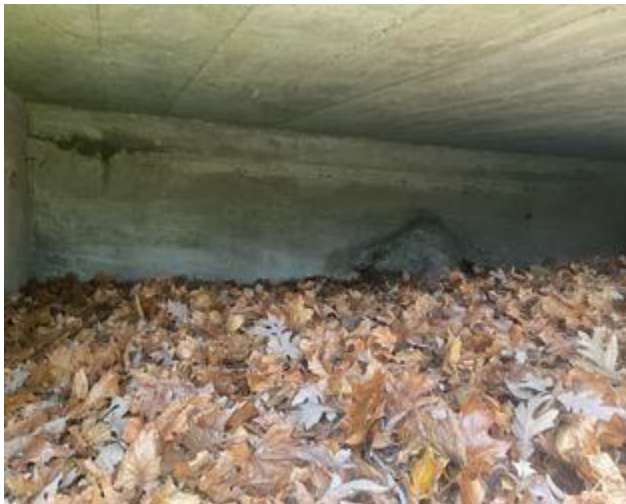
DESCRIPTION: First bay from  
left, minor cracking  
SEVERITY: Low

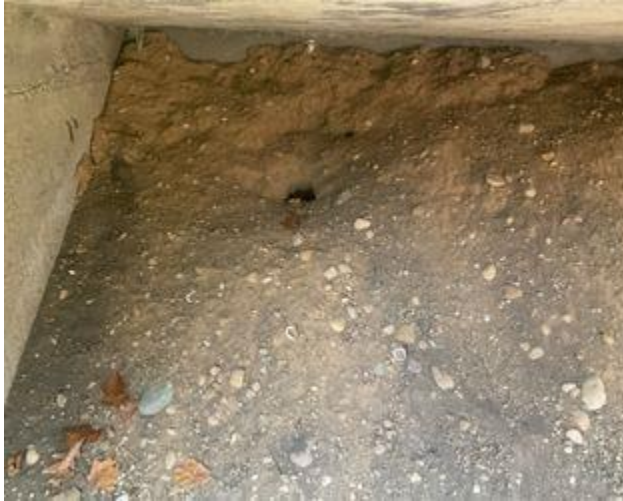
- H. The repairs to the concrete bays appears to be functioning as expected and there are no issues observed.
- I. Animal burrows were observed in fill placed inside of the spillway bays. However, the animal burrows do not pose a threat to the dam as there are concrete walls and footings below the fill.

**DESCRIPTION:** Animal burrow in  
second bay from left on  
downstream side of structure

**SEVERITY:** Low

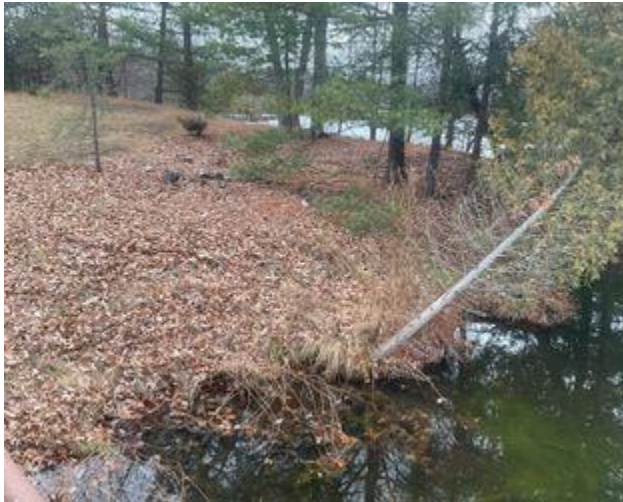
**DESCRIPTION:** Right bank  
upstream of structure

**SEVERITY:** Low

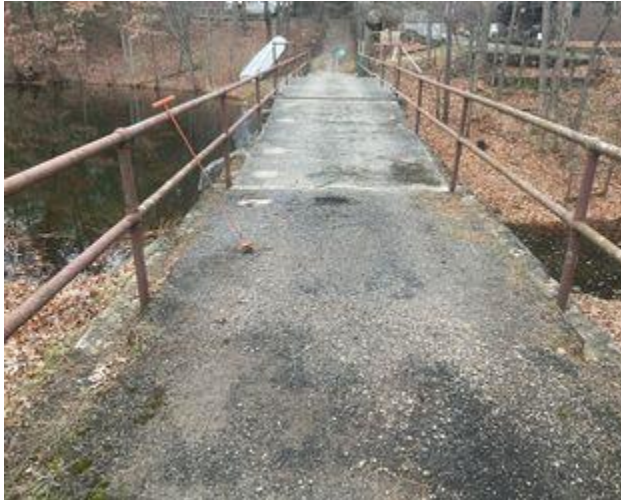
**DESCRIPTION:** Delamination on top of walkway noted especially toward the ends of the structure. Photo looking toward left bank

**SEVERITY:** Low

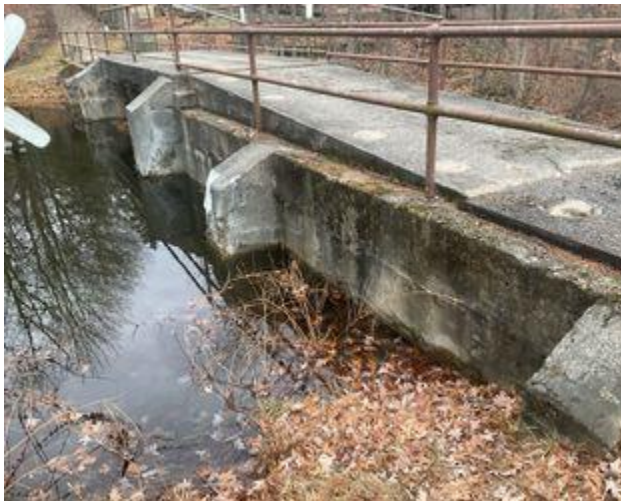
**DESCRIPTION:** Looking toward left bank on upstream side of structure

**SEVERITY:** Low

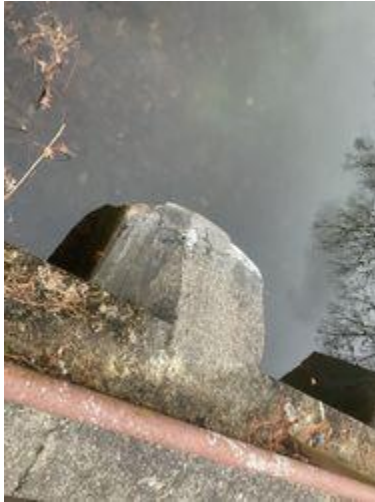
**DESCRIPTION:** Second abutment from right showing signs of delamination and cracking on upstream end, photo looking east

**SEVERITY:** Low

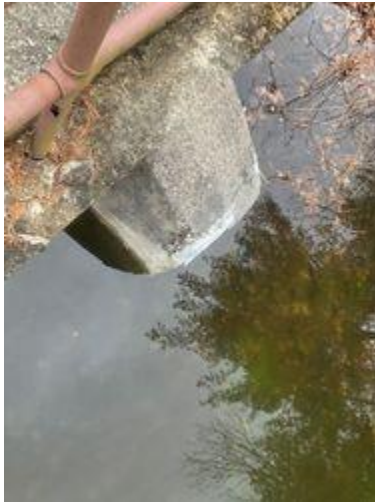
**DESCRIPTION:** Second abutment from right bank showing signs of delamination and cracking on upstream side of dam, photo looking west

**SEVERITY:** Low

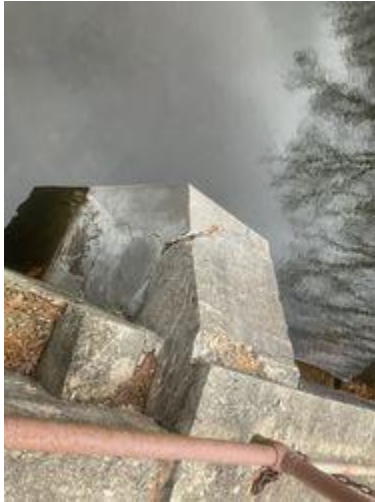
**DESCRIPTION:** Third abutment from right showing signs of delamination and cracking on upstream side, photo looking east

**SEVERITY:** Low

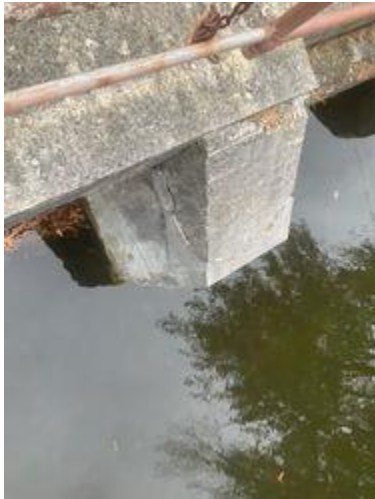
**DESCRIPTION:** Third abutment from right bank showing signs of delamination and cracking, photo looking west

**SEVERITY:** Low

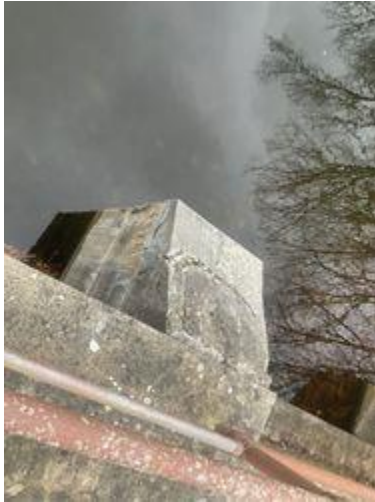
**DESCRIPTION:** Third abutment from left showing signs of delamination and cracking, photo looking east

**SEVERITY:** Low

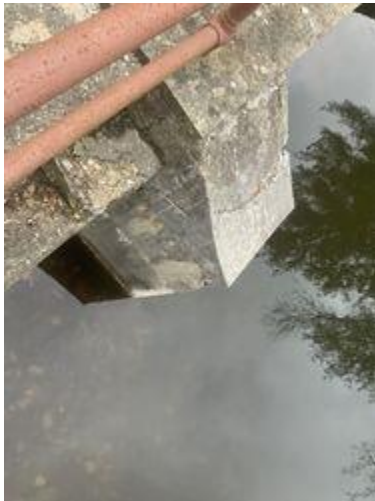
**DESCRIPTION:** Third abutment from left showing signs of delamination and cracking, photo looking west

**SEVERITY:** Low

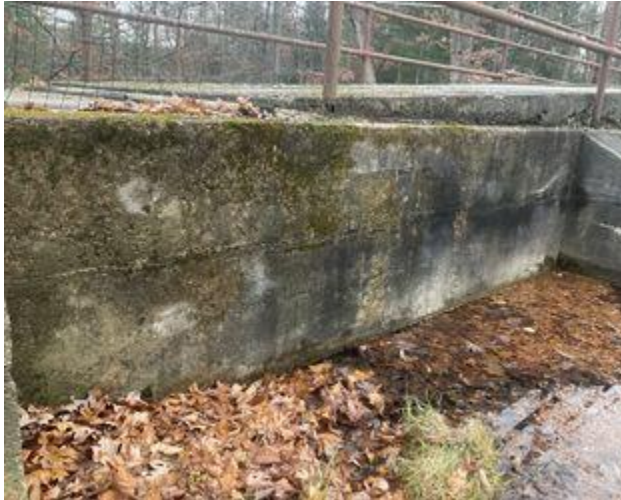
**DESCRIPTION:** Concrete separated between pours on upstream end of structure

**SEVERITY:** Low

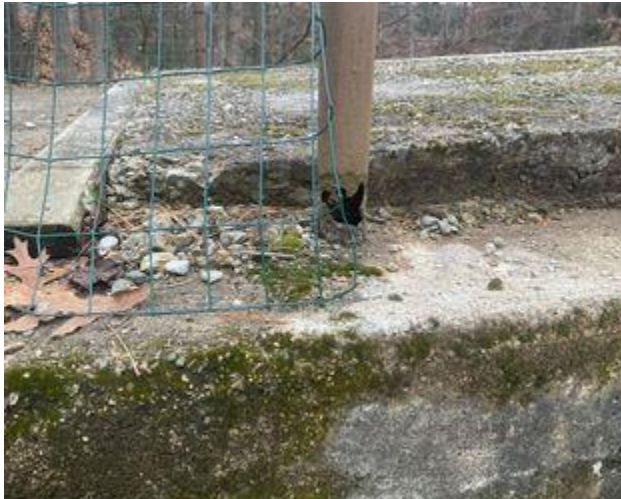
3. The metal safety railings of the dam are corroding.

**DESCRIPTION:** Rusted rail post. third post from left on upstream side

**SEVERITY:** Low

Recommend: Paint the metal safety railings and replace corroding sections with holes in them. Also, plan to either fully repair or replace all metal safety railings in the next 10 years if possible.

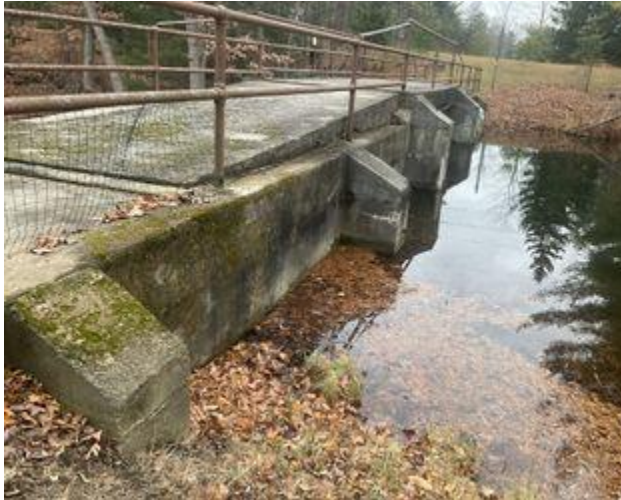
**DESCRIPTION:** Looking toward right bank on upstream side of dam

**SEVERITY:** Low

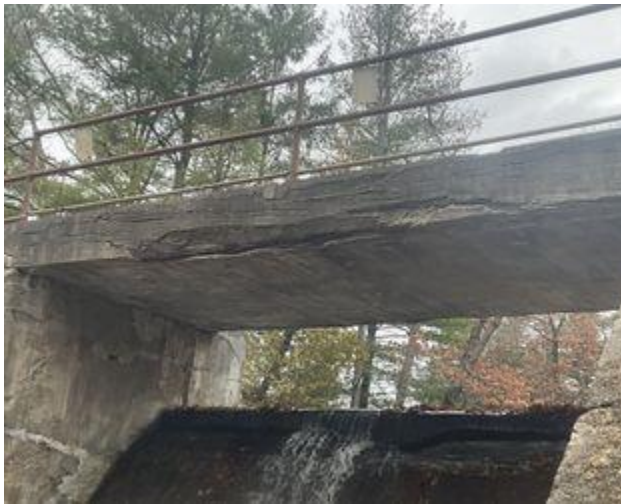
**DESCRIPTION:** Spalling and cracking noted on main deck of spillway on downstream side of dam

**SEVERITY:** Medium

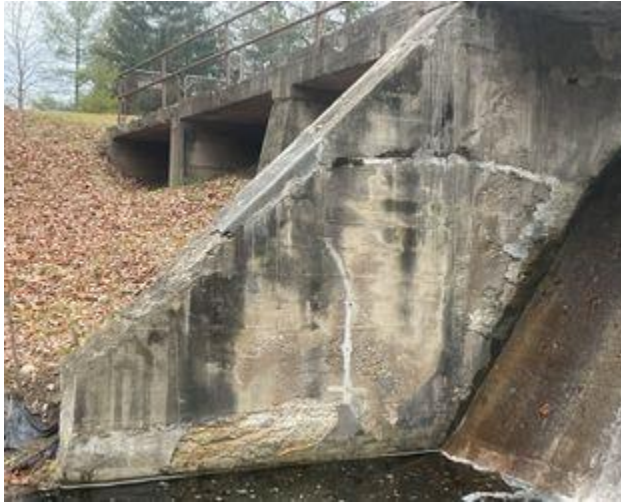
**DESCRIPTION:** Cracking and delamination on right abutment of main spillway

**SEVERITY:** Medium

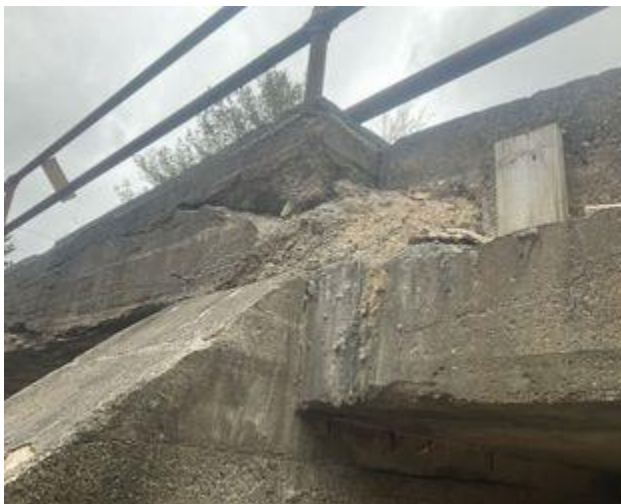
**DESCRIPTION:** Spalling at left downstream end of structure

**SEVERITY:** Low

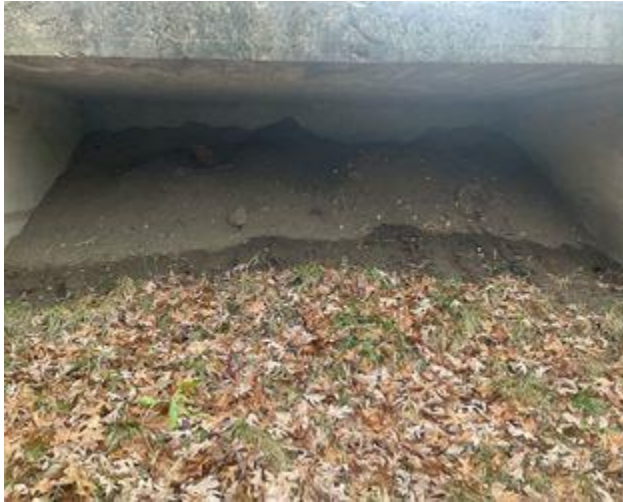
**DESCRIPTION:** Second bay from right end of structure

**SEVERITY:** Low

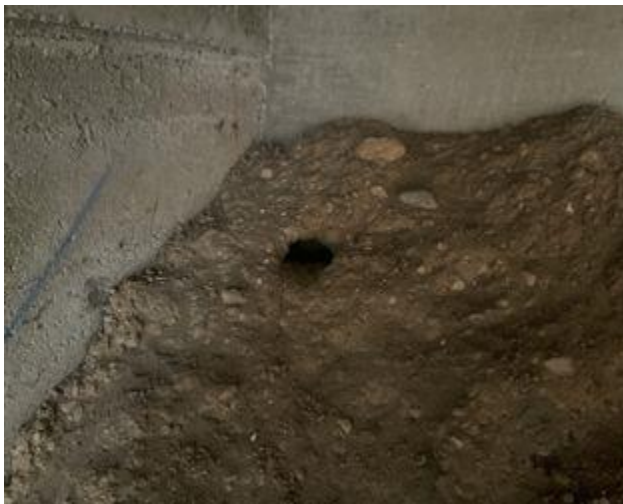
**DESCRIPTION:** Animal burrow noted in second bay from right end of structure

**SEVERITY:** Low

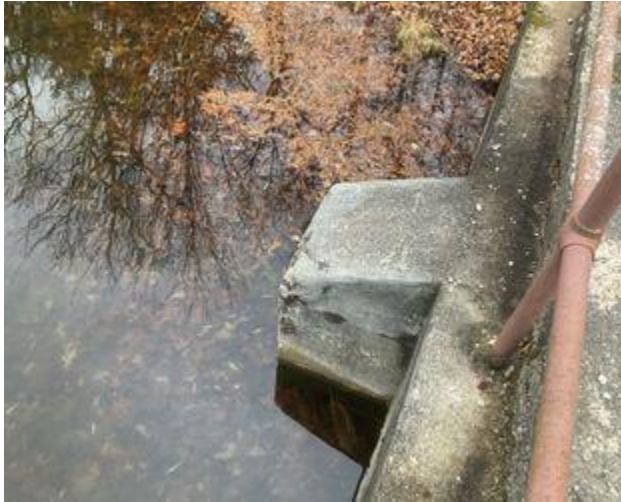
**DESCRIPTION:** Second abutment from left on upstream end of structure showing signs of delamination and cracking

**SEVERITY:** Low

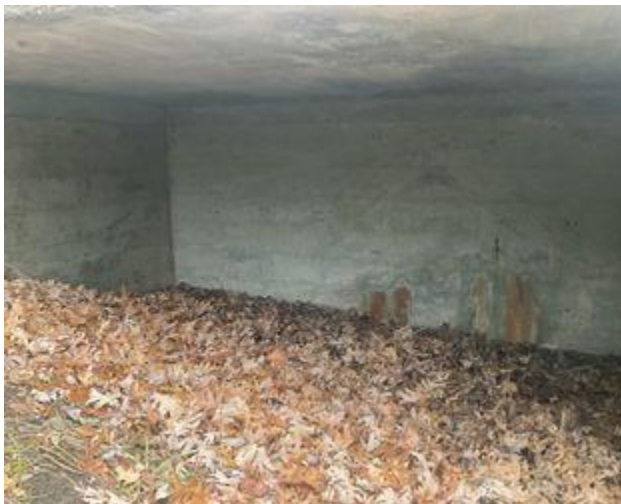
**DESCRIPTION:** First bay from right end of structure, minor efflorescence

**SEVERITY:** Low

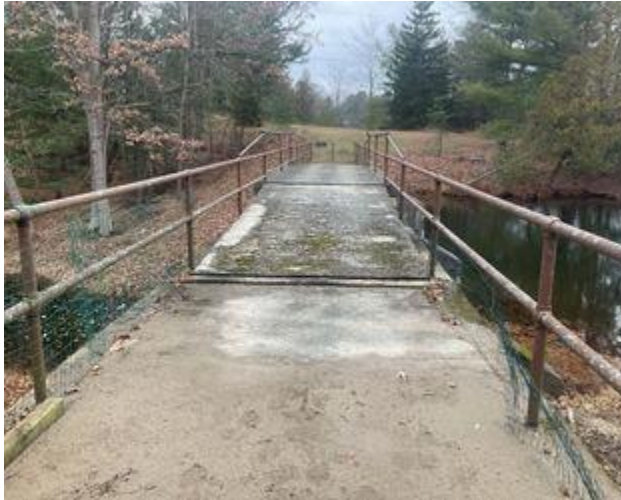
**DESCRIPTION:** Delamination on top of walkway noted especially toward the ends of the structure. Photo looking west.

**SEVERITY:** Low

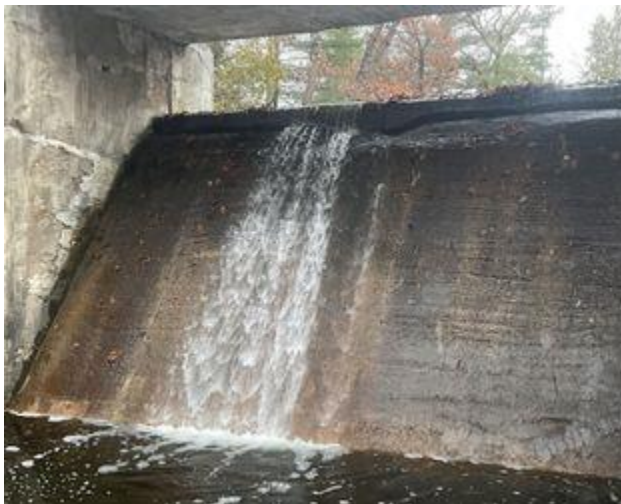
**DESCRIPTION:** Main spillway, note possible wearing at top center of spillway

**SEVERITY:** Low

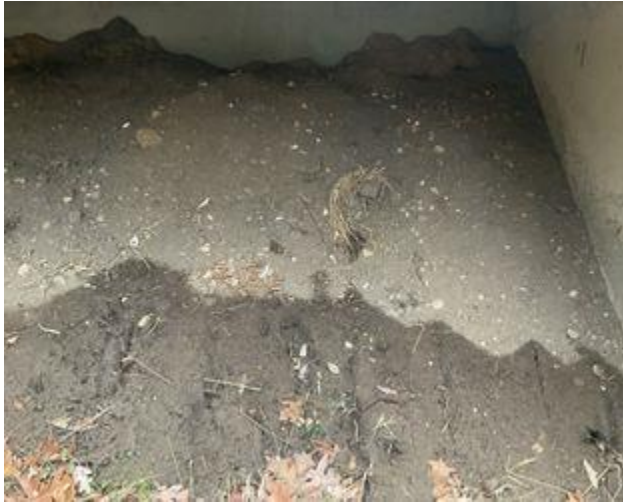
**DESCRIPTION:** Animal burrows  
noted in second bay from right  
end of structure

**SEVERITY:** Low

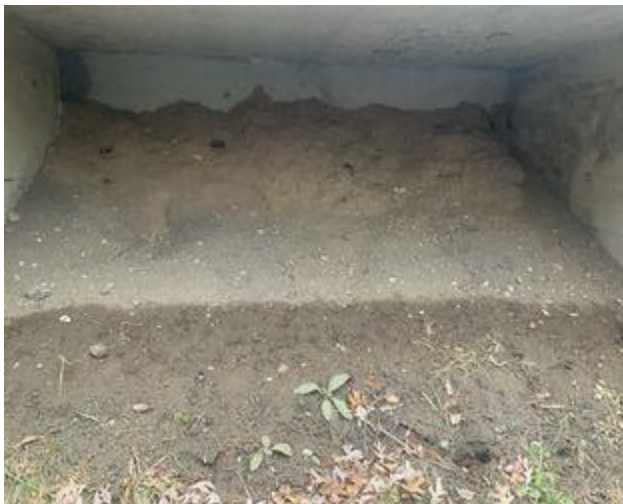
**DESCRIPTION:** Animal burrows  
noted in third bay from right  
end of structure

**SEVERITY:** Low

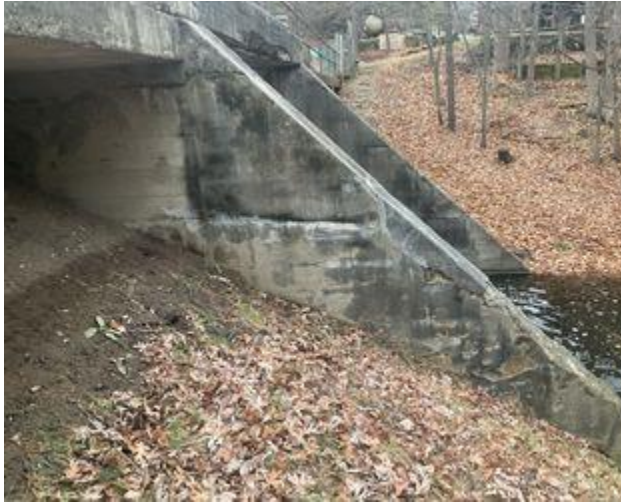
**DESCRIPTION:** Delamination noted on right abutment of main spillway on downstream side of dam

**SEVERITY:** Low

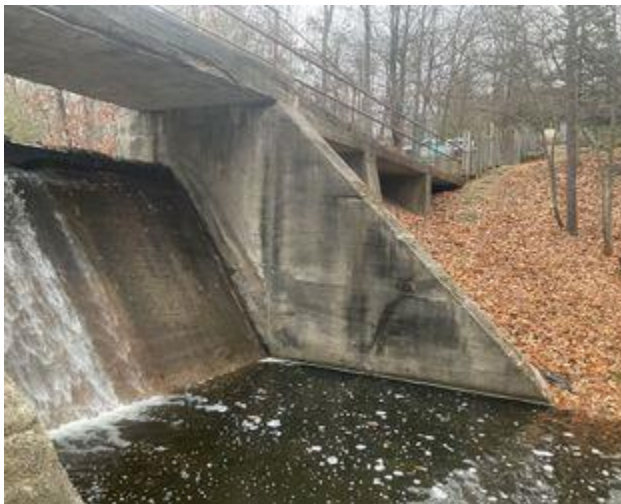
**DESCRIPTION:** Left abutment on downstream end of spillway. Minor cracking toward bottom of abutment wall

**SEVERITY:** Low

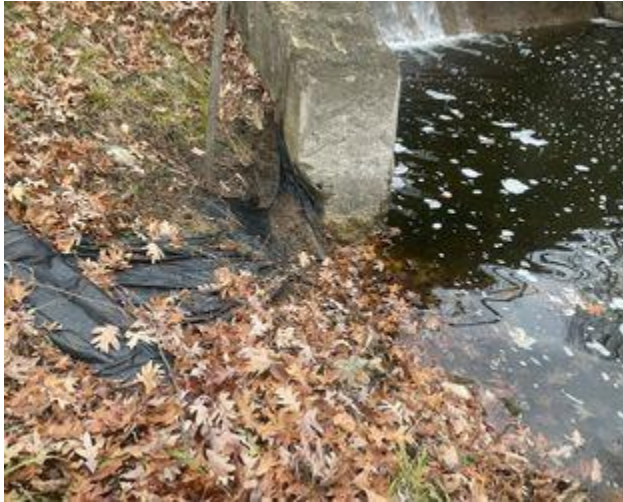
**DESCRIPTION:** Erosion at downstream of right abutment wall

**SEVERITY:** Low

Recommend: Install filter fabric and plain riprap in these areas to prevent further erosion from storm events.

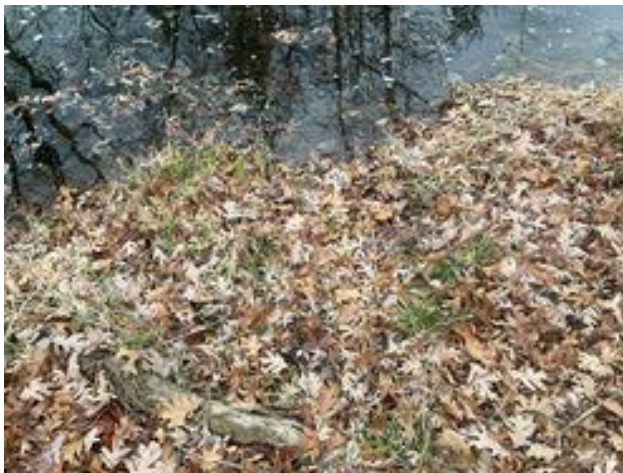
- F. There is minor erosion on the west side of the downstream slope which appears to be caused by runoff from the access road.
- G. Vegetation on the downstream slopes is well established except where the runoff mentioned above is accessing the site.

**DESCRIPTION:** Minor erosion on right bank downstream of the structure

**SEVERITY:** Low

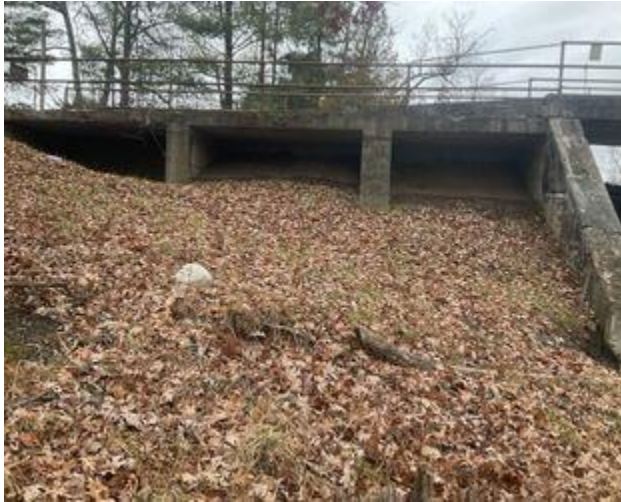
**DESCRIPTION:** Right side of downstream dam face

**SEVERITY:** Low

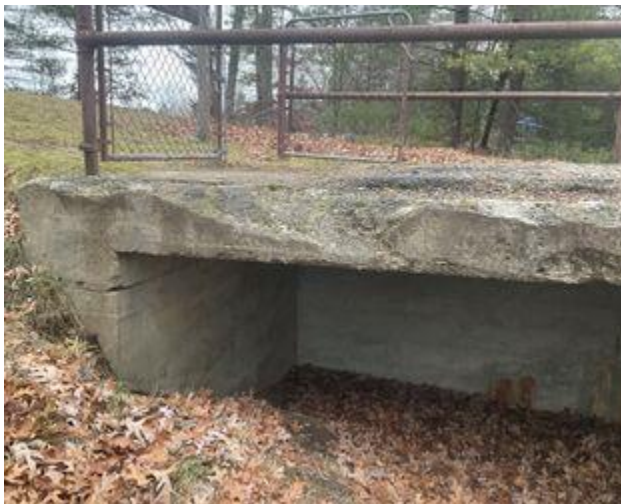
**DESCRIPTION:** Crack and spalling on right downstream side of structure

**SEVERITY:** Low

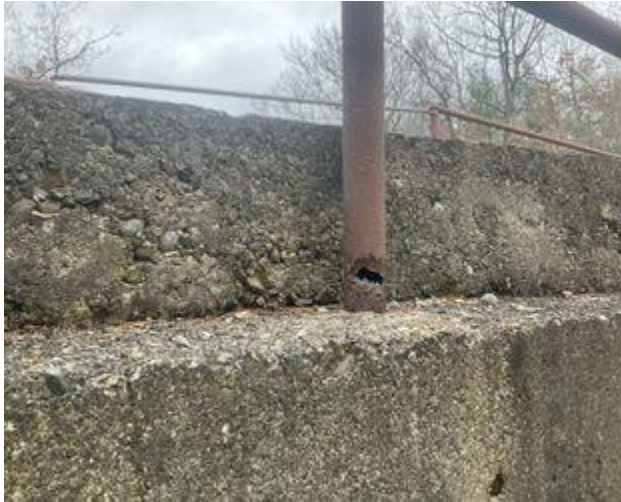
**DESCRIPTION:** Hole in fourth rail post from right on downstream side of structure

**SEVERITY:** Low

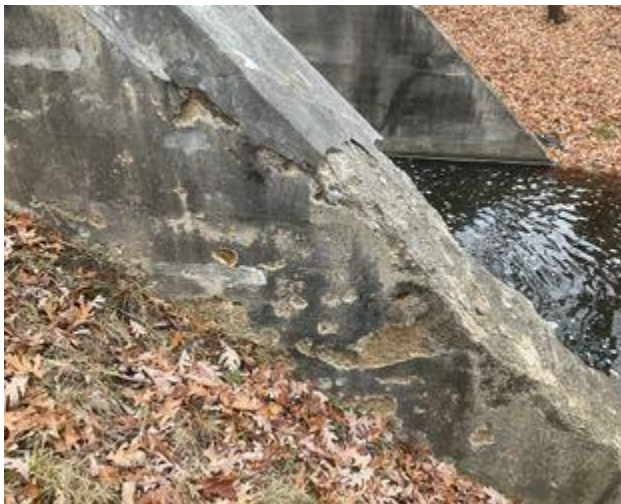
**DESCRIPTION:** Spalling and delamination on right main spillway abutment on the downstream side of the structure

**SEVERITY:** Medium
