# DAM SAFETY INSPECTION REPORT

Indian Lake Dam  
Oakland County

MDNR DAM ID NUMBER: 00687

DATE OF INSPECTION: October 13, 1994

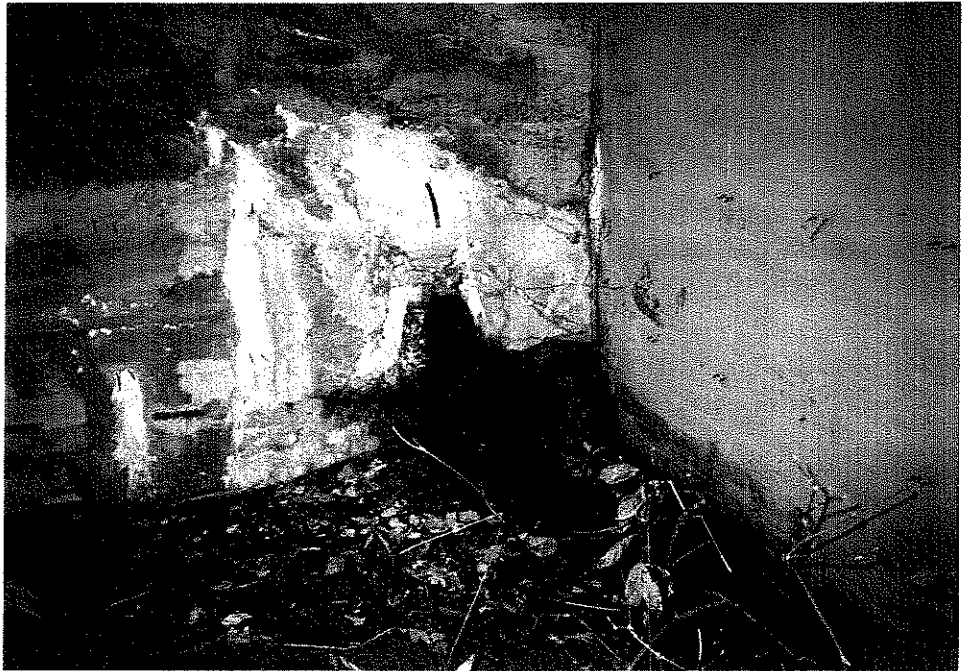
portions of the structure. However, none of the spalling seems to be endangering the structural integrity of the dam (see photos #7 and #8). There are a few areas of water seeping through the concrete both north and south of the spillways (see photos #5 and #6). Repair of these areas was attempted by the previous owner as per the current owners notes in *Appendix C*. These areas of seepage should be repaired immediately. The spalled concrete should also be repaired in order to prevent continued degradation of the dam.

PHOTO #5  
SEEPAGE OF WATER THROUGH  
DAM, SOUTH OF CREEK

1. Repair the seepage cracks on both the north and south downstream sides of the dam.
2. Repair the spalled concrete in the areas mentioned in this report.
3. Continue to keep the upstream and downstream earthen abutments clear of large trees and shrubs.
4. Set up Operation and Maintenance Plan. (see below)

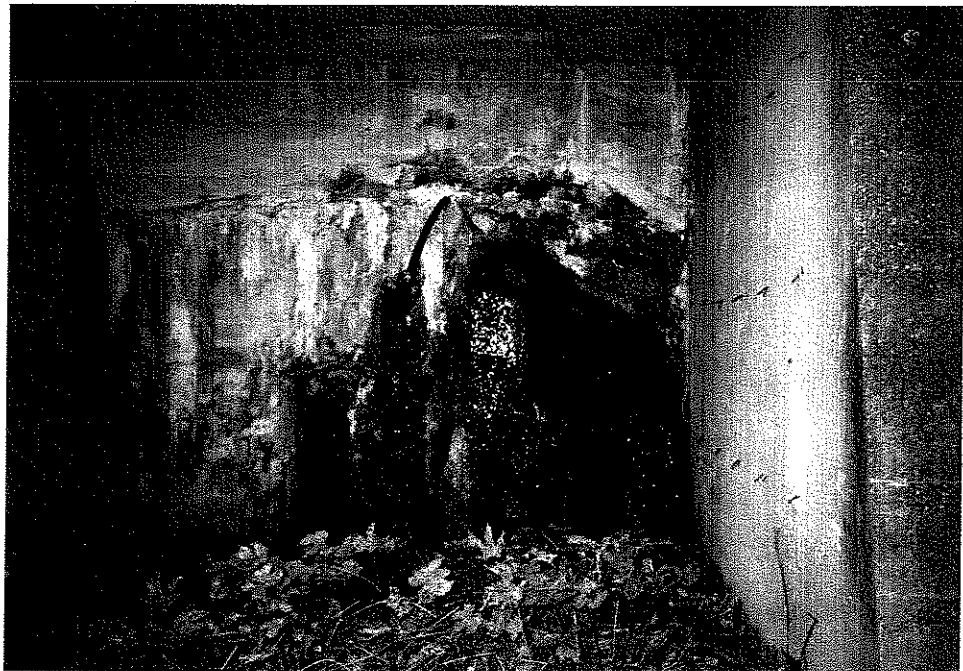
PHOTO #6  
SEEPAGE OF WATER THROUGH  
DAM, NORTH OF CREEK

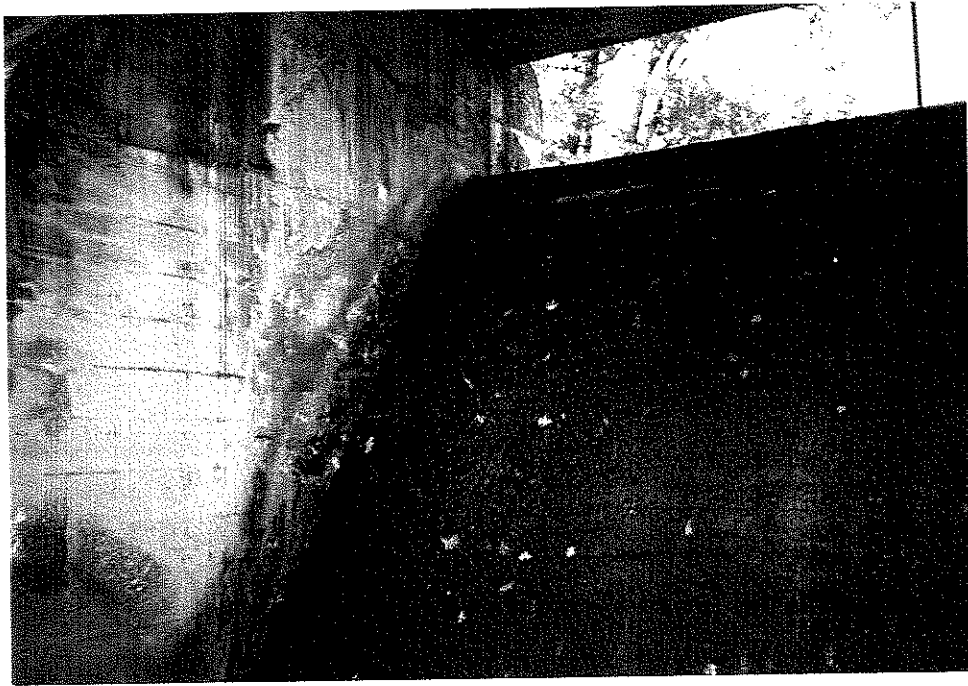
PHOTO #7  
SPALLED CONCRETE NEAR  
SPILLWAY, SOUTH OF CREEK

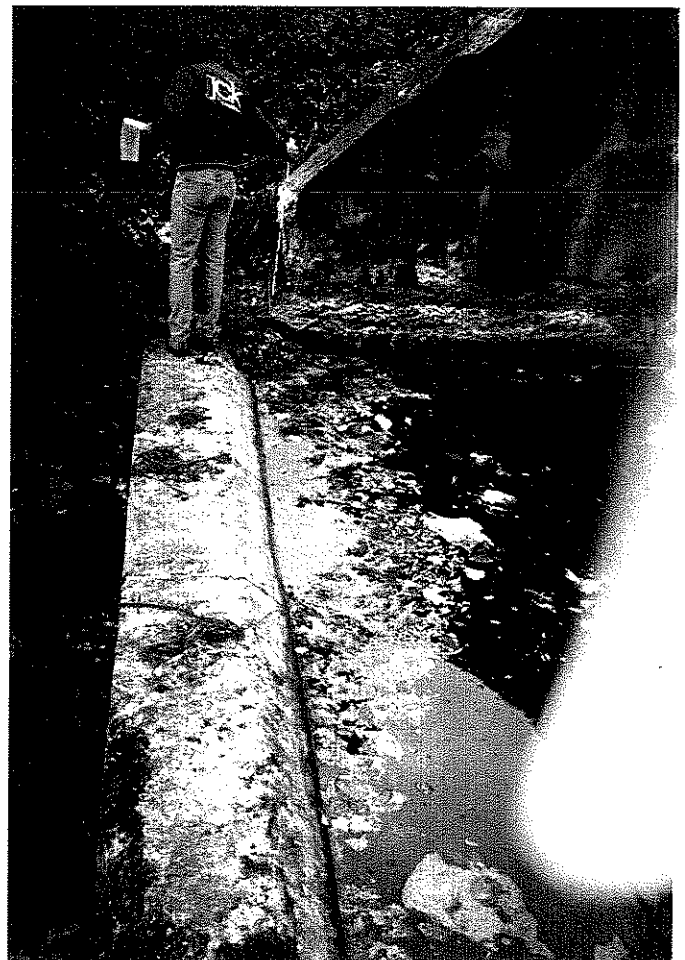
The concrete spillway, stilling basin and energy dissipation sill are all in relatively good condition having only slight spalling of the concrete. Scour and erosion were not apparent.

PHOTO #10  
ENERGY DISSIPATION SILL  
AND STILLING BASIN
