Re: Storm Water Basin Maintenance

Storage Basin Maintenance - Inspection Report

Basin ID #: 003BDO1 Location Description: Autumwood (basin)
Inspected by: RMS Type of Inspection: Routine Complaint Storm Event
Date: 10-18-18 Time: 1:40 Weather: 55° Sunny

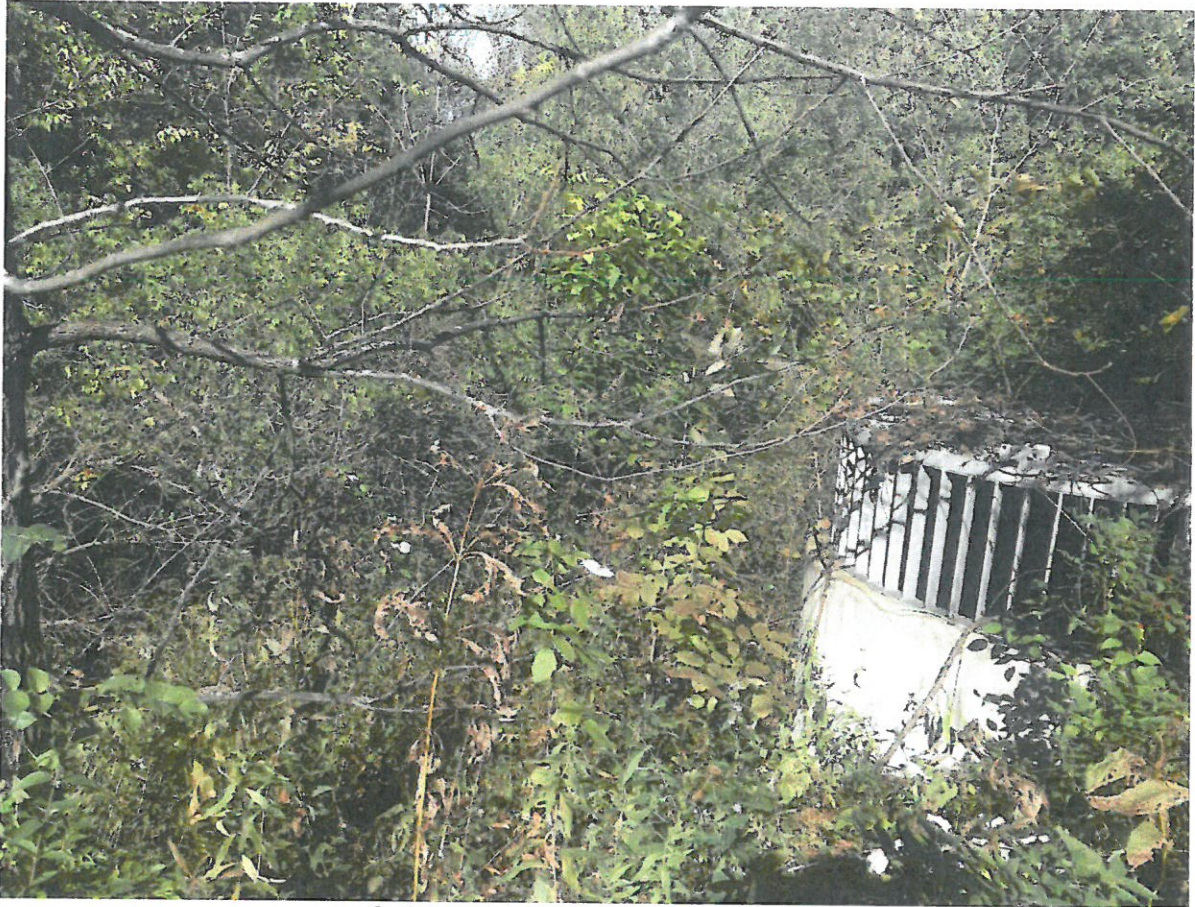
Are pipes/inlets going in/out of the pond clogged or obstructed? Yes No
Comments:
Is the outlet control structure free of debris and functioning properly? Yes No
Comments: debris over top of grate
Is the outfall downstream of the basin functioning properly? Yes No
Comments:
Does it appear that any buildings/structures may be impacted by improper maintenance of the basin?
 Yes No Comments:

Outlet control structure, facing northwest

Cut trees and vegetation from areas around inlets and outlets; remove cuttings from basin. Remove debris from grate over outlet control structure.
