THE IVATT INFORMER

Recording progress with LMS 10000

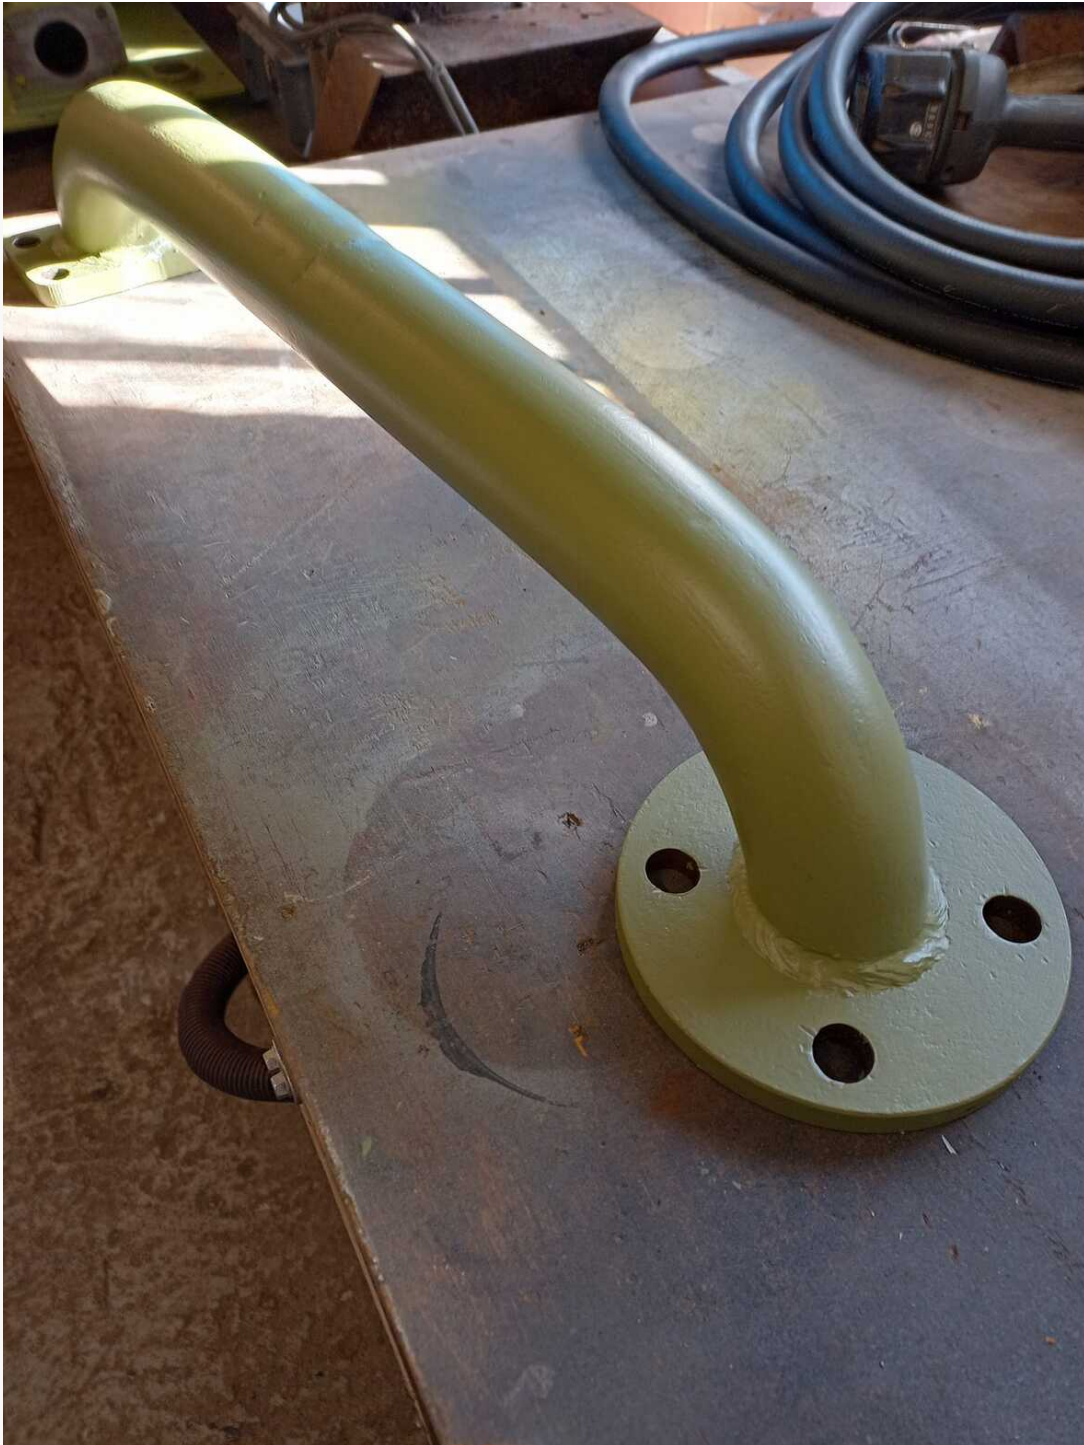
I performed for a few hours on Tuesday, not a great deal happening at the moment as I'm still chasing around for replacement parts. I did get the separator tank vac pipe painted and selected and started cleaning the next candidate for the treatment. I couldn't find the correct size eyebolts to lift the exhauster to get to clean it properly. I've now been given permission to look in Paul's kit to find some. Next week I want to measure the rotor/casing clearances, I've removed the pipe to allow access to the internals, boy you should have seen the gooey gloop (oil) that crawled out once the pipe came off, sorry I didn't photograph the removed pipe (but it's only the same as the one I painted), it's my first action next Tuesday.

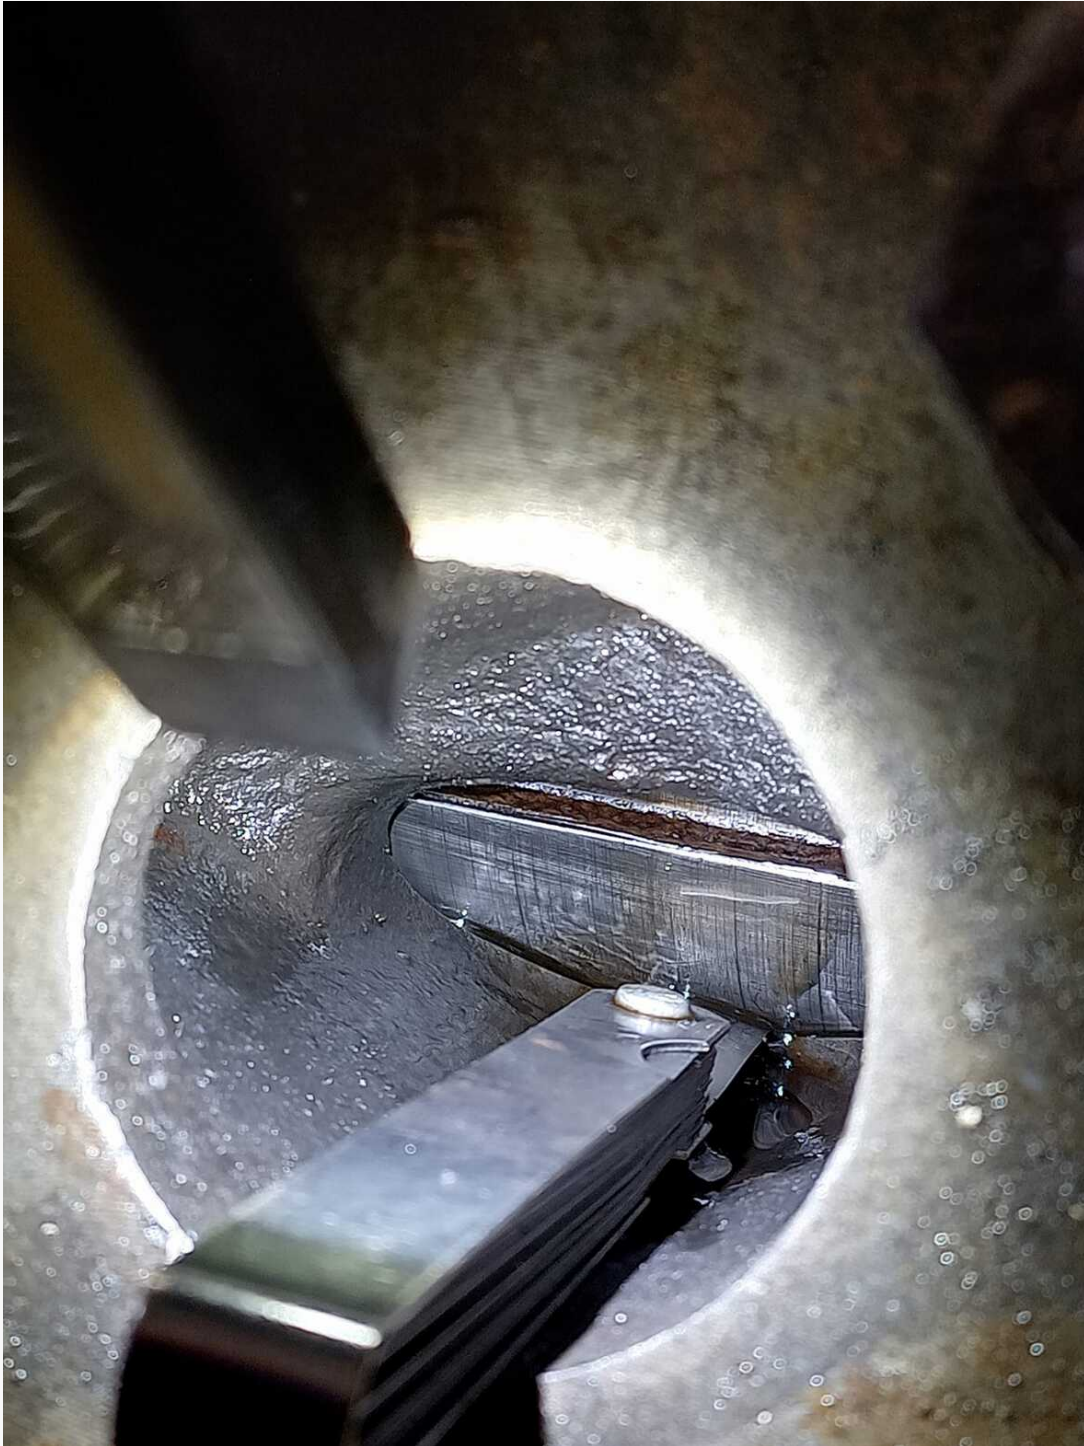
It was a day of checking and measuring really, first job was to double check the dimensions, wear tolerances and clearances of the rotor/vane. Then compare these to the vane clearances and tolerances on the production drawing that has been supplied to manufacture the replacement vanes in modern materials, all dimensions checked out ok, in my employment days these checks would have been done by another engineer.

I then moved onto checking the rotor/casing running clearance on another exhauster, this is a step in the maintenance procedure to prove if the machine is still serviceable. The running clearances proved that this machine is in serviceable condition and it will be stripped, cleaned examined, painted and rebuilt with new vanes once the other machine is back together.

The picture show the rotor/casing clearances being checked with a 0.0025" feeler gauge, and how worn the vanes are when installed in the rotor slots. Measurements suggest 0.090" in this case although the maximum wear tolerance stated in the service manual states 9/64" about 0.150".

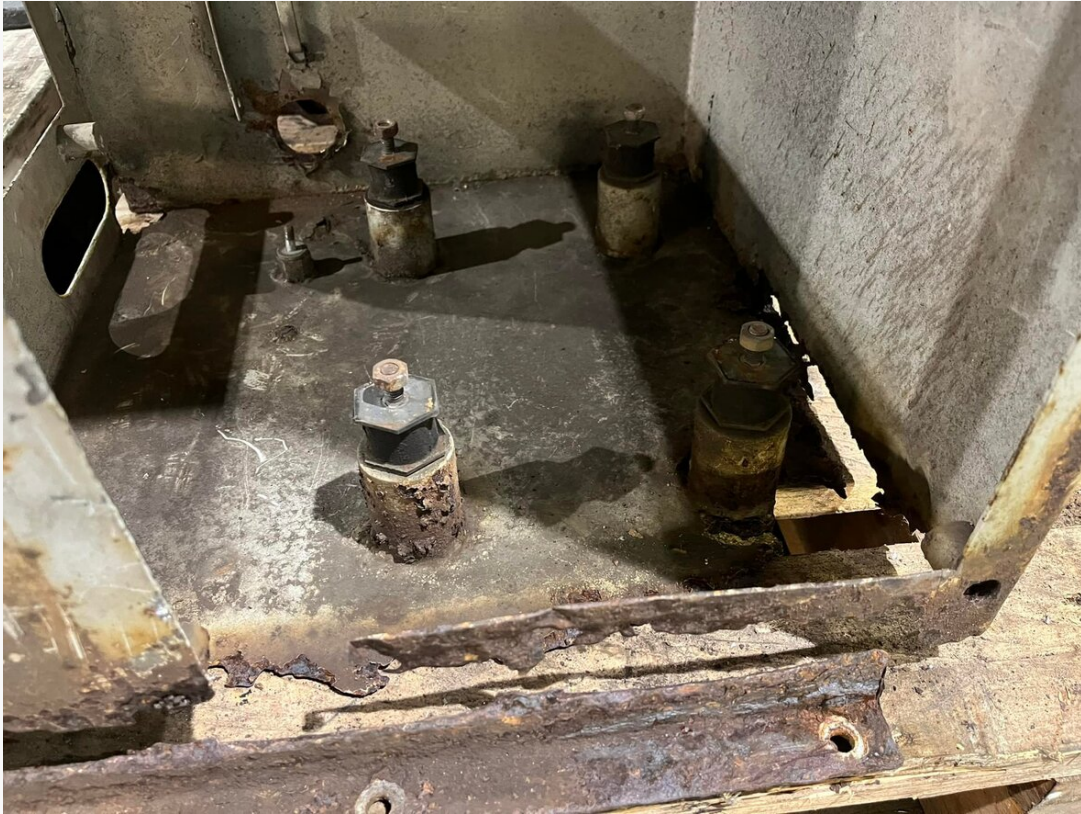
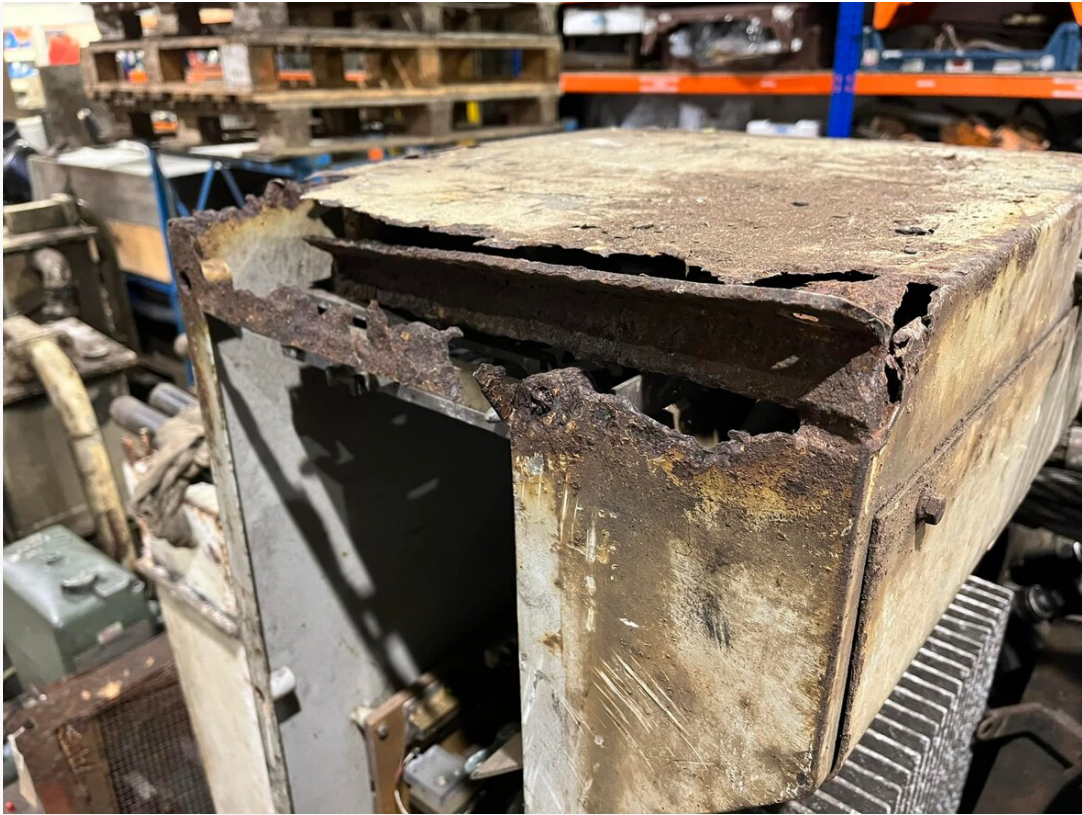
On the 11th the battery box from 58022 had been stripped out ready to be repaired. Meanwhile all the internal parts will be cleaned up, tested and repaired if necessary. It has suffered from sitting in

a puddle for many years, which wasn't previously a problem as originally we weren't going to use it. On inspection, the cubicle and alternator turned out to be in better condition than we thought, so the decision was made to use both. The charger is more or less complete, and we now have several working control modules, so once Phil has repaired the hole in the bottom, the whole unit will be refurbished. Luckily none of the internal components were sitting in water, as the control module tray sits on these pedestals. You can see the area needing repair at the bottom and on the second photo. An easy cosmetic repair.

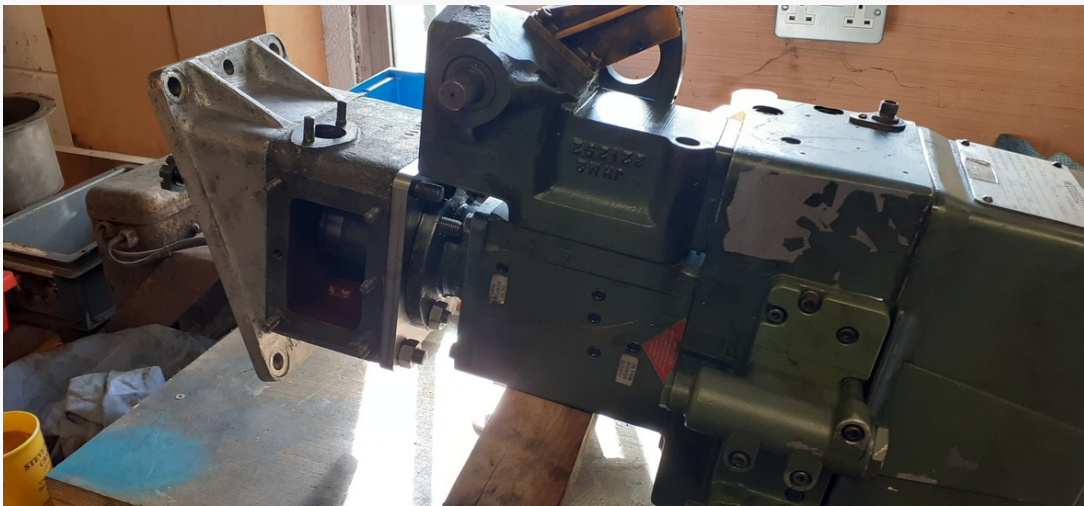
On the 18th Phil sent us a picture of the adaptor fitted to the former class 56 Governor. Fantastic work being done by Gareth Davies. This will attach between our 16SVT power unit and the ex-class 56 Governor. Here it is seen during a trial fitting.

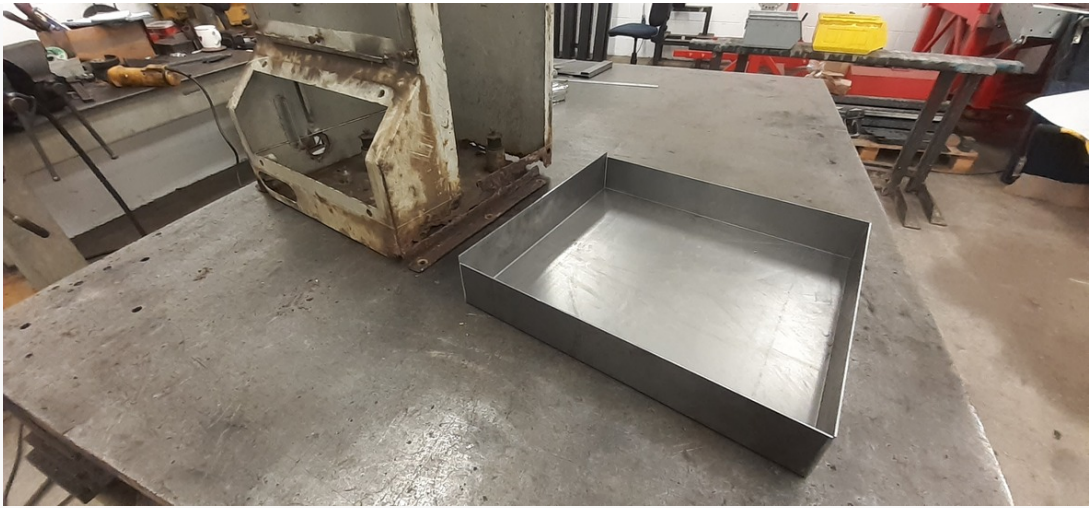
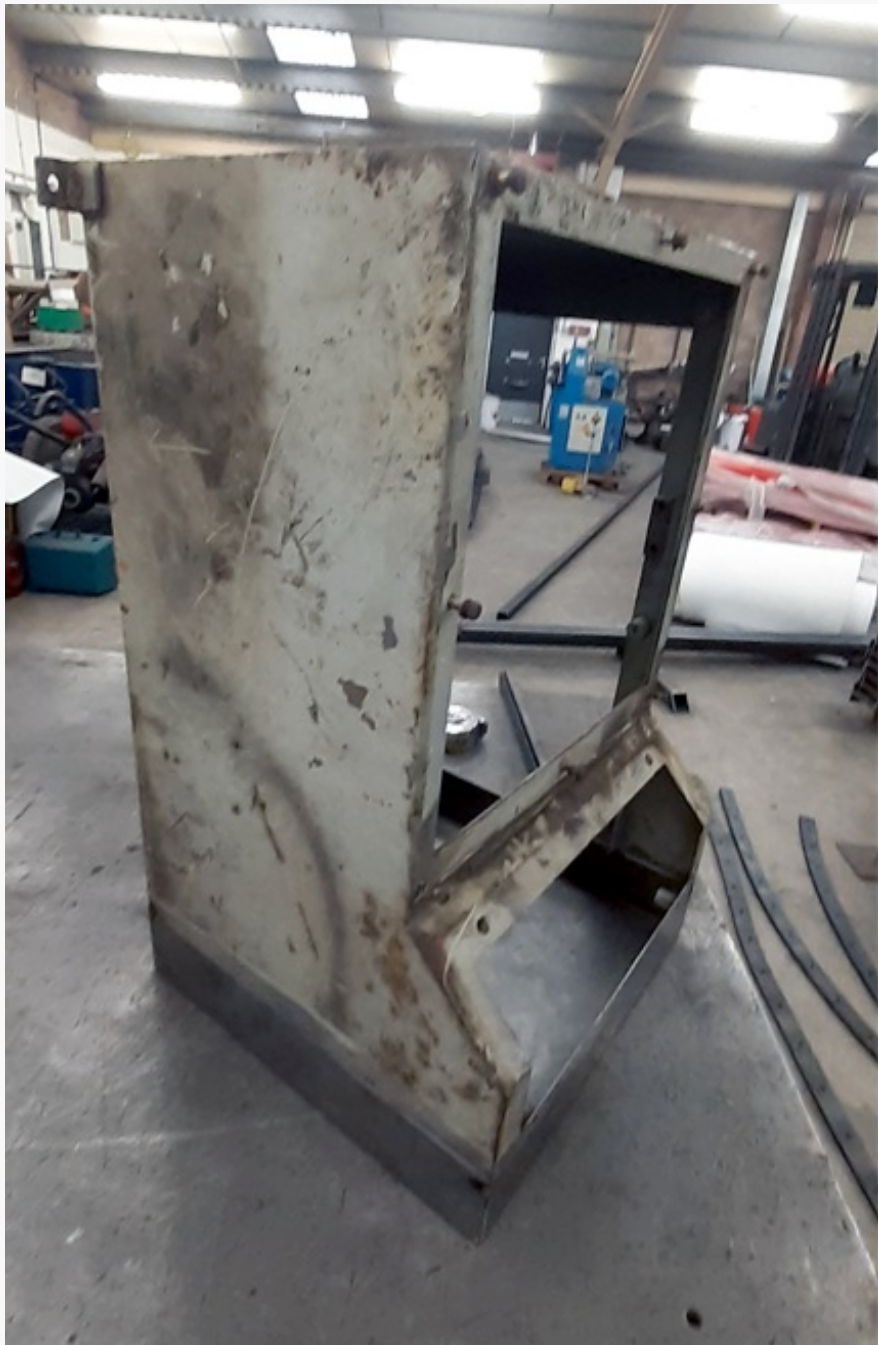
On the last day of March Phil told us "Almost finished the repairs to the battery charger cabinet . Removed badly corroded base ,and fabricated new section and welded in . Thanks to Gareth at TAS Eng for use of the facilities. "
