# AERIAL PV THERMAL INSPECTION REPORT (Sample)

123 OCEAN DRIVE  
LONG BEACH, NY  
AUGUST 10, 2021

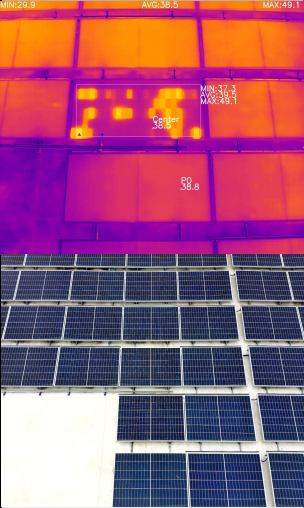
| PHOTO | FILE NAME | ANOMALY TYPE | LOCATION ON MAP | PRIORITY | DELTA T |
|---|---|---|---|---|---|
| | IRX_2005.jpg | Hotspot<br>Cell Multi<br>Medium | 1 | High | 11.8 |

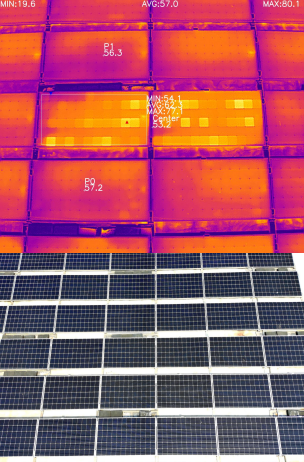
| PHOTO | FILE NAME | ANOMALY TYPE | LOCATION ON MAP | PRIORITY | DELTA T |
|---|---|---|---|---|---|
| | IRX_2181.jpg | Hotspot<br>Cell Multi<br>Medium | 2 | High | 23 |

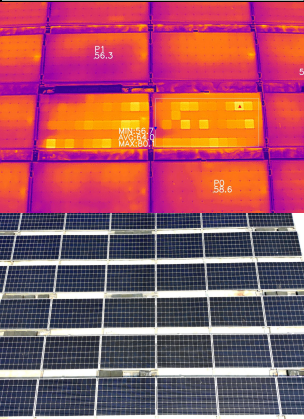
| PHOTO | FILE NAME | ANOMALY TYPE | LOCATION ON MAP | PRIORITY | DELTA T |
|---|---|---|---|---|---|
| | IRX_2181.jpg<br><br>MAX_2181.jpg | Hotspot<br>Cell Multi<br>Medium | 3 | High | 23.4 |

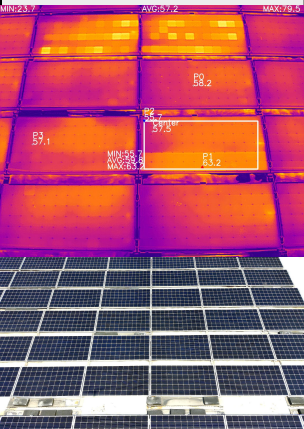
| PHOTO | FILE NAME | ANOMALY TYPE | LOCATION ON MAP | PRIORITY | DELTA T |
|---|---|---|---|---|---|
| | IRX_2156.jpg<br><br>MAX_2156.jpg | Diode | 4 | Medium | 8.5 |
