Interim Report on the capsizing of “The Big Hairy”

- 56) On the 2 August 2024 Mr Lyons inspected *The Big Hairy*, at Bundaberg Port Marina.
- 57) On 23 August 2024 Mr Lyons issued a comprehensive Expert Naval Architect's Interim Report titled: Inspection of failed ballast keel on the yacht "The Big Hairy" HIN AU-WWA187638/TIM01Q/ON 857223. Attached at Annex A.

**INSPECTION OF FAILED BALLAST KEEL
ON THE YACHT
THE BIG HAIRY
HIN AU-WWA187638 / TIM01Q / ON 857223**

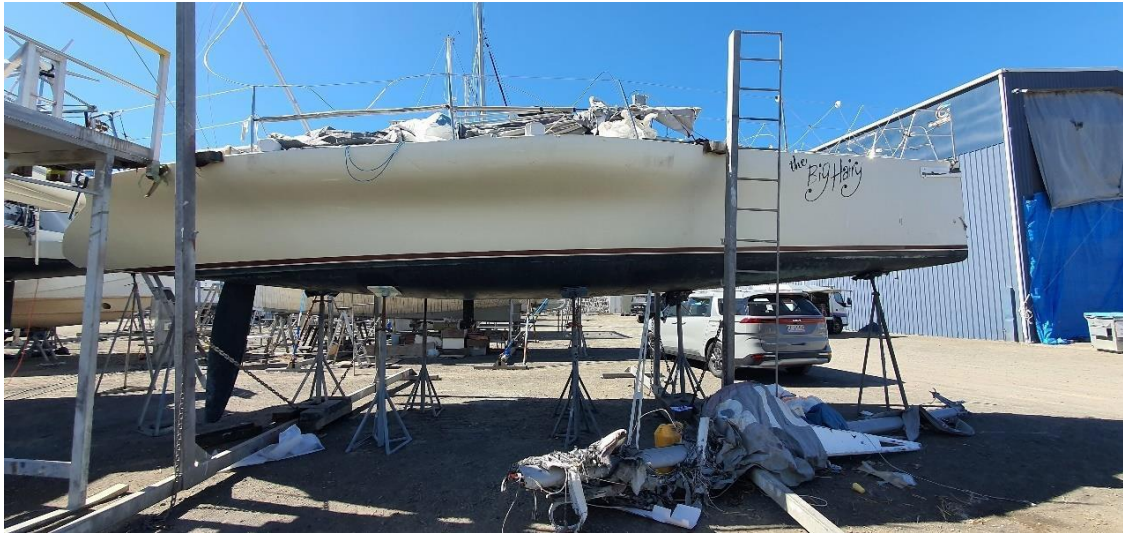
Fig.1 – The vessel at Bundaberg Port Marina on 2 August 2024.

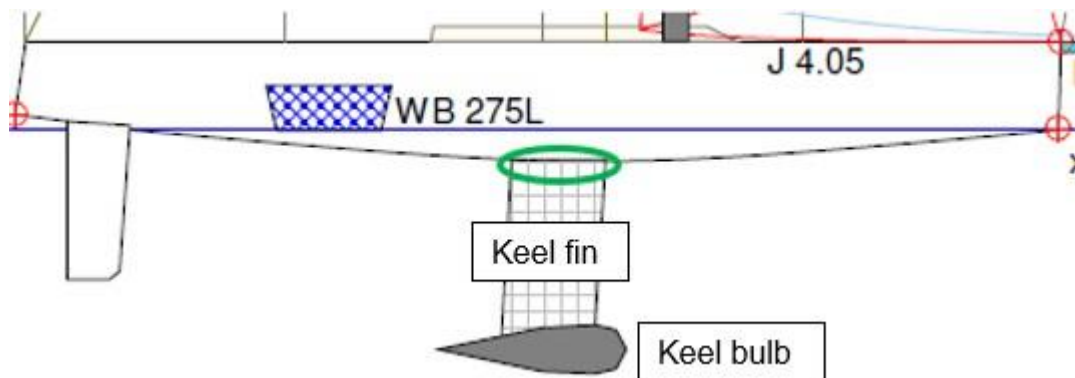
Fig.2 – The keel **root** shown within the green ellipse (marked up image taken from the vessel’s ‘IRC’ handicap rating certificate, obtained from Australian Sailing).

At the same time, the root must be of sufficient minimum size to ensure the strength of the attachment of the keel to the hull. The vessel’s keel fin is fabricated from welded mild steel and bolted to the hull.

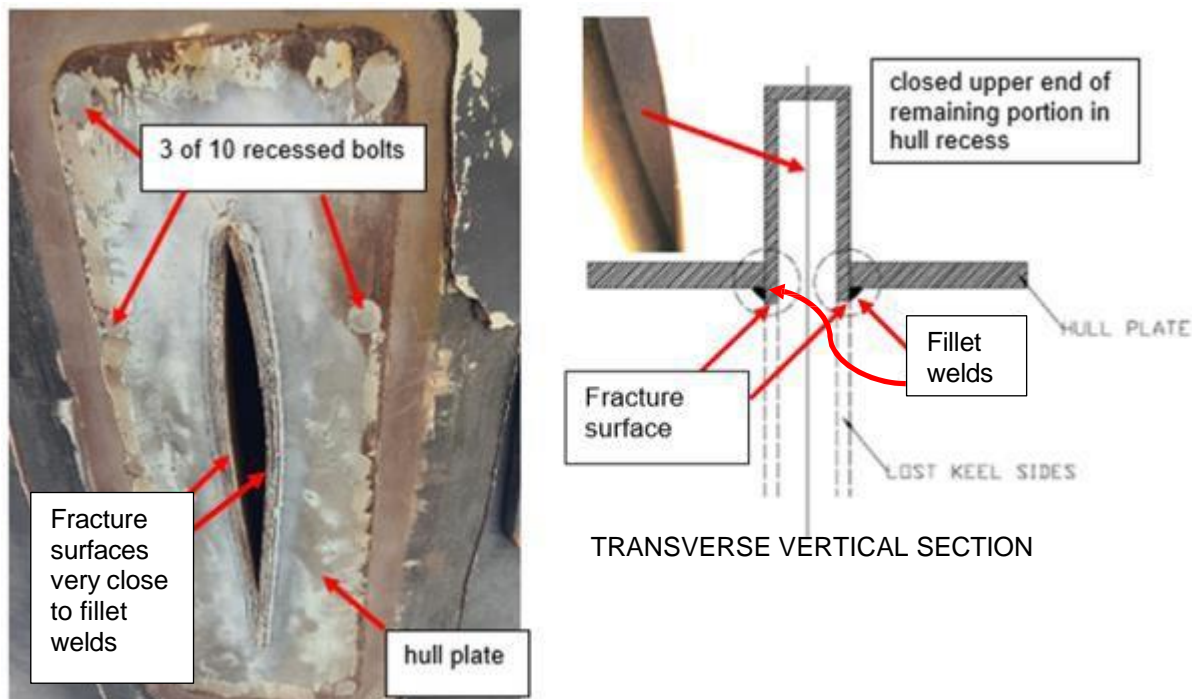
Fig.3 (above, left) – The keel **root** showing the break's **fracture surfaces** very close to the fillet welds at the keel root (the fin below it was lost at the time of the incident). The term 'fillet weld' is given to a line of weld connecting two pieces of metal at an angle to one another, in this case perpendicular (90°) to each other. **Fig.4 (above, right)** – transverse vertical section through the keel, showing the remaining portion of keel fin that inserts into a hull recess, and the horizontal rectangular steel **hull plate**. The photo in **Fig. 5 below** represents the intact arrangement (from the same or similar vessel—the photo's true origins have not been confirmed but are representative of the actual arrangement on the vessel):

- 22 The fracture surfaces are co-incident with, or in very close proximity to the welds (no more than the keel sides' plate thickness of 10 mm and mostly less).
- 23 Cracking at the boundaries of the fracture surface closest to the welds appears to be co-incident with the **toes** of the welds. The toes are the junction of the weld face and the base metal:

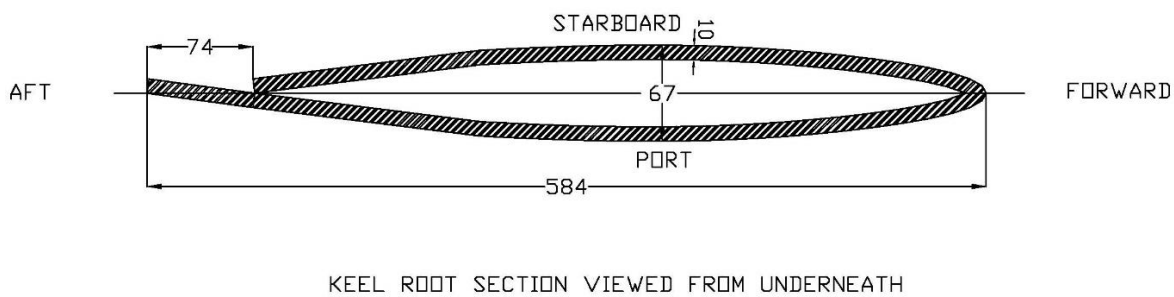
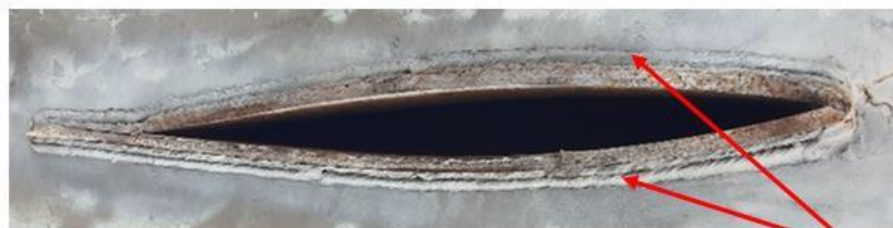
Fig.s 6 & 7 – Drawing (above) with dimensions [mm] and photo (below) of the keel **root** fracture surface.

- 27 My inspection of the fracture surface of the vessel leads me to believe, based on my experience and expertise, that the keel has broken at the welds at the keel root as a result of fatigue, exacerbated by inconsistent weld quality, the contribution of the Heat Affected Zone and the decision to place a weld at such a critical stress location as the keel root. Further physical testing is needed to confirm these findings.

I recommend that sectioning, polishing and examination of the root welds be undertaken in accordance with a specimen extraction and testing regime, following which this interim report can be finalised.

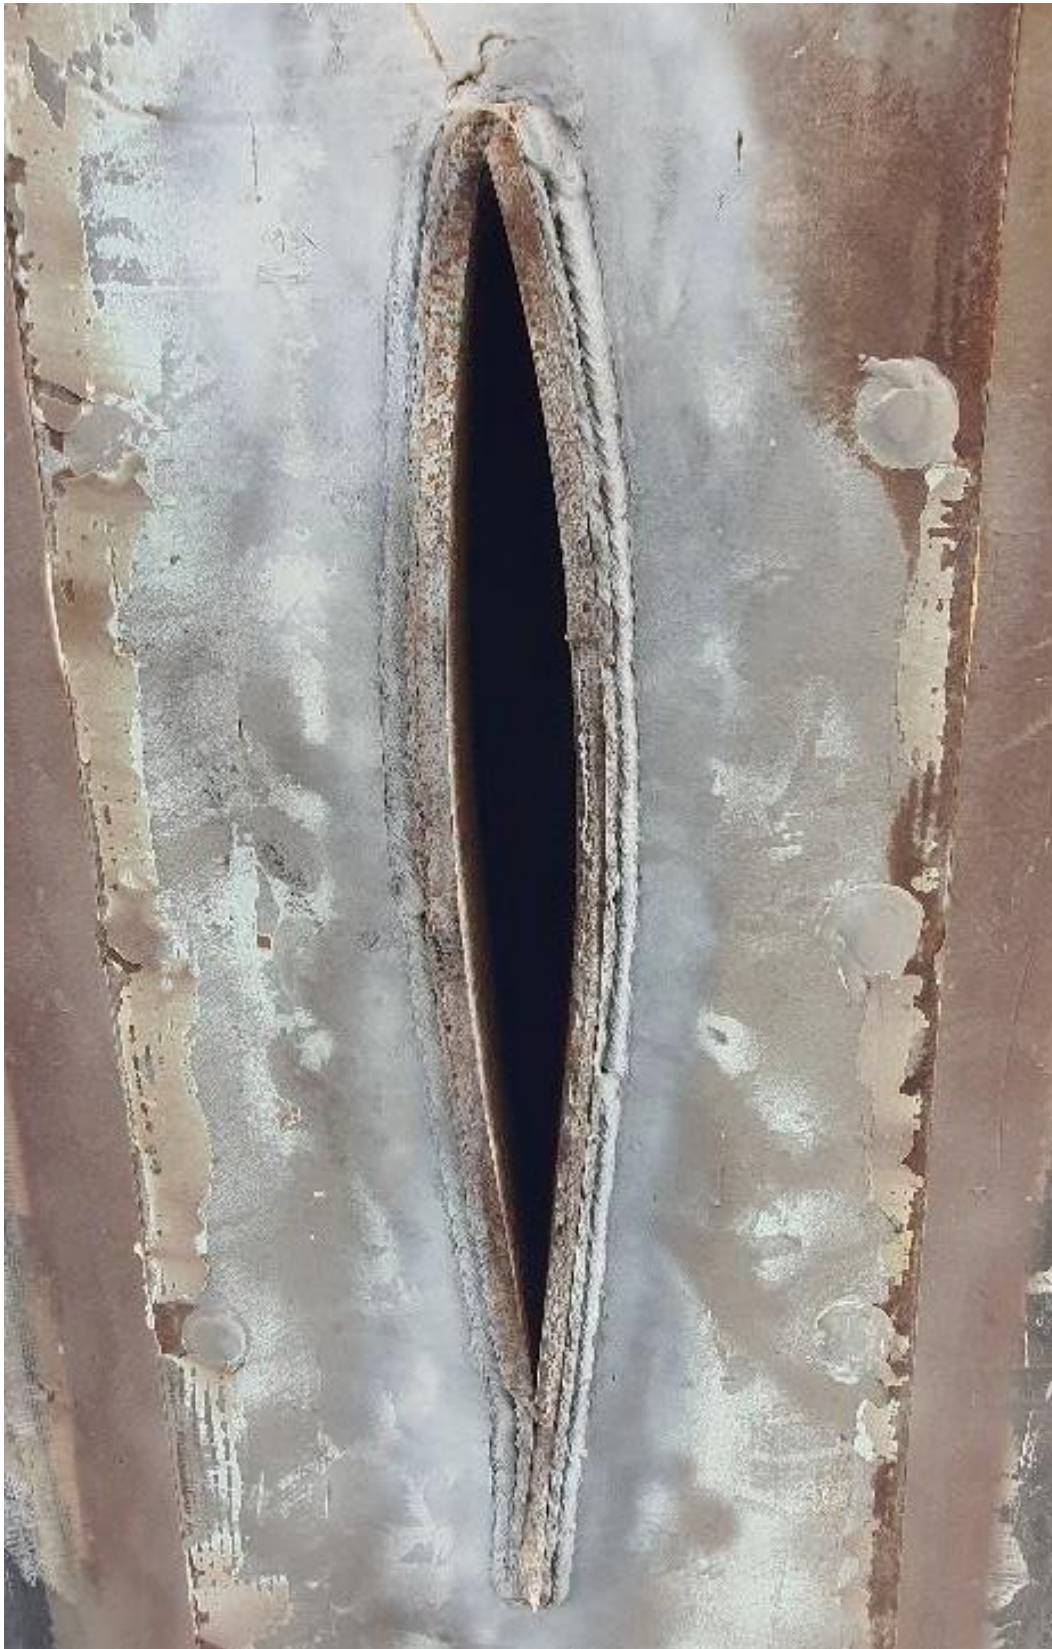
Fig.11 – Fracture surface—forward direction to top of page, vessel's port side to right of photo.

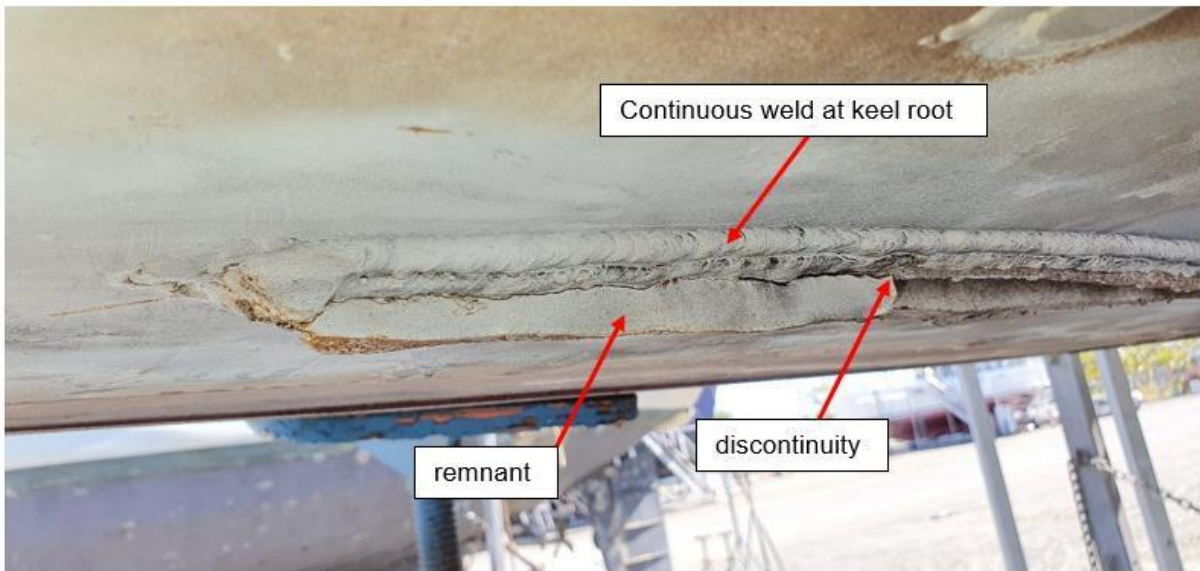
Fig.12 – Fracture surface, vessel's bow to left, taken from perspective of the vessel's port side.

Remnant piece shows where crack changed direction at a discontinuity such as a notch or inclusion. The view is consistent with the starboard (right-hand) side of the keel root failing first on starboard tack (vessel sailing with wind blowing over the right-hand side), then remaining port (left-hand) side of keel root failing thereafter, with total detachment of the keel.

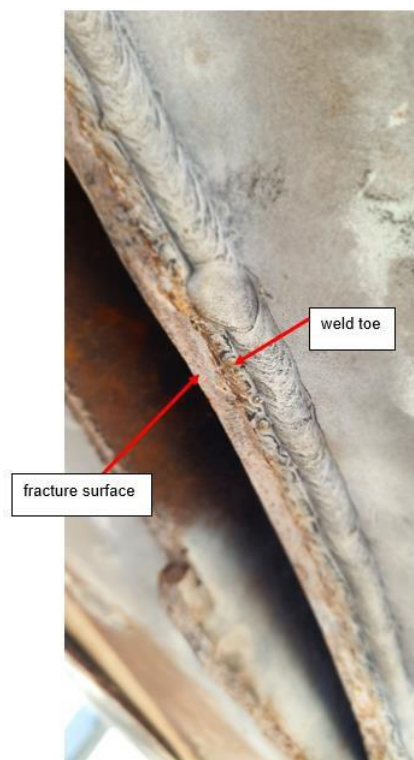
Fig.13 – Fracture surface in the parent metal directly adjacent to the weld toe on the starboard side looking forward. Possibly a double line of weld, to be confirmed by sectioning and polishing in further tests that are required in order to finalise this report

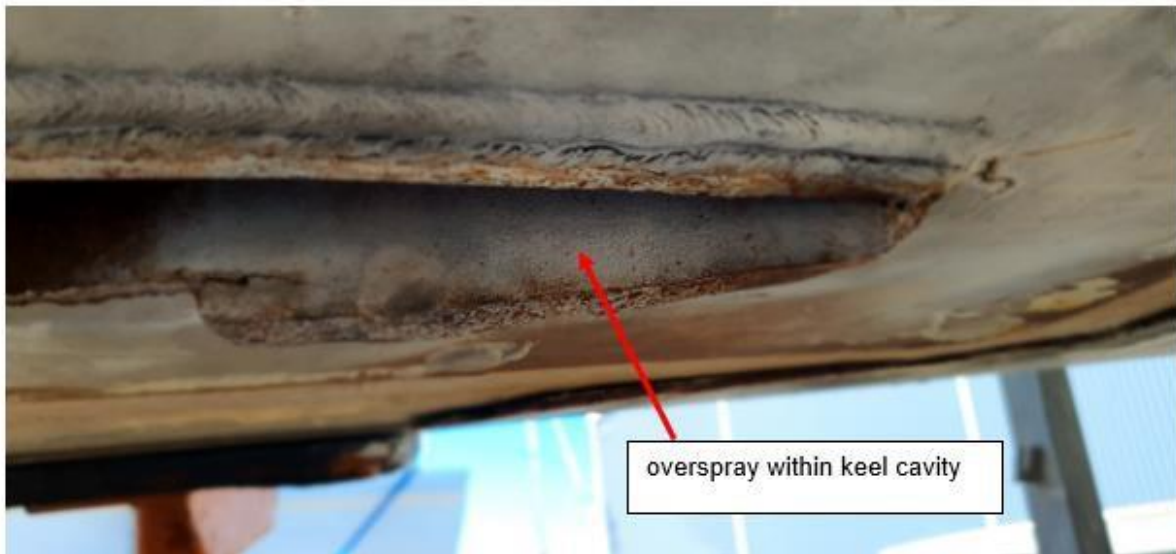
Fig.14 – White-coloured paint overspray within the keel cavity suggests that the keel had gaps in the welded connection of its root that let paint in. If present, gaps are also additional sites of crack initiation and promote further fatigue failure.

33 There was surface corrosion of the welds and parent metal, and I suspect, porosity, inclusions and gaps all of which are deleterious to the keel's strength of attachment at the root.
