# **Rolex Sydney Hobart Yacht Race 2024**

## **Review Committee Report**

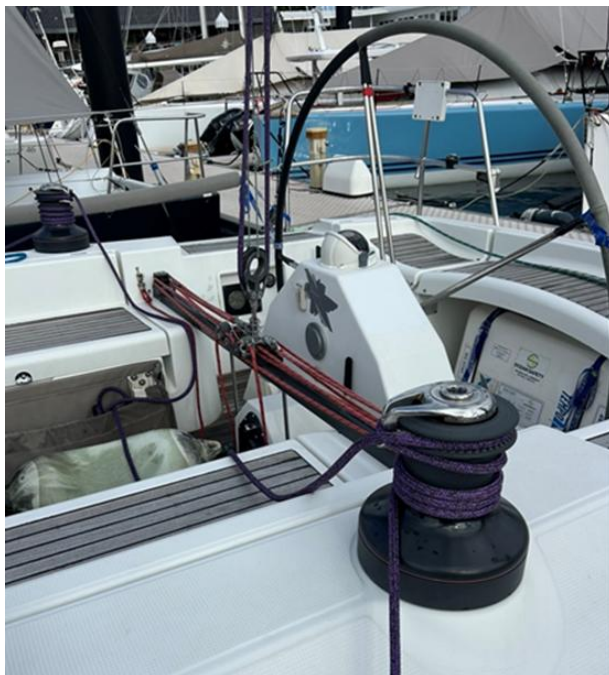
*The traveller and mainsheet winch arrangements onboard Bowline*

59. At 0200 the watch was changing and a decision was made to gybe the boat back to the rhumb line - from the starboard to the port tack. After the gybe, Nick Smith, 'the most experienced sailor onboard – having sailed two legs of the Clipper Round the World Yacht Race', was going off watch. For some unknown reason he decided to check the mainsheet traveller or possibly adjust the backstay as the boat settled down on its new course. Nick was on his knees on the cockpit floor forward of the mainsheet traveller. The boat was then hit by a cross sea possibly on the starboard quarter which forced the stern through the wind and the boat 'crash gybed' with the mainsail whipping across from the starboard to the port side. Nick was caught in the bight<sup>11</sup> of the mainsheet during the gybe and his chest was forced against the port mainsail winch with great force and catastrophic consequences.

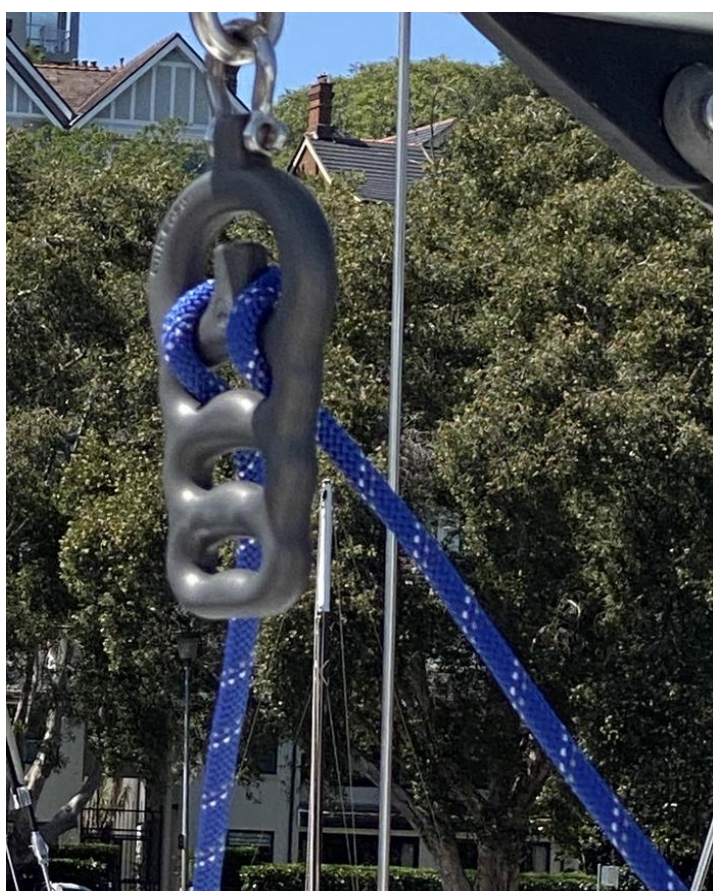
**Wichard Gyb'Easy Boom Brake – Rumchaser**

178. *Bowline* had investigated the option to use a boom brake several years ago when the boat was purchased but was not able to find one suitable for the boat. *Rumchaser*, a J/122e two hander, had a "Gyb'Easy' boom brake system installed that ran through a semi-rigid carabiner on the boom, immediately aft of the vang, and led back to the helm on either side of the boat for easy adjustment.
