PAŃSTWOWA KOMISJA BADANIA  
WYPADKÓW MORSKICH

**PRODIGY 2  
SAILING YACHT**

Sinking of the yacht due to the ballast fin breaking off on  
the North Sea on 13 October 2017

**FINAL REPORT**

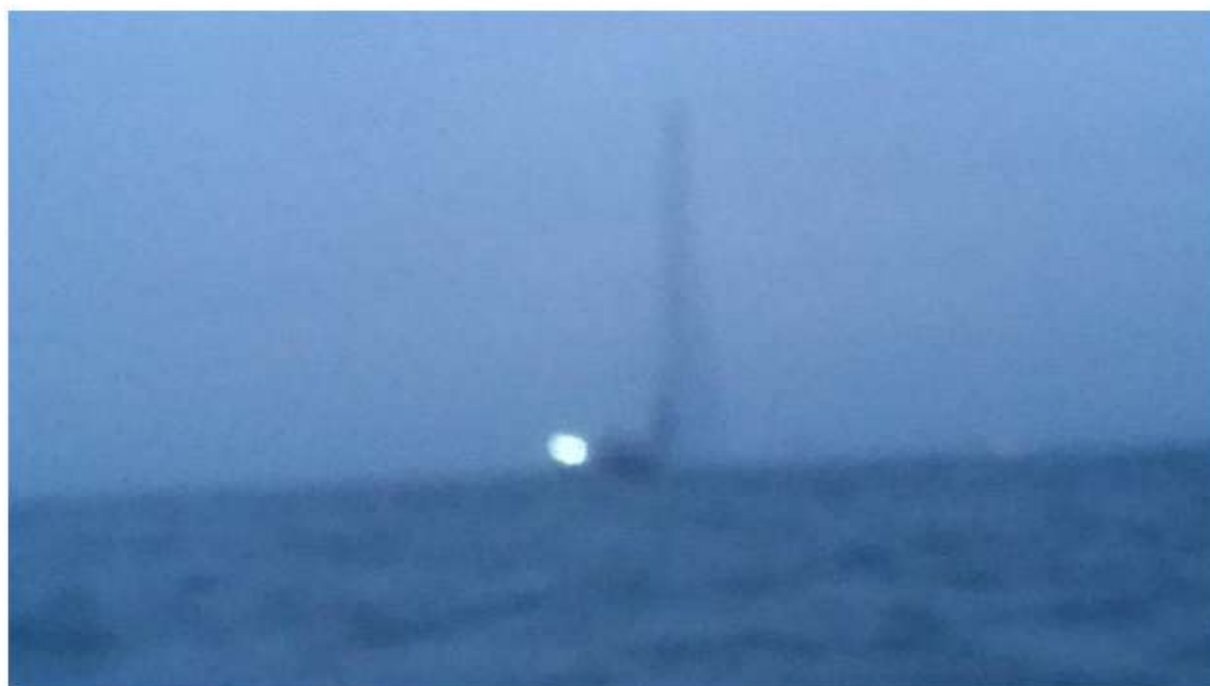
The painter was cut off, and for a short time the crew could observe the sinking yacht, filming it and taking photos with a mobile phone. In the last photo, taken at 18:52 hours, despite the low image definition, we can see the yacht without any list, still showing the sternlight

*Photograph 3. "Prodigy 2" yacht without crew (source: crew member)*

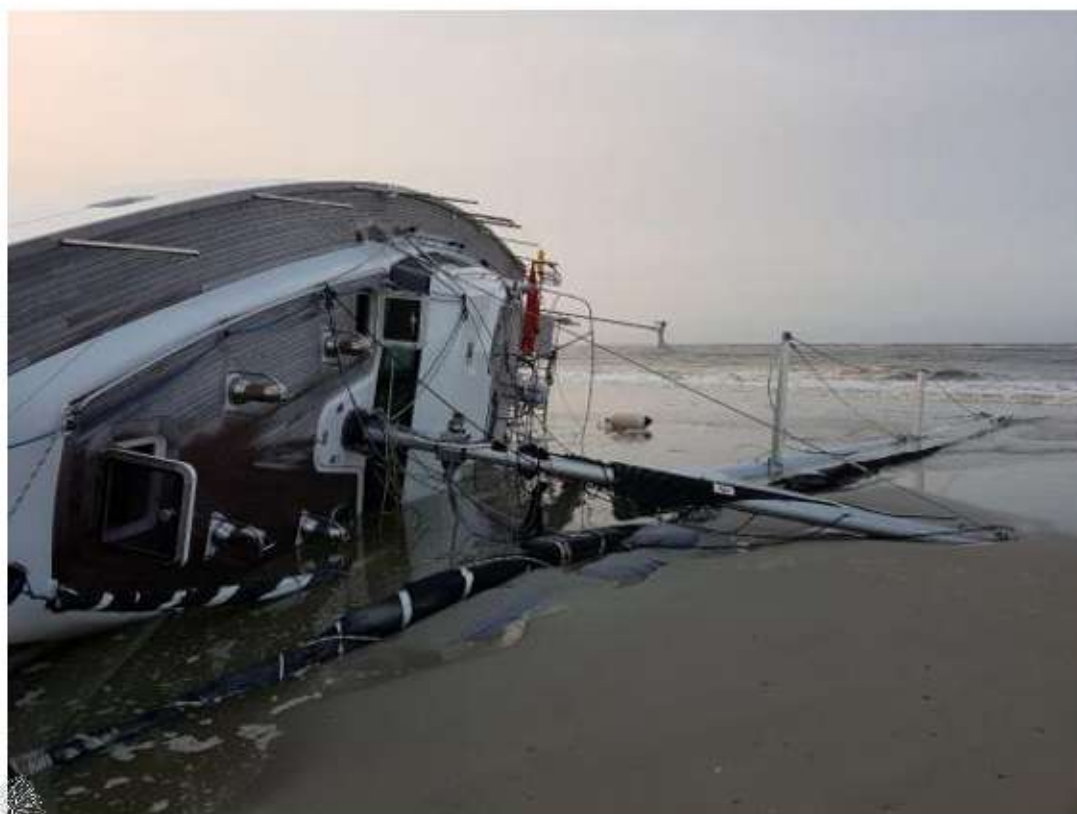
The yacht wreck drifted further on the surface towards the east, finally settling down on 16 October at the shore of the Langeoog island, near the position of  $\varphi = 53^{\circ} 45.73' N$   $\lambda = 007^{\circ} 34.58' E$ , around 8 miles from the accident site. The waves hitting the yacht led to its total destruction.

The ballast fin torn off from the hull together with part of the sheathing has not been found.

*Photograph 4. Wreck of the yacht tossed onshore at the Langeoog island*

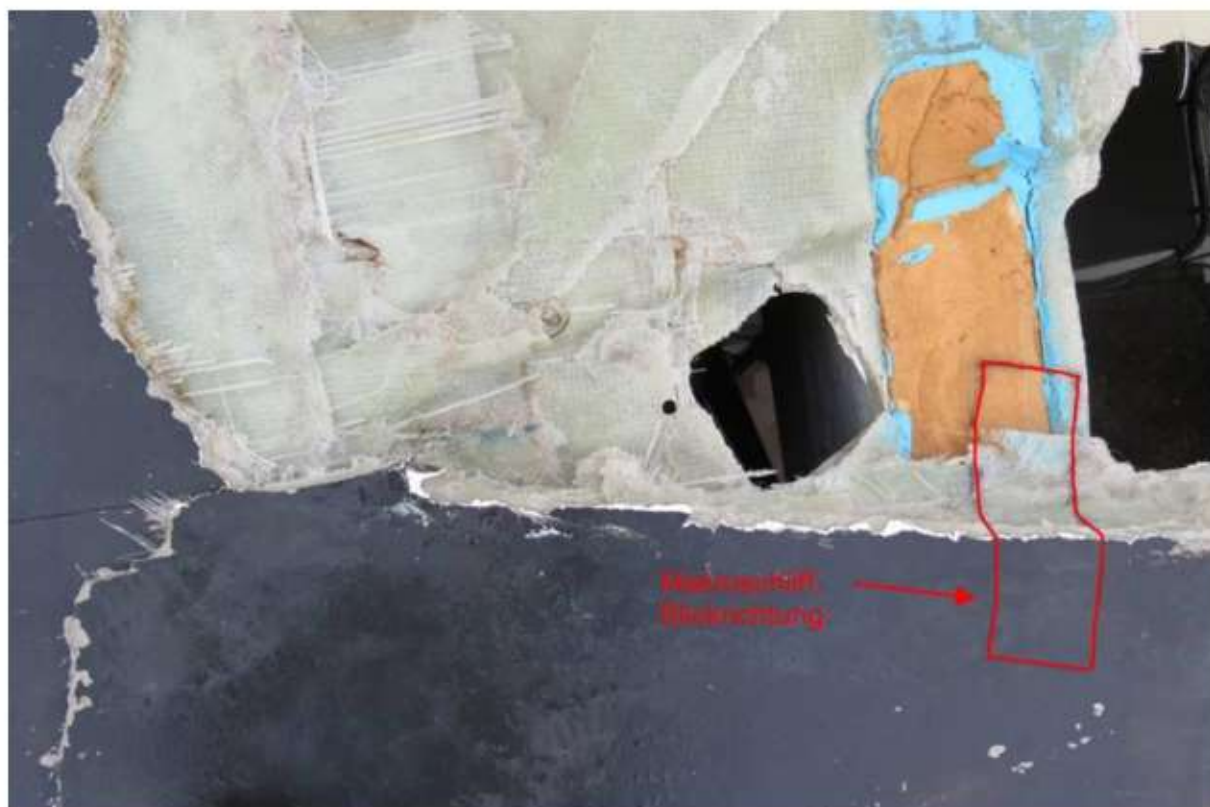
In conclusion of the testing, GMA determined that “the thickness of laminate in the transition into the recession area is 10 mm instead of the required 24 mm, which corresponds to a 55% decrease. The quality of bonds and the adhesion of individual laminate layers to each other are to a large extent insufficient. This is most likely related to the manufacturing conditions / construction conditions and the related material damage”.<sup>9</sup>

Photograph 5. The area where the material sample was collected from (source: GMA – 3664)

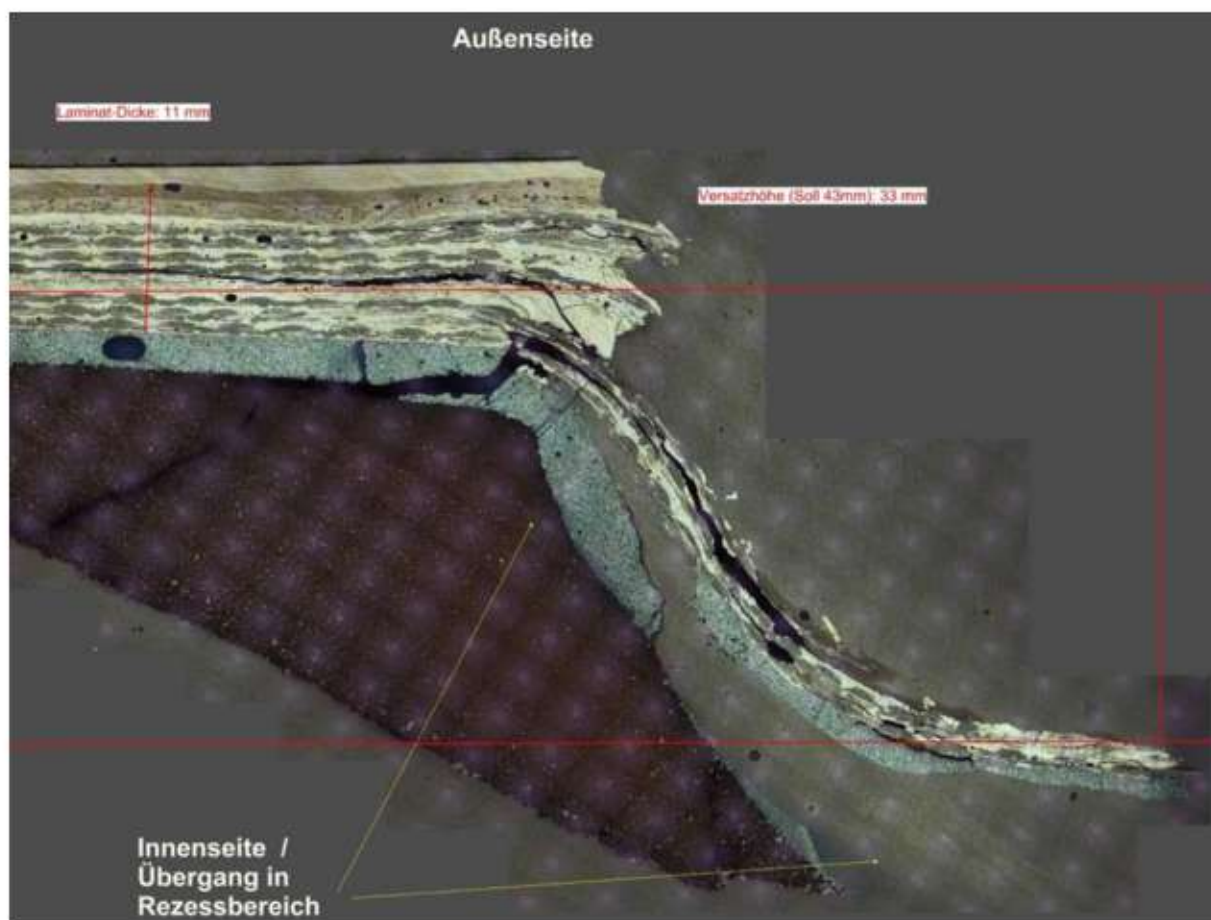
*Photograph 6. Macro-section of a fracture at the transition into the recess region – where the sample was collected from (source: GMA – 3664)*

The decrease of laminate thickness to 10 mm (without the gel-coat) indicated in the report in the area where the design indicates the size of ca. 24 mm required an additional analysis.

Photograph No 6 shows the result of a recess depth measurement and it was ca. 33 mm.

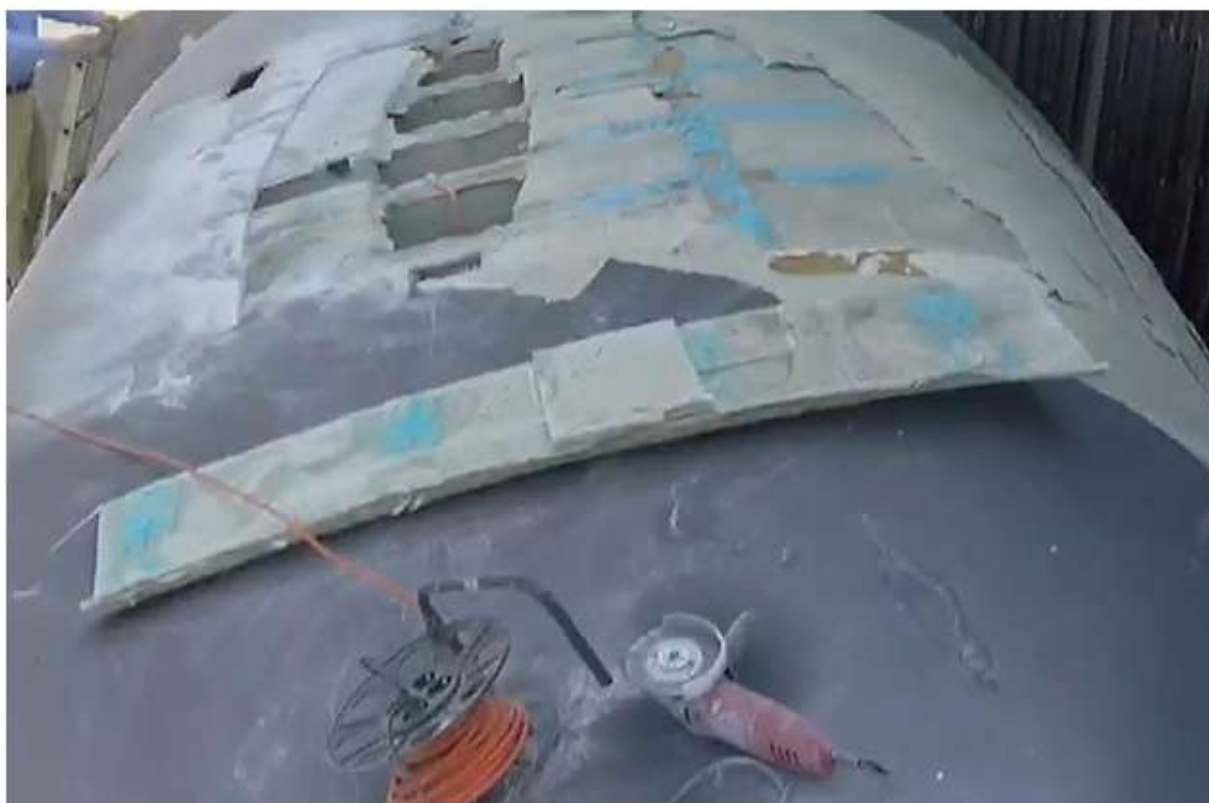
The commission did not carry out any additional strength analysis of the samples from the recess area due to the yacht owner having cut out this strip of sheathing earlier. The owner stated that the obtained sheathing fragments were used to carry out their own strength testing and the remaining fragments were retained for the purposes of any possible compensation proceedings.

*Photograph 7. Strip of sheathing cut out by the yacht owner (source: yacht owner)*

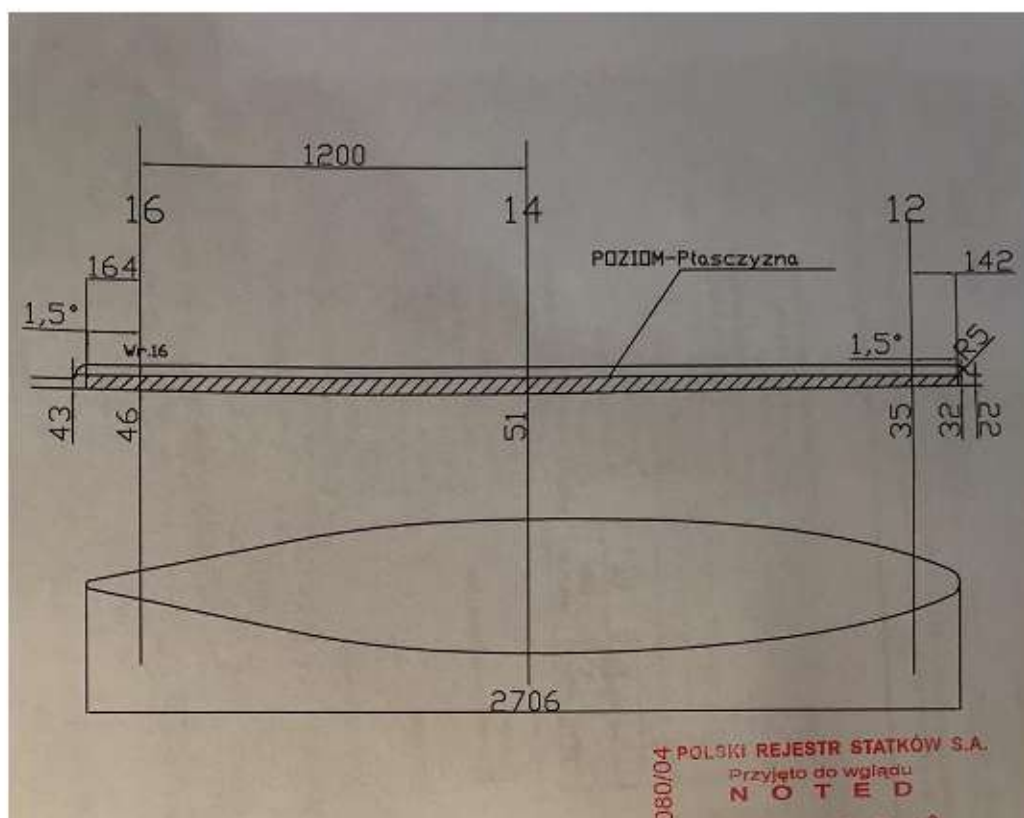
The ballast recess plan drafted by CORS for the Kalif 58 model provided for a variable depth from 32 mm in the bow section to 43 mm in the stern section in order to eliminate the 1.5° rise of the hull (deviation from the base plane) in the recess area. During the construction of “Prodigy 2”, the recess was constructed with a constant depth of ca. 33 mm. The plate mounting the ballast fin to the hull had a constant thickness of 30 mm and was hidden completely in the recess.

*Fig 2 Ballast recess according to plan 09/16 CORS for the Kalif 58 model*

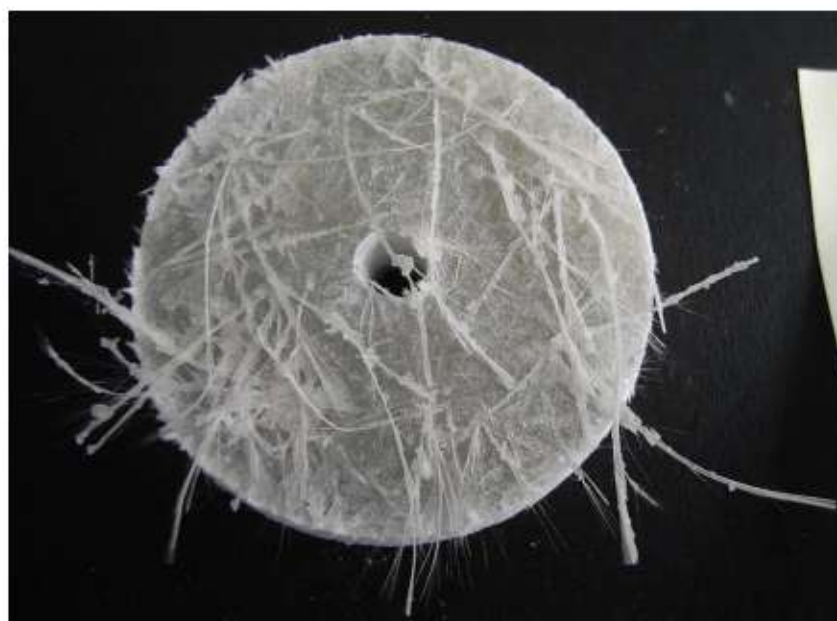
Another element that had an impact on the mechanical properties of laminates was the quality of their execution.

*Photograph 8. Visible loose glass fibres with resin "drops" attached  
(source: GMA – 3664)*

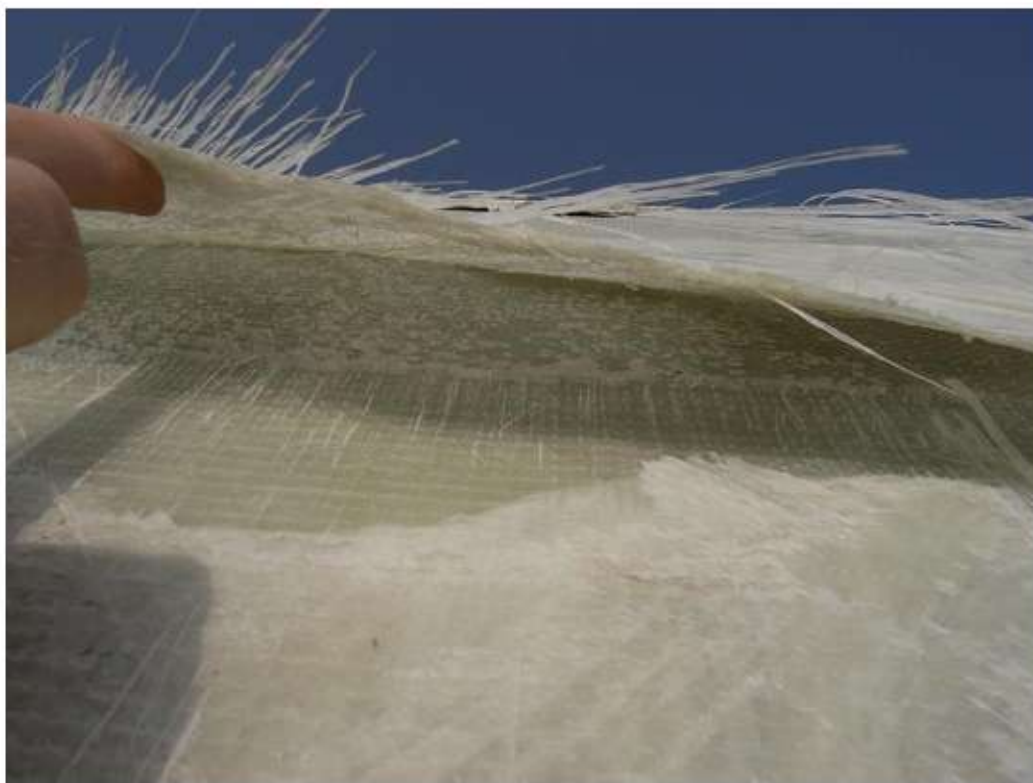
The samples subject to analysis and the inspection of the hull showed glistening areas of delaminated hull. The laminate could be separated and torn out by hand.

*Photograph 9. Condition of laminate on the yacht's hull (source: Zucker & Partner Gmb)*

The quality of the monolithic bottom strip of sheathing in the area of the ballast fin's mounting to the yacht's hull was found to have been low. During the inspection, low adhesiveness of some laminate layers to each other has been discovered. The completely smooth surfaces of individual laminate layers without the indicated adhesiveness are a proof of the thesis mentioned above. This could have been caused by the yacht manufacturer's failure to maintain the execution technology of individual works in the lamination process of the hull sheathing. Of particular importance was maintaining breaks between the lamination of individual layers and their thorough cleaning and roughening before commencing to laminate further layers. The failure to maintain the quality of these works caused intermediate layers to form on the surface of laminates (e.g. paraffin-like substances) and the failure to mechanically remove them resulted then in the lack of adhesiveness between individual laminate layers. This contributed to a significant weakening of the laminate as a monolith and the appearance of numerous delaminations in the laminate, as well as the failure to transmit forces from the keel onto the hull bracing. In consequence, larger loads were being transferred

by the bottom layers of the delaminated laminate instead of working as a monolithic form, as provided for by the yacht designer. There are also visible traces of wrong or improper percolation of individual layers of glass fabric with resin. This was also a cause for the easy separation of individual layers from each other.

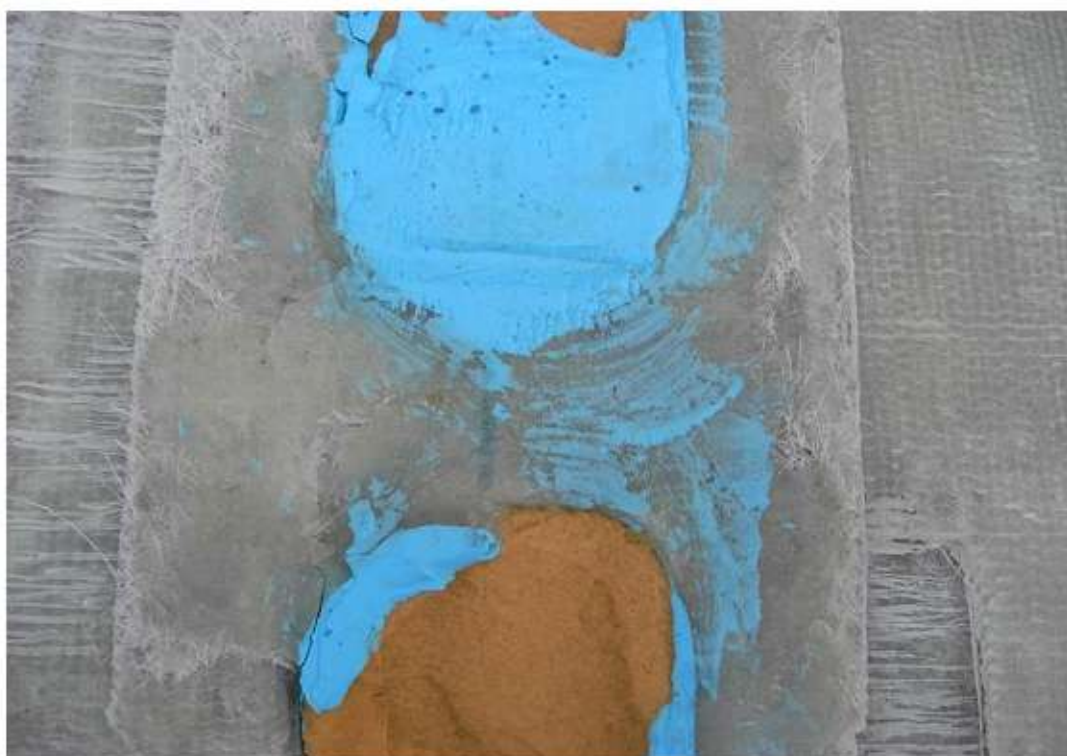
A proof of the low quality of the lamination process may be traces of glue on the sheathing ( colour blue on the photographs) in areas outside of the bracing. It is worth pointing out here that the load-bearing capacity of the glue mentioned above is low.

*Photograph 10. Traces of glue outside of the bracing foam (source: Zucker & Partner GmbH report)*

The glue should have been removed during the lamination of areas outside of the bracing. The failure to do this contributed to the delamination process, which was particularly dangerous in the direct vicinity of the bracing, where various layers of laminate passing under the bracing foam and over the bracing foam join together. A natural mechanical notch forms in this place and, at the same time, this is an important node transmitting forces originating from the keel. The discovery of glue here disturbed the functioning of this structural node, weakening it significantly, which could have led to the incorrect transmission of forces to the bracing and the tearing off of the keel.

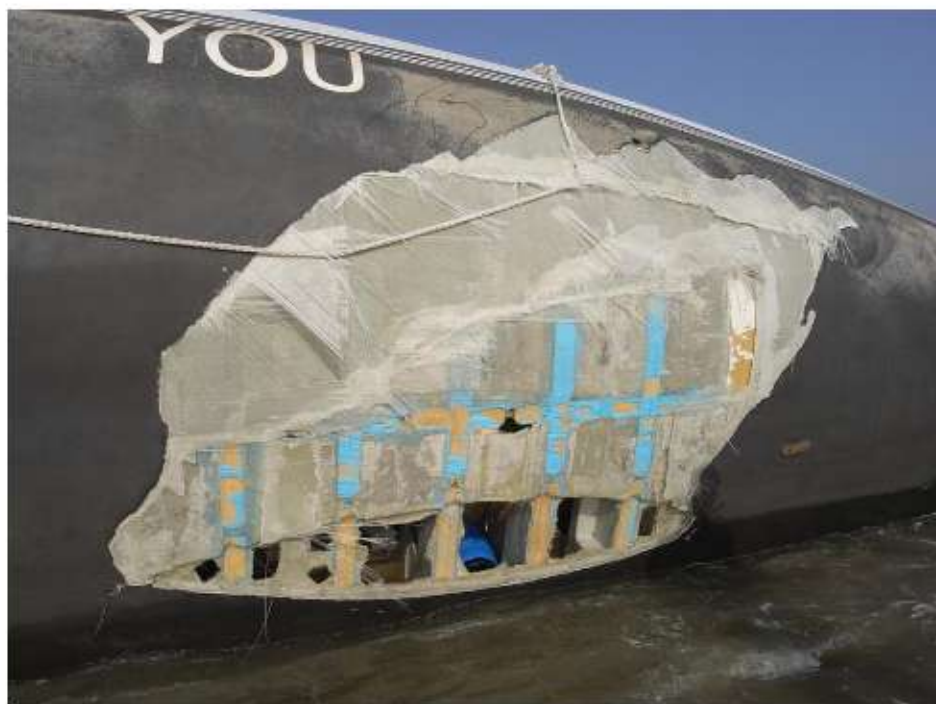
The smaller dimensions of the washers designed and manufactured for attaching the ballast fin to the hull led to increasing the local pressures, which resulted in partial damage to the internal laminate coatings, and could have brought about wrong transmission of the forces on hull bracings and loss of the ballast fin. If there was insufficient room for the washers, the builders should have considered joining the individual washers to each other in a structural way, which would have increased the mounting strength, at the same time reducing local stresses and pressures.

*Photograph 11. Starboard view of the torn off recess and laminate layers (source: GMA-3664)*

Photograph 11 clearly shows the “pulling” of double (2 pcs) and single (3 pcs) washers through the internal hull sheathing layer. According to PRS regulations, the dimensions of washers for bolts mounting the keel should not be smaller than four times the mounting bolt diameter. In this case M30 bolts were used, thus the minimum washer diameter should be no less than 120 mm<sup>14</sup>. In order to meet this requirement, the washers should have the minimum dimensions of 106 x 106 (mm).

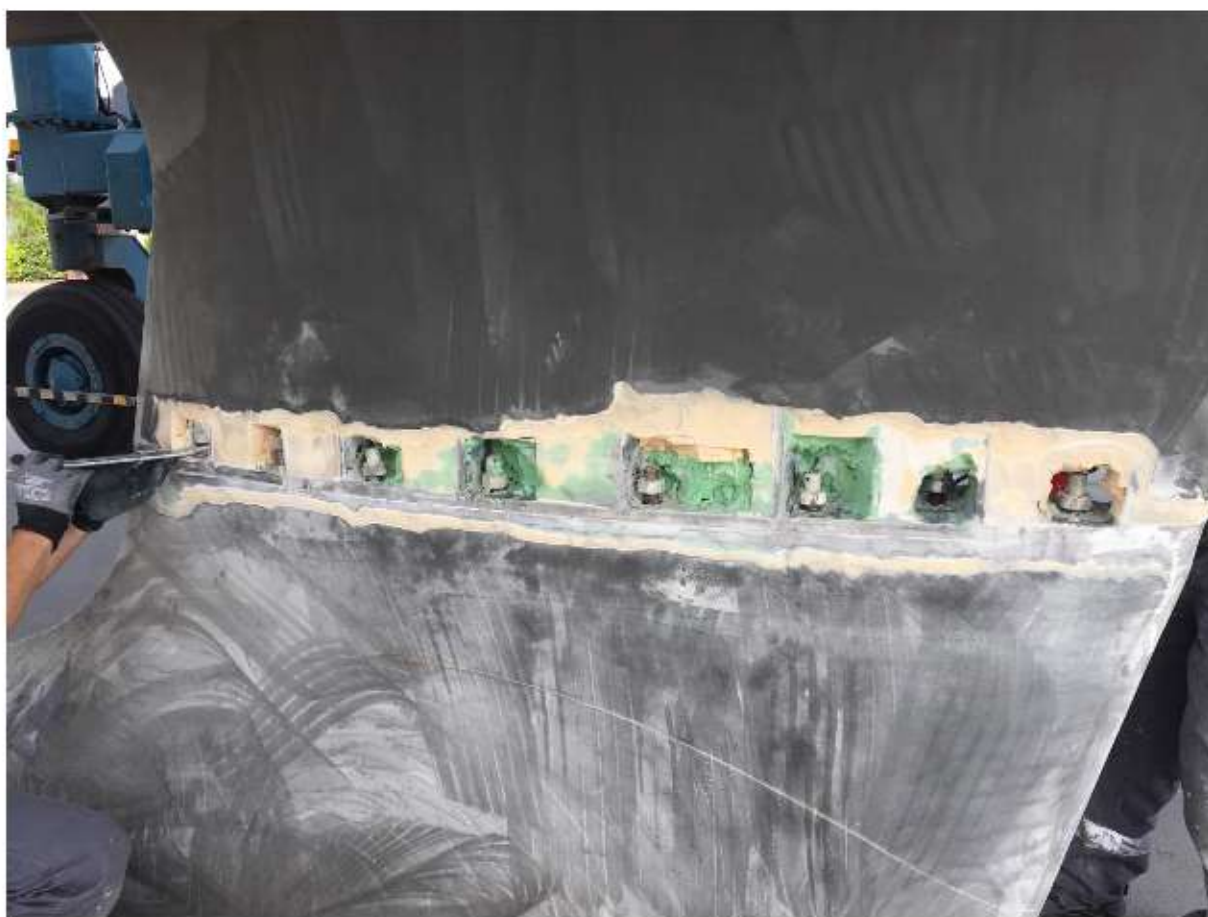
On 9 May 2017 the yacht was transported to Gdańsk, to the Galeon Wiślince shipyard, where the rudder and the ballast fin (the fin and bulb keel)<sup>19</sup> were installed. Following the launch, the yacht sailed to the AZS harbour in Górki Zachodnie for sail and rigging installation. Following the inclining test on 15 June 2017, the yacht underwent short two-day cruises on the Gdańsk Bay. The test results confirmed that the yacht was – in the owner’s opinion – too “soft” (low GM value) and, furthermore, had a slight trim by the stern, causing insufficient bow draught for the effective operation of the bow thruster at the average draught of around 2.6m. Between 11 and 13 August 2017 the ballast fin was extended in Jastarnia by installing an insert between the fin and the bulb keel.

*Photograph 13. Separation of the fin from the bulb keel (source: yacht builder)*
