**MARINE INVESTIGATION REPORT
M10F0003**

KNOCKDOWN AND CAPSIZING

**SAIL TRAINING YACHT *CONCORDIA*
300 MILES SSE OFF RIO DE JANEIRO, BRAZIL
17 FEBRUARY 2010**

Report Number M10F0003

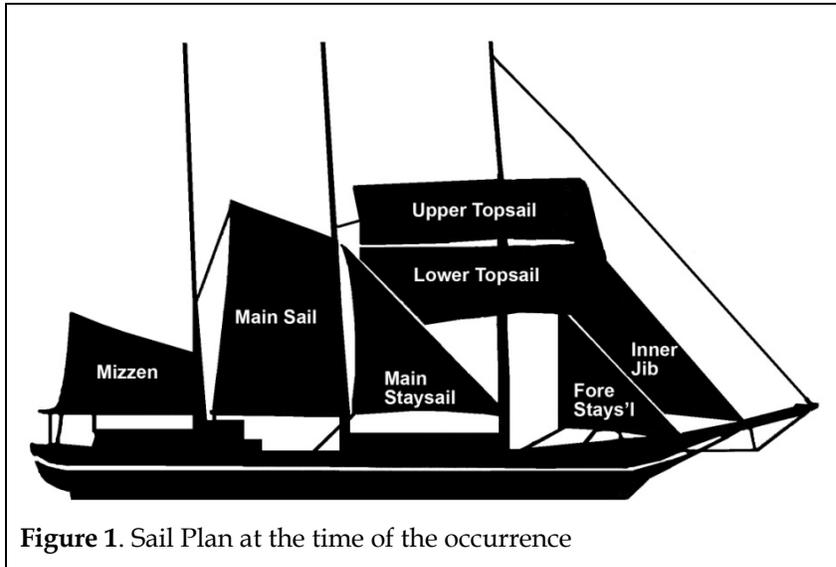
Figure 1. Sail Plan at the time of the occurrence

On the morning of 17 February 2010, in anticipation of the expected weather, the master shortened sail, culminating in the following sail plan at the end of his watch (1200): inner jib, fore staysail, upper and lower topsails, main staysail, main, and reefed mizzen sails (see Figure 1).¹² The 2/O, whose watch was from 12 to 4, arrived in the wheelhouse at 1150. During the handover of the watch, the master and the

2/O discussed the sail plan and the 2/O was advised that it was suitable for winds up to 40 knots. The master instructed the 2/O to maintain, if possible, the wind abaft the beam and to keep a comfortable heel angle for the classes. He also instructed the 2/O to brace the yards and to trim the sails as required as the wind backed, and to bear off to port and run before any squalls. The 2/O and master then discussed action to be taken in case it was necessary to reduce sail. The vessel was on a broad reach,¹³ on a starboard tack, with a course between 200° and 220° (G). The apparent wind speeds were between 15 to 18 knots, with seas of 1.5 to 2 meters from the north and a long, low southerly swell. The air temperature was between 29°C and 31°C.

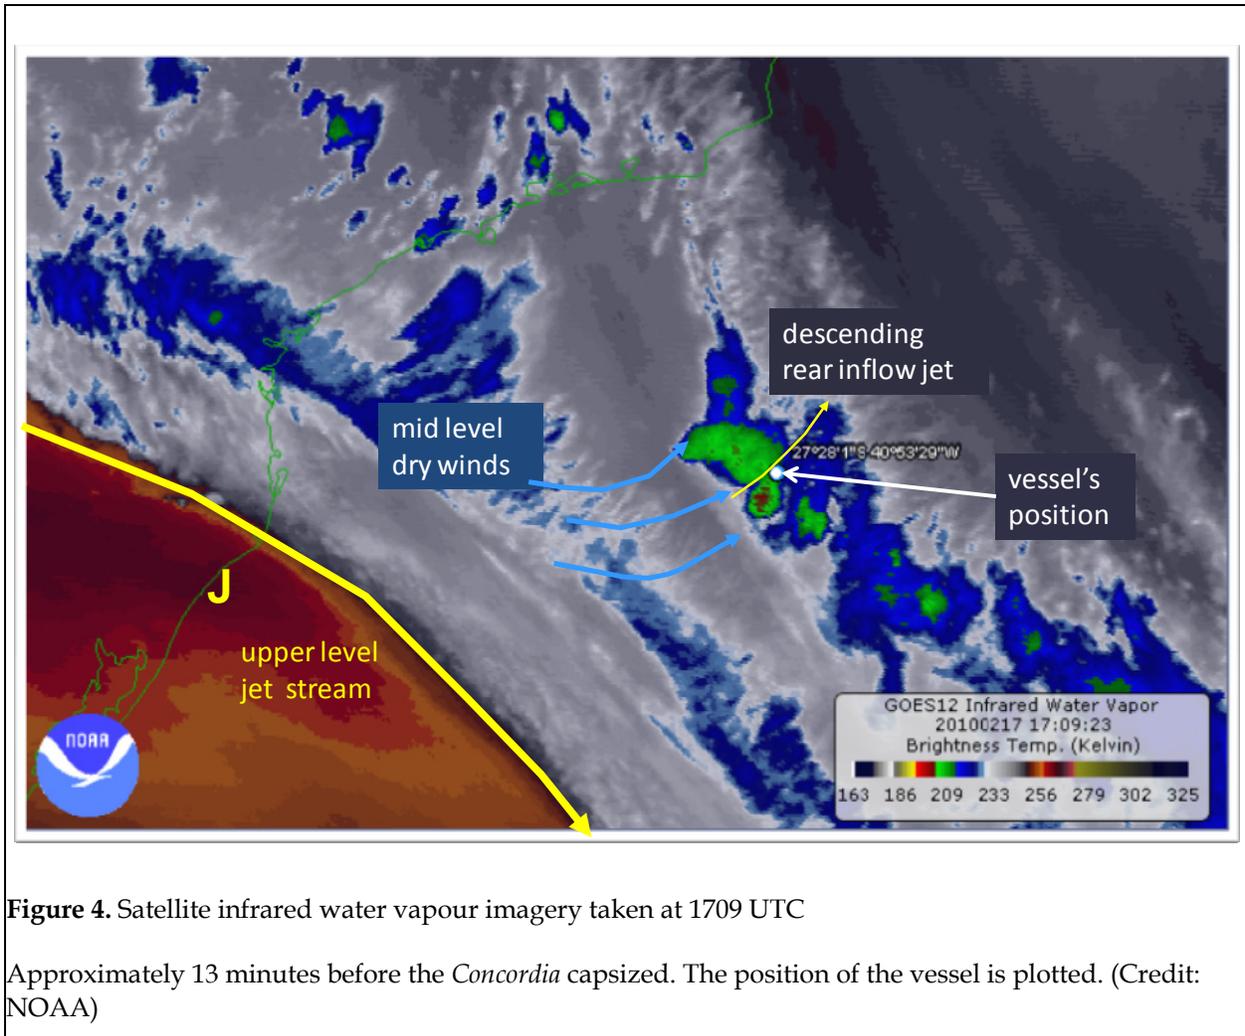
Figure 4. Satellite infrared water vapour imagery taken at 1709 UTC

At 1409, infrared and water vapour satellite imagery indicated a dry rear-inflow notch on the southwest flank of the storm complex (in between the 2 most intense storm cells), pointing directly toward the location of the *Concordia* (see Figure 3). Subsequent satellite imagery also showed a fairly rapid decay of all of the storms over the area in question during the hours following the knockdown.

Approximately 13 minutes before the *Concordia* capsized. The position of the vessel is plotted. (Credit: NOAA)

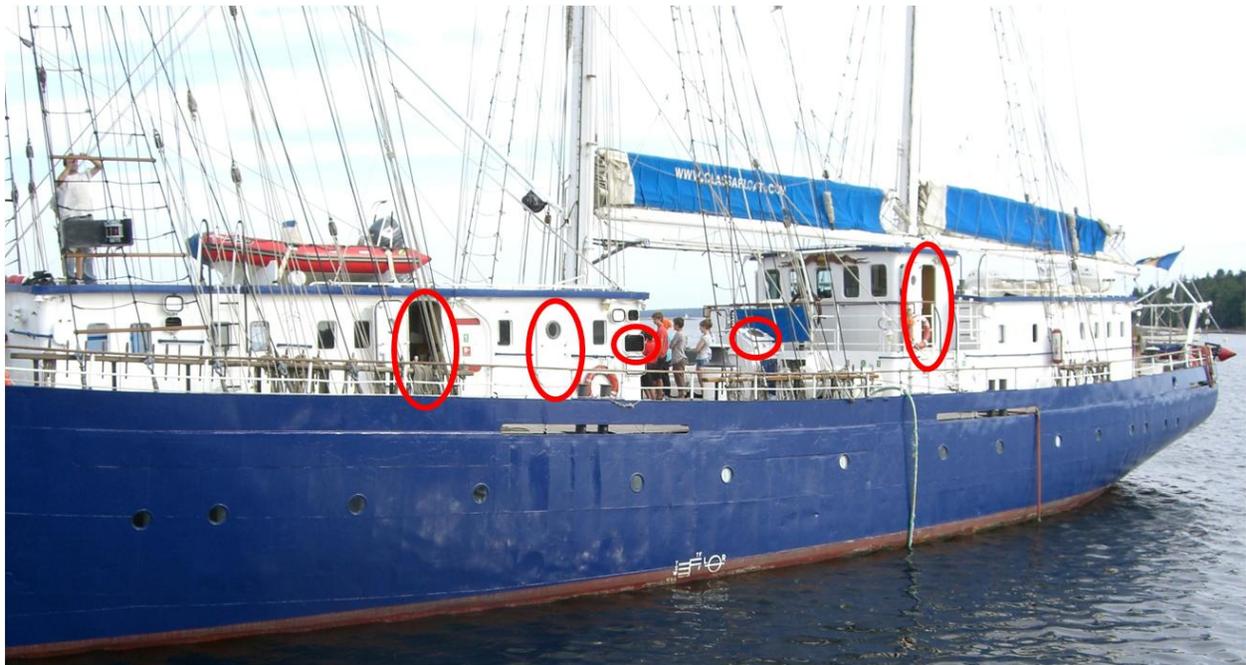
**Photo 3.** Some critical port side openings

Description	Angle of Immersion
Galley Door (forward deckhouse, port side)	56.5°
Mess Door (forward deckhouse, port side)	58.4°
Sanitary Exhaust Vent (forward deckhouse, port side) ^{Note}	65.0°
Radio Room Window (aft deckhouse, port side)	68.6°
Wheelhouse Door (aft deckhouse, port side)	74.2°
Chart room interior door	87.9°
Engine Exhaust (top of mizzen mast) ^{Note}	91.7°
Engine Room Skylight (forward of wheelhouse, offset to starboard) ^{Note}	100.5°
Mess Stairway (inside forward deckhouse) ^{Note}	116.5°

Note: Immersion of these openings would lead to downflooding of the hull.

Circled from forward to aft: mess room door, galley door, sanitary exhaust vent, engine room skylight and wheelhouse door.

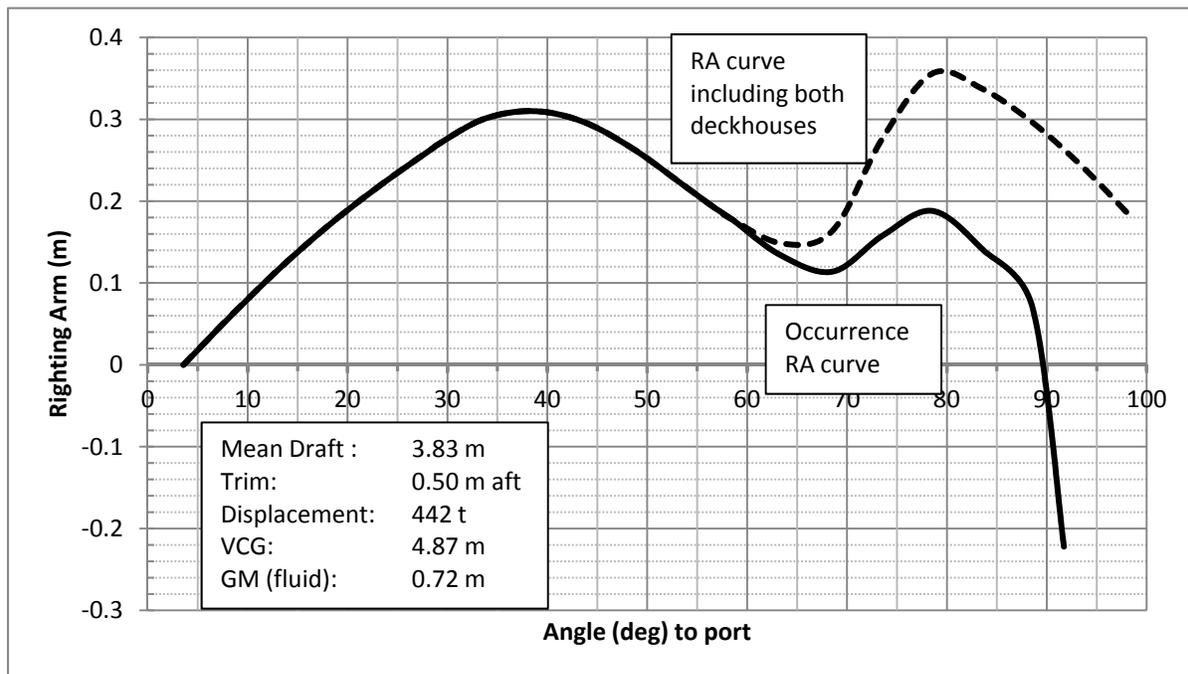
Figure 5. Occurrence righting arm (RA) curve⁶³ showing the effect of lost buoyancy from the deckhouses

The RA curves presented in *Concordia's* stability booklet are based on the assumption that the weathertight doors in the 2 deckhouses are secured closed, and thus that the deckhouses contribute to the vessel's buoyancy. The resulting effect on the vessel's righting ability can be seen as a second 'bump' in the RA curve beyond angles of around 60° (see Figure 5).

As mentioned previously, the deckhouse doors on the port side were open at the time of the occurrence. The resulting effect on the vessel's righting ability was modelled by eliminating the buoyancy contribution of the relevant deckhouse beyond those angles which would immerse its door(s) as shown in Table 3—the forward deckhouse was discounted after about 58 degrees and the aft deckhouse after about 88 degrees. The RA curve at the time the occurrence was thereby derived and is shown in Figure 5 below.

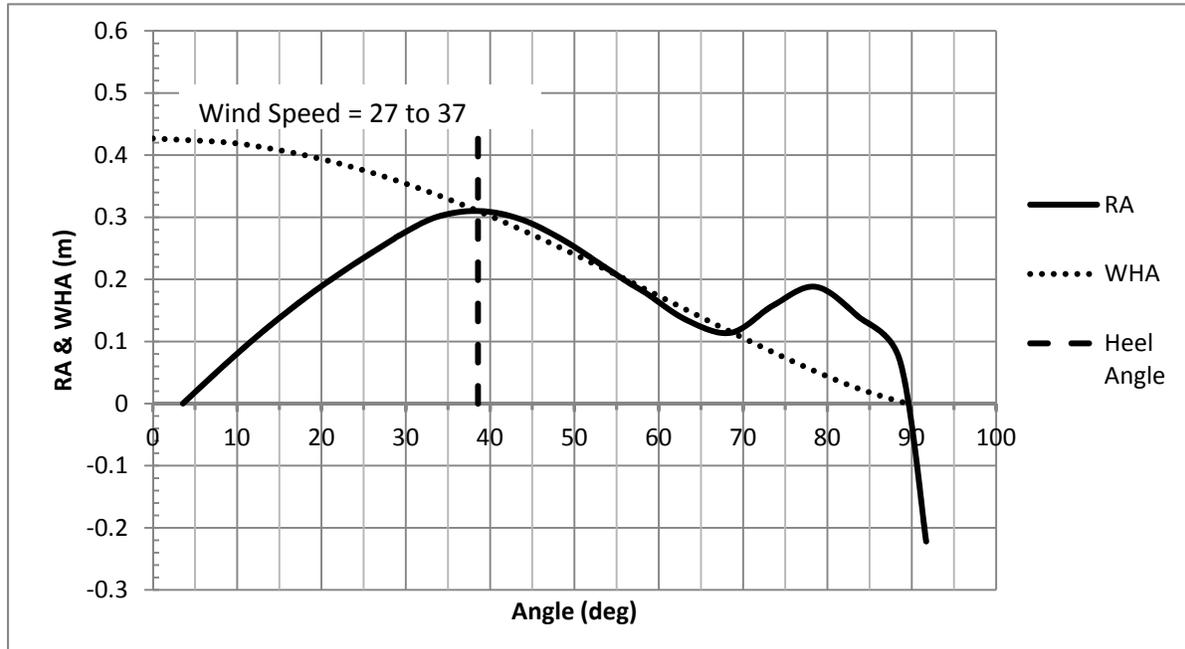
Figure 6. Occurrence righting arm (RA) / wind heeling arm (WHA) curves

It can also be seen in Appendix G that to induce wind heel angles beyond 70° or so, the necessary apparent wind speeds increase significantly to the point where winds in excess of 60 knots would be required to knock the vessel down to an angle in the range of 80°.

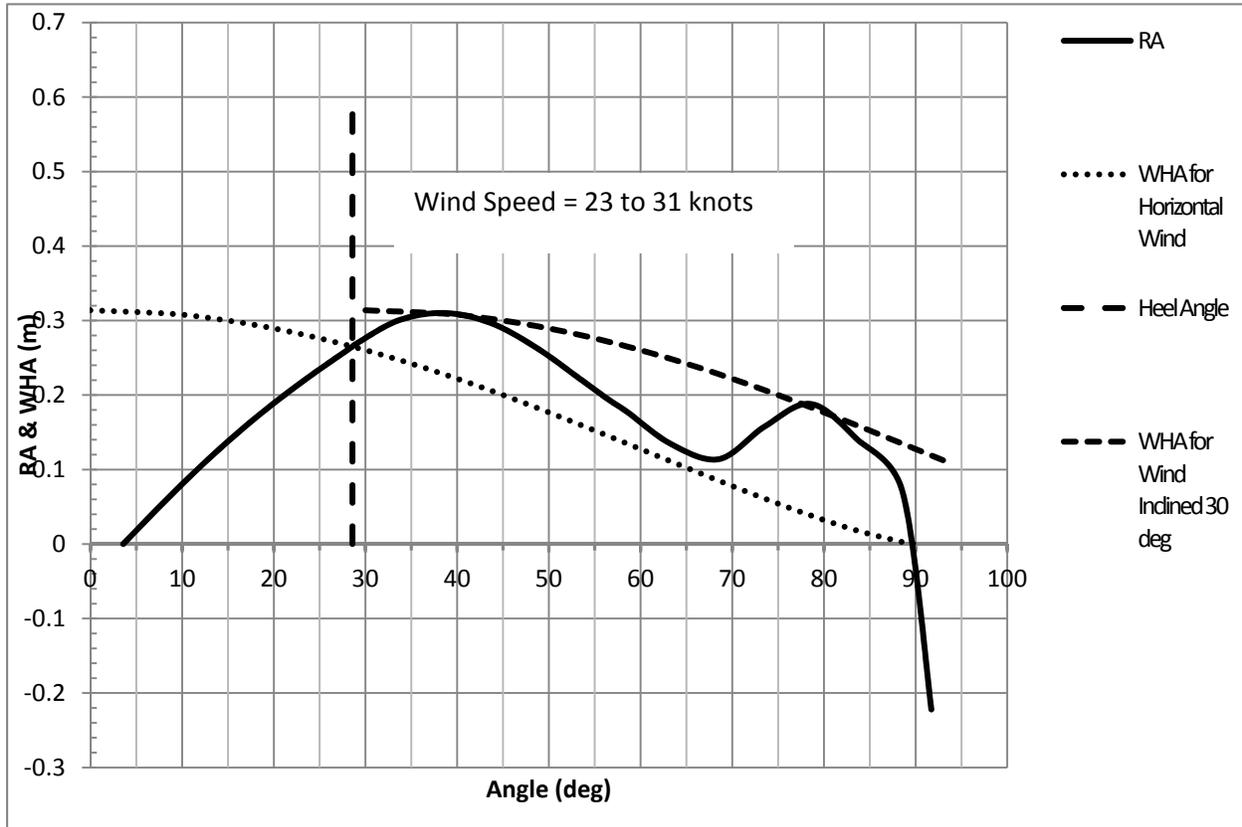
Figure 7. Wind heeling arm curve for wind inclined 30 ° from the horizontal

Figure 7 demonstrates this effect on the *Concordia's* righting ability. First, it is assumed that the vessel is heeled to an angle around 28° due to a horizontal wind. According to the relationship between apparent wind speed and heel angle shown in Appendix G, horizontal winds of between 23 and 31 knots would be sufficient to induce this heel angle. Then, the heeling arm curve is shifted 30° to the right, assuming the winds have shifted to 30° from the horizontal. As can be seen in Figure 7, the vessel's righting ability would be completely overcome by this combination of wind speed and inclination.

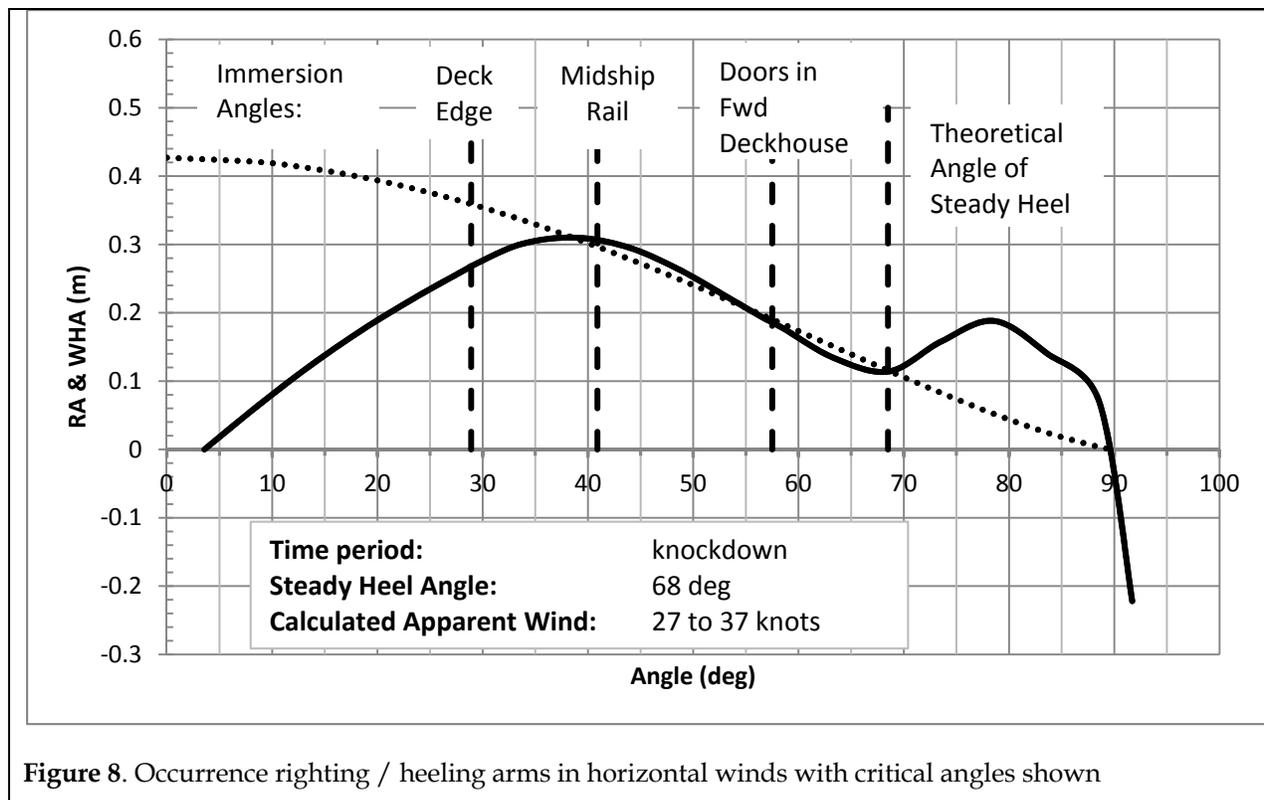
As Figure 8 indicates, although the vessel would theoretically take up a steady heel angle of almost 70° in such winds, water would have begun entering at various critical points before that angle was reached – first, via the open doors in the forward deckhouse (56.5°), then shortly thereafter via the sanitary exhaust vent, which was just aft of that (65°). With all of the doors on the port or lee side, as well as the ventilators and engine room skylight in the open position at the time of the knockdown, there was nothing to prevent or mitigate the downflooding that followed, progressing until the vessel ultimately lost all stability, rolled over, and capsized. The vessel’s ability to recover would have been further hindered by the weight of water entrained in the sails as they submerged, in addition to the possible shifting of weights/equipment.

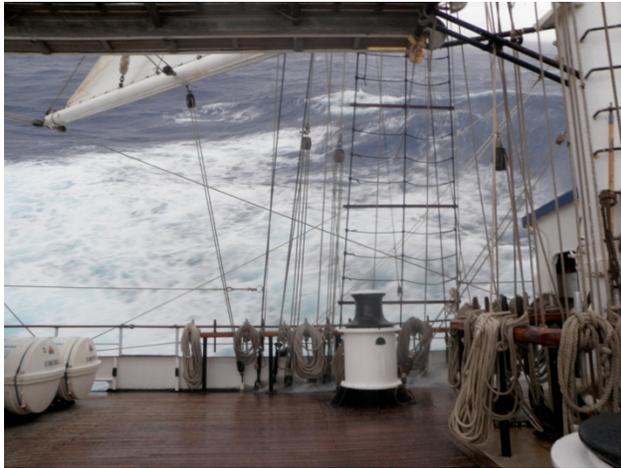
Photo 4. Port deck edge immersed at 29°

Although the righting arm curve indicates that the vessel would theoretically experience negative or capsizing moments once at 90° of heel, the capsize, which occurred some minutes later, would likely have been delayed by the damping effect of sails and rigging as they dipped in the water as well as the initial buoyancy of the deckhouses (until the point at which they flooded through their open doors).
