**Report**

# The loss of the sailing vessel, *Essence* 22 July 2021

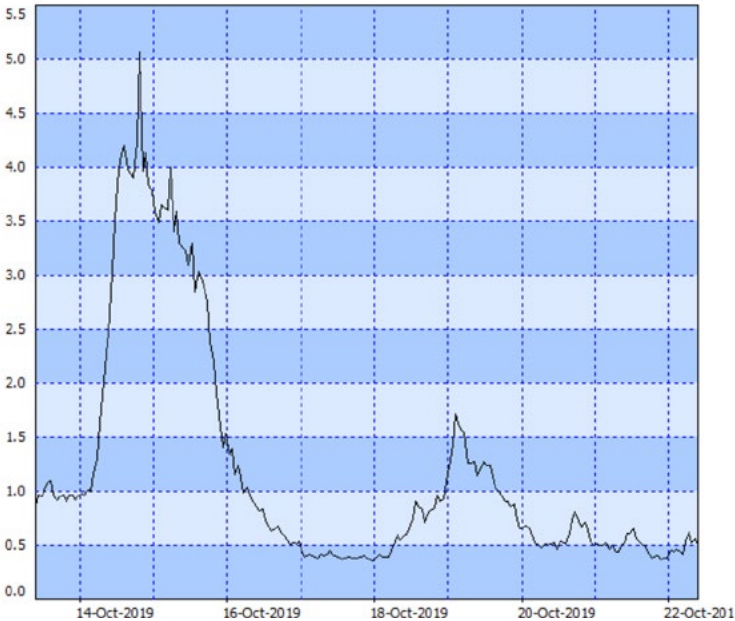
**Diagram 3: Significant wave height data**

The significant wave height depicted in diagram three is the average of the highest one-third (33%) of waves, from trough to crest, that occurred in a given period and provides evidence of wave heights of just over five metres:

The wave rider diagrams are evidence of wave heights in excess of seven metres, with wave periods of eight seconds at the peak of the storm. These readings equate to steep breaking seas as described by surviving crew and witnessed by rescuers. Close distance waves of this size can be generated when they reach shallower waters within New Zealand’s continental shelf and create dangerous seas for smaller vessels like **Essence**. On arrival at the scene, the crew of the Orion assessed the seas to be six to seven metres in height.

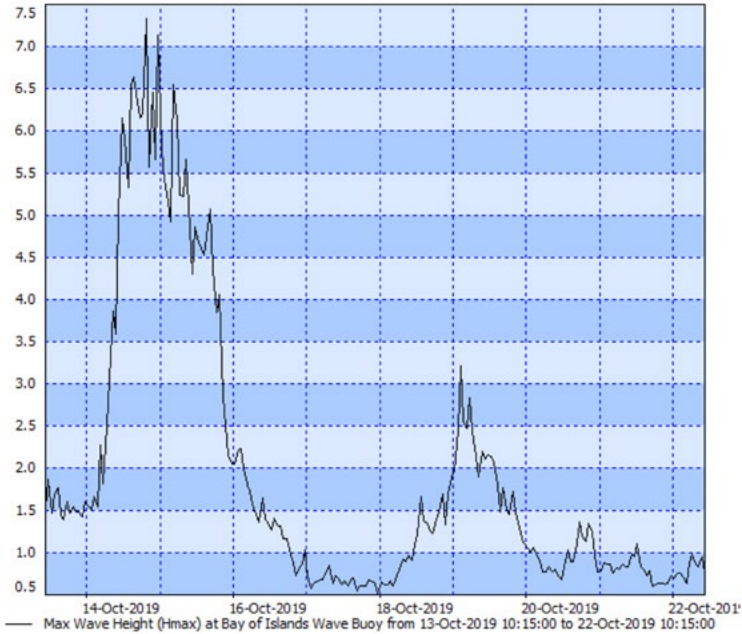
**Diagram 4: Maximum wave height data**

The maximum wave height depicted in diagram four represents the average wave height, from trough to crest, of the highest one-third of the waves and provides evidence of wave heights of over seven metres:

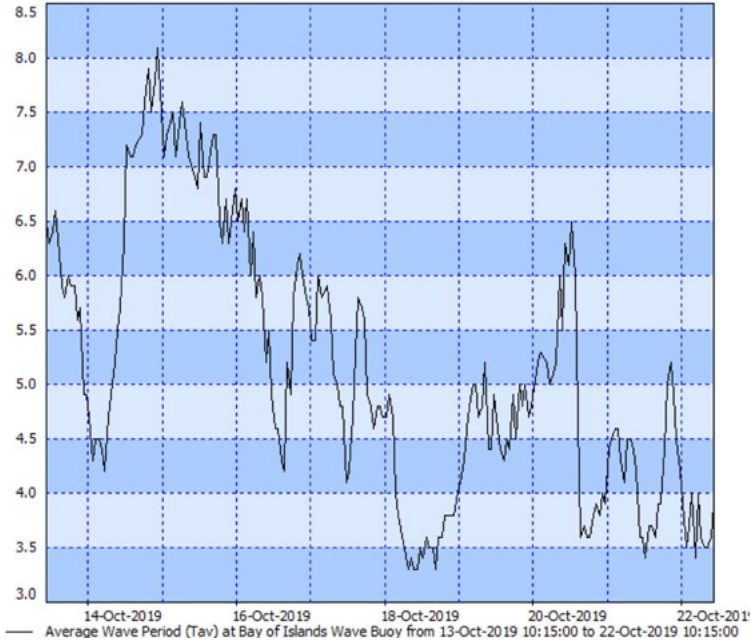
**Diagram 5: Average wave period**

The average wave period depicted in diagram five represents the distance between two waves passing through a stationary point, measured in seconds:

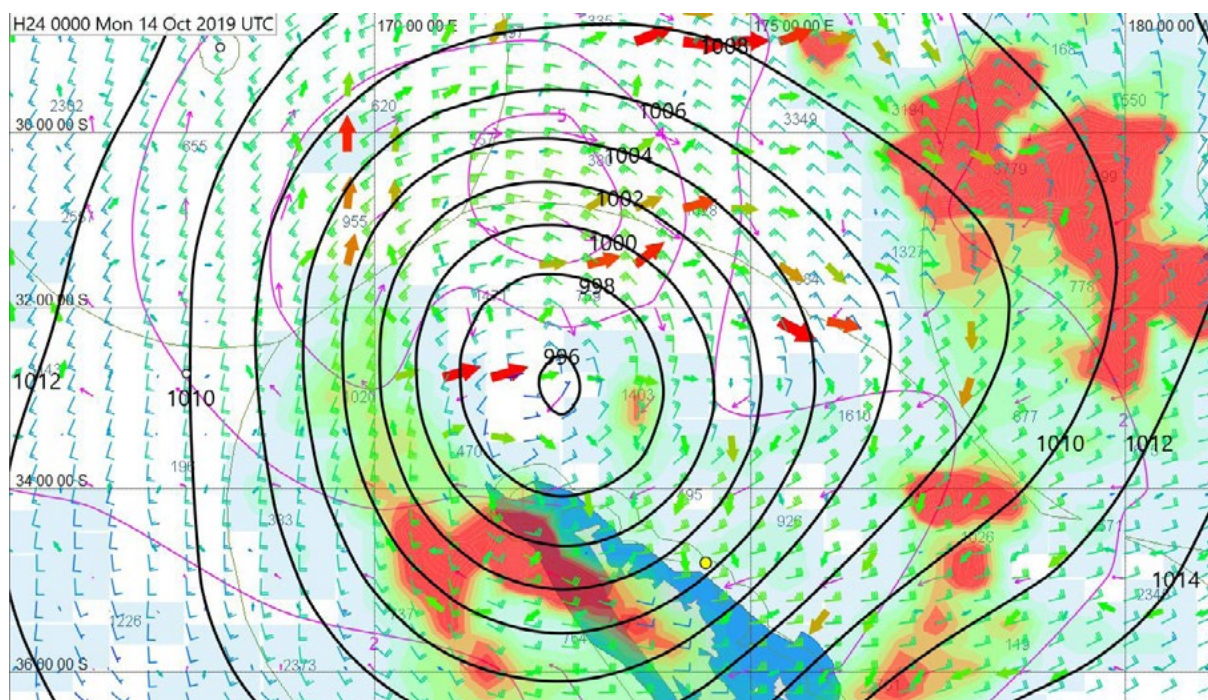
**Diagram 6: Projection chart**  
(courtesy Bob McDavitt)

At midday on 14 October 2019, a projection chart depicted a deep low pressure system of 996hPa, centred north of North Cape with strong easterly conditions in the Bay of Islands/Cape Brett area:

**Essence** foundered in the south east quadrant of the low pressure system. Most authorities on low pressure system avoidance recommend avoiding quadrants where more dangerous seas can be generated. In the southern hemisphere, mariners should avoid the south east quadrant of intense low pressure systems as more severe conditions are usually generated in this sector. A passage plan should avoid dangerous quadrants where possible and, if encountered, a determination should be made if it is necessary to sail on a heading towards a safer quadrant. Also, if there is a possibility of encountering dangerous seas whilst closing on a lee shore, consideration should always be given to standing out to sea and heaving to with adequate sea room to allow a low pressure system to pass before heading towards a shore. An important factor to consider when closing on a lee shore in heavy seas is that more dangerous seas can be encountered due to the shelving coastline.

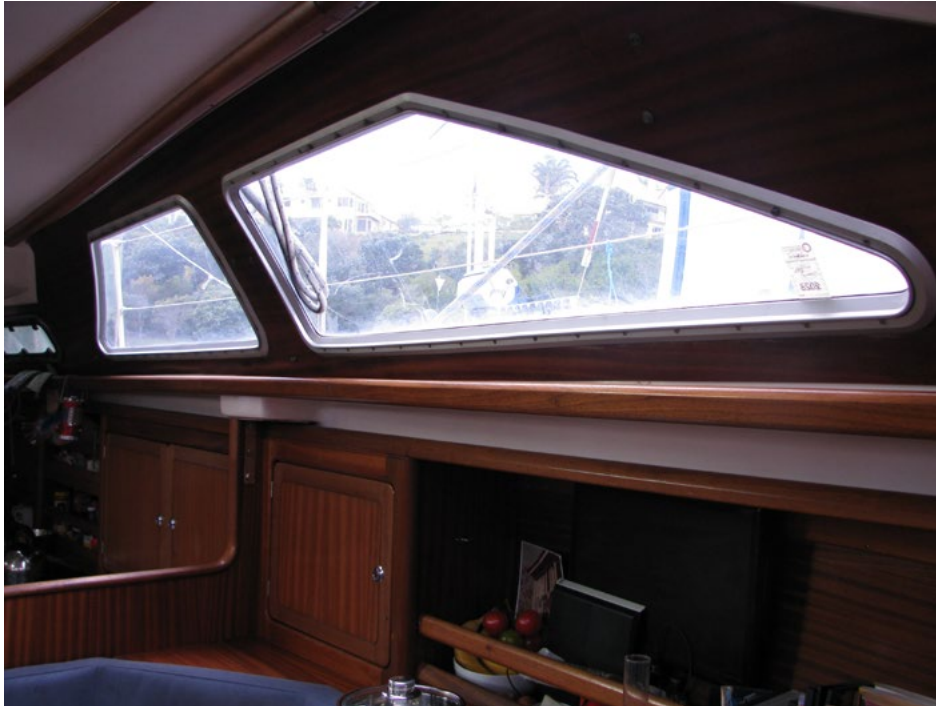
The cabin windows on **Essence** were approximately double the size specified under the Regulations as requiring storm coverings, however, as storm coverings were understood to have been on board, **Essence** was compliant in this respect.

**Photograph 4: Cabin windows in excess of 1852cm<sup>2</sup> in a Bavaria Oceans 47 sister ship**

The crew stated that the impact of the vessel falling into the trough caused the windows to blow out. This may also have caused the forward hatch to open. The impact of landing in the trough is likely to have caused the hull, cabin and deck to flex due to hydraulic forces. This is also likely to have caused pressure within the cabin which, combined with the flexing, may have caused the windows to blow out. It is noted that prior to the final knockdown, a crewman observed the cabin flexing due to wave pressure.

There is an increasing trend to have larger windows, in particular among production vessels that are touted as being suitable for ocean voyages. The larger the area of window, the greater the risk of failure, particularly for many production vessels that are subject to flexing in extreme conditions.

There is a commonly held view that windows will always break inwards due to external wave pressure and this can often be the case, however, many relatively modern production vessels, such as **Essence**, are constructed from materials that are more susceptible to flexing under pressure. This, when combined with the larger windows that are commonly found in modern sailing vessels, makes the rebated substrate area around the windows more susceptible to failure.

Heavy seas generated by storm force conditions caused **Essence** to suffer a severe knockdown, resulting in cabin windows being compromised followed by a sudden ingress of water of sufficient volume to render her unseaworthy with no hope of recovery.

The cabin windows and forward hatch were not protected by storm coverings and, due to their size, were vulnerable to forces generated from the knockdown. Had storm coverings been in place, it is likely **Essence** would not have foundered.

Where warranted, consideration should be given to installing storm coverings for windows under 1852cm<sup>2</sup>. Whilst not required under the Regulations, window strength, rebating and other relevant factors should be considered in determining if such action is prudent for the safety of the vessel in question.

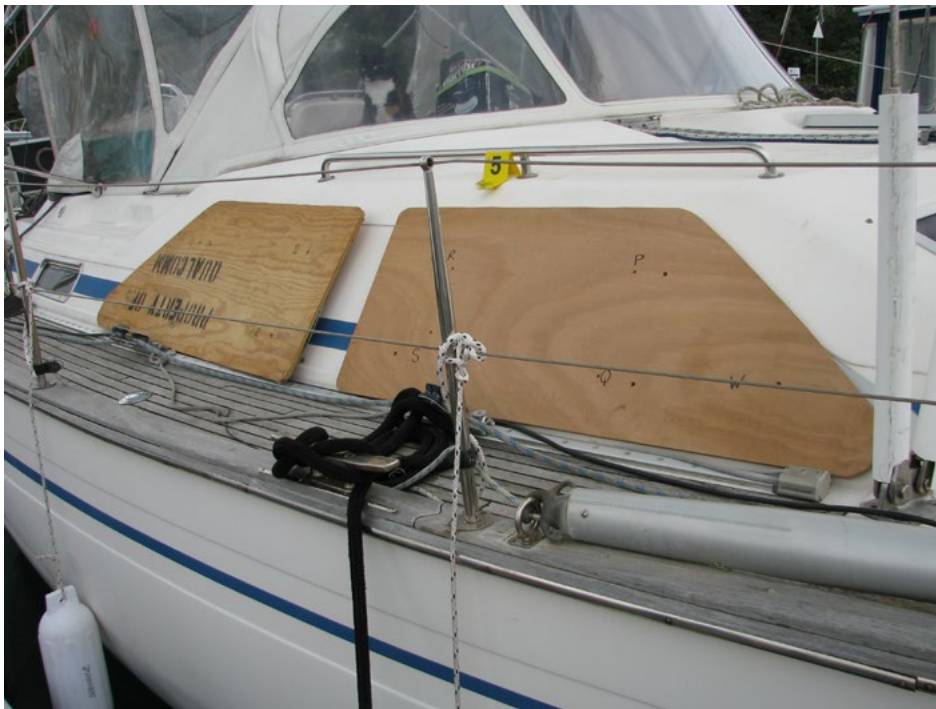
**Photograph 5: Plywood storm coverings in position, but not secured over windows, on a Bavaria Oceans 47 sister ship**

Whilst the Maritime NZ investigation has revealed a number of issues in relation to the operation of **Essence**, the key finding for the loss of **Essence** was the failure to have storm coverings secured in heavy seas.

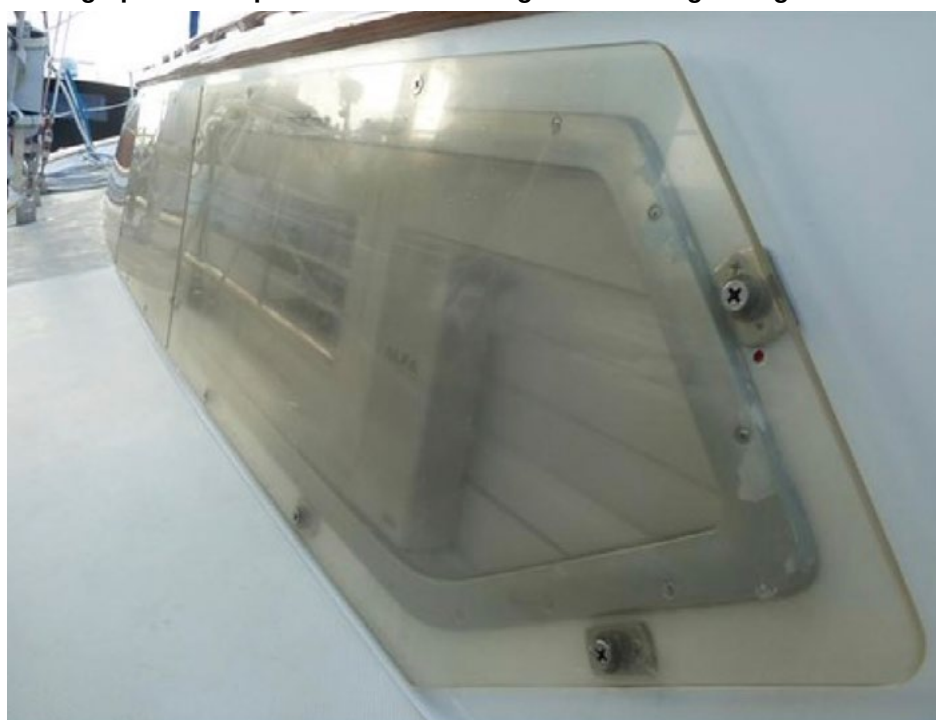
### Photograph 6: Example of a storm covering with securing arrangements
