Report on the investigations of two fatal accidents

on board the UK registered yacht

CV21

122nm west of Porto, Portugal

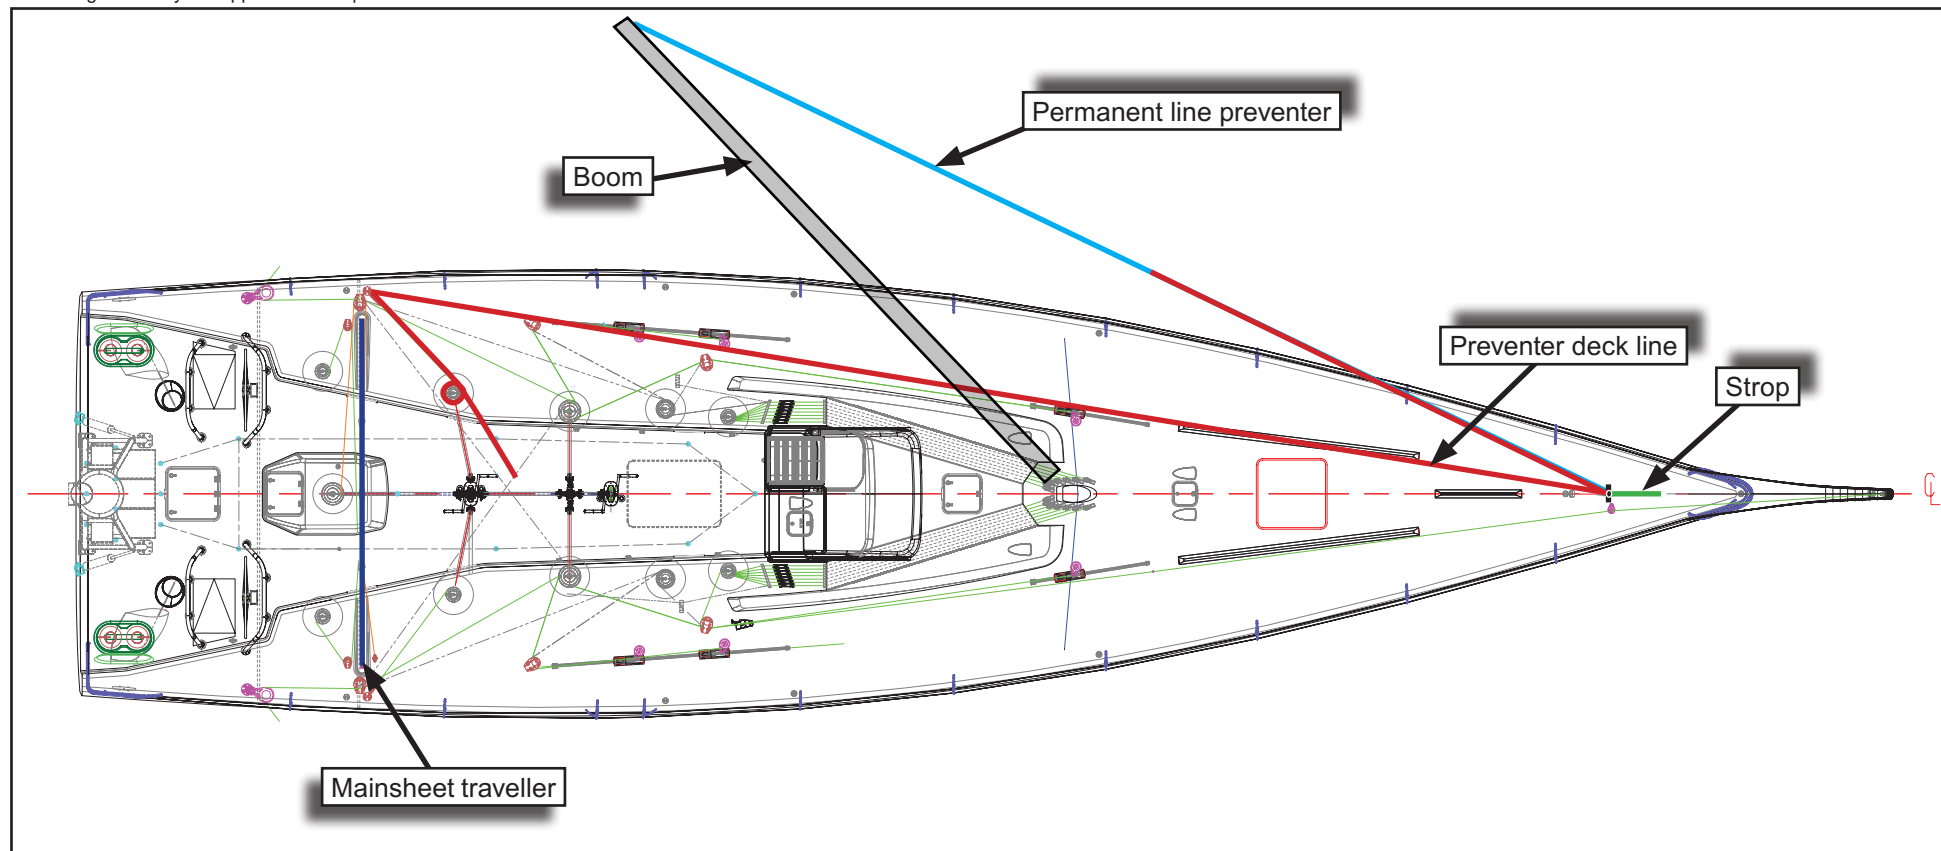
Figure 9: Preventer line arrangement (as illustrated by MAIB)

During previous Races, Clipper yachts had experienced numerous problems with the preventer line arrangement causing severe distortion to cleats and deck fittings. Originally, the preventer line ran from the boom end to a snatch block on the foredeck, then back to the cockpit. This avoided the need for a crew member to go forward to adjust the line. After numerous failures, Clipper sought to replace the snatch blocks with an alternative arrangement.

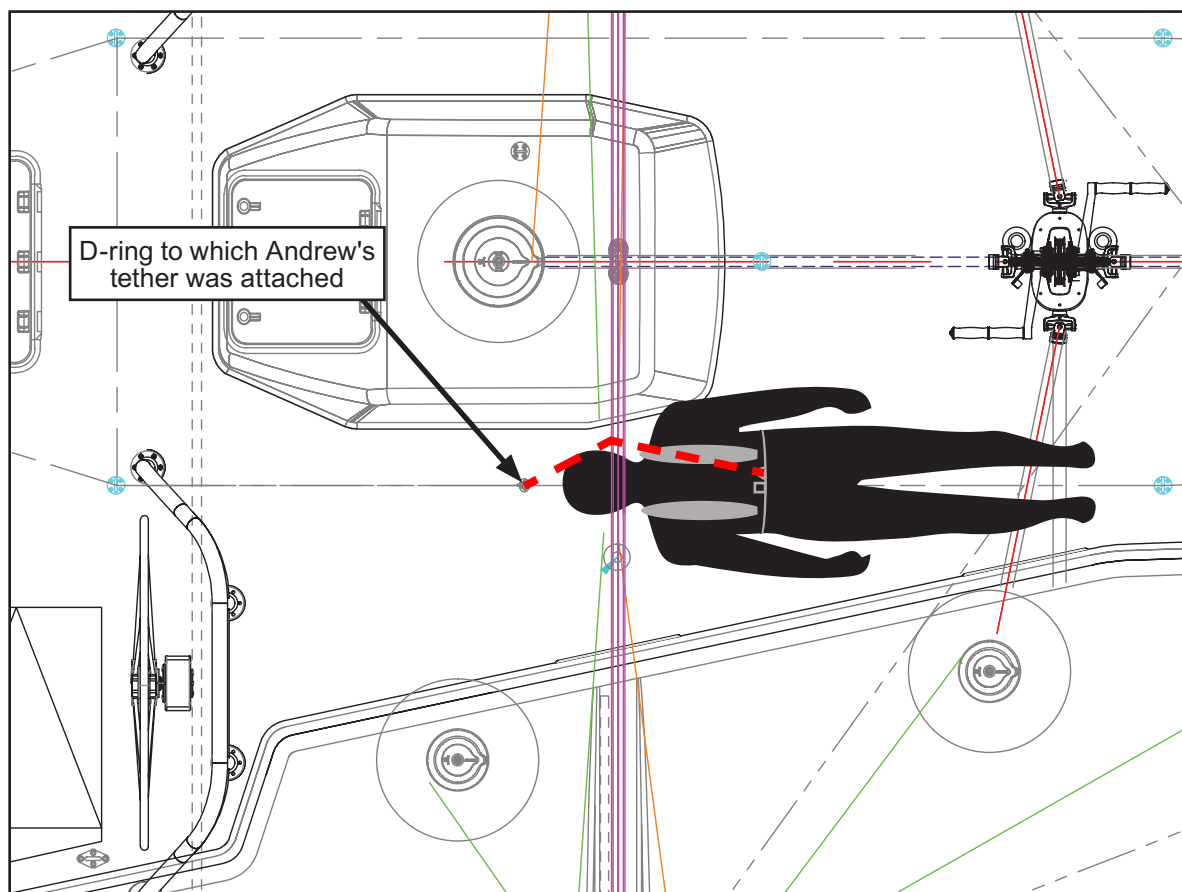
Figure 12: Indicative position of Andrew following gybe

After making sure that it was safe to enter the danger zone the skipper crossed to the starboard side of the deck, where Andrew was lying at a slight angle to the cockpit side coaming. Sarah Young was already with Andrew and informed the skipper that she could not find a pulse. The skipper used his head torch to shine

A postmortem examination of Andrew Ashman identified that he had died as a result of a broken neck from contact with a solid object. There was damage to his spinal cord and he had suffered a brain haemorrhage. The report also stated that Andrew had a bruise measuring approximately 6cm x 3cm on the right side of his neck, along with bruising to the back of his arms, left knee and right shin. Andrew was 170cm tall and weighed 105kg.

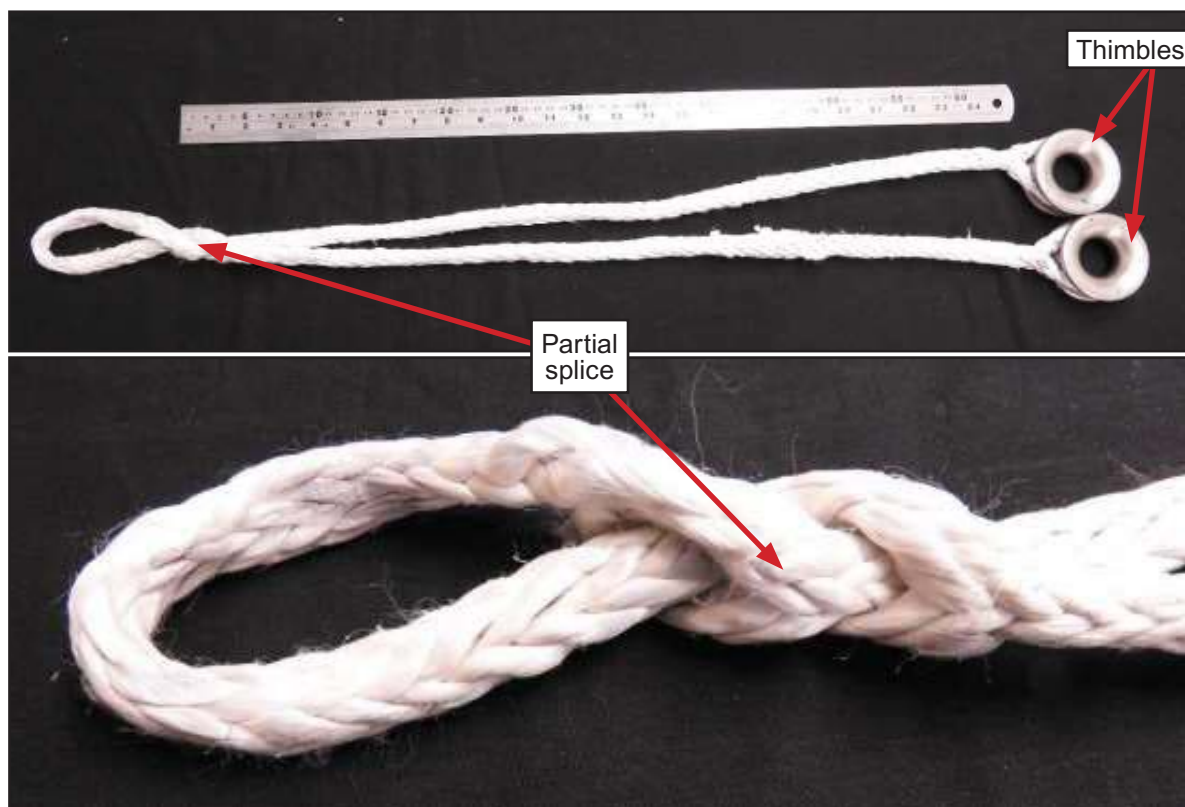
Figure 13: Preventer strop

An assessment of the preventer arrangement by Clipper concluded that it was fit for purpose and the rigger's line managers gave him approval to fit the strop onto the Clipper 70 fleet before the beginning of the 2015-2016 Race. The strengths of the preventer line, strop and pad-eye were estimated but not documented and no estimate of their expected in service loading had been recorded.

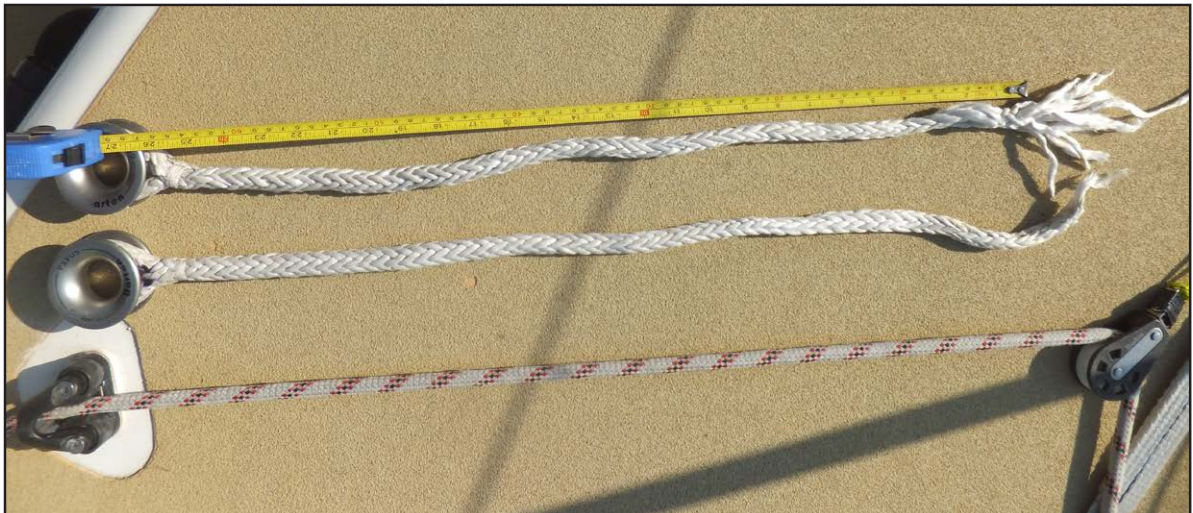
Figure 14: Failed preventer strop

The test report concluded that the primary failure mode was consistent with overload failure at the strop's partial splice, which might have been exacerbated by uneven loading of the splice, resulting in fewer fibres bearing the load, thereby creating a high stress point and pinch points.

Following the accident, actions taken by Clipper were aimed at improving crew safety on board the Clipper 70s, and included: the introduction of a second preventer line; the marking of the area to be avoided while running downwind, when an accidental gybe was possible; and, debriefing the crew with the lessons learned from the preventer strop failure.

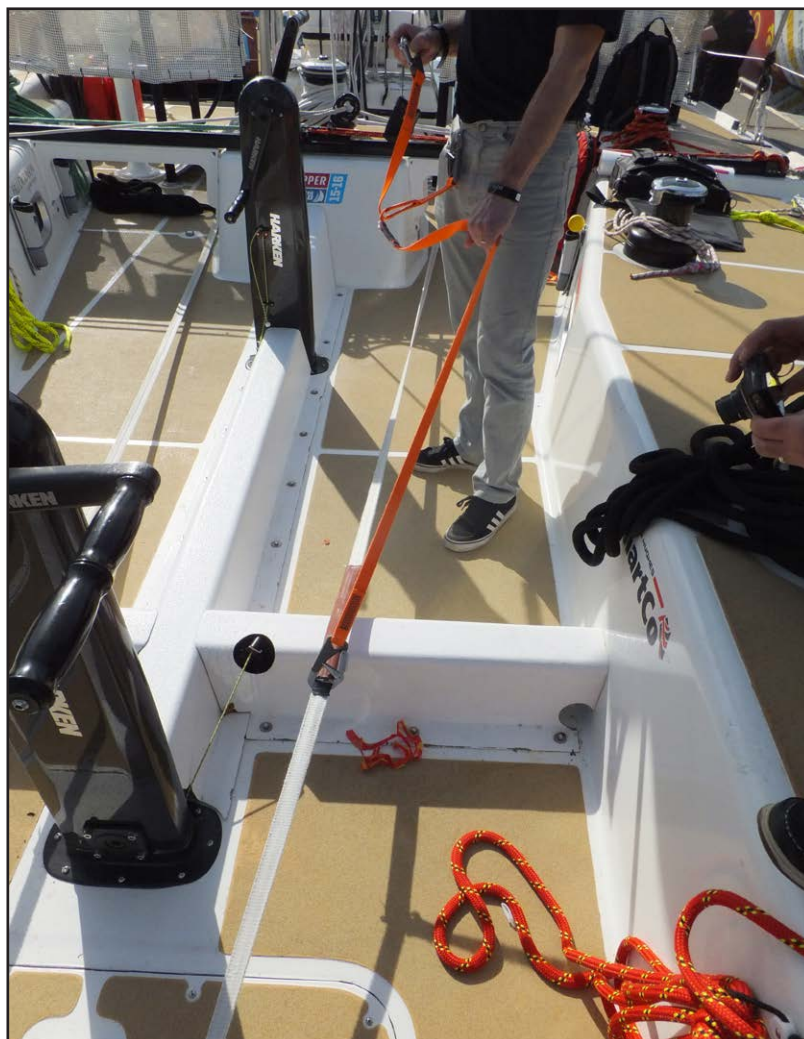
Figure 25: Cockpit jackstay and anti-chafe sleeve

Given the difficulties with moving and working while tethered, the tether securing arrangements, hard points and jackstays must facilitate their ease of use as much as possible. An example in this case was the anti-chafe sleeve on the jackstays fitted to the cockpit floor, which prevented a tether clip from sliding freely over it (**Figure 25**). This inconvenience led to some crew not clipping on at all when moving between the companionway and the helm positions.

The rigging of jackstays and hard points requires compromises, otherwise cockpit and deck layouts could become unworkable, but securing points must be derived with practicality in mind and procedures for their use developed accordingly. The watch leader, unclipping to move quickly aft to deploy the dan buoy in this accident, placed himself at significant risk of being washed overboard. Ensuring a crew member is always tethered within range of the dan buoy must be a factor to be considered when positioning crew at the start of a watch.

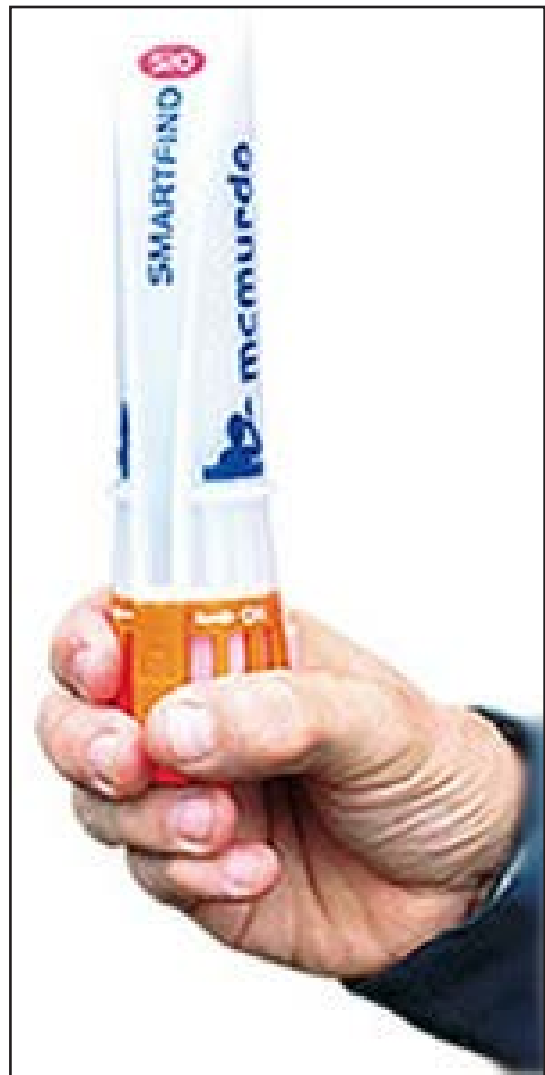
Figure 26: McMurdo S10 AIS beacon held in correct orientation

The AIS beacon fitted to the dan buoy was intended to be held vertically out of the water (**Figure 26**) to ensure it was able to locate its position via GPS and transmit the distress message on VHF radio. In the weather conditions encountered, the dan buoy - especially with the additional weight of the AIS beacon attached - is likely to have been blown virtually horizontal. The AIS beacon could at times have been submerged, preventing signal transmission and, with the

beacon not in a vertical orientation its reception range would have been reduced significantly. The effectiveness of fitting an AIS beacon to the dan buoy needs further consideration.
