Date: 14 April 2025

Oref: 20250405

**S/Y ABSOLUTELY MAGIC – Agioi Theodoroi - April 2025**

**Condition and Evaluation Survey**

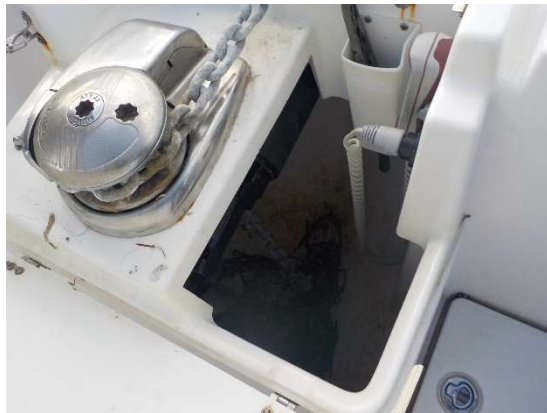
Anchor windlass

Anchor electrical windlass is located on the main deck forward in the centre. The windlass was last serviced March 2025.

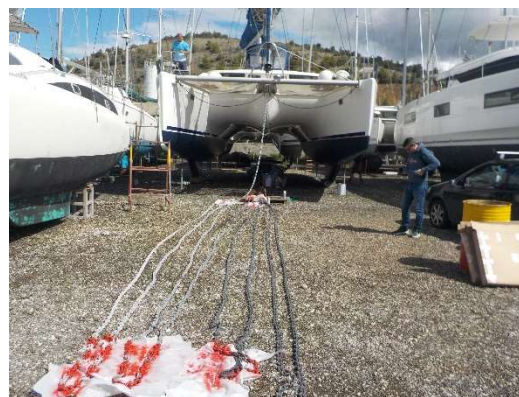
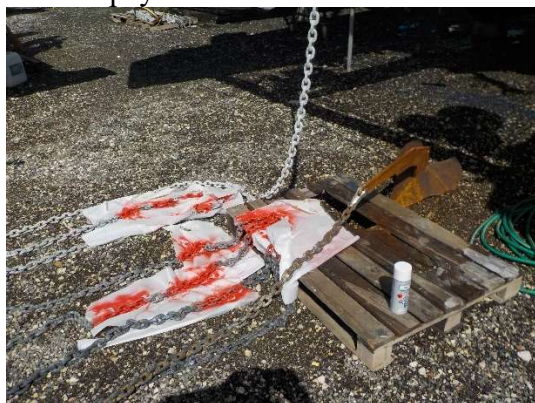
Anchor chain is 12mm diameter and 90 meters long. During our survey the chain was under maintenance and with shackles painted.

Anchor chain maintenance

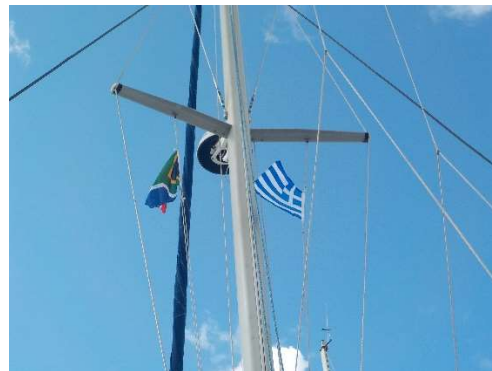
The yacht is equipped with a full battened main sail and a furling Genoa installed at 2016. The standing rigging (fractional sloop type) mast could not be ascended with safety, so the rig was examined as far as possible from the deck. The mast's height is 21.40m from DWL. The lower part of the mast and tabernacle were in sound condition, with no sign of corrosion or physical damage. The boom and gooseneck were found to be in good condition. To be noted that the standing rigging system was renewed in 2024.

View of Mast, spreader, shrouds, back & fore

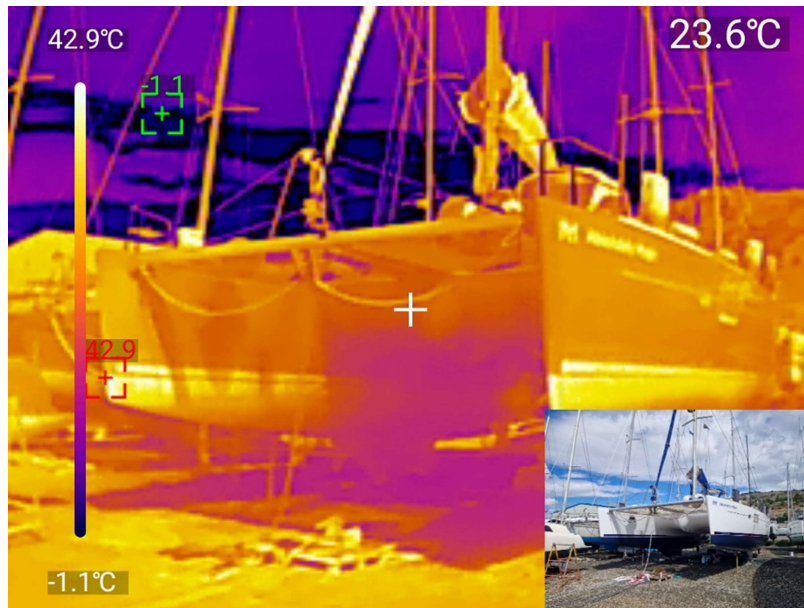
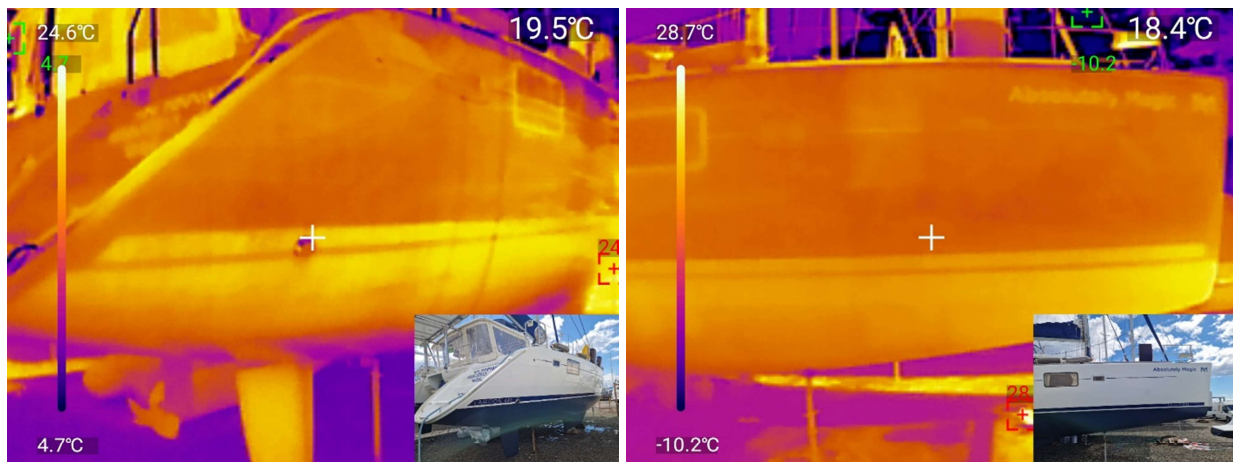
Initially the hull moisture was evaluated with the use of thermal scanning camera Uti721m from UNI-T, which revealed a unified thermal behaviour throughout the hull, indicating that there is not concentrated humidity under the first layer of gel coat.

Representative photos of thermal imaging of general condition of hull

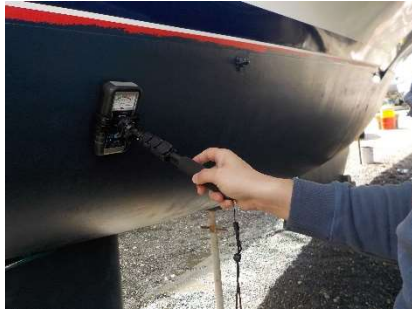
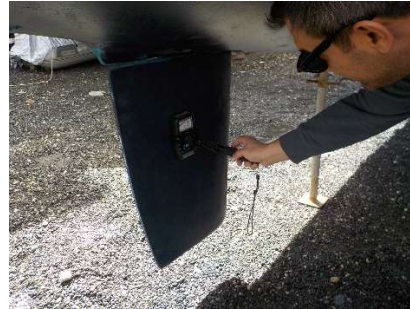
Moisture inspection with TRAMEX Skipper

No signs of osmotic blistering were detected and the risk of it can be considered generally low.

All readings were in the range of 30 and 40 on the comparative scale and which does not indicate the presence of any entrapped moisture nor any areas of risk.
