**P 9.4****HAIL DAMAGE TO ASPHALT ROOF SHINGLES**

Timothy P. Marshall\*, Richard F. Herzog, and Scott J. Morrison  
Haag Engineering Co.  
Dallas, Texas

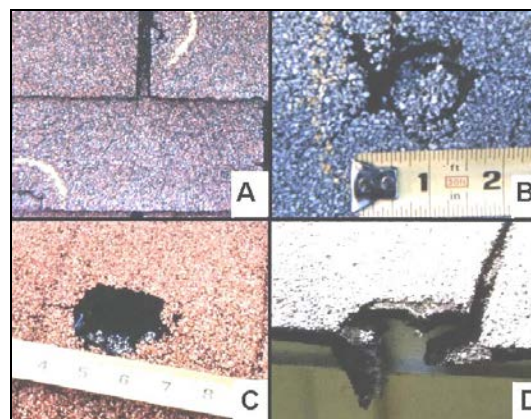
Morrison (1999) defined damage to roofing as a diminution of water-shedding capability or a reduction in the expected long-term life of the roofing material. Marshall and Herzog (1999) more specifically defined functional hail-caused damage to asphalt shingles as punctures, tears, or fractures (bruises) in the shingle mats (Figure 1). Shingle bruises are an indentation with fracture in the mat that feels soft like that of an apple bruise. The bruise is usually obvious as granules are also dislodged from the impact area exposing the asphaltic mat.

**Figure 1:** Hail damage to asphalt shingles: a) broken edges, b) bruise, c) puncture, d) torn edge.

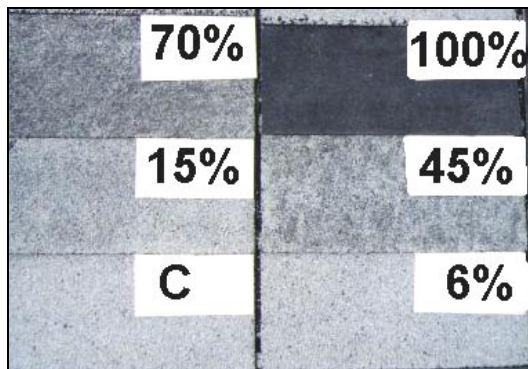
In order to determine how many granules, if any, must be removed in order to affect the service life or water shedding ability of the shingle, the authors' firm conducted a granule loss study on asphalt shingles. Varying quantities of granules were removed with a wire brush from new, three-tab, glass-fiber mat shingles. The shingles then were exposed naturally to the weather in Dallas, Texas for a period of ten years. The quantities of granules removed were none (control), and approximately 6, 15, 45, and 70 percent of the total granules on the shingles. Another shingle was installed upside down such that the asphaltic mat was exposed to the weather. The shingles were installed conventionally over a plywood deck on a 4:12 pitch that faced south. The shingles were examined at intervals throughout the ten year period as well as at the conclusion of the study (Figures 2 and 3).

**Figure 2.** Test panel at the beginning of the study showing percentage of granules removed. "C" is the control.

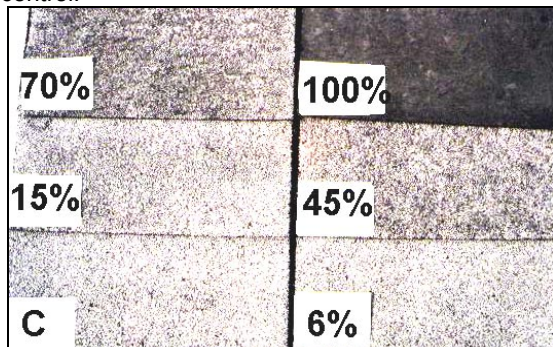
**Figure 3.** Same view as Figure 2 only at the conclusion of the ten-year study.

In one year, the exposed asphalt had oxidized grey but there was no visible evidence of surface cracks or erosion. After five years, areas of exposed asphalt had oxidized but this did not affect the function of the shingles to shed water. Surface erosion was visible on the shingle without granules, and some of the glass fibers had become exposed. After ten years, no significant change was noted in the shingles except for the shingle without granules. More glass fibers were exposed on this shingle due to erosion; but, the shingle continued to shed water (Figure 4).

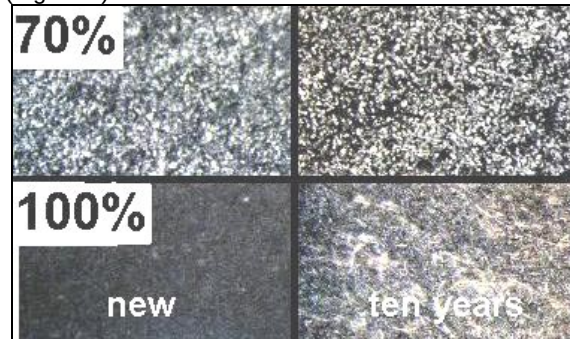
**Figure 4.** Close up views of new shingle and ten-year weathering with both 70 percent of the granules removed and no granules, respectively.

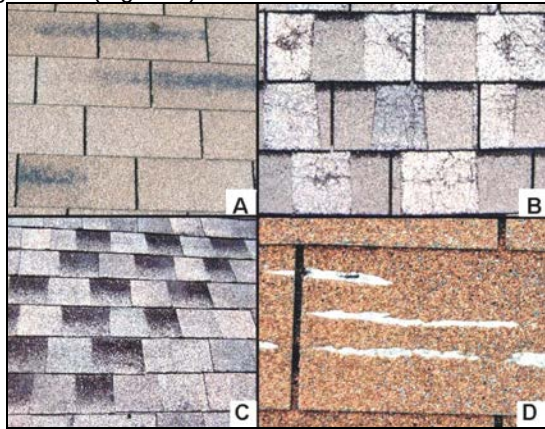
Asphalt shingles are manufactured in a high speed, fully automated process. Occasionally, certain defects involve insufficient granule or asphalt coverage, or the use of poor quality asphalt. Shingle manufacturers should "cull" or remove such defects before the shingles are shipped. However, the level of quality control of shingle products varies. Thus, it is not unusual to find shingle defects on a roof that involves bands or spots of missing asphalt and/or granules (Figure 5).

**Figure 5.** Various shingle manufacturing defects: a) lack of granule adhesion on a three-tab, b) blotchy appliques, c) asphalt exposed in lower laminate, and d) lines of missing asphalt and granules.

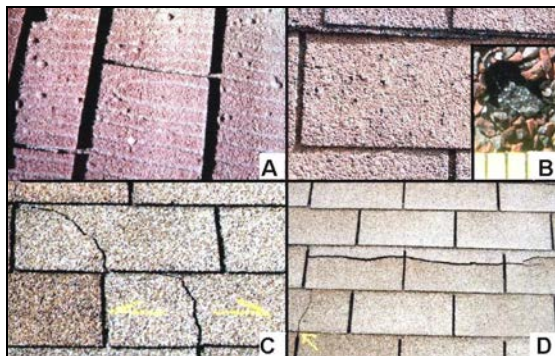
**Figure 6.** Various shingle anomalies not caused by hail: a) closed blisters, b) open blisters including close-up view in the inset photograph, c) diagonal splitting, and d) horizontal splitting.

Shingle blisters occur from a combination of poor quality asphalt combined with heat. They appear as small bubbles in the shingle surfaces where a portion of the granule surface is raised. Eventually, the shingle bubbles rupture exposing steep-sided voids in the shingle surfaces that frequently extends down to the shingle mat. Shingle blisters are usually 1/4 in. (.6 cm) in diameter or less and are not caused by hailstone impact.

Diagonal and horizontal splitting of asphalt shingles involves a combination of asphalt shrinkage, deck movement, and low tensile strength in the mat. Ribble et al. (1993) further explain such problems with asphalt shingles.

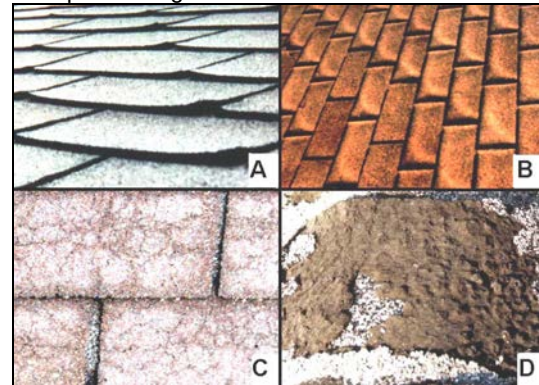
**Figure 7.** Various shingle anomalies not caused by hail: a) cupping, b) clawing, c) crazing, and d) flaking.

Cupping and clawing results from asphalt shrinkage on the top and bottom surfaces of the shingles, respectively. The corners and edges of the shingles are prone to curling or cupping as the mat shrinks. Crazing of the shingle surfaces also results from asphalt shrinkage. Eventually, chunks of granules flake away from the mat leaving the asphalt-coated mat exposed to the weather.

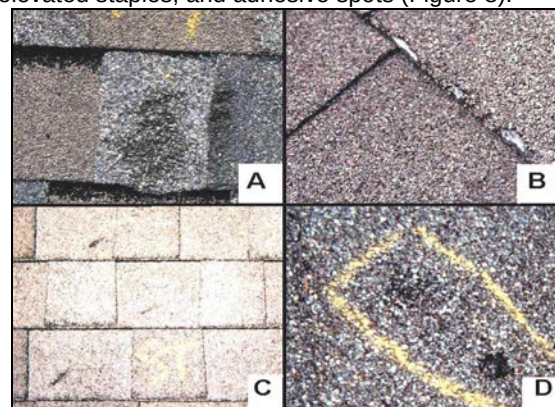
**Figure 8.** Shingle installation deficiencies: a) marring, b) edge scuffing, c) elevated fasteners, and d) adhesive spots.

Shingle marring occurs when people walk across the roof on a day when the shingles are hot, soft, and pliable. The asphalt in the shingle surface softens to the point where it is pushed aside along with the granules and typically forms a ridge on the outside edge of the mark. Persons walking on the roof can also remove granules along the bottom edges of the shingles.

Elevated fasteners can occur during the installation of the shingles and can protrude through or buckle the overlying shingles. The fasteners are either not driven flush to the shingle or are driven into joints between the roof decking. Elevated fasteners are not caused by hail striking the roof.

Adhesive can drip off the shingles onto the other shingles leaving a round, dark spot that can be mistaken by some as hail damage. If the adhesive from one shingle contacts another shingle and bonds to it, a portion of the shingle surface can be removed when the shingles are separated leaving a rounded area of missing granules that can also be mistaken by some as hail damage.

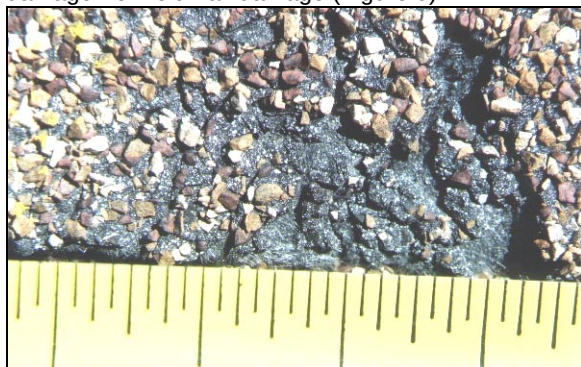
Shingles are particularly susceptible to hail damage if they have little or no underlying support, especially along ridges, rakes, eaves, and valleys. Shingle edges also are vulnerable to being chipped or broken. Therefore, the entire roof must be examined. Recently exposed asphalt appears black or unweathered, whereas asphalt exposed for several months oxidizes forming a surface film that is a grey color. This color difference is one way to tell new hail damage from old hail damage (Figure 9).

**Figure 9.** An example of 9-year-old hail damage to a glass-fiber mat asphalt shingle.

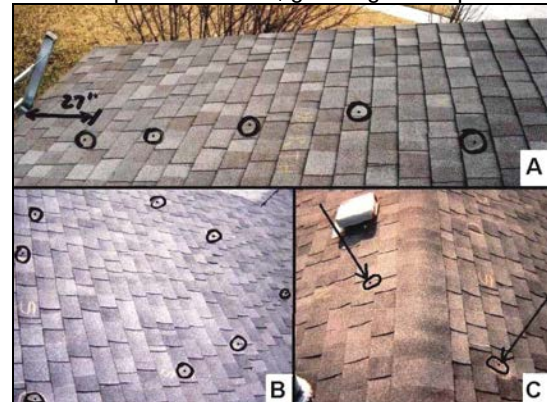
On occasion, some people have utilized various tools or other objects in an attempt to simulate hail damage on a roof. Popular items have included: 1) ball peen hammers, 2) claw hammers, 3) coins, and 4) screwdrivers. The authors have recognized a number of factors that distinguish intentional damage from hail damage. For example, intentional damage is not randomly distributed on the roof but usually occurs in groups or lines concentrated in upper portions of the roof, away from roof edges. Impact angles of the tool or object are nearly perpendicular to the affected roof slope, therefore indicating multiple impact directions (Figure 10). In contrast, hail would leave a random distribution of damage on the roof. The windward slope typically sustains the most concentrated and direct hail impacts whereas the leeward slopes have fewer, glancing hail impacts.

**Figure 10.** Intentional roof damage examples: a) line of impact marks, b) circular arrangement of impact marks, and c) impact marks perpendicular to each affected slope with no marks on the ridge.

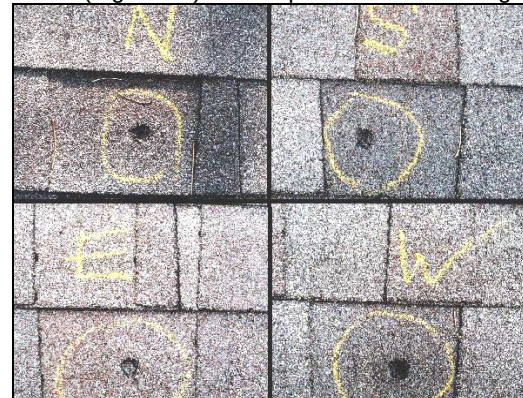
Intentional damage is concentrated frequently in the interior or center portions of the shingles, away from shingle edges, as it is human nature to hit the center of an object. Such centered impacts usually are found on each affected slope, regardless of slope direction (Figure 11). The impacts tend to be singular,

**Figure 11.** Attempts to simulate hail damage with a ball peen hammer.

occurring once per shingle. In contrast, hail does not prefer the centers of the shingles nor strike shingles once consistently.

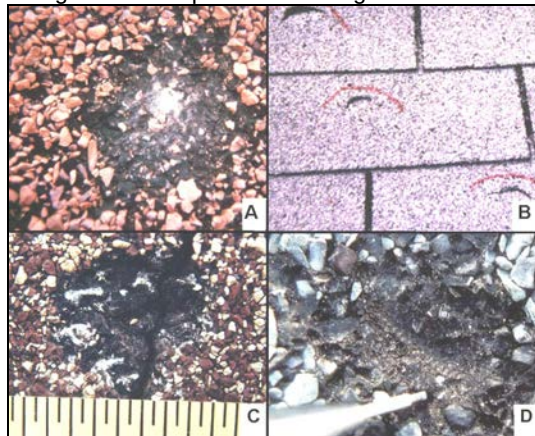
In our inspections of suspicious roof damage, we utilize a series of magnification rings to closely photograph the impact marks. Typically, shingles struck by metal objects will have broken or shattered the ceramic coating on the granules. This will leave a "powder" residue containing shattered ceramic material within the impact mark. Any side-to-side or "rounding out" motions will tend to leave swirl marks within the powder residue and/or leave smudges in the exposed asphalt surface (Figure 12).

When claw hammers are utilized, the metal peen frequently does not strike the roof slopes exactly perpendicular but tends to tilt forward slightly leaving a characteristic curving fracture in the shingles that opens towards the direction of impact. The concave fracture in the shingle resembles a "frowny" face when looking upslope. Granules closest to the concave side of the fracture are frequently compressed uniformly into the shingle mat.

Sometimes coins are utilized to leave small divots in the shingle surface. Quarter coins have small ridges around their perimeters that can leave a series of ridges in the asphalt under magnification.

**Figure 12.** Close-up views of mechanically caused impacts to shingles using: a) a ball-peen hammer, b) claw hammer, c) screwdriver, and d) quarter coin.

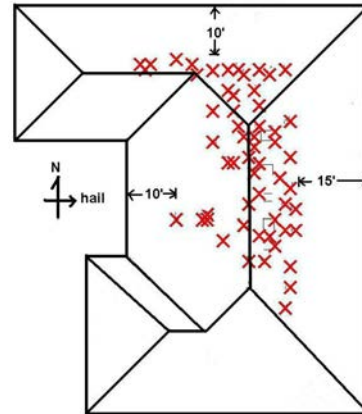
After a general examination of the building surroundings is performed, a roof plan diagram is drawn and shingle marks are plotted. Any pattern or grouping of shingle marks quickly becomes apparent in the diagram (Figure 13). The diagram will indicate those roof slopes or ridges that are notably without shingle marks as well as any grouping of marks. Usually, large areas of the affected roof slopes are without shingle marks as are other, perhaps smaller, roof slopes that face the same direction. Shingle marks closest to the roof edge are measured.

**Figure 13.** Roof plan diagram showing the distribution of mechanically-caused impact marks in an alleged hail damage claim.
