Report of Marine Survey

Vessel: 2001 Cobalt 360

Purpose: Pre-purchase and Evaluation

Date of Survey: September, 5th 2017

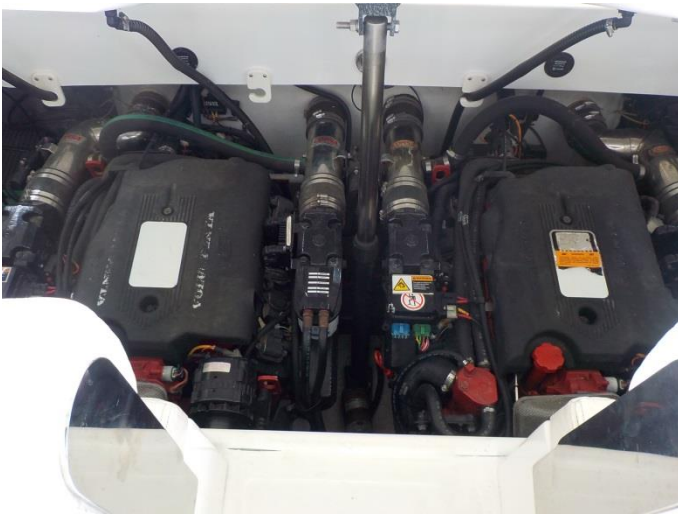
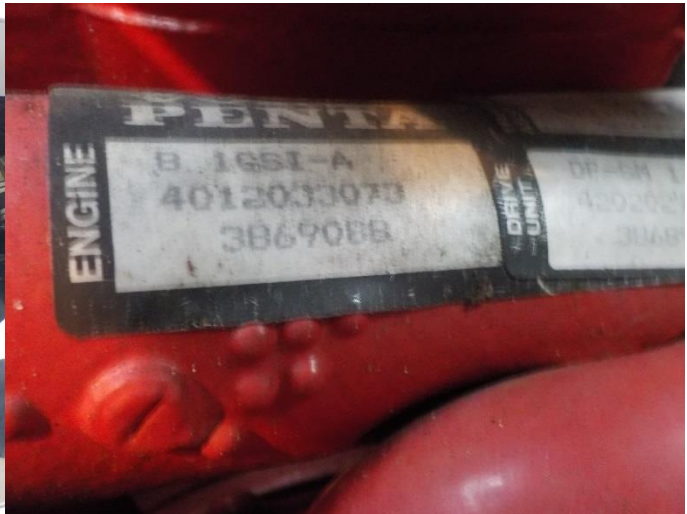
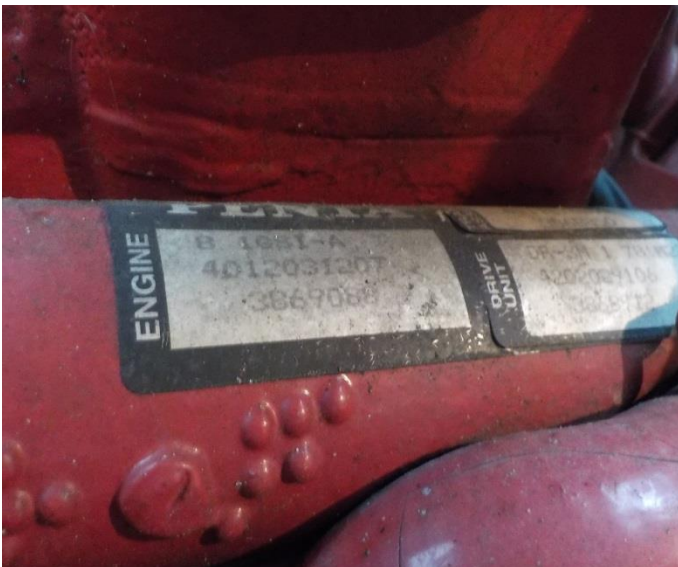
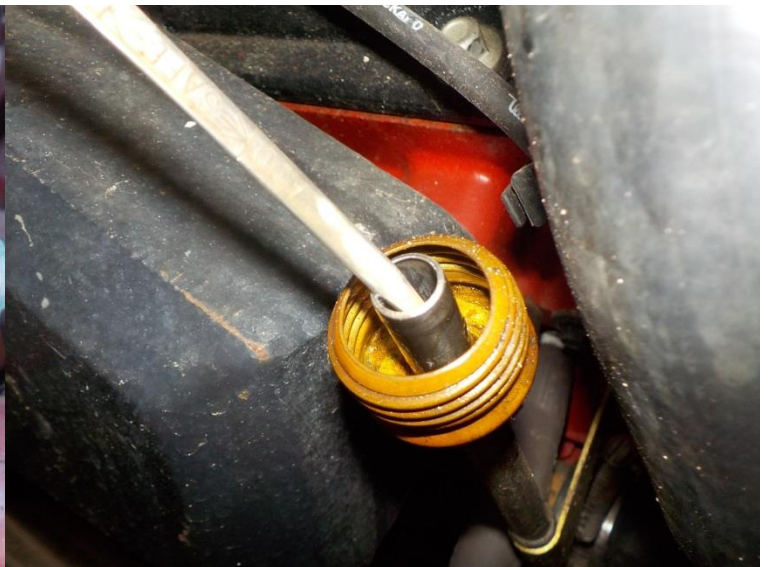
Engine mounted. Secure with no leaks sighted.

Engine mounts appear to be well secured to the support stringers. Percussion tested where accessible, no delamination sighted.
