Report of Marine Survey

Vessel: 2013 Cobalt 24 SD

Purpose: Pre-purchase and Evaluation

Date of Survey: September, 9th 2017

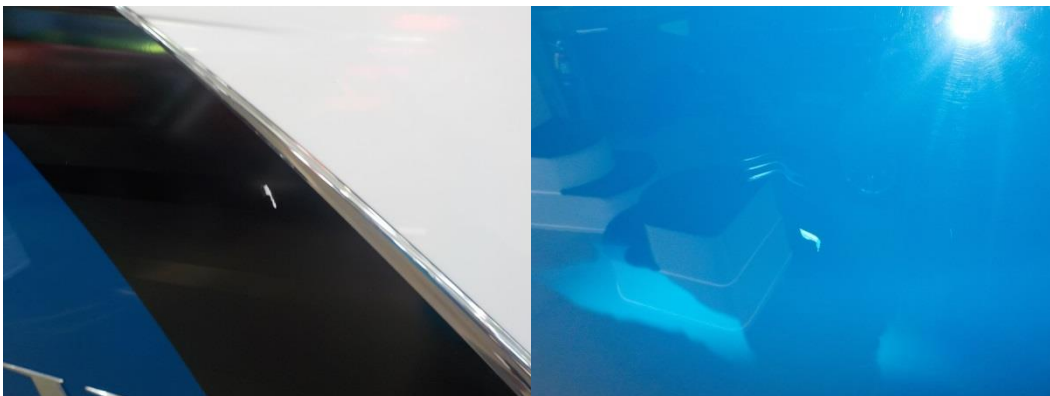
Fiberglass with white gelcoat surface, blue vinyl graphics along hull side(s).
Bottom hull is black gelcoat. **NOTE: Damage sighted in the following areas: (1) Port-Aft-1"x1/4" tear in graphic vinyl. (2) Port-Midships-2"x2" rub mark. Repair/Clean as needed for cosmetic purposes.**

1. NOTE: Damage sighted in the following areas: (1) Port-Aft-1"x1/4" tear in graphic vinyl. (2) Port-Midships-2"x2" rub mark. Repair/Clean as needed for cosmetic purposes.
2. NOTE: Vinyl on aft bulkhead of head compartment slightly dirty. Clean as needed for cosmetic purposes.
3. NOTE: Several minor scuffs/scratches were visible on hull bottom. Buff/Repair as needed for cosmetic purposes.

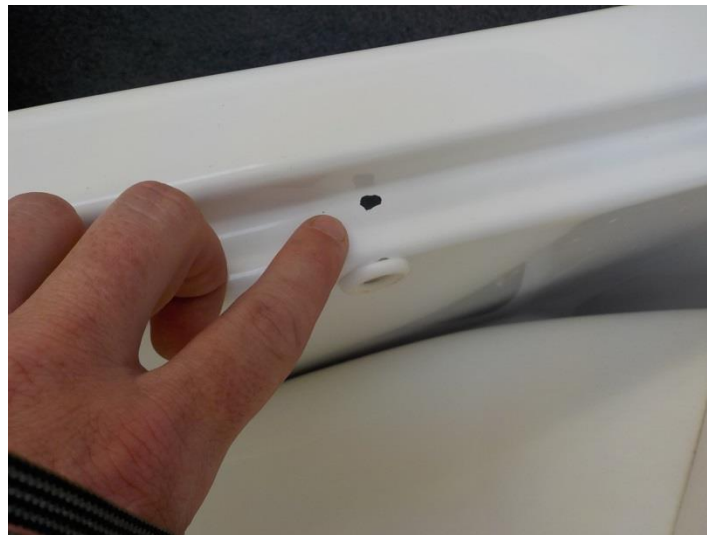
White with molded in non-skid surface. NOTE: Bow-Starboard storage locker has a 1/4" x 1/4" gel-coat void. Repair as needed for cosmetic purposes.

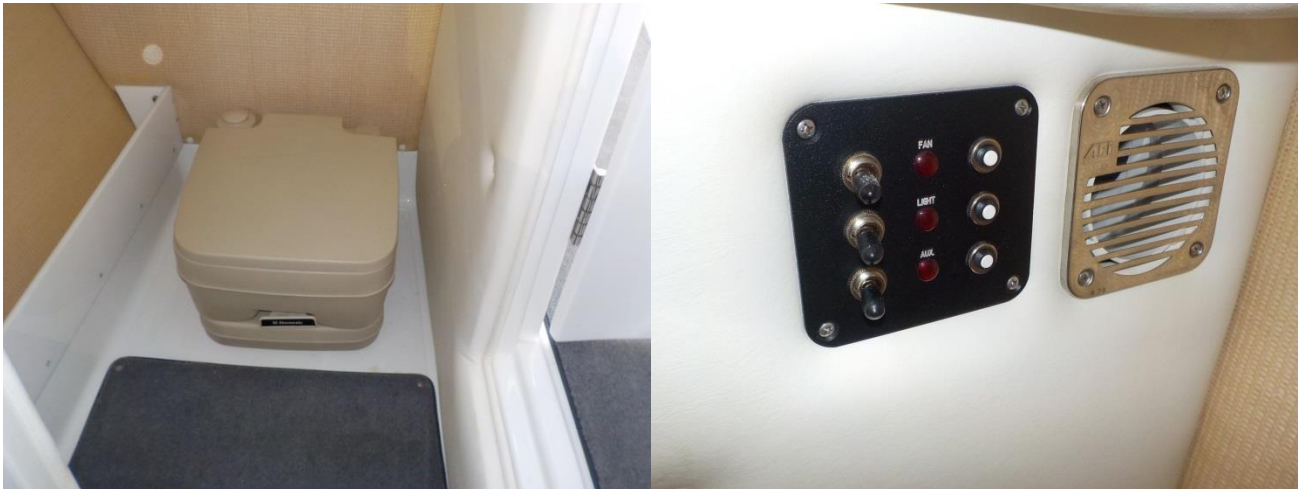
NOTE: Vinyl on aft bulkhead of head compartment slightly dirty. Clean as needed for cosmetic purposes.

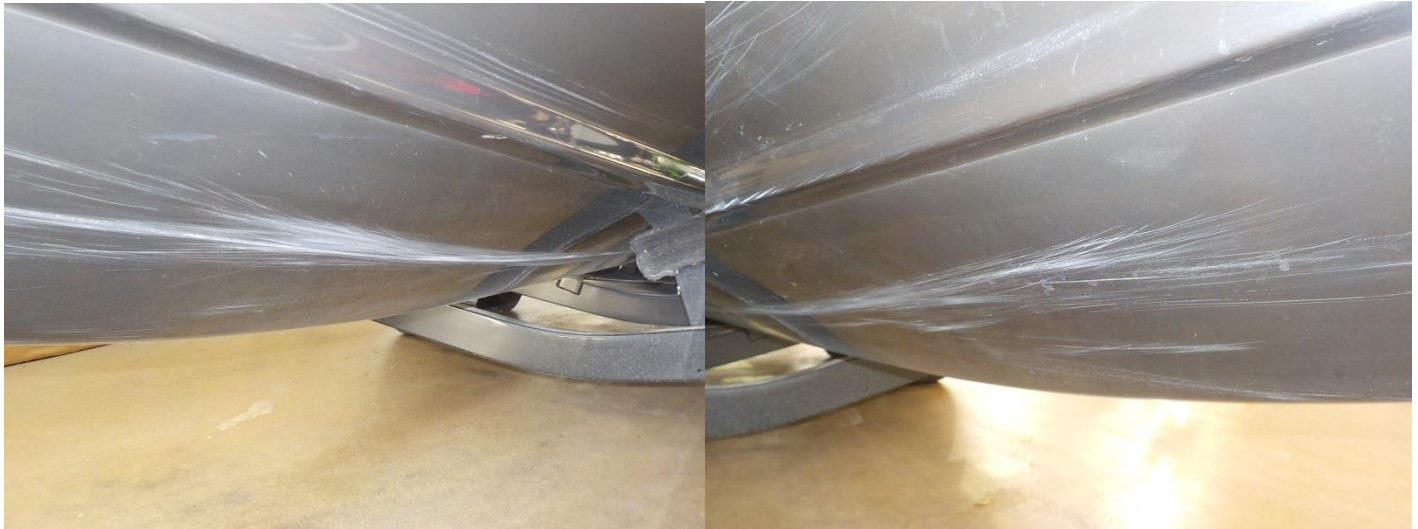
Fiberglass with black gelcoat. NOTE: Several minor scuffs/scratches were visible on hull bottom. Buff/Repair as needed for cosmetic purposes.
