Report of Marine Survey

Vessel: 2001 Cruisers 3470 Express

Purpose: Pre-purchase and Evaluation

Date of Survey: July, 20th 2017

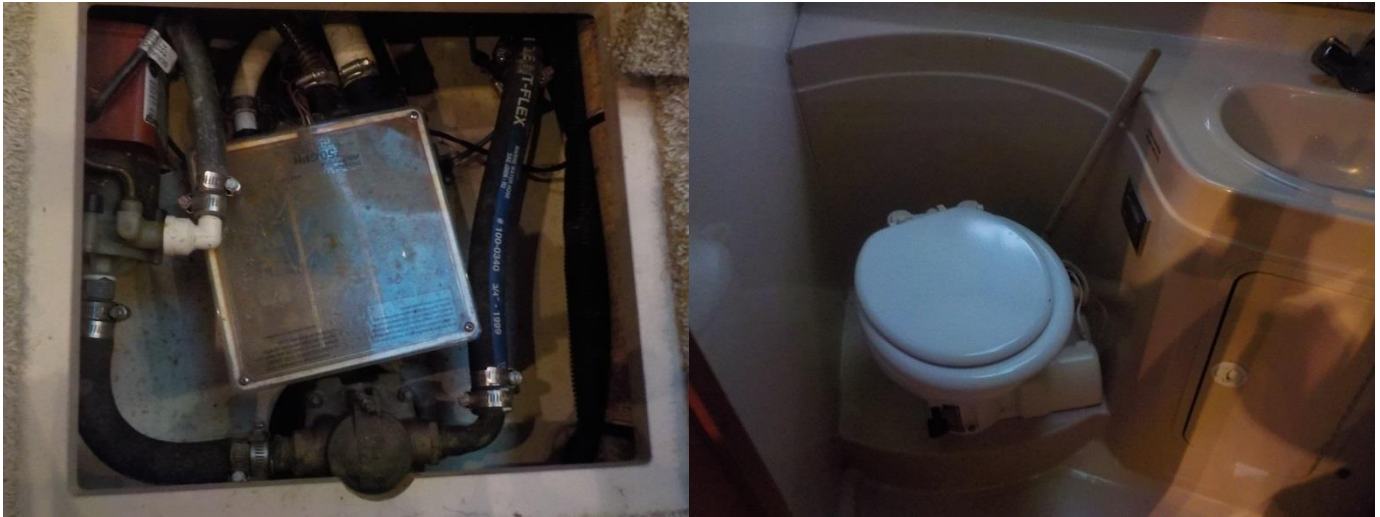
One shower sump box located under salon sole. Not Operational. **NOTE: Sump box pump is not operational. Repair.**

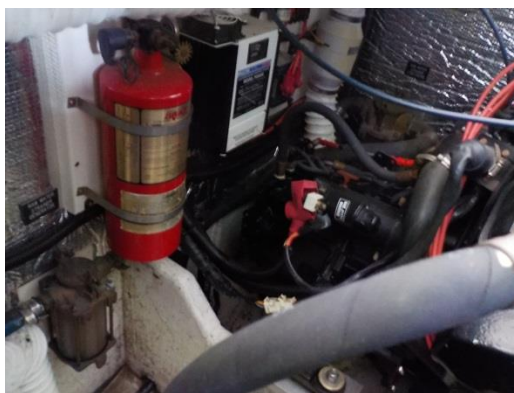
Fireboy Clean Agent system sighted in the engine compartment. Gauge on bottle shows full. Secured with an LED helm light, operational. **NOTE: Fixed fire extinguisher in engine space has outdated certification tag. ABYC A-4 and NFPA 302 recommends that fixed fire protection systems be inspected and reweighed at one year intervals and tagged accordingly. Comply. NOTE: Halon or other “clean agent” type fire extinguishers must be weighed to determine true contents. Monitor lights and gauges only show there is pressure available and do not reflect the quantity available. Annual inspection and a tag to show date is required.**
