# **Report of Marine Survey**

**Vessel: 2008 Chris Craft Catalina 23**

**Purpose: Pre-purchase and Evaluation**

**Date of Survey: January, 25th 2018**

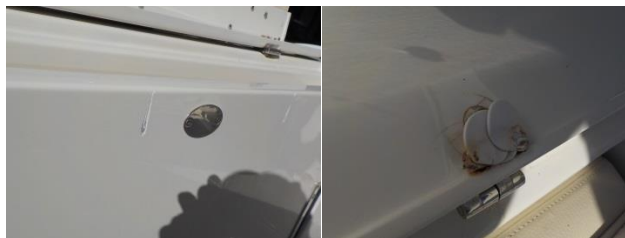
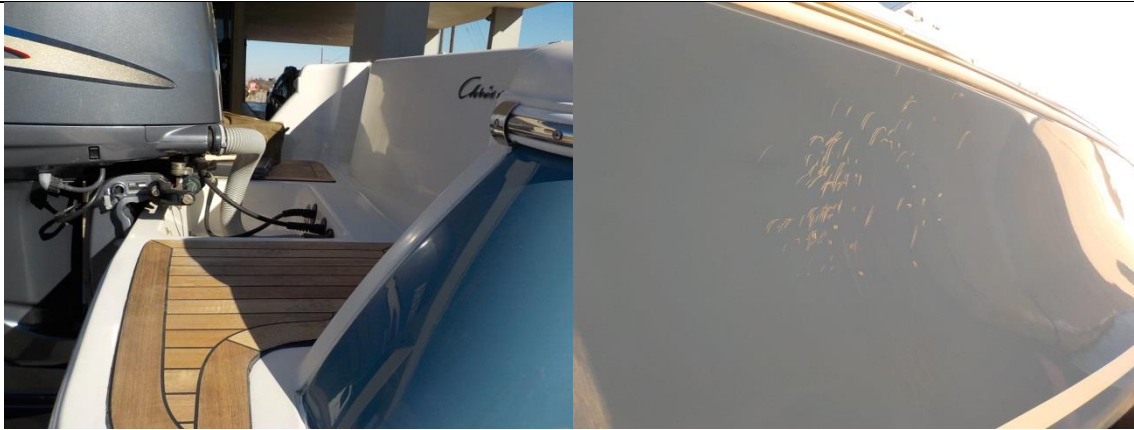
Conventional transom with attached outboard motor. No damages sighted. Motor bracket is well secured as sighted from exterior. **NOTE:** Slight cosmetic gelcoat repair marks, gouges and stress cracks were sighted on transom around aft seat brackets. Repair as needed for cosmetic purposes.

2. NOTE: Slight cosmetic gelcoat repair marks, gouges and stress cracks were sighted on transom around aft seat brackets. Repair as needed for cosmetic purposes.

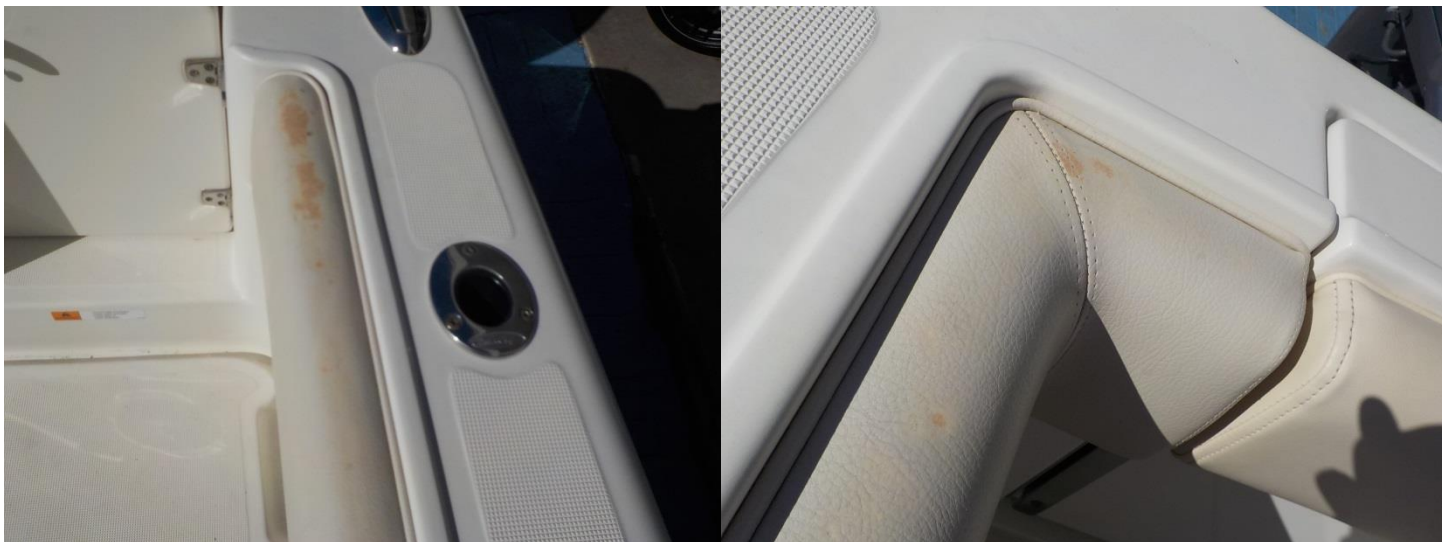
Forward of helm there is bench style vinyl covered seating with additional vinyl cushions that attach to forward storage hatch decking. All Vinyl is white and in good condition except where noted. **NOTE: (1) Port-Aft-Stains sighted on top of vinyl covered padded bulwark bolster in 12"x2" area. (2) Starboard-Aft-Stains sighted in multiple areas on bulwark bolster padding. (3) Bow Cushions – Stains sighted in several spots. (4) Bow-Bulwark bolster has 2"x2" stain. Repair/Clean all as needed for cosmetic purposes.**

4. NOTE: (1) Port-Aft-Stains sighted on top of vinyl covered padded bulwark bolster in 12"x2" area. (2) Starboard-Aft-Stains sighted in multiple areas on bulwark bolster padding. (3) Bow Cushions – Stains sighted in several spots. (4) Bow-Bulwark bolster has 2"x2" stain. Repair/Clean all as needed for cosmetic purposes.

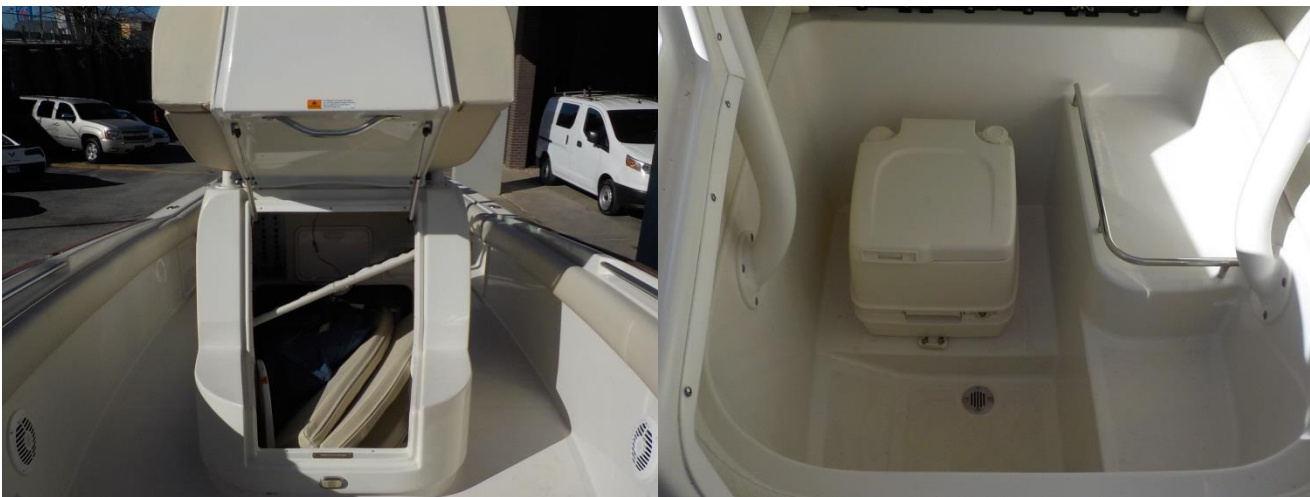
Center console hinged at forward section for access to porta-pottie, batteries and console wiring. **NOTE: Overhead is not attached/falling down in porta-pottie compartment. Repair. Also, vinyl bulwark covering is becoming detached at overhead seam on both sides of porta-pottie compartment. Repair.**

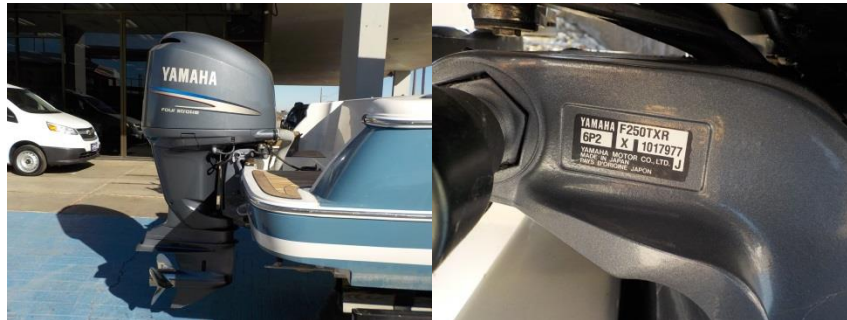
**Lower Unit/Gearbox:** Sound, operational. Minimal galvanic corrosion spotted. **NOTE: 8" long gouge sighted on starboard side of gearbox. Repair for cosmetic purposes.**

Sound, operational. **NOTE: Starboard side trim cylinder is leaking hydraulic fluid. Repair.**

5. NOTE: 8" long gouge sighted on starboard side of gearbox. Repair for cosmetic purposes.
6. NOTE: Bottom paint is thin and flaking in several areas. Sand and replace with fresh bottom paint or gelcoat.

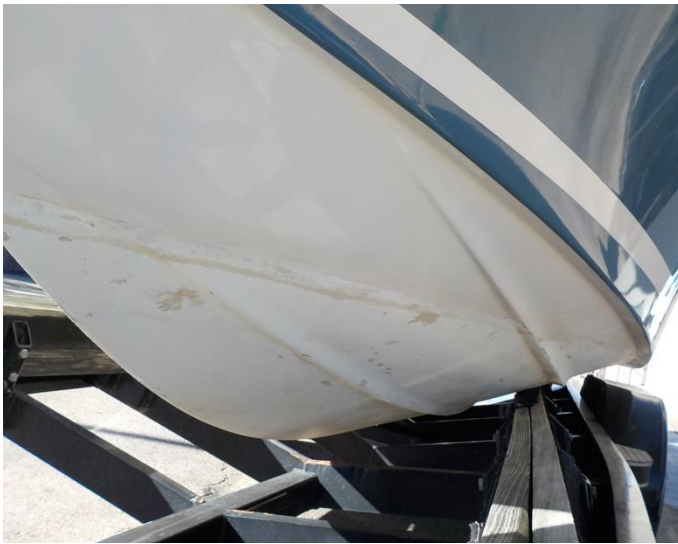
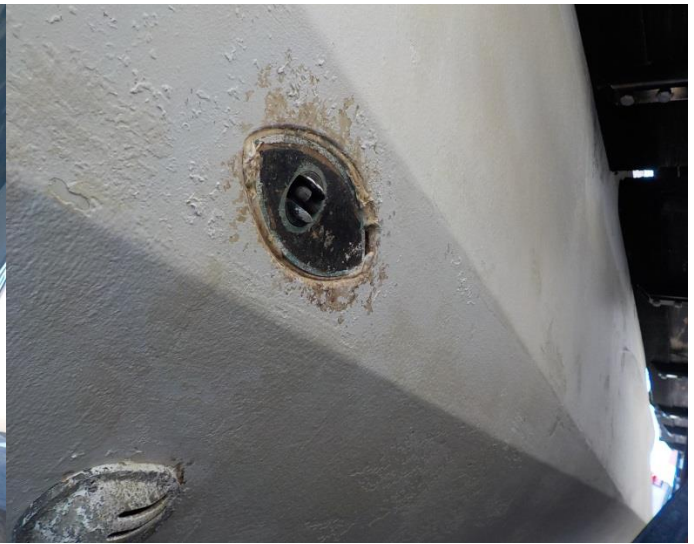
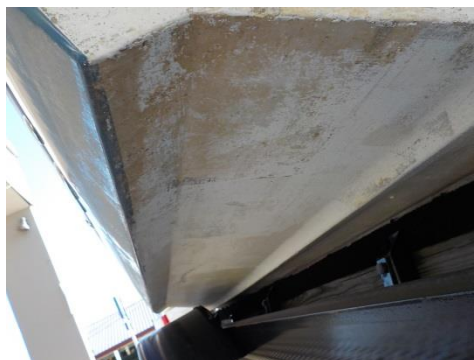
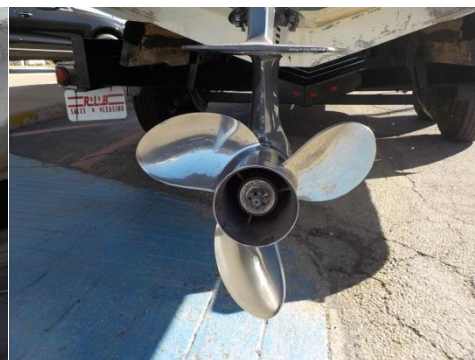
Yes. White bottom paint sighted. NOTE: Bottom paint is thin and flaking in several areas. Sand and replace with fresh bottom paint or gelcoat.

NOTE: Transducer caulking has deteriorated. Re-bed transducer with marine grade 3m 5200 adhesive sealant.

Two anodes sighted. One on each Lenco trim tab. **NOTE: Anode is missing from outboard motor lower unit trim tab. Replace.**
