Report of Marine Survey

Vessel: 2017 Mastercraft X23

Purpose: Pre-Purchase Condition & Valuation

Date of Survey: November 26th, 2025

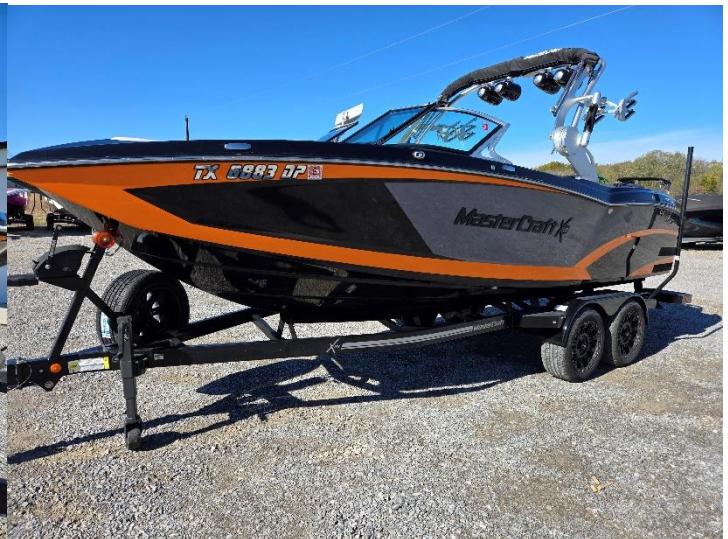
Port Side

Component	Description	Condition/Notes
Hull Construction Material	Molded FRP	
Hull Surface	Black metal flake colored gelcoat with orange striping along the hull sides.	Good clean overall condition, well buffed. NOTE: (1) Port-midships- 4"x4" scuff mark along the hull side. (2) Port-aft- 1"x1" gouge below the rub rail. (3) Port-bow- 1" gouge below the rub rail. (4) Starboard-aft- 1" scuff mark below the rub rail. (5) Transom- 3" scratch mark above the swim platform below the rub rail. Repair all as needed for cosmetic purposes.
Transom – Construction Material	Molded FRP. Flat shaped.	See "Interior Hull & Structural Components" and "Out of Water" sections of report for details.
Rub Rail	Black colored rubber rub rail with stainless insert covering the hull to deck joint.	Well secured, minimal wear and tear sighted.
Swim Platform	Attached FRP swim platform.	Well secured, no damages sighted. NOTE: Sea-dek covering the swim platform has several minor scratches and worn areas. Repair/clean as needed for cosmetic purposes.

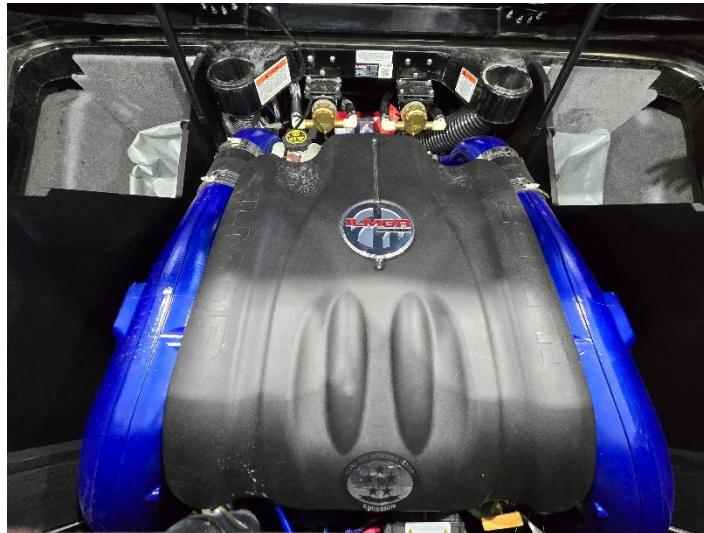
Component	Description	Condition/Notes
Propulsion Type	Inboard V Drive	
NO# - Type – Cylinders – HP - Aspiration	NO#: One Type: Gasoline 4-stroke Cylinders: V 8 Horsepower: 430 Aspiration: Natural	
Make - Model - Serial#	Make: Ilmor Model: 6.2 Serial#: 013187	
Engine Hours	281	As per engine display screen at the helm dash.
Cooling System	Raw water and closed cooled with heat exchanger and thru-hull intake.	Coolant level full as per expansion tank markings.
Belts & Pulleys	Serviceable.	Minimal to no corrosion on pulleys. No splitting sighted on belts.
Hoses & Clamps	Hoses are in serviceable condition and are securely clamped at each connection where accessible.	
Oil Level & Condition	Full and clean as per dipstick markings.	
Mounts & Beds	Engine mounts are well secured and minimal corrosion was sighted.	
Flame Arrestor	Engine is equipped with a flame arrestor as per CFR requirements.	Well secured and mostly clean.

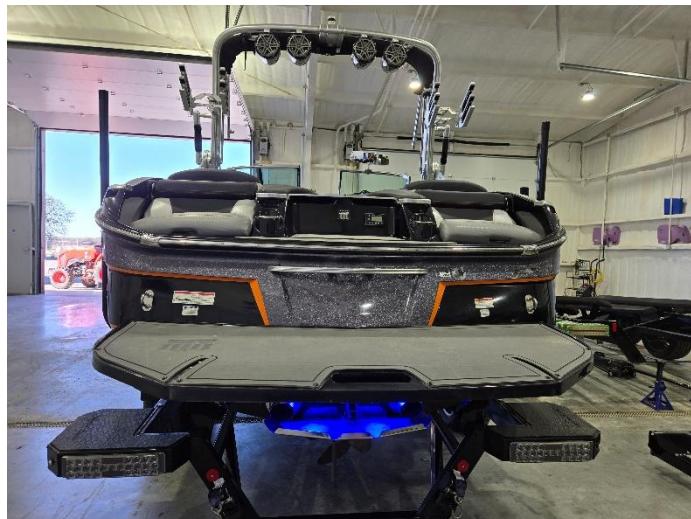
Transom

Component	Description	Condition/Notes
Surf Gates	Wake plate mounted on each side of the transom.	No damages sighted, well secured.
Power Wedge	Stainless power wedge mounted to the centerline of the transom.	No damages sighted, well secured.

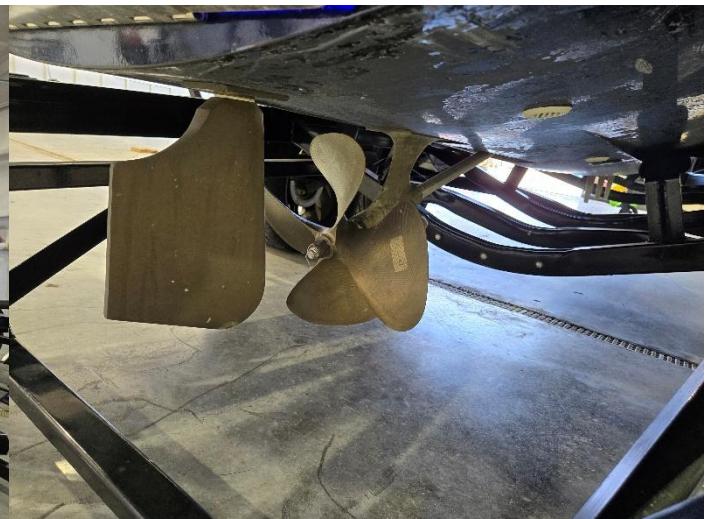
Running Gear

Prop Shaft	Stainless shaft. Size: 1 1/4"	No damages or corrosion sighted.
Strut	Bronze strut.	No damages sighted, well bedded and secured.
Rudder	Bronze rudder.	No damages sighted, well secured with minimal play.
Shaft (Cutlass) Bearing	Serviceable.	
Propeller	Bronze four bladed propeller. Size/Pitch: 16 x 19	No damages sighted, cotter pin in place.
