# **Report of Marine Survey**

**Vessel: 2021 Axis T22**

**Purpose: Pre-Purchase Condition & Valuation Survey**

**Date of Survey: October 23rd, 2023**

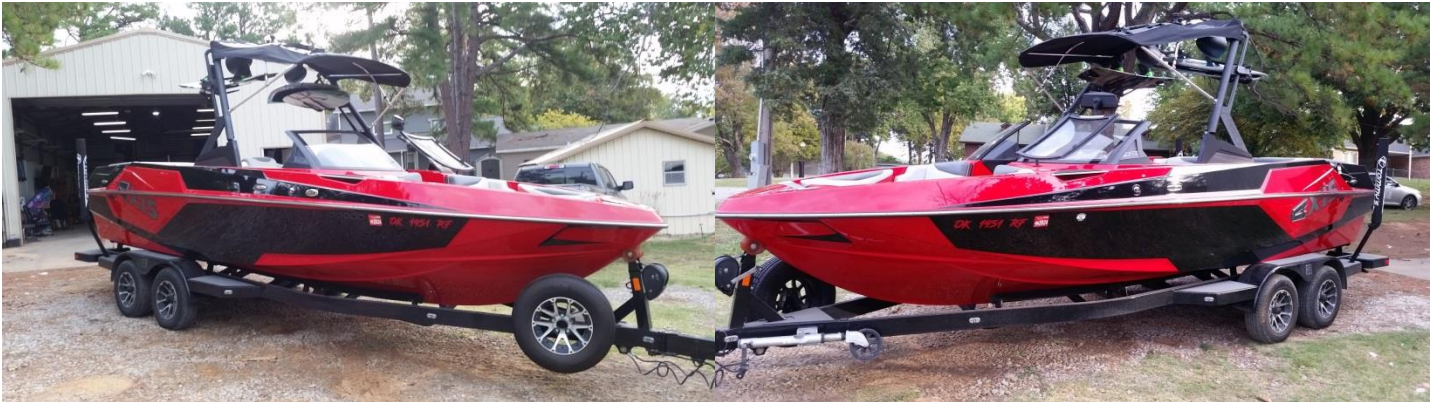
Starboard Side

Port Side

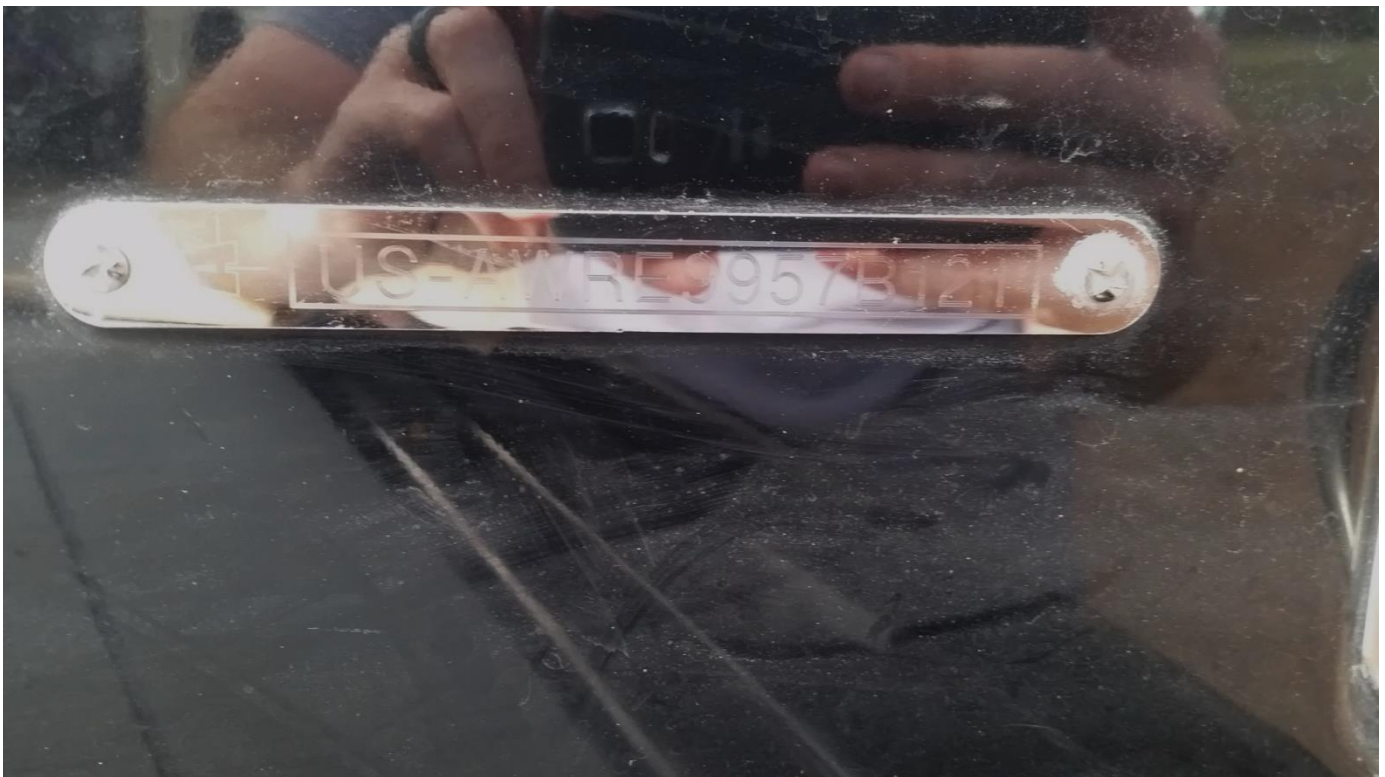
HIN# Starboard Aft Corner

**Hull ID number verification:** AWRE9957B121

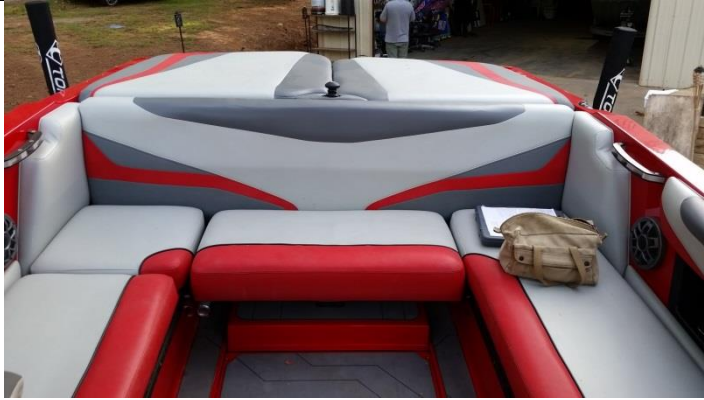
Aft Seating

<b>Helm Station:</b>	Helm located on starboard midships side of cockpit and equipped with molded instrument dash, control station and captain’s chair.
<b>Sole/Deck:</b>	Grey colored “Sea-Dek” throughout cockpit and on swim platform. <b>NOTE: Sea-dek throughout vessel is dirty and nicked in various areas, and is slightly peeled up along center deck hatch. Clean/repair/replace all as needed for cosmetic purposes.</b>
<b>Bimini Top:</b>	Stainless framed bimini top with black colored “sunbrella” material integrated into wakeboard tower and covering cockpit. Good overall condition.
<b>Seating:</b>	Adjustable captains seat at helm station with wrap-around “U” shaped seating in aft cockpit and “V” shaped seating at bow. Sunpad cushions on engine hatch cover. Vinyl cushions throughout vessel are white/silver/red in color and are in good overall condition. <b>NOTE: Aft seat cushions have several torn seams. Repair for cosmetic purposes and to prevent further damage.</b>

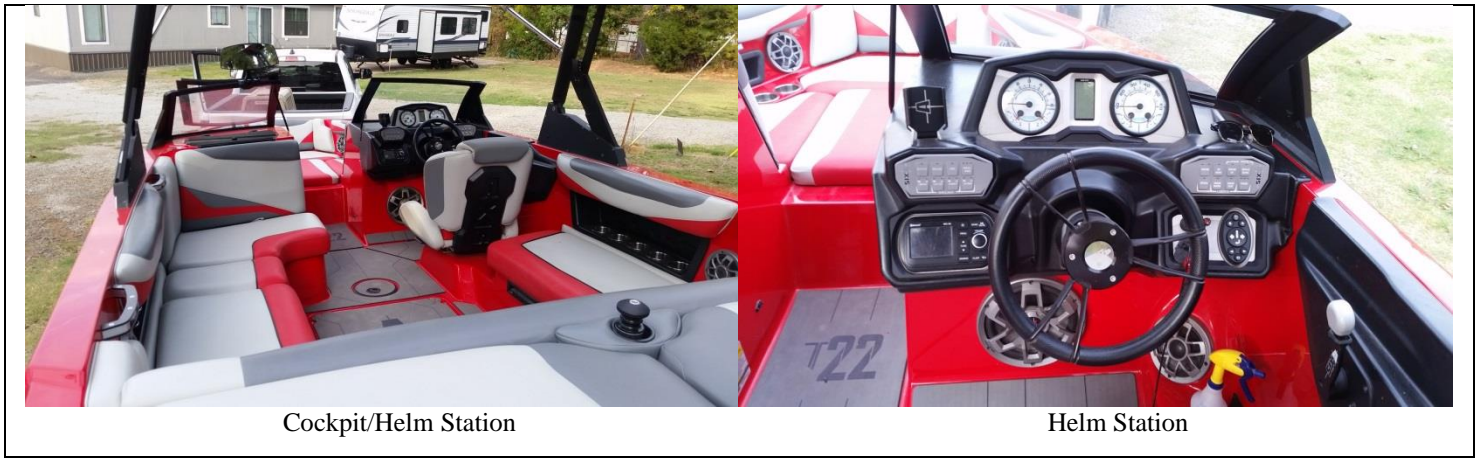
Cockpit/Helm Station

Helm Station

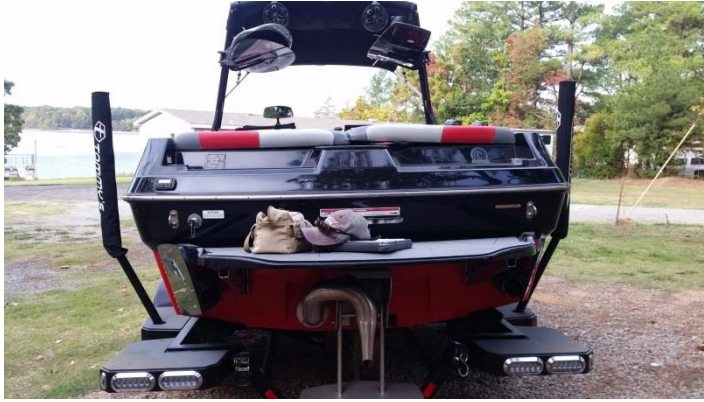
Transom

Percussion tested with phenolic hammer, no delamination or soft spots detected. No stress cracks or damages sighted.

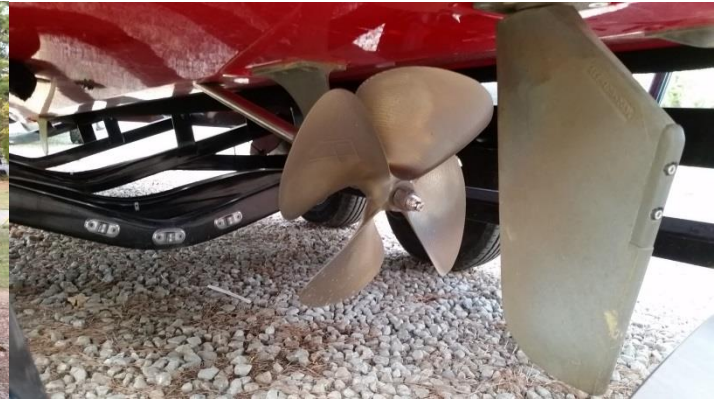
Running Gear

Stainless. Appears aligned, no corrosion or damages sighted.

Single bronze strut. Well bedded and secured. No damages sighted.

**Propeller:**Single bronze four bladed propeller. No damages, pitting, nicked, bent or burnt blades sighted. *Size/Pitch:* 15 x 13
