Report of Marine Survey

Vessel: 1996 Catalina 320 Sailboat

Purpose: Pre-Purchase Condition & Valuation

Date of Survey: September 28th, 2023

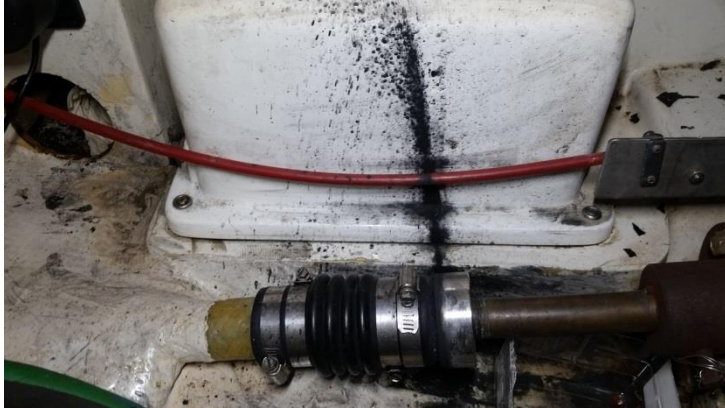
Shaft Seal: Packless Shaft Seal. *NOTE: Black colored "sling" mark sighted next to shaft seal indicating excessive wear/lack of lubrication. Have mechanic inspect and make necessary repairs. Failure to do so could result in catastrophic failure.*

Shaft Seal/Sling Mark Finding

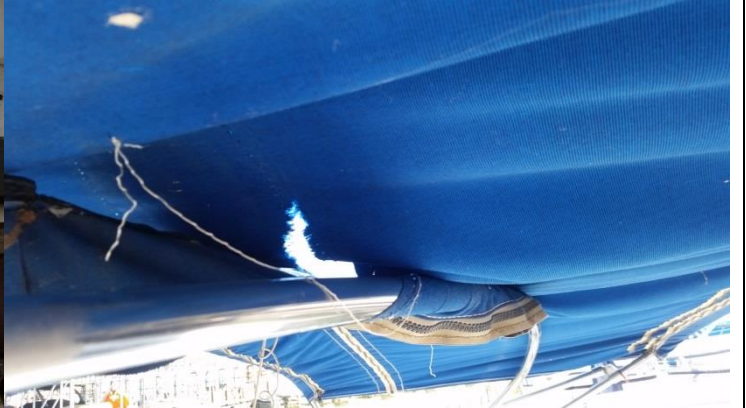
Stainless framed bimini top with blue sunbrella covering cockpit. **NOTE: Bimini fabric is ripped/torn in places and several threads are torn. Repair/replace as needed.**

Torn Bimini

4. NOTE: Bimini fabric is ripped/torn in places and several threads are torn. Repair/replace as needed.
5. NOTE: Forward cabin door (for V-berth) is broken. Repair.
