Report of Marine Survey

Vessel: 2003 Cobalt 246

Purpose: Inspection and Valuation

Date of Survey: January 7th, 2020

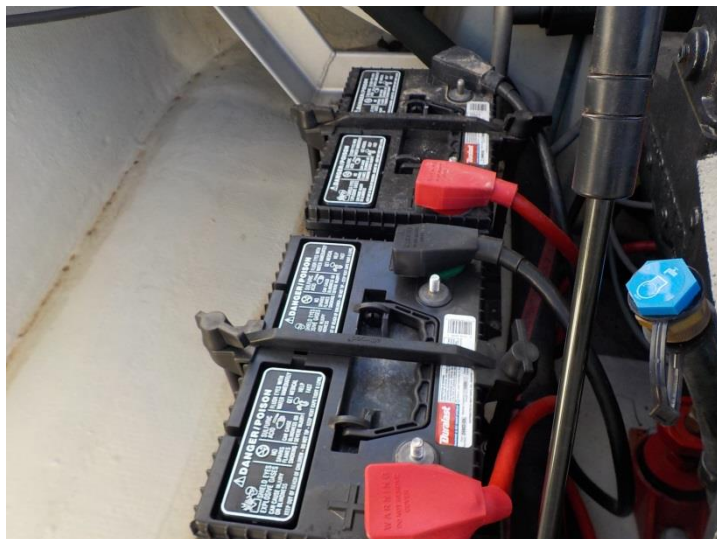
Batteries

Voltage System:	12v
Vessel Batteries:	Two “Duralast” lead acid 24 size batteries sighted in engine compartment. Secured in trays with brackets as per ABYC recommendations.
Battery Switch:	“Perko” battery switch located under aft seat cushion. Operational. Secured and installed in dry place.
Wiring Connectors:	Ring spade or crimp on connectors sighted for wiring connections. Boots are installed on all battery terminals as per ABYC recommendations.
Charging System:	Alternator on engine. No external charger.
Distribution Panel:	12v switches located at helm and next to engine throttle/shifter.
DC Wiring:	Stranded insulated wire. Secured every 18” as per ABYC recommendations where accessible for inspection.

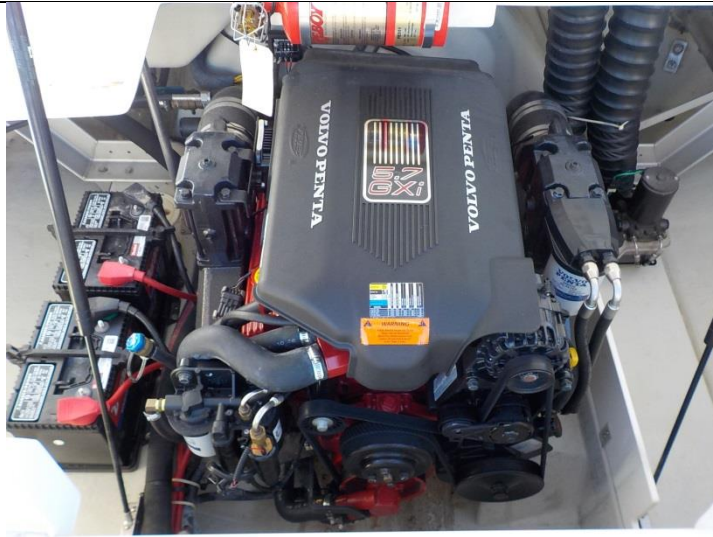
Propulsion Type:	Inboard Outboard.
NO#/Type/Cylinders:	One gasoline fuel injected V8 engine. 320 horsepower.
Make/Model/Serial:	<i>Make:</i> Volvo Penta <i>Model#</i> 5.7 GXI-E 3869222 <i>Serial#</i> 4012089667
Engine Hours:	359 hours as per meter inside engine compartment.
Hoses and Clamps:	Average condition, no cracks sighted. Hoses are double clamp where required.
Belts and Pulleys:	Belts are serviceable. No cracks or splits sighted. Pulleys/belts appear to be in line.
Cooling System(s):	Raw water cooled with raw water intake through lower out drive unit, circulated through engine and combined with engine exhaust and routed through out drive props.
Oil Level/Condition:	Full and clean on dipstick. No evidence of water in lube oil.
Flame Arrestor(s):	USCG approved. Clean.
Engine Ventilation:	Blowers and natural ventilation. See safety section of survey for details.
Engine Fuel Pump:	Engine mounted fuel pump. Ignition protected. No leakage sighted.

Engine Fuel Filter:	Engine mounted fuel filter. No leaks sighted.
Engine mounts/beds:	Engine mounts appear to be well secured to the support stringers. Percussion tested where accessible, no delamination sighted.
Ground Cable:	Connected.

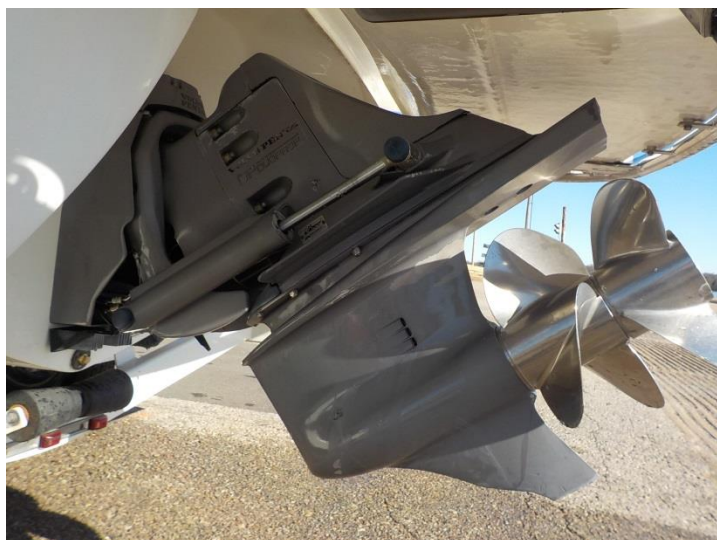
Port Side of Outdrive

Sound, operational. **NOTE: Minor amount of galvanic corrosion sighted on outdrive, specifically on skeg, around prohub and trim cylinders. Monitor condition and sand/repaint at next service interval.**

Notes:	NOTE: Unknown amount of time since outdrive was last serviced. Surveyor recommends having outdrive serviced including bellows, lower unit oil, u-joint and gimbal bearing.

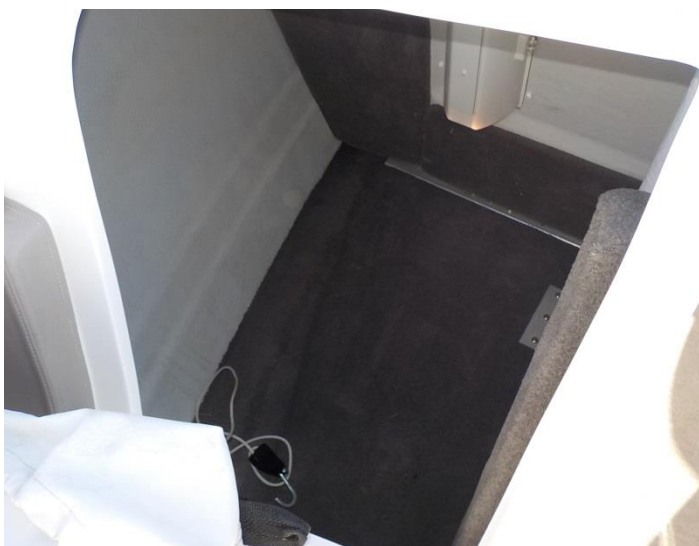
**Head Compartment**

Located under dash on port side. **NOTE: No porta-pottie sighted in head compartment. Be advised.**

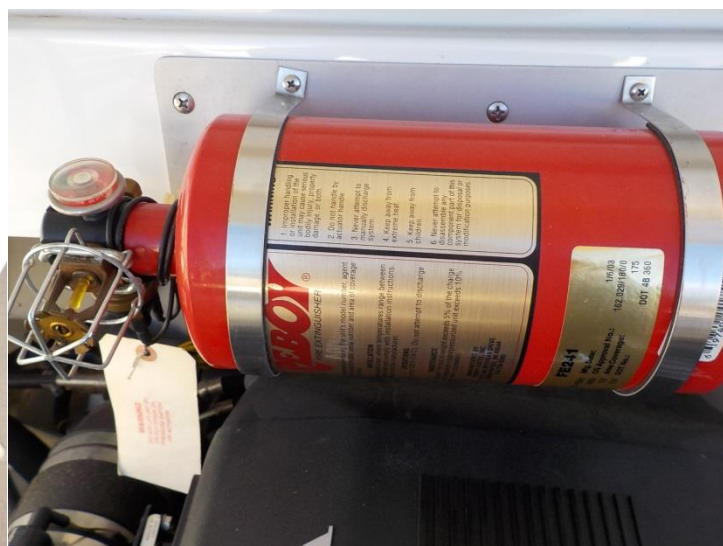
**Automatic Fire Extinguisher Bottle**

Bilge Blower(s):	One inline blower sighted and properly secured. Properly connected to engine vent and routed to lower 1/3 rd of engine compartment as per ABYC. NOTE: Blower motor is making loud bearing noise. Repair ventilation blower.
Fire Extinguishers:	“Kidde” 3lb dry chemical extinguisher sighted next to helm seat and is secured with bracket. Gauge reads full. USCG compliant.
Fixed Extinguisher:	“Fireboy” Clean agent automatic fire extinguishing bottle located in engine compartment, secured on bulkhead with stainless straps. Gauge reads full. NOTE: Fixed fire extinguisher in engine space has outdated certification tag. ABYC A-4 and NFPA 302 recommends that fixed fire protection systems be inspected and reweighed at one year intervals and tagged accordingly. Comply.

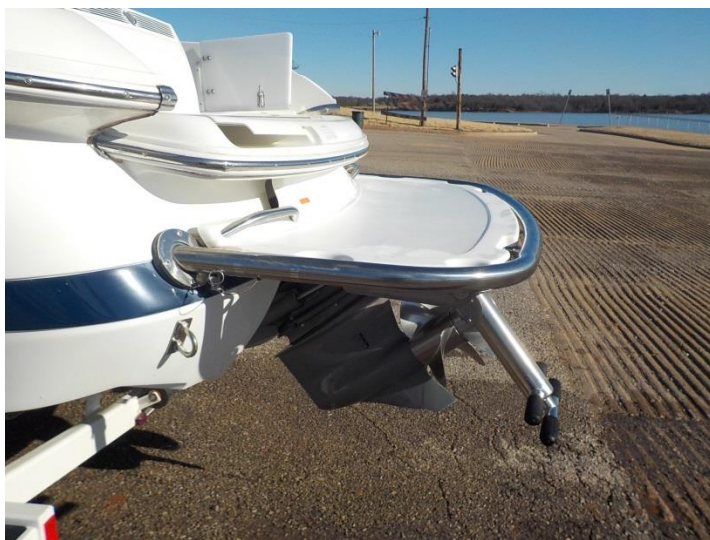
**Swim Platform**

Hull Construction Material:	Fiberglass with white gelcoat surface. Blue striping at waterline and above rub rail. Gelcoat on hull sides is in good clean well buffed condition. NOTE: (1) Starboard-bow- 1/8" gelcoat void above rub rail. (2) Starboard-bow- 3"x1" scuff mark above rub rail. Repair both as needed for cosmetic purposes.
Swim Platform:	Fiberglass, attached onto transom. No damages or soft spots detected.
Rub Rail:	Stainless on white plastic backing plate. Well secured, no missing screws, caulking appears sufficient.
Transom:	Re-enforced frp transom with attached outdrive. Percussion tested, no delamination or thudding detected.
Boarding Ladder:	Stainless telescoping boarding ladder under swim platform on port side. Operational, complies with ABYC recommendations.

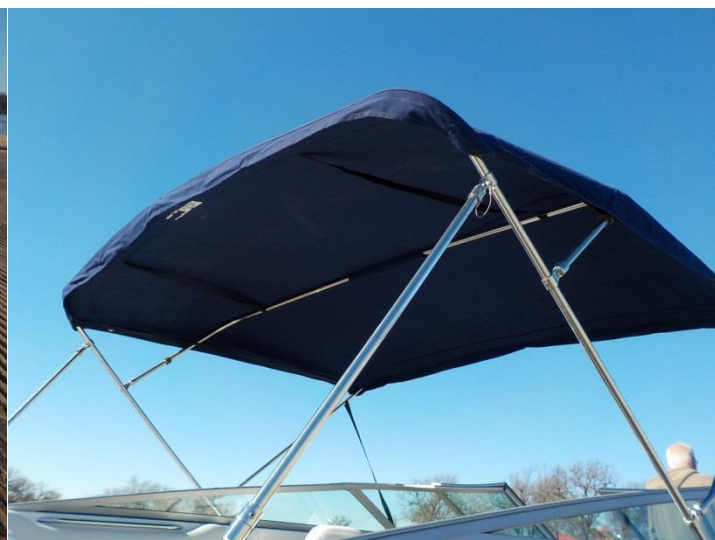
**Bimini Top**

Stainless framed bimini top with blue "Sunbrella" covering cockpit. Boot for storage. Average overall condition. No nicks, tears or damages sighted.
