Report of Marine Survey

Vessel: 1984 Harbor Master 520

Purpose: Condition and Valuation

Date of Survey: August 28th, 2019

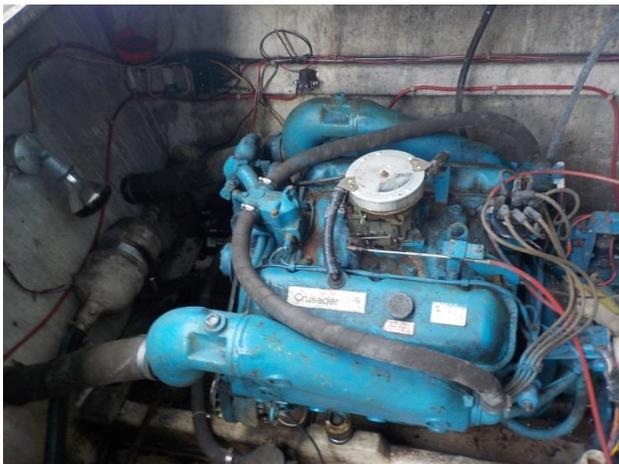
Port Engine

Engines Started:Attempted to start and run both engines at dock. **NOTE:** (1) Starboard engine starts but will not stay running. (2) Port engine will not start. Repair both engines.
