Report of Marine Survey

Vessel: 2003 Luhrs 34 Convertible

Purpose: Pre-Purchase Condition & Valuation

Date of Survey: December 8th, 2023

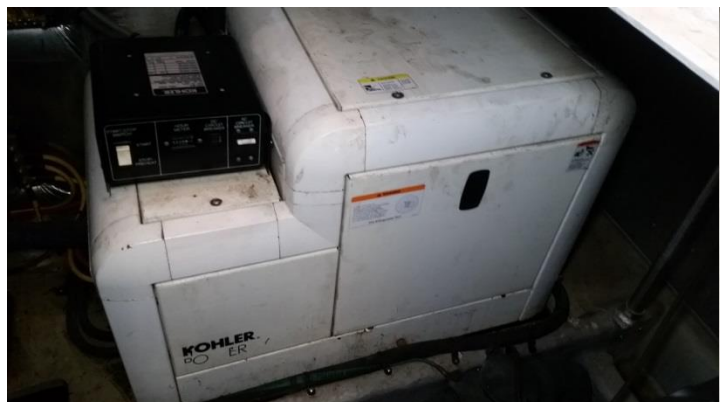
Generator

Side hull exit exhaust with fiberglass muffler and wet exhaust hose. Hoses are securely double clamped at each connection as per ABYC recommendations. **NOTE: Exhaust hose from generator to muffler is severely cracked. Replace hose.**

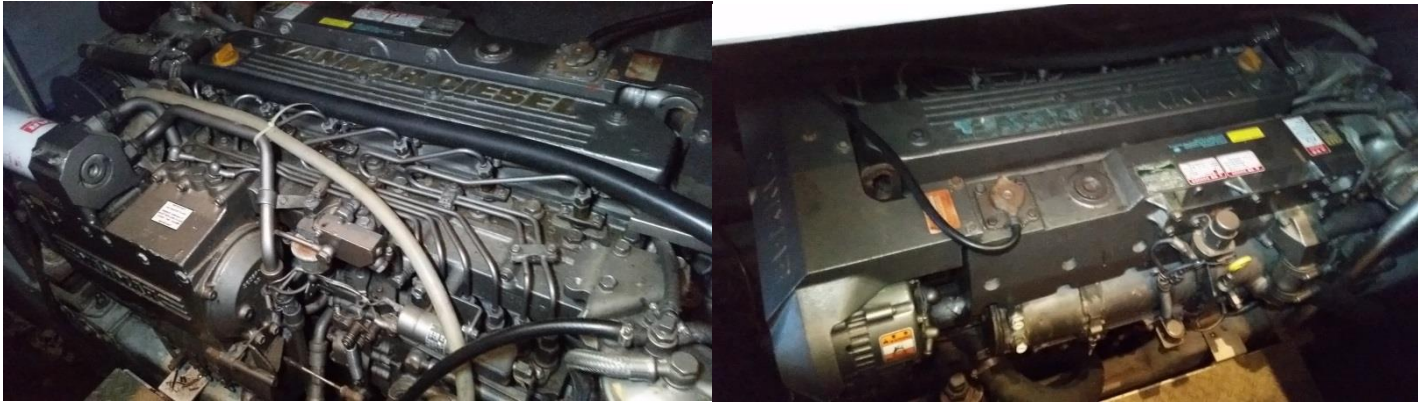
Port Engine
	Starboard Engine

Hoses are clamped where required and are in serviceable condition except where noted. **NOTE: Hose going from heat exchanger to exhaust on each engine is severely cracked and is leaking water on the starboard engine. Replace hose on each engine. NOTE: Water hose on starboard engine located under the alternator is leaking/spraying water into the bilge when the engine is running. Repair.**
