# **Report of Marine Survey**

**Vessel: 2007 Sea Ray 320 Sundancer**

**Purpose: Pre-Purchase Condition & Valuation**

**Date of Survey: December 15th, 2023**

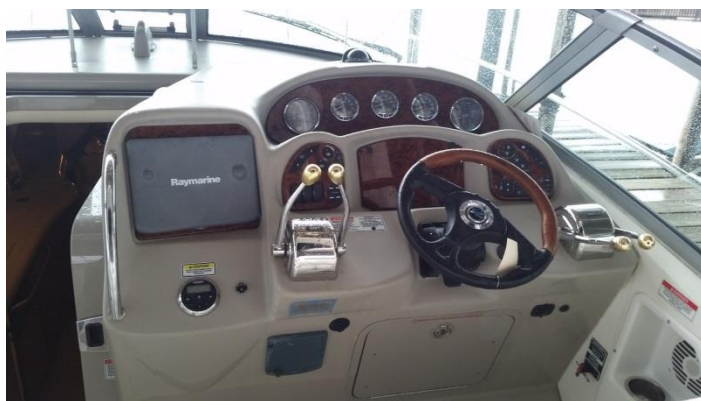
Helm Station

Analogue gauges for speedometer, engine hours, engine tachometer, fuel level, engine temperature, alternator voltage and oil pressure. **NOTE: Engine status gauges – glass is cracked in places on each gauge. Repair as needed.**

2. NOTE: Bimini top – forward part of bimini – fabric is missing from frame. Replace.
3. NOTE: Engine status gauges – glass is cracked in places on each gauge. Repair as needed.

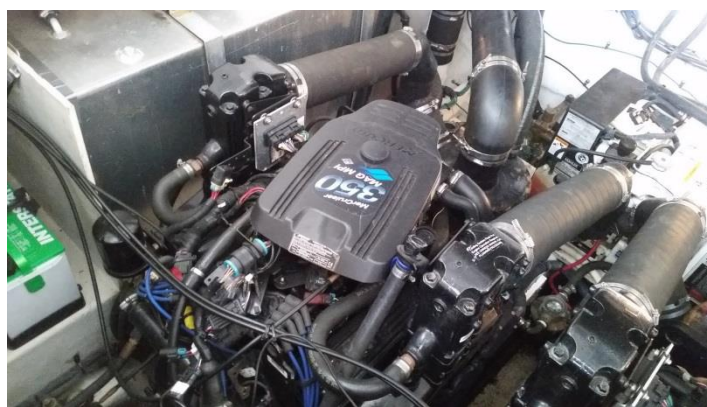
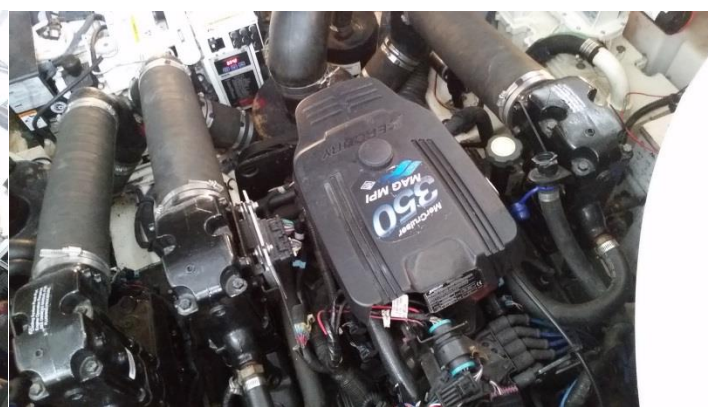
<b>Piping/Clamps:</b>	Fiberglass piping and wet exhaust hose. Hoses are securely double clamped with ½” hose clamps at each connection as per ABYC recommendations. <b>NOTE:</b> Engine “tattle tale” exhaust hoses are cracked on each engine. Replace each.
<b>Manifold/Risers:</b>	Serviceable. No leakage, excess corrosion or cracks sighted. No overheating felt during lake test.

Marine hardwall water hose. Each are securely clamped with stainless hose clamps at each connection. **NOTE:** (1) Raw-water hose on each engine is cracked in various places along entire length from seacock to engine. (2) Generator raw-water hose is cracked in numerous places along entire length from seacock to generator. (3) Air conditioner raw-water hose is cracked in in numerous places along entire length from seacock to pump. Replace all cracked and worn raw-water hoses.

10. NOTE: Starboard rudder packing is leaking. Repair/tighten so it does not leak.
11. NOTE: (1) Raw-water hose on each engine is cracked in various places along entire length from seacock to engine. (2) Generator raw-water hose is cracked in numerous places along entire length from seacock to generator. (3) Air conditioner raw-water hose is cracked in numerous places along entire length from seacock to pump. Replace all cracked and worn raw-water hoses.

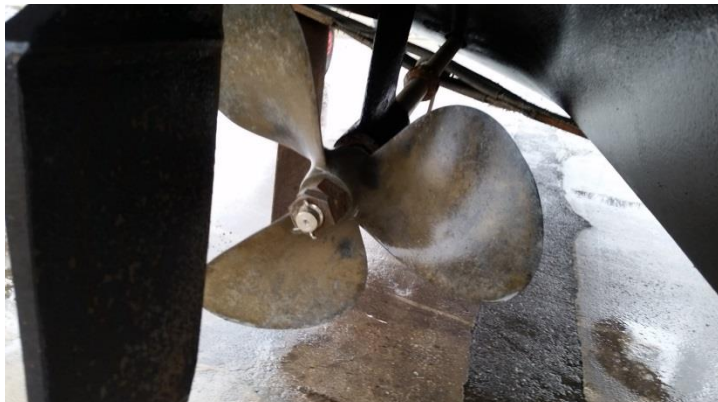
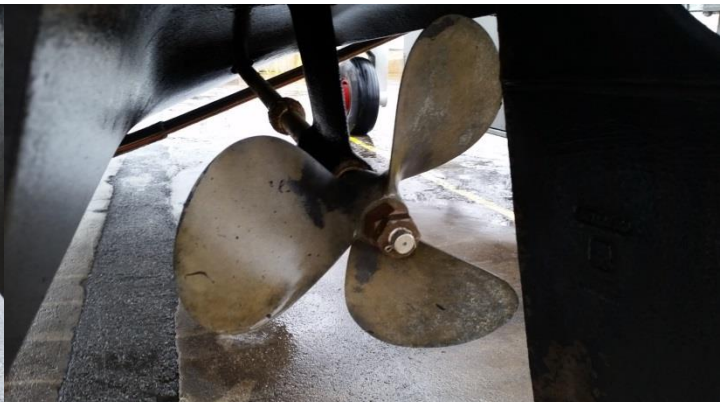
<b>Shafts/Struts:</b>	Single bronze strut and stainless shaft for each engine. Struts are in serviceable condition and bedding appears adequate. Shafts are serviceable.
<b>Shaft Bearing:</b>	Serviceable on each shaft.
<b>Propellers:</b>	Bronze three bladed propeller on each shaft (counter rotating). No bent blades, cracks or damages sighted, cotter pins in place. <i>Size/Pitch:</i> 18 x 19
<b>Rudders:</b>	Bronze rudder(s). Well secured, no damages and minimal corrosion sighted.

8. NOTE: Seacock valves are stiff and difficult to operate. Have mechanic lubricate and exercise each seacock valve to enable easy operation.
9. NOTE: Thru-hull fitting for each engine – intake grate is smashed inward. Replace/repair as needed.
